Structural Inspection

Inspection for Full Plans Application for Conversion at

**Moor Farm,
Talatton,
Exeter,
Devon, EX5 2RF**

Reference R220516/SI/00

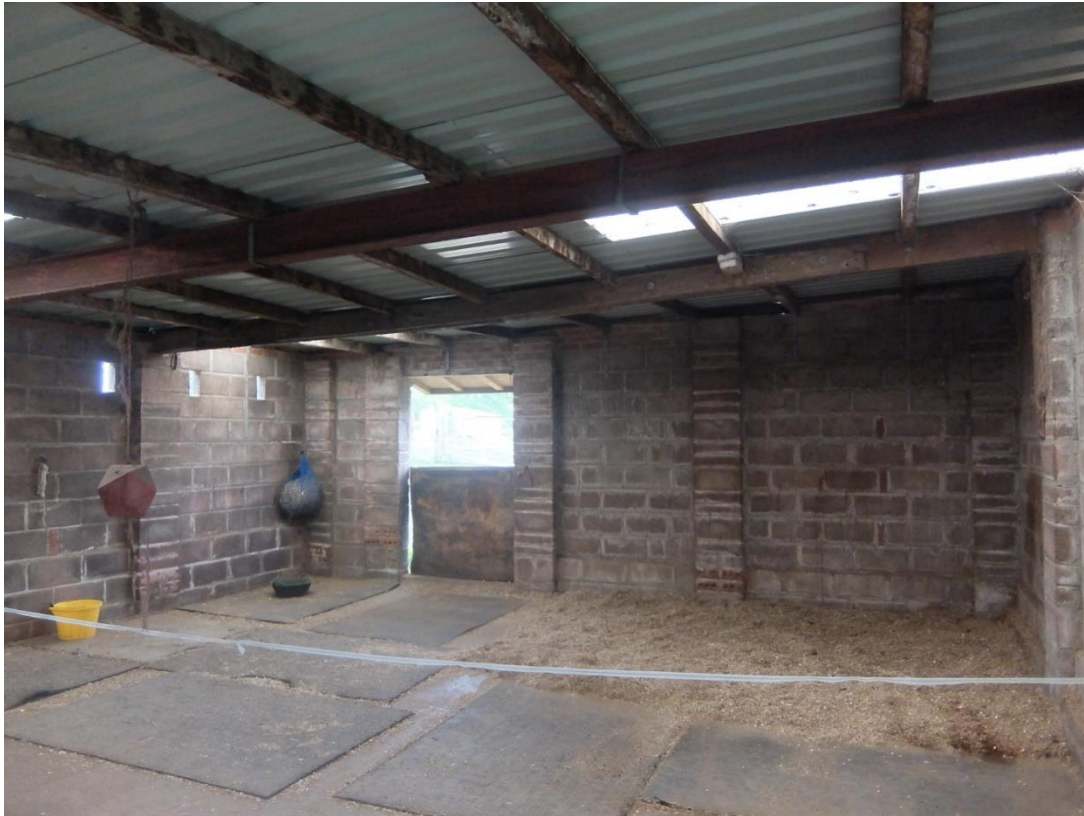
Internal view looking towards right side wall

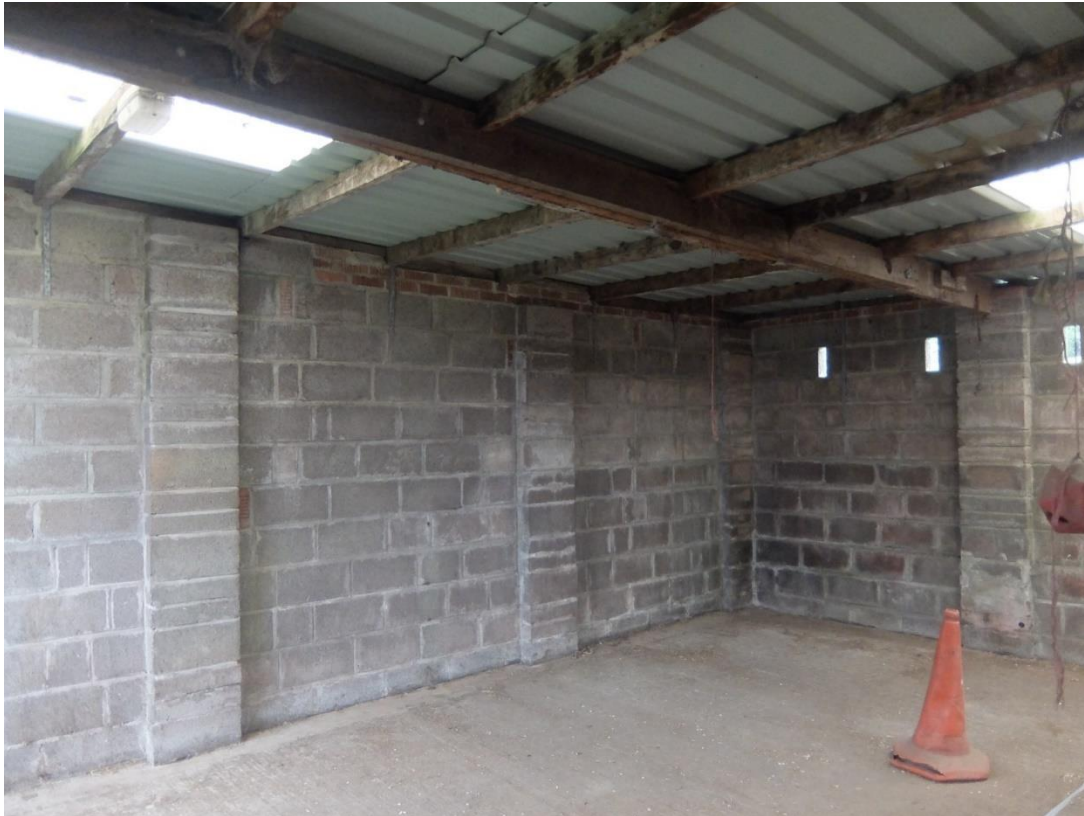
Internal view looking towards rear left corner
