Civil & Structural  
Chartered Engineers

28<sup>th</sup> July 2022

Our ref: CA/2022204  
Your ref:

**Re: STRUCTURAL SURVEY APPRAISAL OF STONE BARN AT PYLEMOOR FARM, WASHFIELD, TIVERTON, EX16 9RF.**

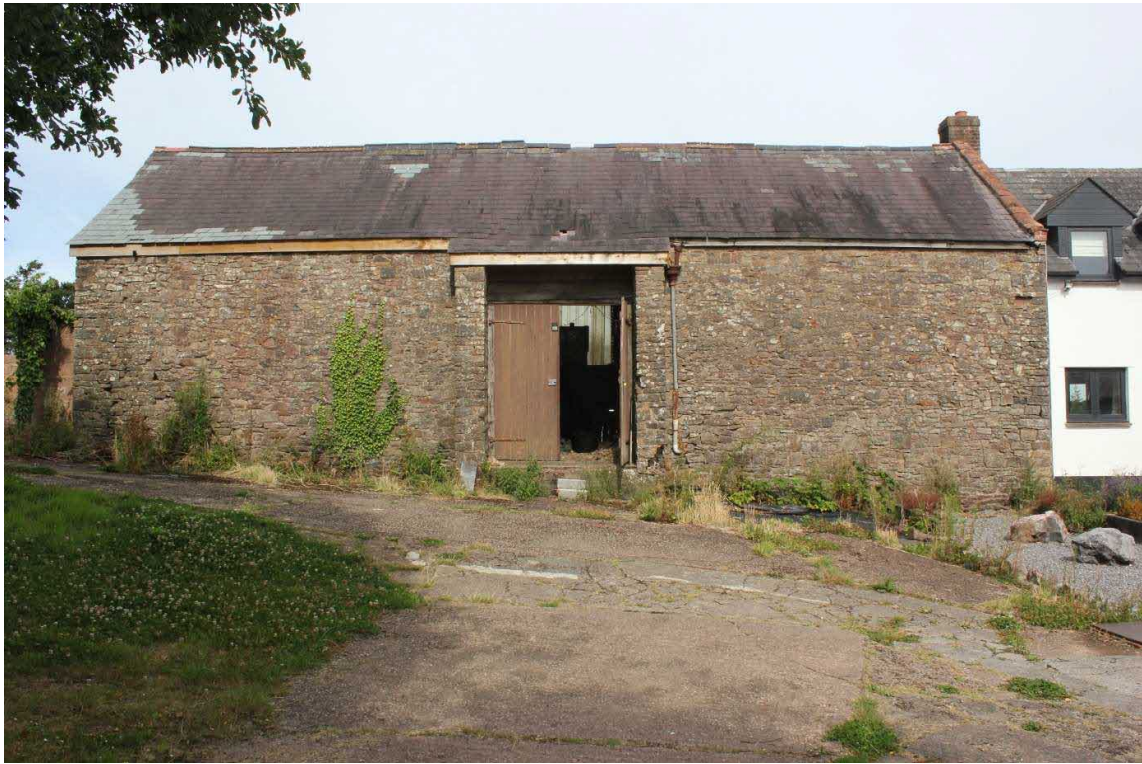
Photograph 3 Side (East) Elevation

External elevations are predominantly of natural stone masonry with some concrete blockwork at blocked up openings. When measured using a 1.2m long spirit level the walls were generally straight and vertical and the corners square, The walls appeared in reasonable condition. On the East and West side elevations, at mid length were full height, 8 ft wide (2.4 m) openings, with external stone piers on either side, from floor slab to eaves [approximately 12 ft (3.6 m)]. On the East side the opening contained double doors while on the West side it contained a dwarf blockwork wall and translucent sheeting. On the East side the ground sloped down, from the south-east corner to the north-east corner, where external ground level was about 37 inches (950 mm) below the barn's floor slab. The walls were measured as 19 inches (480 mm) thick, as were the piers. There was no readily apparent evidence to suggest an issue with either ground movement or ongoing settlement of the walls.

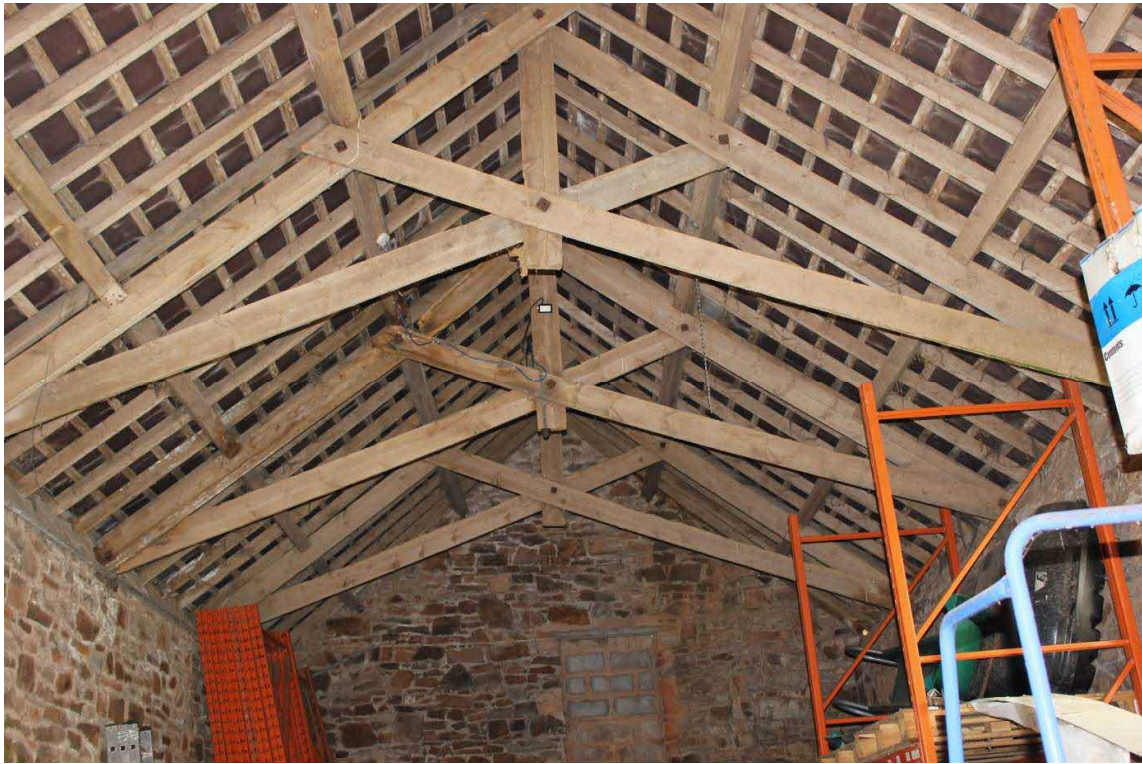
Photograph 9 Internal View of Roof

The roof structure comprised bolted timber trusses of a scissor truss type with two lines of equally spaced timber purlins between ridge and eaves supporting timber purlins. The roof pitch was estimated to be 40 degrees with the six trusses spaced at about 8 ft (2.4 m) centres. The trusses were in very good condition with no readily apparent evidence of undue distress or deformation. The purlins were in good condition and of an appropriate size, as were the rafters. There was some evidence of deflection of the purlins, but this was considered to be within tolerance for the respective spans. At the south elevation the purlins extended through the wall and there was evidence of decay and loss of section to their ends.

It was our opinion that the roof structure was not contemporaneous with the walls, however it appeared to be of significant age and was not, in our opinion, of recent construction. Overall, the roof structure was in good condition and suitable for retention.

The existing purlins, rafters and tiling battens could also be retained. We note that, if required, it would be relatively simple to carry out minor repairs / replacement of damaged or decayed timber members.

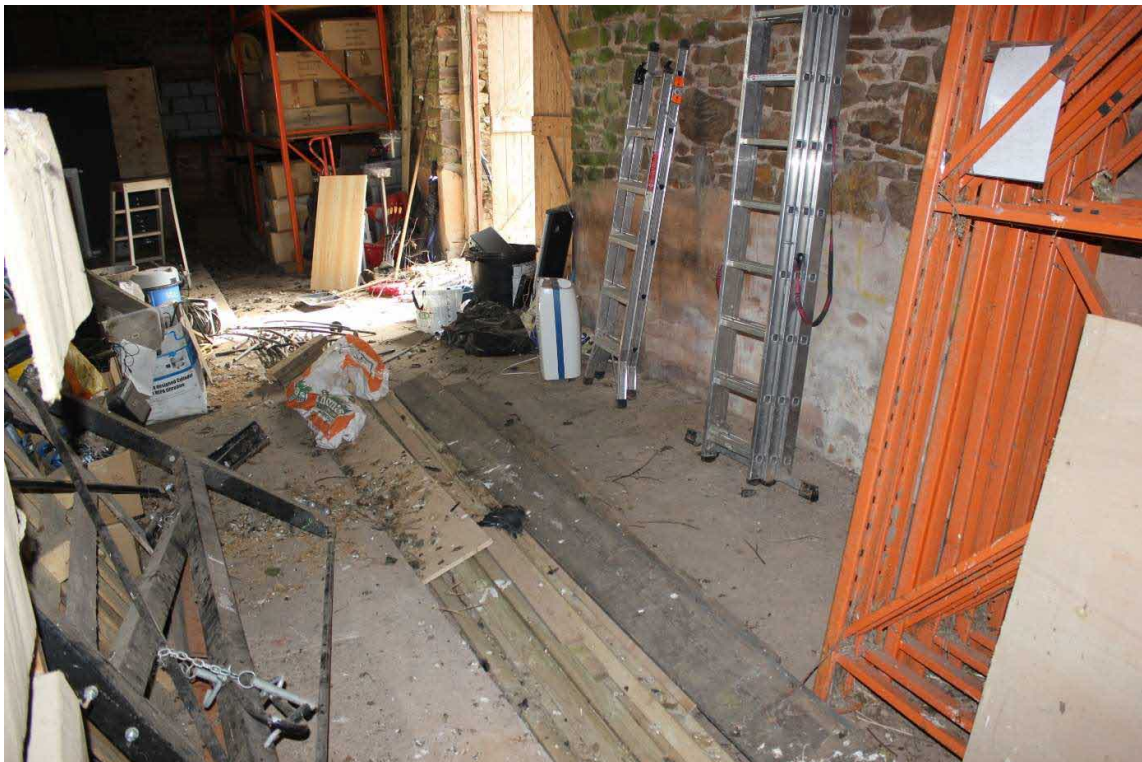
Photograph 10 Internal View of Floor

The ground floor of the barn comprised a concrete ground bearing slab. The slab was in good condition with no readily apparent cracking that would suggest ongoing settlement or ground movement.
