ANDREW MARCHAM & Co.

Re:- Cider Mill Barn, Coldpool Lane, Badgeworth, GL51 4UP

I refer to instructions conveyed in connection with your application to the Local Planning Department for permission to convert the above property to residential use and in this respect, a report of my findings and recommendations is as follows:-

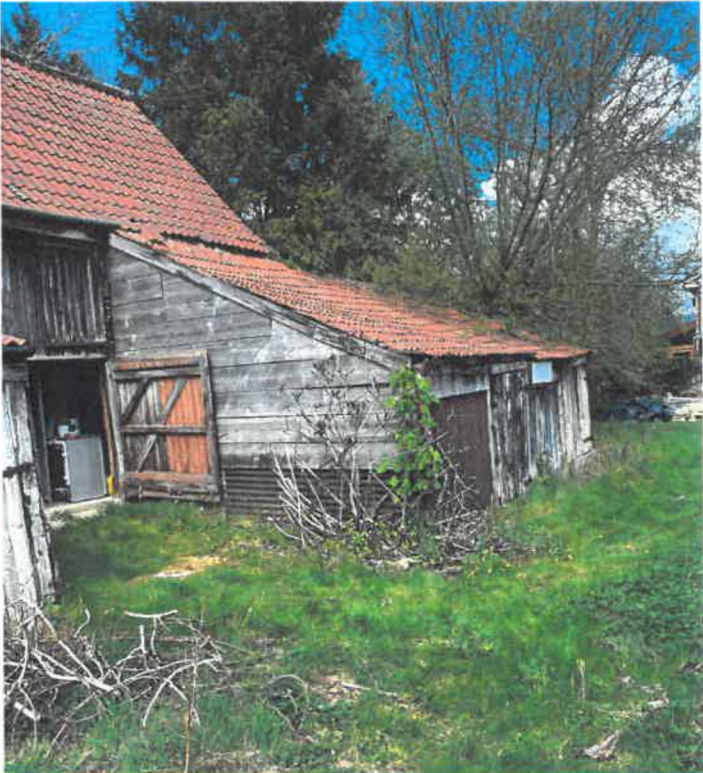
When viewed externally, the main Barn walls were found to be in reasonable vertical and horizontal alignment given overall age of building with no evidence to indicate any ongoing lateral, vertical or foundation related movement present. Similarly, and whilst some surface undulation can be seen at the purlin support locations, the roof slopes are in reasonable alignment with no evidence to indicate any progressive lateral displacement.

Front of building with right hand lean-to projection. Note, roof slopes in very good alignment

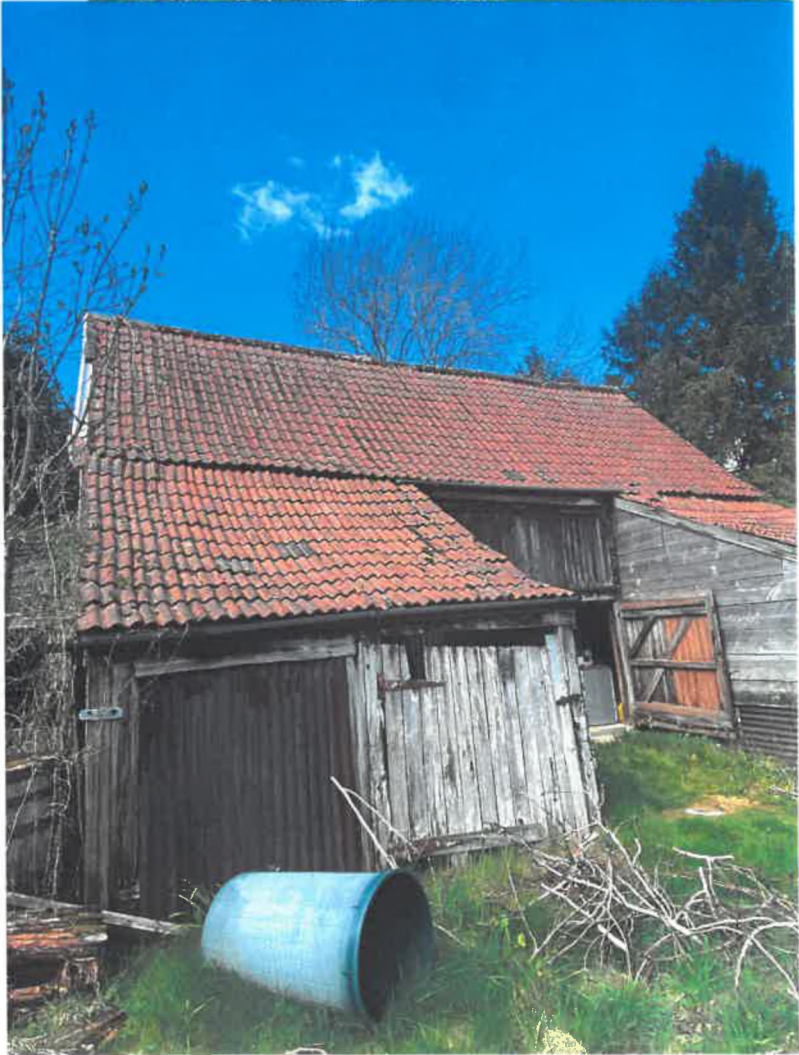
Front roof on left side again in very good alignment to main Barn

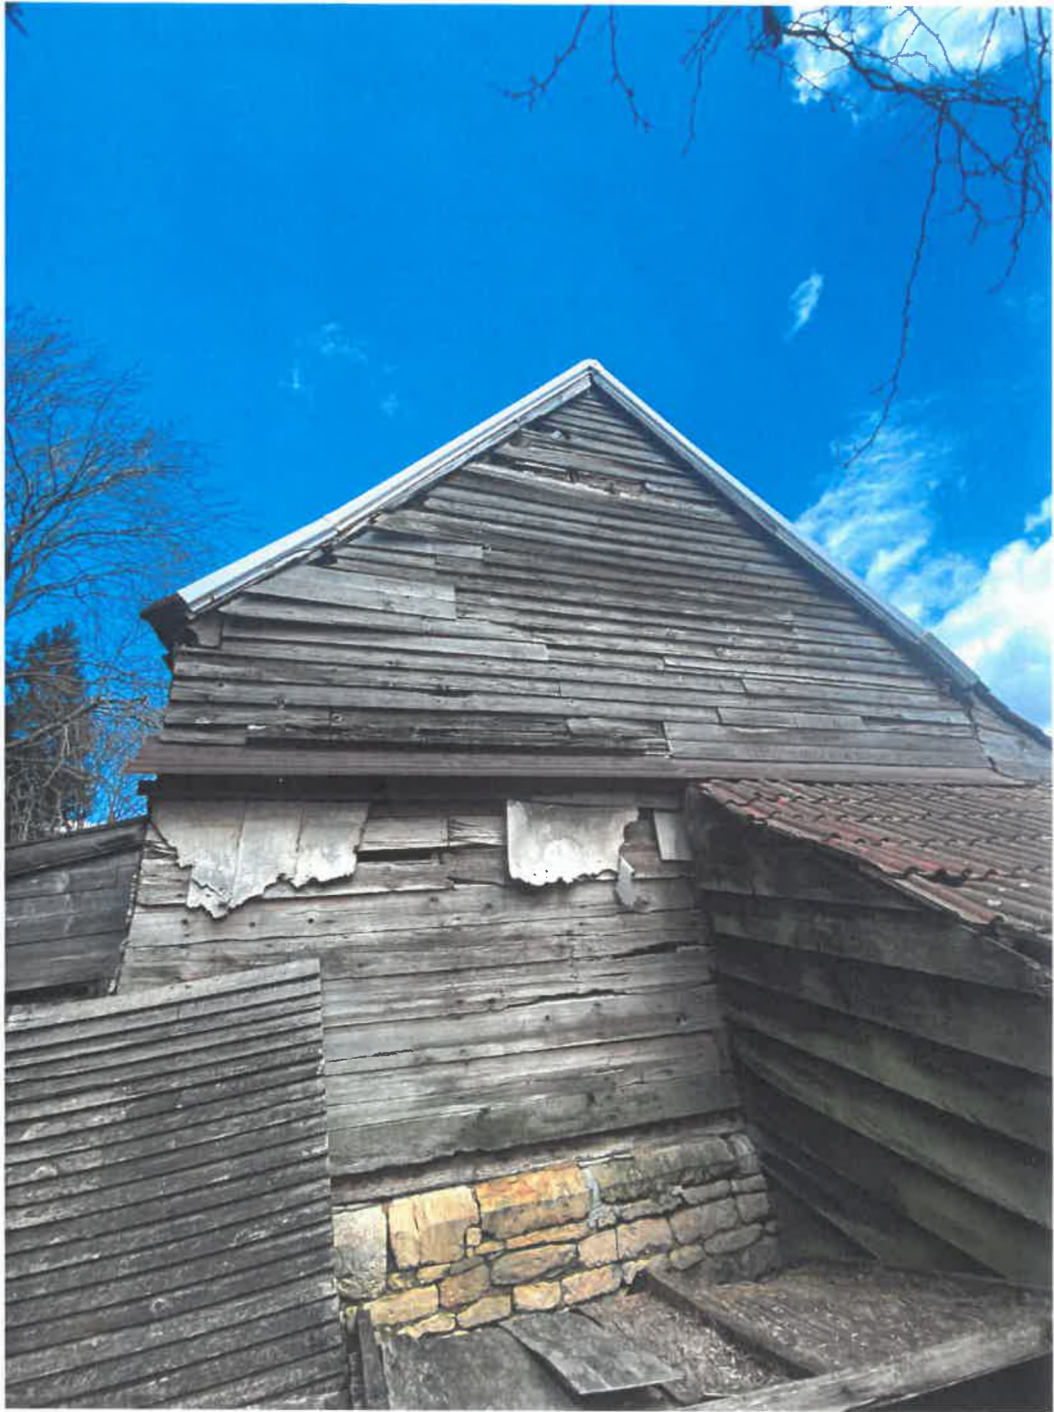
Weather boarded Gable wall rising off fair faced stone plinth

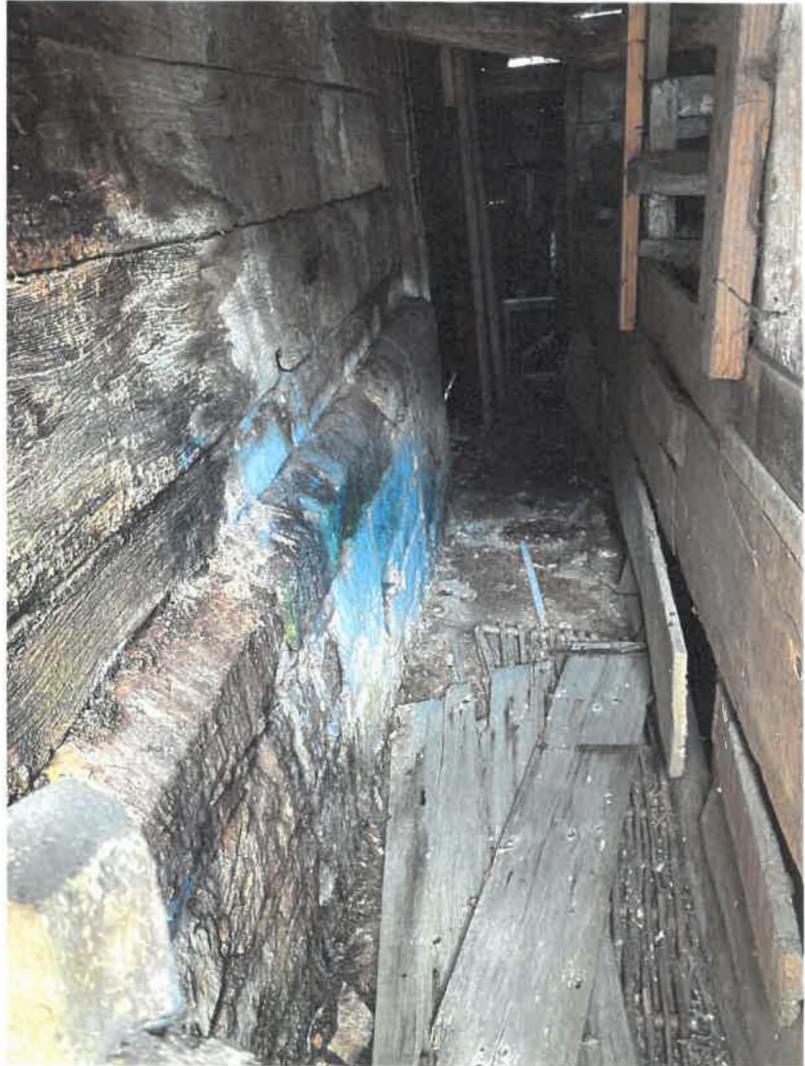
The natural stone plinth around the perimeter of the main Barn has suffered weathering to mortar joints although this is simply a maintenance item and not the result of any ongoing structural movement.

Masonry plinth to main Barn
front wall within lean-to
projection

Regarding existing foundations, conversion to a dwelling will not result in any significant increase in vertical loading and it should not therefore be necessary to underpin or otherwise improve the existing footings. Any stonework found to be in a loose condition should be made good and general repointing is required. Provision of a damp proof course in the stone plinth is not normally recommended for a Grade II Listed building although dampness could be catered for by provision of lime plaster internally.

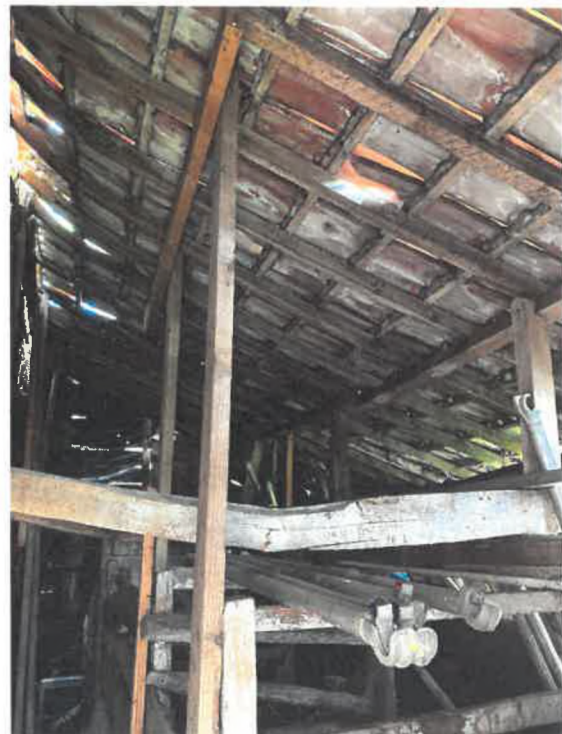
The roof to the single storey front left and right hand projections comprise a simple arrangement of lean-to timbers albeit again generally serviceable for then current roof covering.

Lean-to roof

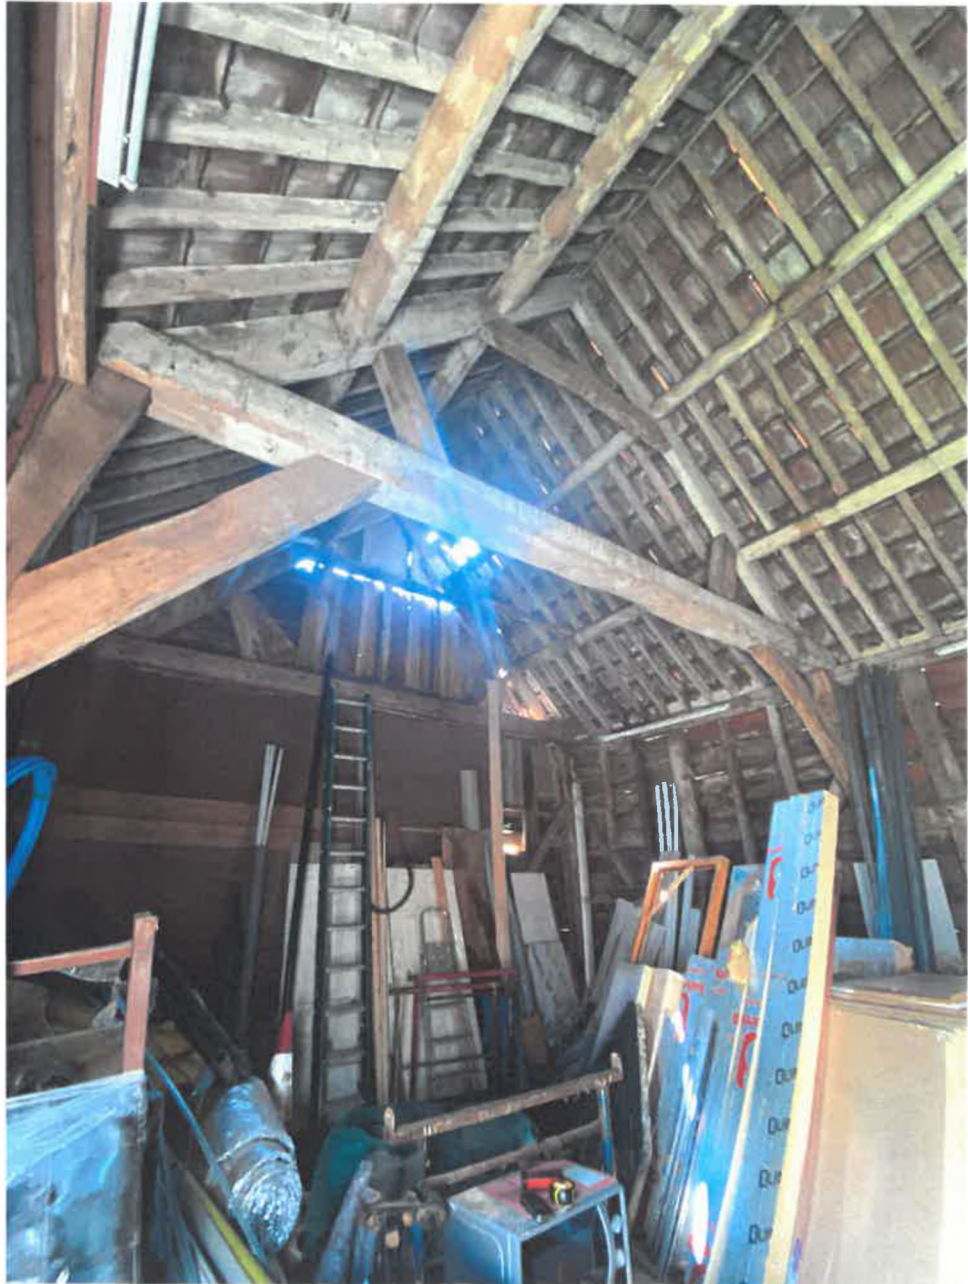
The main roof trusses are of Queen-post configuration of 200mm x 300mm hardwood sections which incorporate knee bracing at the support post locations to maintain lateral stability. There is some evidence of lean towards the rear of the building albeit clearly longstanding and non-progressive. The purlins comprise two, 200mm x 150mm hardwood timbers to each slope which span between the gable ends and the intermediate Queen-post trusse. Such timbers exhibit some evidence of deflection although this is clearly longstanding and non-progressive.

Roof truss with substantial knee bracing to maintain lateral stability

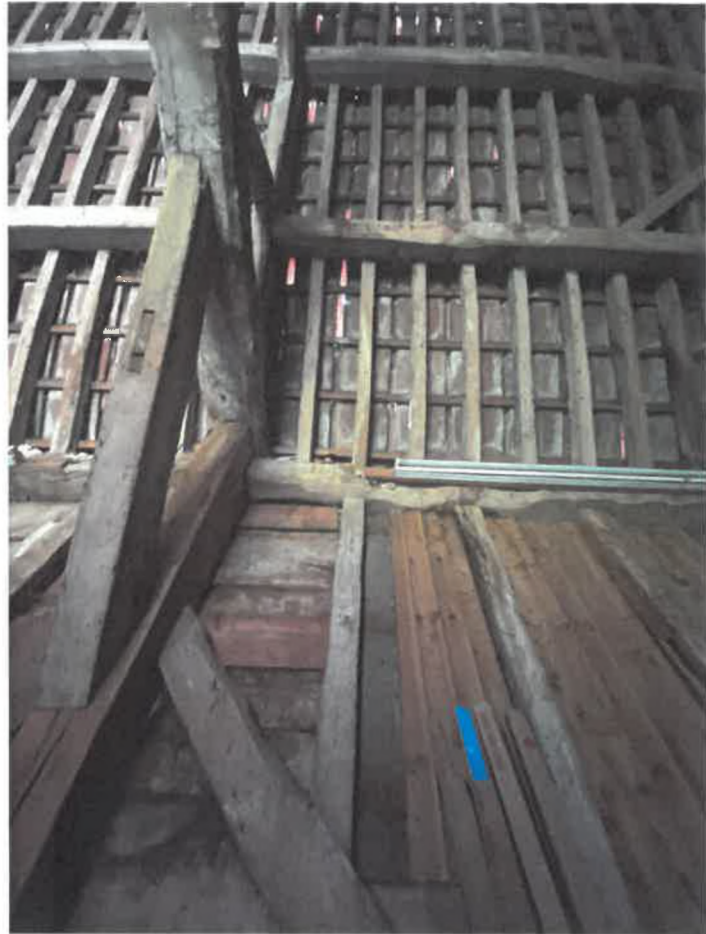
View on underside of roof within Barn, note substantial truss and purlins

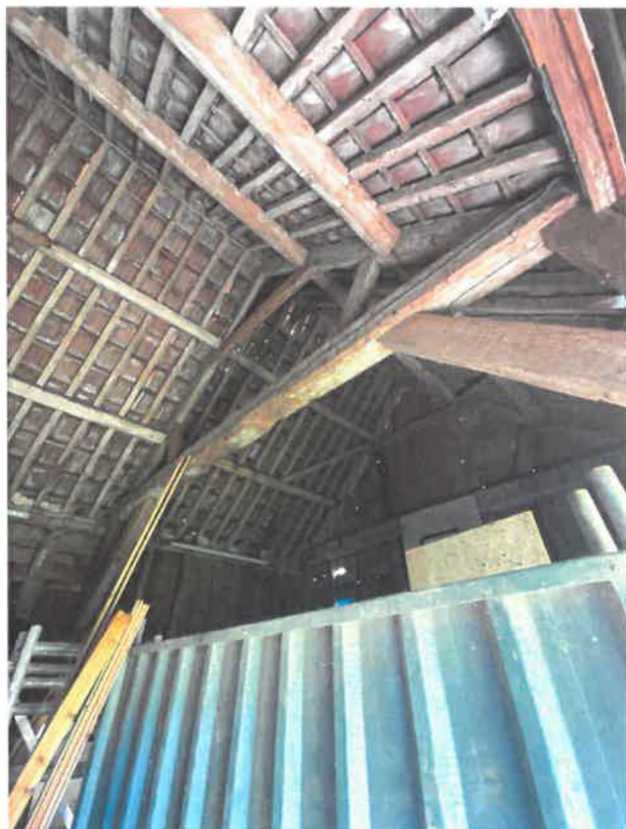
Another view on the substantial roof trusses and purlins
