Re:- Cider Mill Barn, Coldpool Lane, Bad2eworth, GL51 4UP

I refer to instructions conveyed in connection with your application to the Local Planning Department for permission to convert the above property to residential use and in this respect, a report of my findings and recommendations is as follows:-

Inspection

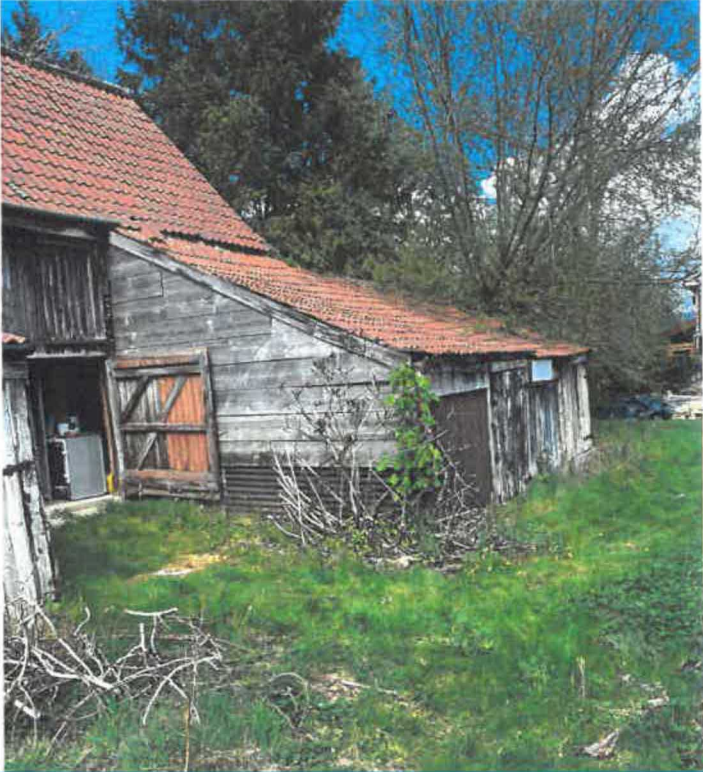
Front of building with right hand lean-to projection. Note, roof slopes in very good alignment

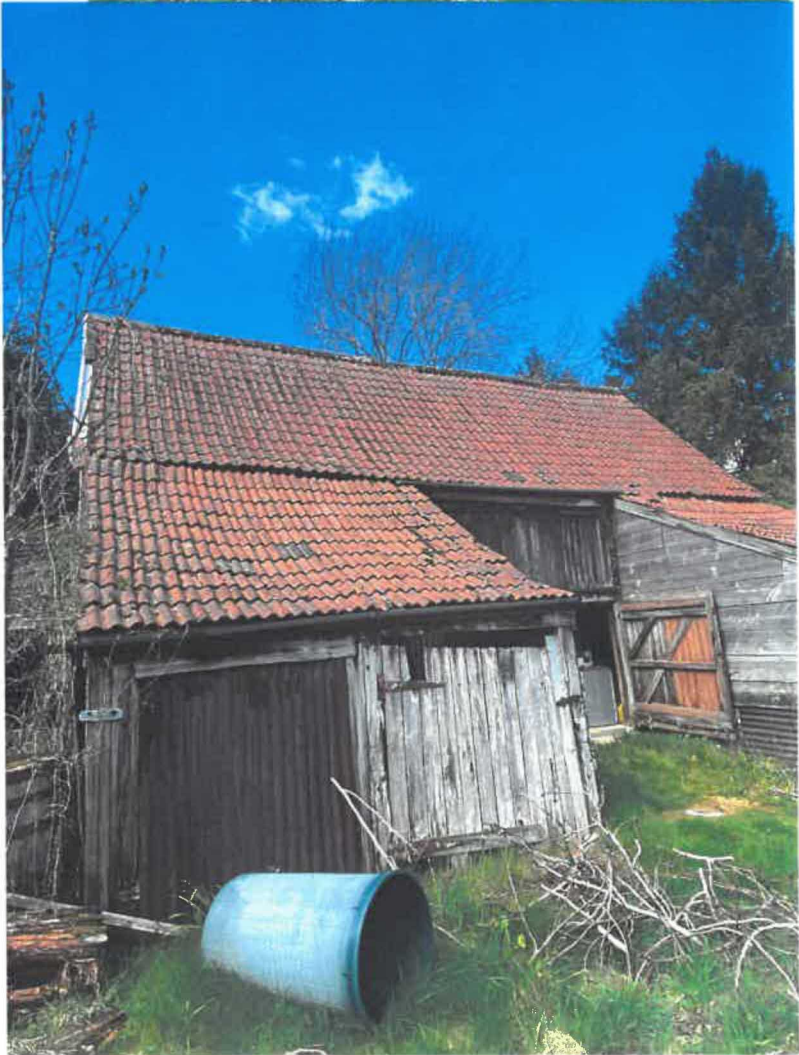
Front roof on left side again in very good alignment to main Barn

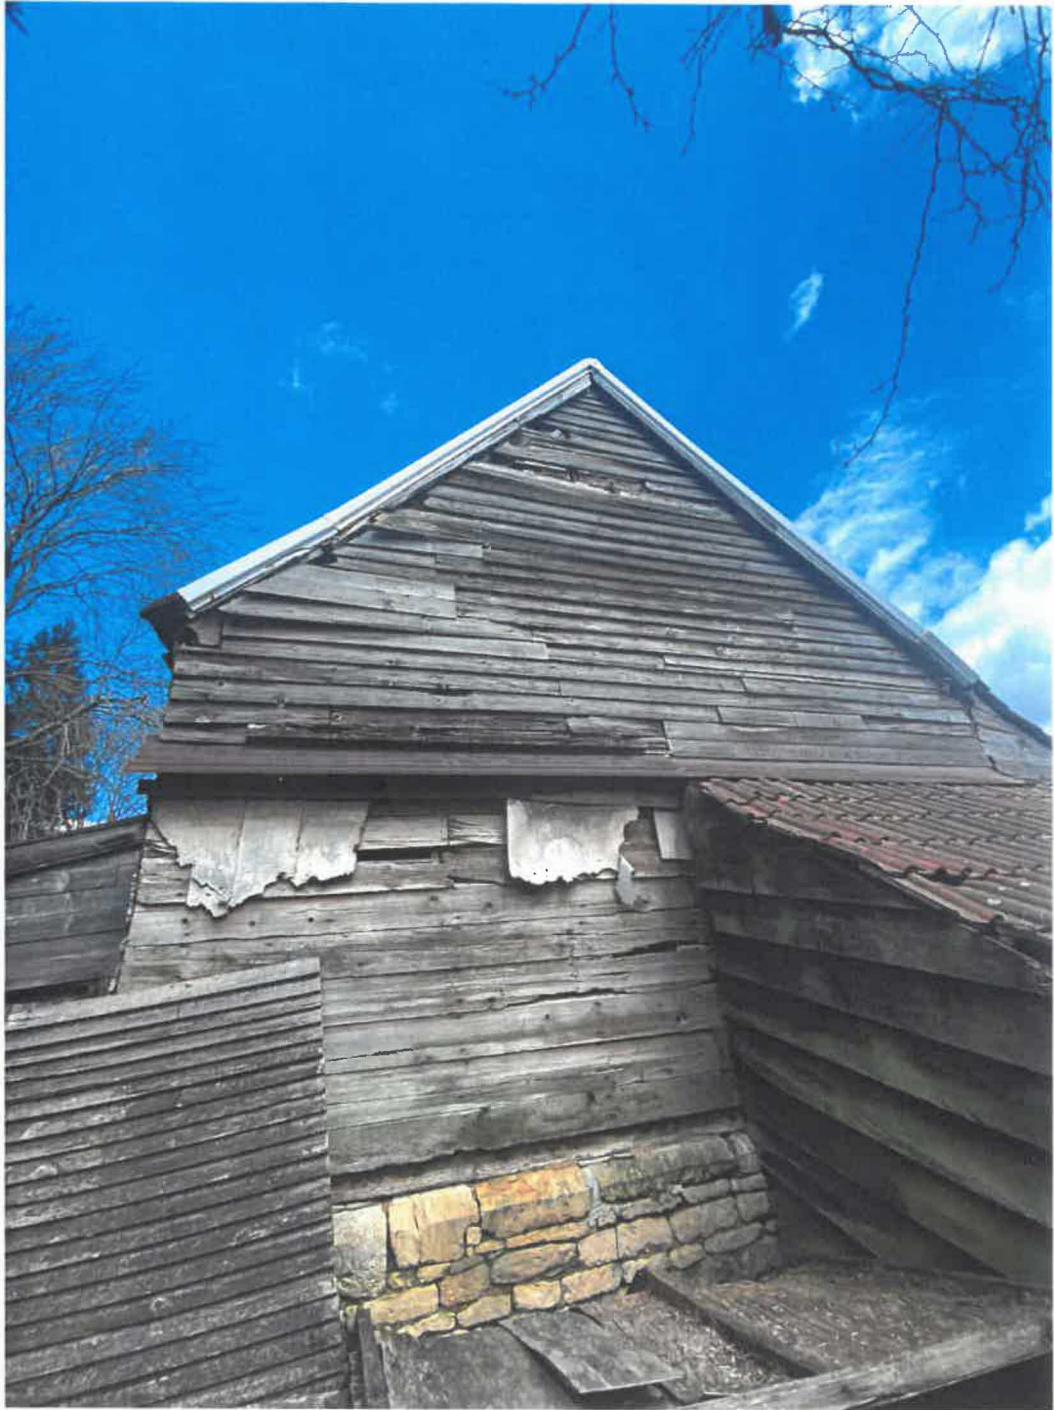
Weather boarded Gable wall rising off fair faced stone plinth

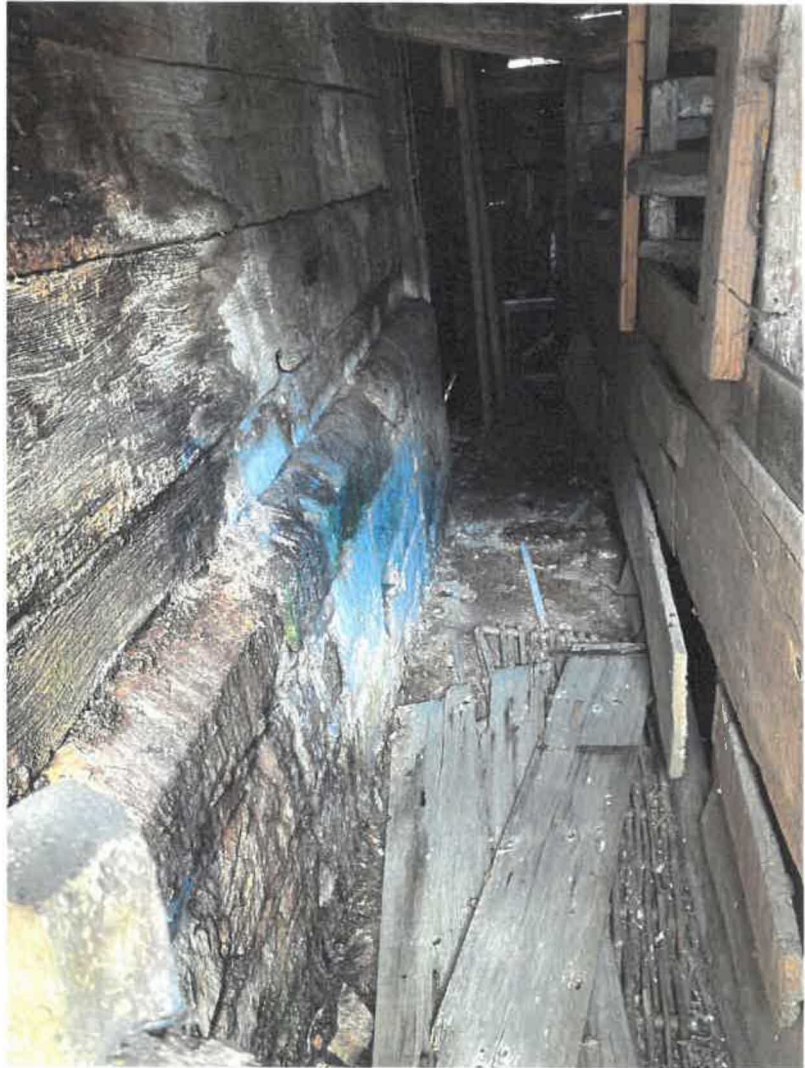
The natural stone plinth around the perimeter of the main Barn has suffered weathering to mortar joints although this is simply a maintenance item and not the result of any ongoing structural movement.

Masonry plinth to main Barn
front wall within lean-to
projection

Regarding existing foundations, conversion to a dwelling will not result in any significant increase in vertical loading and it should not therefore be necessary to underpin or otherwise improve the existing footings. Any stonework found to be in a loose condition should be made good and general repointing is required. Provision of a damp proof course in the stone plinth is not normally recommended for a Grade II Listed building although dampness could be catered for by provision of lime plaster internally.

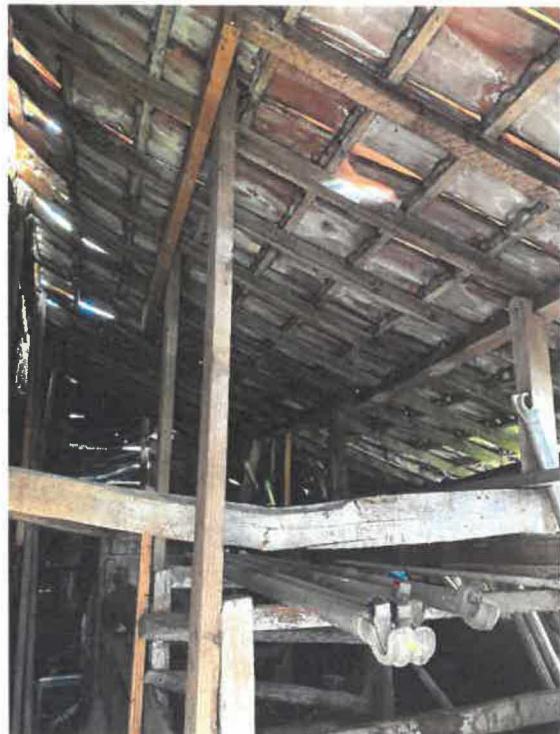
The roof to the single storey front left and right hand projections comprise a simple arrangement of lean-to timbers albeit again generally serviceable for then current roof covering.

Lean-to roof

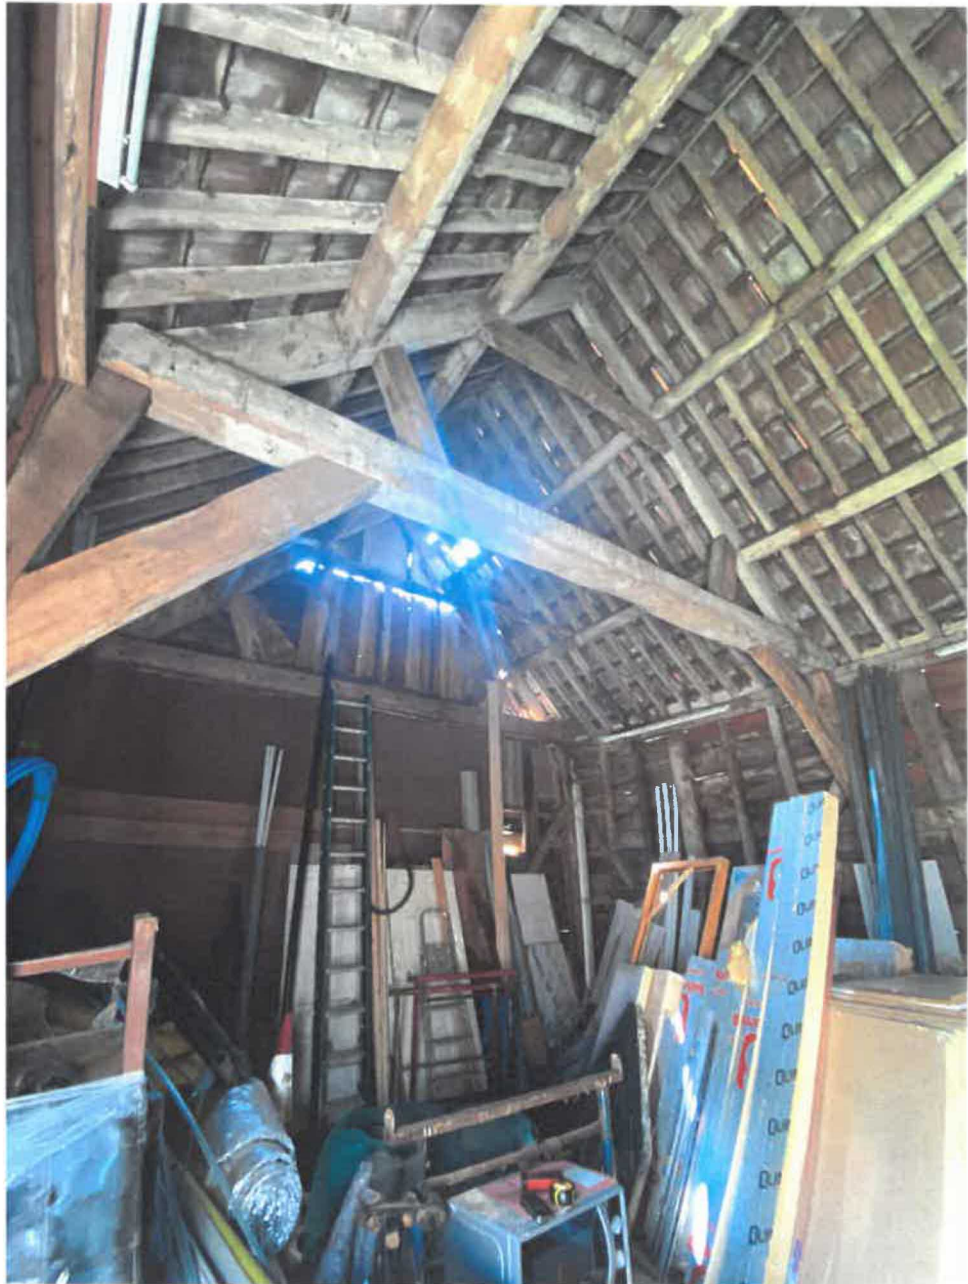
The main roof trusses are of Queen-post configuration of 200mm x 300mm hardwood sections which incorporate knee bracing at the support post locations to maintain lateral stability. There is some evidence of lean towards the rear of the building albeit clearly longstanding and non-progressive. The purlins comprise two, 200mm x 150mm hardwood timbers to each slope which span between the gable ends and the intermediate Queen-post trusse. Such timbers exhibit some evidence of deflection although this is clearly longstanding and non-progressive.

Roof truss with substantial knee bracing to maintain lateral stability

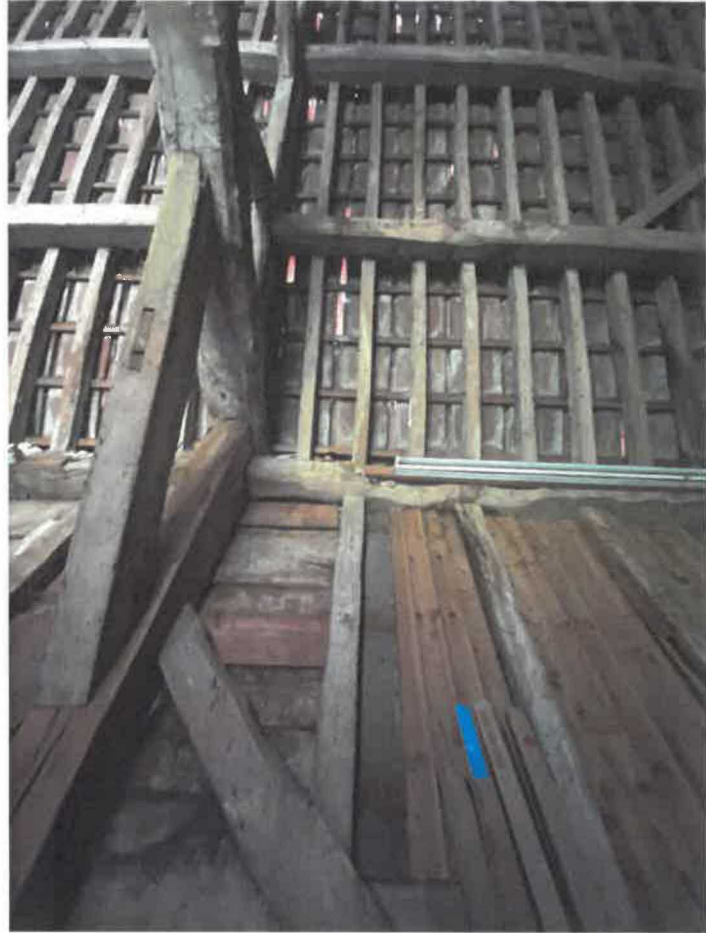
View on underside of roof within Barn, note substantial truss and purlins

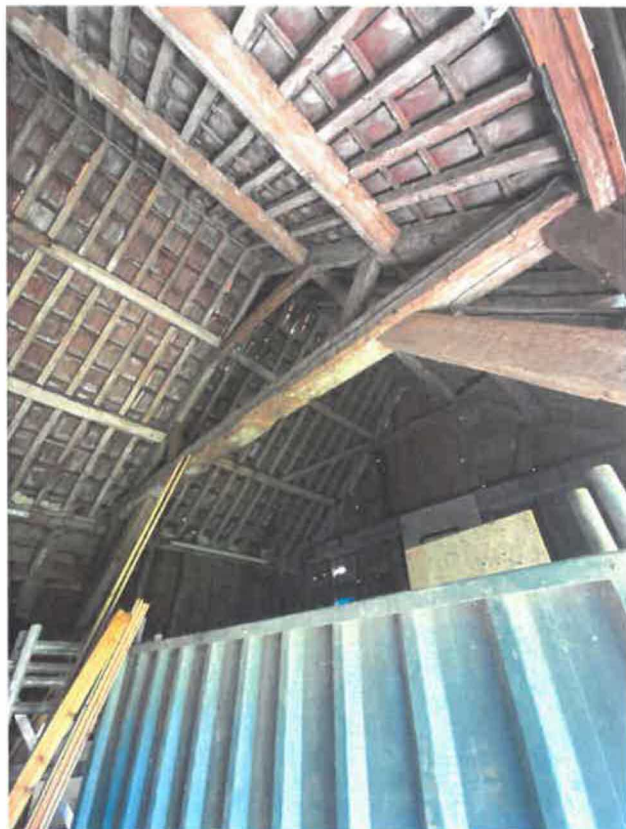
Another view on the substantial roof trusses and purlins
