ARCHAEOLOGICAL WATCHING BRIEF

The Elms, Llantillio Pertholey

Planning Application No: DM/2021/00880

By:
Dr N Phillips 20 May 2022

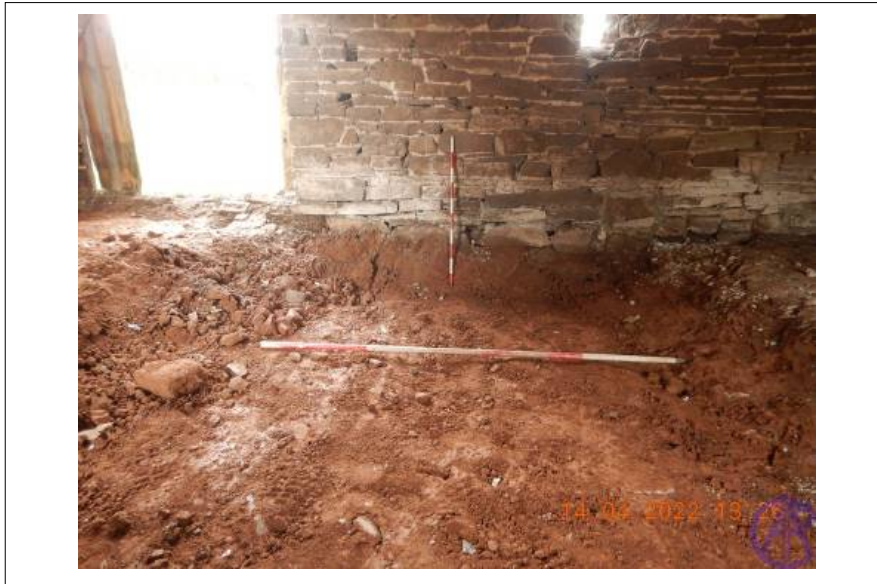
Photo ID: DSCN1694

Room 3, 400mm deep trench, sequence (301) over (302) sandy red clay with fieldstone over compacted red sandy clay, no stone (303)

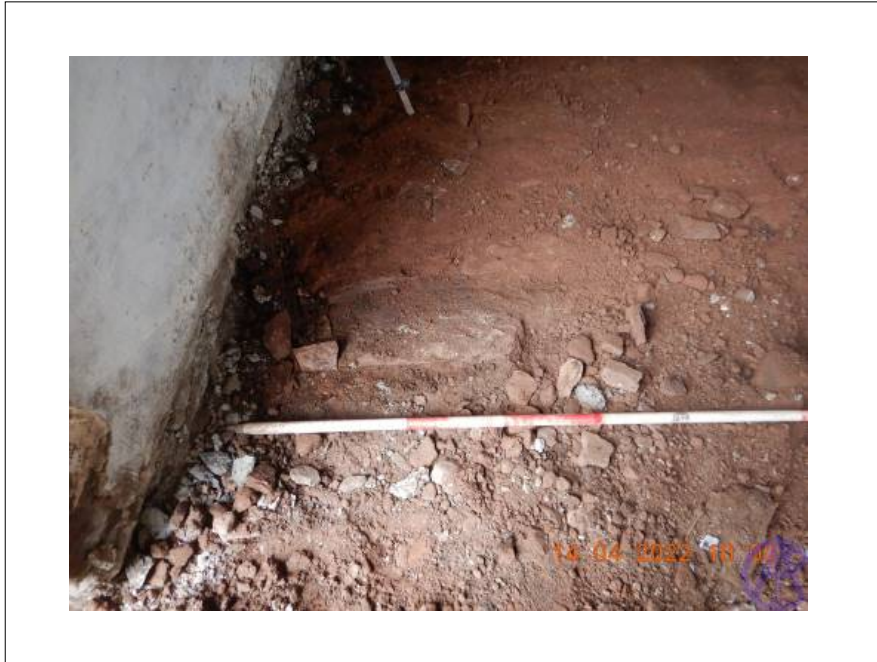
Photo ID: DSCN1691

Room 3, Thin layer of compacted sandy soil, no stone, under (302) but overlaying outcrop of bedrock <303> along eastern wall.

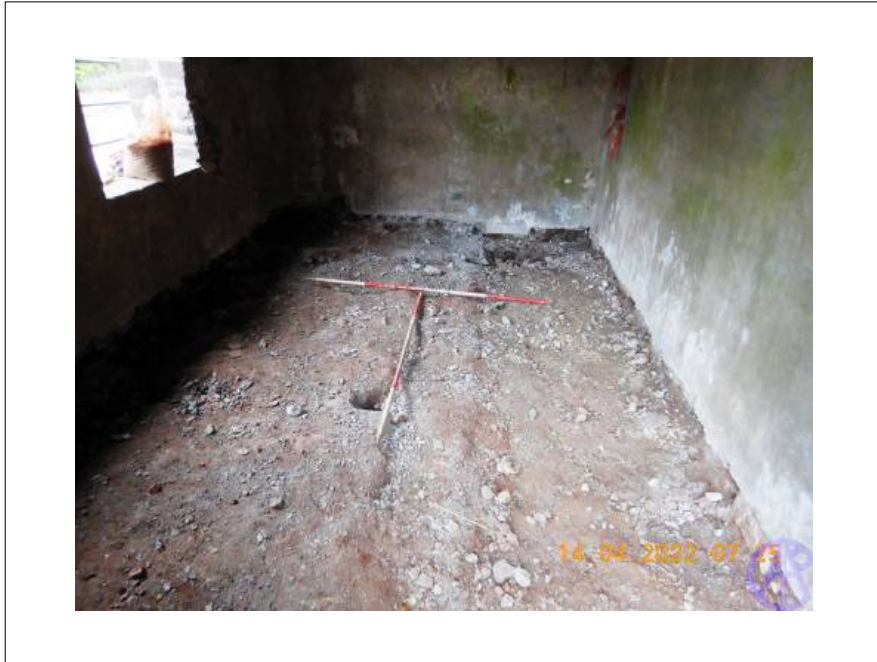
Photo ID: DSCN1681

Room 1. Prior to removal of sub-base mix of light brown sand with majority percentage of small angular stone (101)

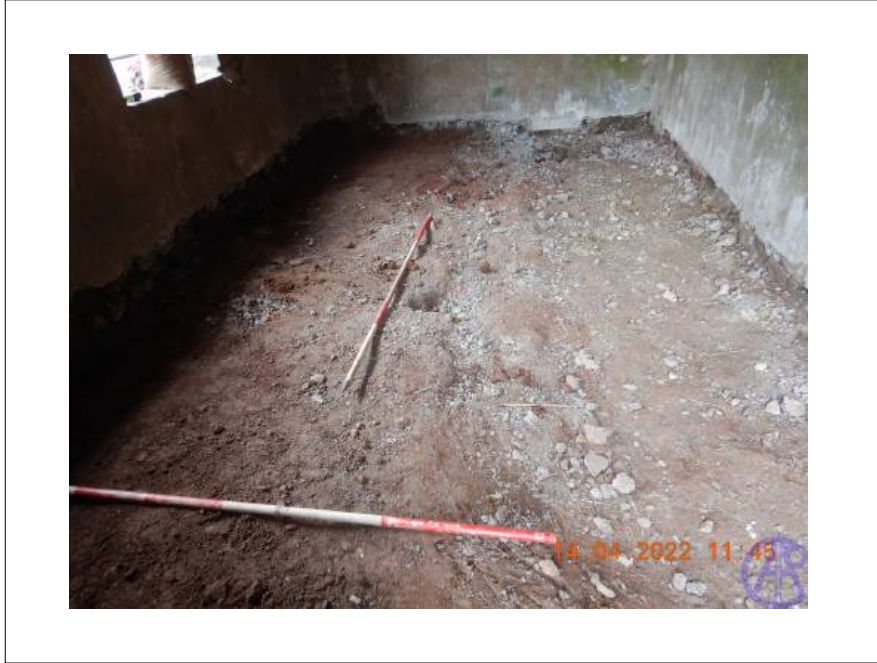
Photo ID: DSCN1693

Room 1 level only reduced at SW corner into (102) compacted red sandy clay, no stone (103)

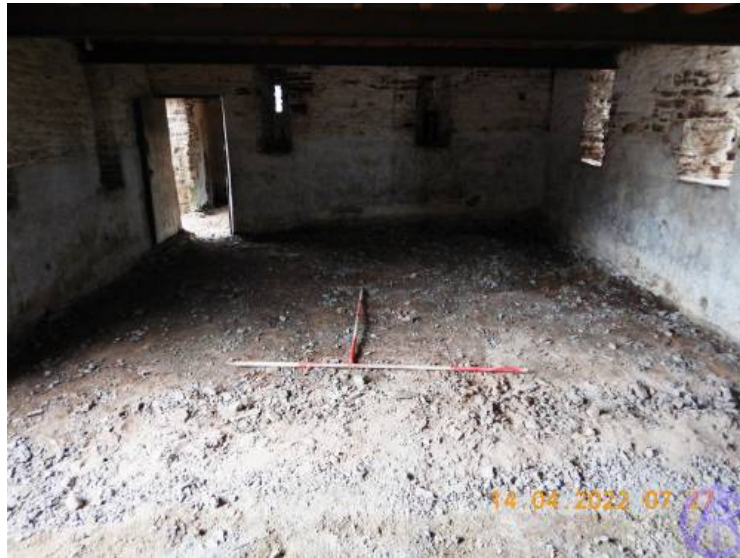
Photo ID: DSCN1683

Room 2. Prior to removal of sub-base mix of light brown sand with majority percentage of small angular stone (201)

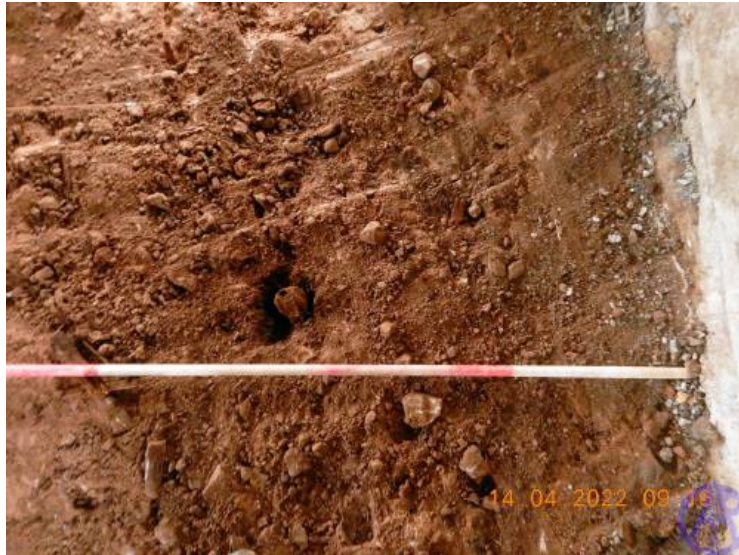
Photo ID: DSCN1688

Room 2. wooden post {203} in cut [204] into (202) with fill (205) soft sandy soil.

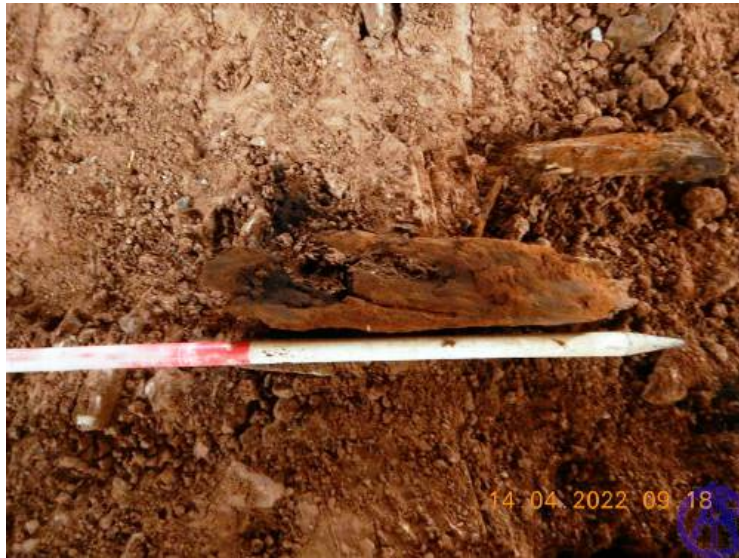
Photo ID: DSCN1689

Wooden post {203} (bottom to left)

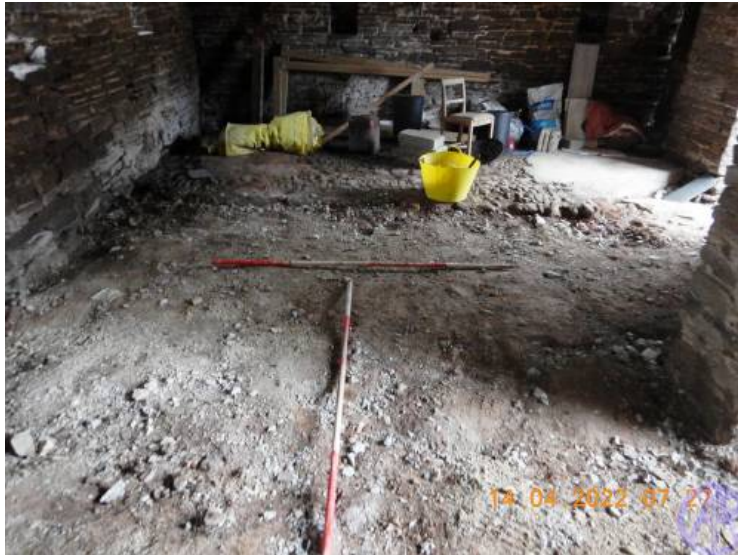
Photo ID: DSCN1684

Northern and central bays of the main barn, room 3 only had a partial concrete floor <300> as the northern end had been laid up to an earlier cobble surface <304>, **PL08** 1684 (*under the storage*). The cobble surface was recorded in the building survey APAC. Ltd. BS/ELP/18 and is observable as an irregular spread averaging about 2.7m along the northern wall; it is to be retained. The floor surface (301), immediately under <300>, is again identical to adjacent room 2 as is the lower sequence of (302) sandy clay no stone. However, a deeper section of 600mm was required at the western edge of room 3 and this impacted natural sandstone (303) **PL01**. Two small 50mm square post holes were noticed close to the western edge [305] & [306]. As they were almost perfect in the friable ground, with no fill, they were disregarded as modern, possibly survey peg holes **PL09** 1692.

Room 3. Prior to removal of sub-base mix of light brown sand with majority percentage of small angular stone (301)

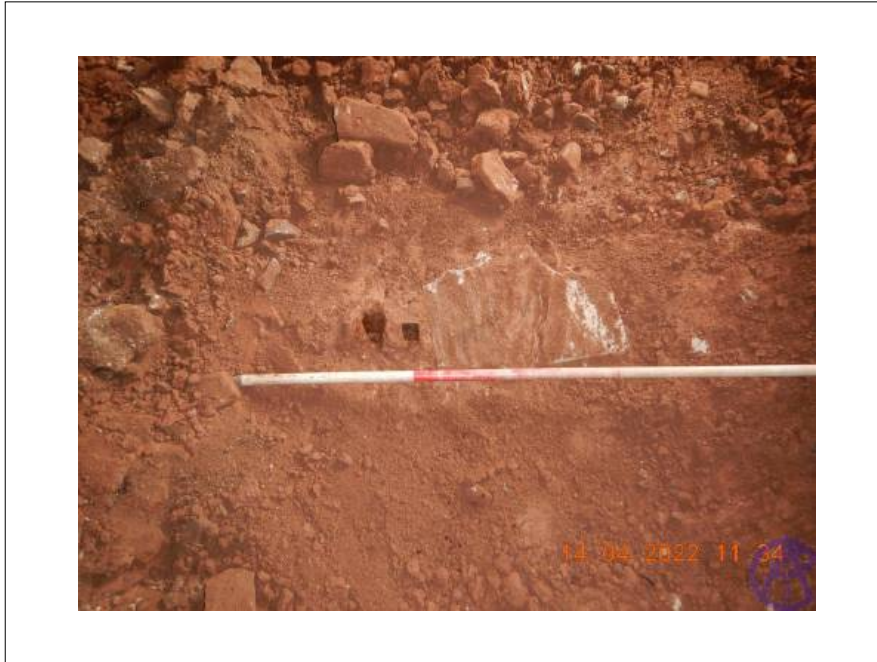
Photo ID: DSCN1692

Room 3. sequence (301) sandy red clay with fieldstone over (302) s, over compacted red sandy clay, no stone over (303) natural red sandstone. Two square section post holes [304] [305]. Modern and empty

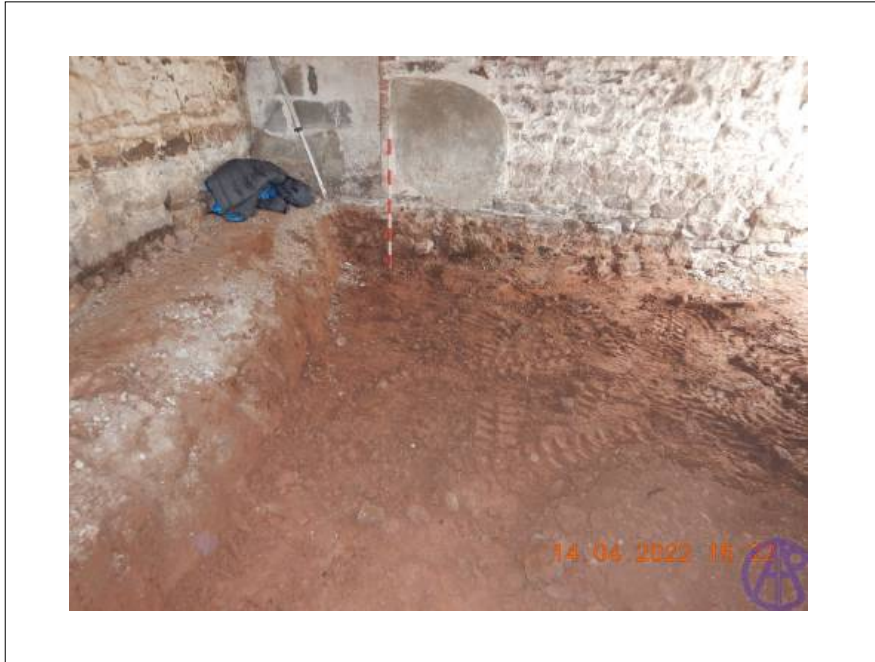
Photo ID: DSCN1698

Room 4, 700mm deep trench, sequence (401) over (402) sandy red clay with fieldstone over compacted red sandy clay, no stone (403). Berm left along W wall at level of sub-base (401)

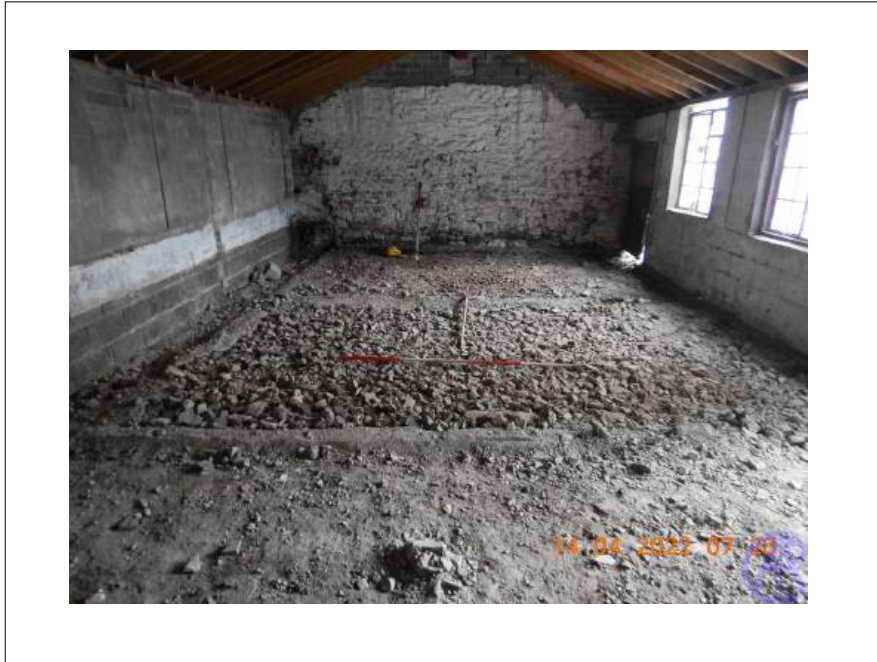
Photo ID: DSCN1685

Room 5. Prior to removal of sub-base mix of light brown sand with majority percentage of small angular stone (501)

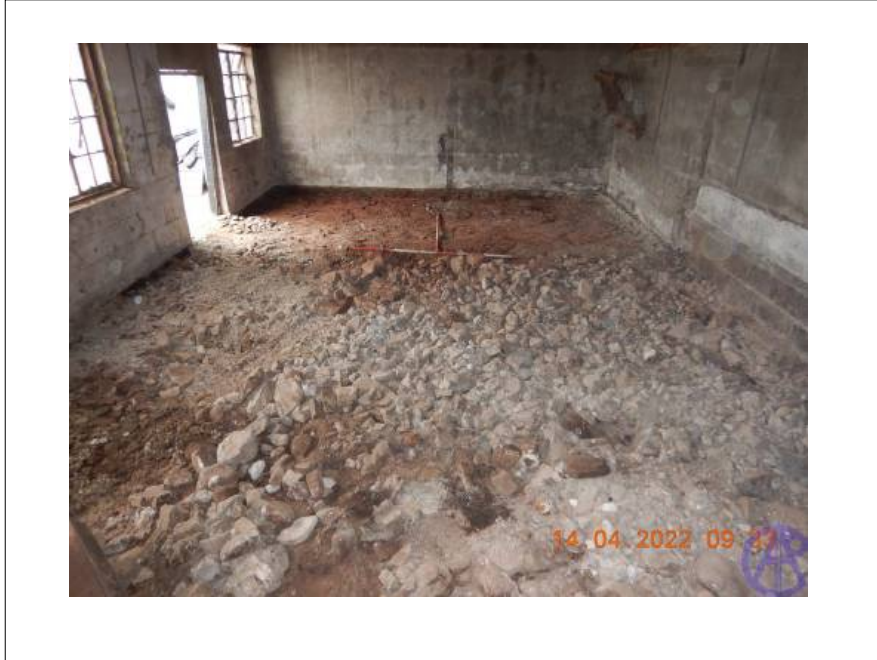
Photo ID: DSCN1690

Room 5 is a separate building from the barn complex and forms an annex to the main farmhouse. A much more recent building, it is mostly a breeze block construction with again a concrete floor <500> under which was the sandy clay with fieldstone deposit, (501) **PL11** 1685. Once the levelling of (501) was underway a difference was noticed at the west, when it tapered off to a layer of rubble infill (502), around a third of the way towards the east **PL12** 1690. The thin layer of sandy clay with no stone was absent.

Room 5. Context (501) sub-base towards left. (502) to rear, Infill of angular rubble (503) below required depth. Left inset

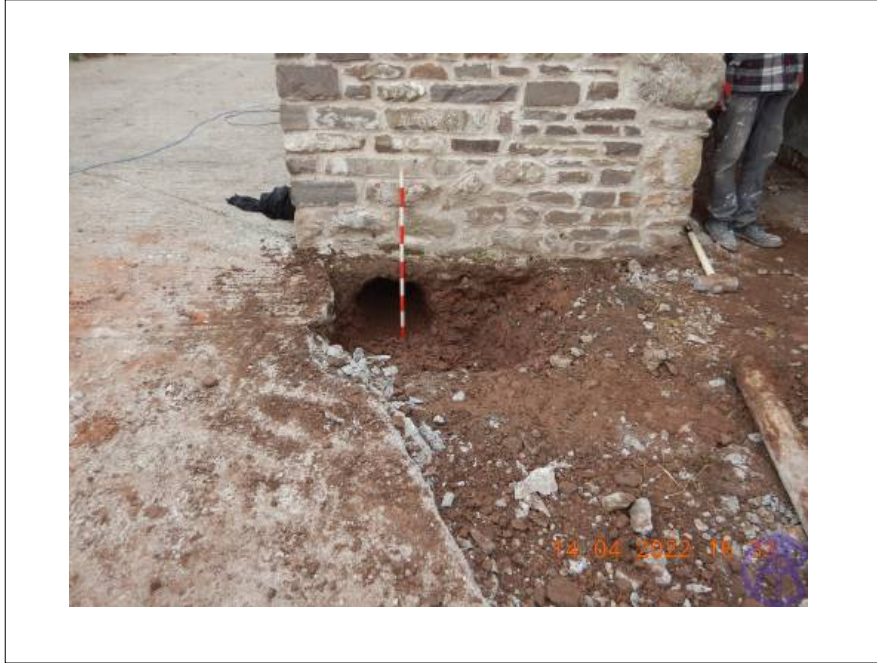
Photo ID: DSCN1701

This excavation within room 1 was covered above, its continuation across the courtyard changed only in that the concrete surface <700> was later than <100>, within the room. The sandy clay with stone (701) over sandy clay no stone (702) was encountered as expected, but as the depth of the trench decreased due to the ground slope and the intended junction with the existing pipe {703} no natural surface was found, **PL13** 1701.

External trench SW corner of room 1 for drainage. Cut through (103)

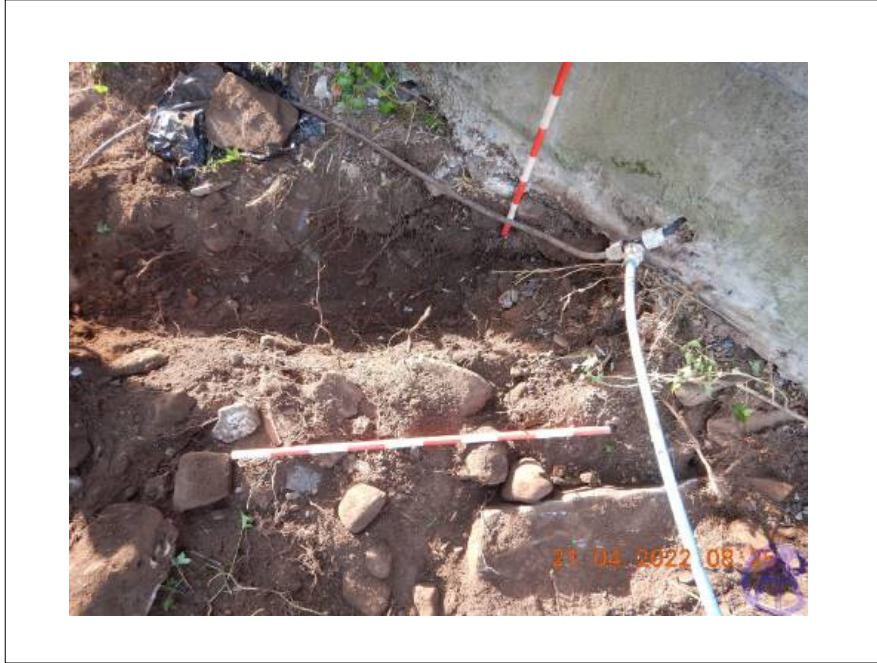
Photo ID: DSCN1703

External, rear of outbuildings. Initial excavation reveals pre-existing black plastic water pipe {802}, (800), (801), (803)

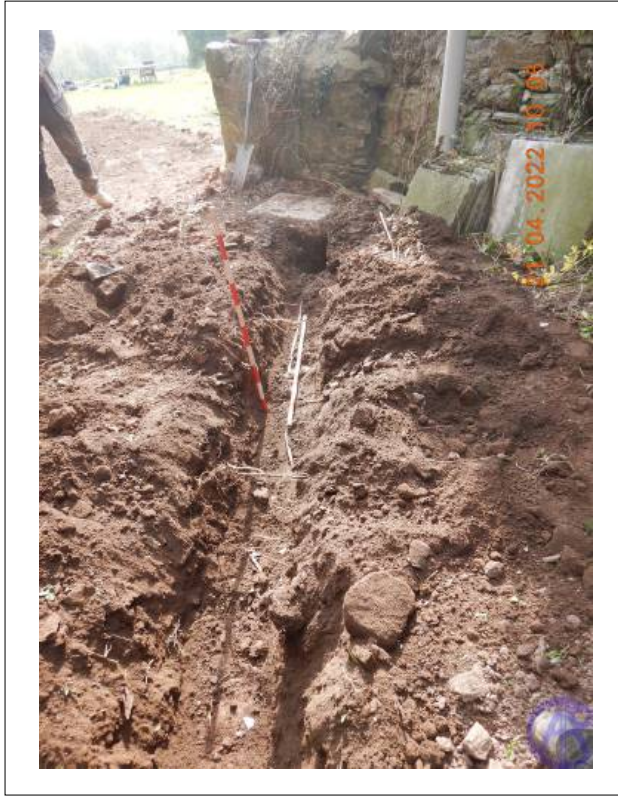
Photo ID: DSCN1707

Trench 2 was some distance from the other work, being situated along the northern, outside of building 5 and the farmhouse. The initial point of excavation coincided with an existing plastic water pipe {803}, **PL14** 1703, which continued along the entire trench. Trench 2 therefore, was along an entirely disturbed tract of ground. The sequence was just about recognisable as <800> topsoil over a fill of sandy soil with loose gravels, over a potentially natural deposit of sandy clay with no stones, **PL15** 1707.

Eastern end of trench: {802}, (800), (801), (803)
