BS5837:2012 Tree Survey  
 Land at Muffins Gap  
 Lombard Street  
 Orston  
 Nottinghamshire  
 NGR SK76797 40787

Report prepared by: C Barker	Date Issued: 15 January 2021
	Reviewed by: KLB	Report Version: V2
	Report ref: <b>P2167 /1120 /01</b>	C B E Consulting Highbank, 5 Grantham Road, Navenby Lincoln. LN5 0JJ. Telephone (01522) 810086. <a href="http://www.cbeconsulting.co.uk">www.cbeconsulting.co.uk</a>

# BS5837 Tree Survey, Land at Muffins Gap, Orston

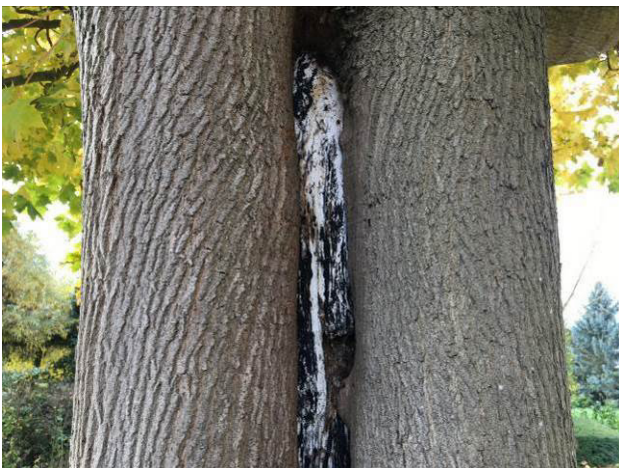
Cavity / Wound in T1
