BS5837:2012 Tree Survey  
Land at The Cottage  
Mill Lane  
Normanton on Trent  
Nottinghamshire  
NGR SK78998 69036

Survey by  
Christopher Barker CEnv dipHort ACIEEM

Report prepared by: C Barker	Date Issued: 15 December 2021 Report Version: V1
Reviewed by: KLB	C B E Consulting Highbank, 5 Grantham Road, Navenby Lincoln. LN5 0JJ. Telephone (01522) 810086. <a href="http://www.cbeconsulting.co.uk">www.cbeconsulting.co.uk</a>
Report ref: P2444 /1221 /01

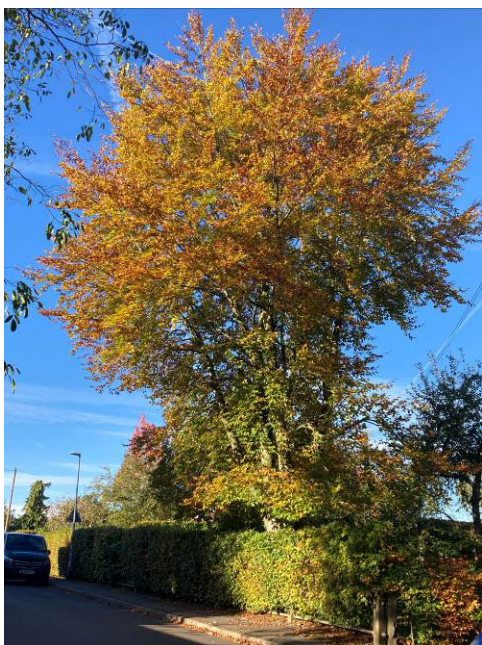
Beech T1

**Beech T1** is located along the southern boundary of the garden directly adjacent to Tuxford Road in a position of high visibility. This tree has a lifted crown which is trimmed on the north eastern side to avoid an overhead cable. This tree will need future trimming to maintain this cable and the canopy is likely to be seasonally trimmed to maintain a balanced round canopy. This tree has at least 20 years of useful life remaining and has been placed into Category B. In addition, there is a **Spruce T2** situated close to the road which is probably a former Christmas Tree planted out in the garden. This tree has 20 years or more of useful life remaining has been placed within Category B.

Adjusting the RPA to take into account the impact of Tuxford Road, it is likely that around 25% of the RPA of this tree will lie underneath the access and driveway and this will require ground protection measures (incorporating a cellular confinement system) and a 'no-dig' construction methodology to be employed. The crown of this tree has been lifted and is trimmed to avoid cables on the north-eastern side and this reduction of the canopy will mitigate in part the impact of the access and driveway but a porous surface will be required to allow in water and air. However, it may be possible to move the proposed access to avoid this tree entirely or significantly reduce the impact on the RPA.

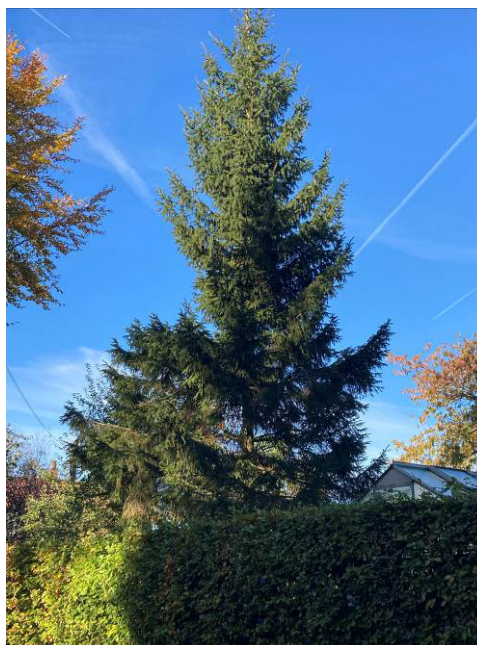
Spruce T2

The loss of Spruce along the frontage of Tuxford Road cannot be avoided if the access is placed where proposed. The loss of this tree will not be particularly significant in terms of visual amenity of canopy cover as it is of small stature and there are far larger trees protected under a TPO on the opposite (south) side of this road. There will be some impact on Beech T1 where the access crosses the eastern side of the RPA of this tree.

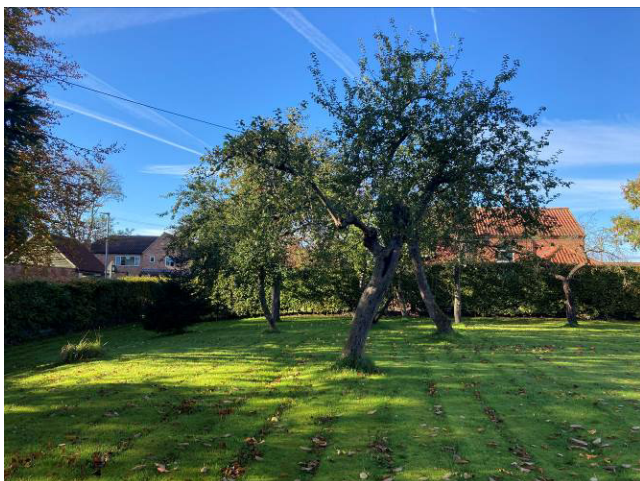
T3 – T9

The majority of the trees surveyed. Specifically **trees T3 – T12 and T16 – T18** are fruit trees of small stature and varied condition placed within Categories C and U.

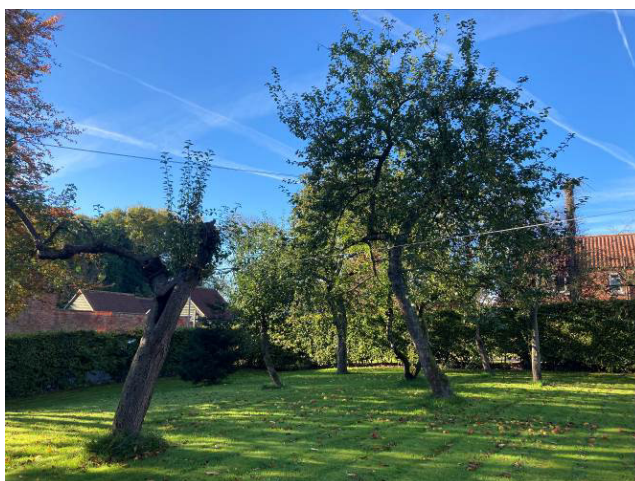
T11 and T12

T11	Cherry <i>Prunus avium</i> Cul	4	220	N-1 S-3 E-3 W-3	2	OM	<10	P	Irregular twisted crown extending south west. Significant dead wood with second trunk removed. No structural faults visible from ground level but is in decline.	None	U	2.6
T12	Apple <i>Malus domestica</i> CUL	5	210	N-1 S-1 E-3 W-1	2	SM	10	P	Irregular upright crown extending east. No structural faults visible from ground level	Not a priority for retention.	C2	2.5
T13	Apple <i>Malus domestica</i> CUL	4	235	N-1 S-2 E-2 W-2	2	SM	10	F	Pollarded on north side. Irregular crown extends south. No structural faults visible from ground level	Not a priority for retention.	C2	2.8
T14	Cherry <i>Prunus avium</i> Cul	9	460	N-6 S-6 E-5 W-6	4	M	20	F	Trunk divides at 2magl. Broad spreading crown with internal regeneration. No structural faults visible from ground level	Retain if practical to do so and protect the RPA and canopy.	B2	5.5
T15	Cherry <i>Prunus avium</i> Cul	10	300	N-4 S-4 E-5 W-5	5	M	20	G	Broad balanced crown lifted. No structural faults visible from ground level	Retain if practical to do so and protect the RPA and canopy.	B2	3.6

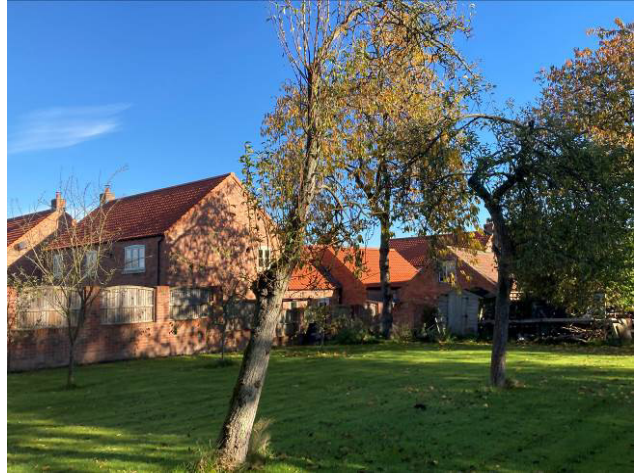
Fruit trees in garden centre

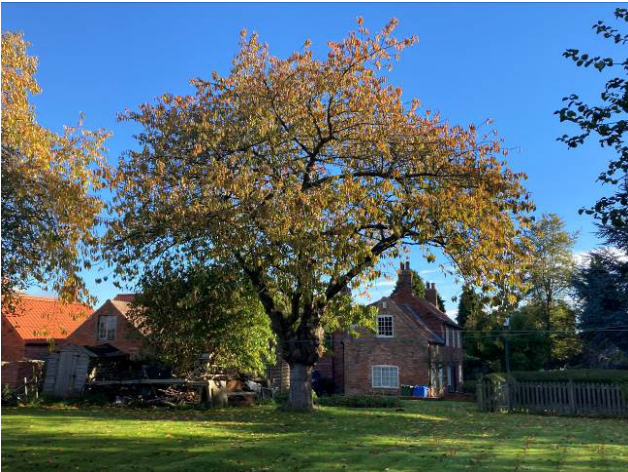
Cherry T14

**Trees T14 and T15** are both Cherry situated along or just outside of the eastern boundary of the garden area being considered for development. These are trees of reasonable stature visible from outside of the garden area and both trees are placed within Category B.

It is a reasonable assumption that all, or the majority of the smaller fruit trees within the garden interior will be removed and that the boundary trees T14 / T15 and T19 within adjacent land can be retained and afforded sufficient space to avoid any impact or significant constraint to present or future growth.

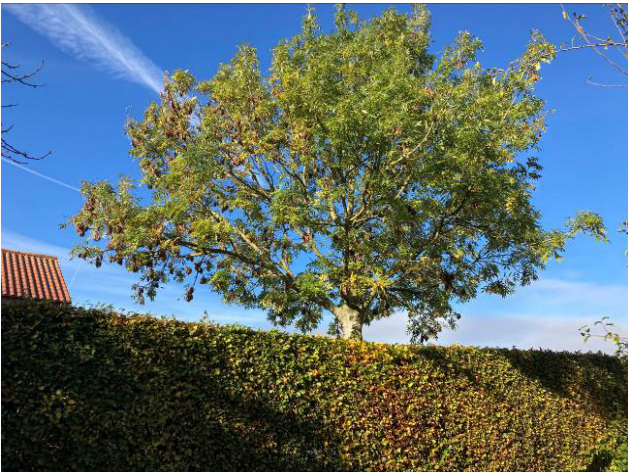
Ash T19

**Ash T19** is situated in the garden to the west of the survey area. This tree has a raised crown which does extend across the boundary over the trimmed boundary hedgerow. This tree is of good quality and has been placed into Category B

18	Plum	C2	It is presumed that this tree will be removed from the rear garden area of the new property.
19	Ash	B2	This tree can be retained and the crown and RPA fully protected by fencing.
