2021/24 BELL
EXISTING BARN AND STABLES
STRUCTURAL DEFECTS AUDIT

PROPOSED CONVERSION OF REDUNDANT
AGRICULTURAL FARM OUTBUILDINGS TO FORM ONE
DWELLING UNIT FOR OWNER TO OCCUPY AND ONE
DWELLING UNIT FOR RENTAL ACCOMMODATION.

FORWOOD FARM, TRESWELL

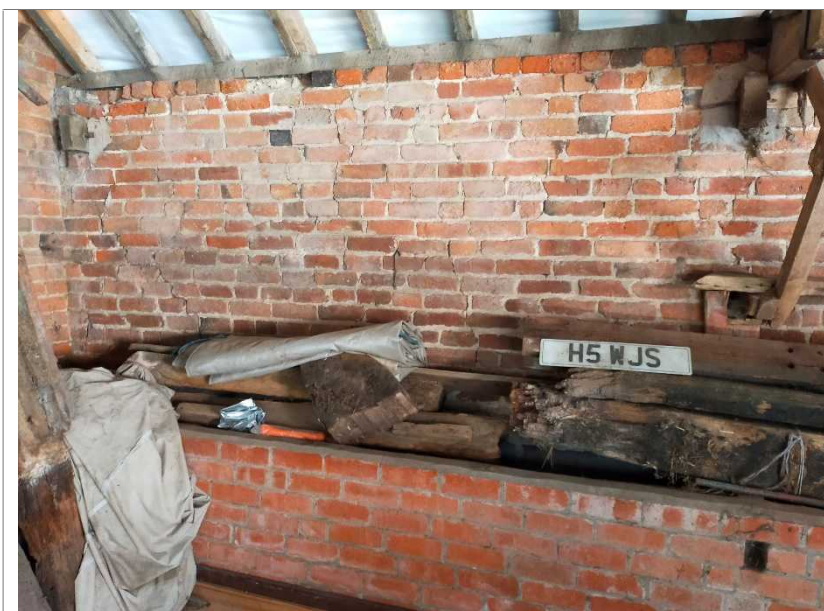
Photo 01 –

Due to a lack of footings at the base of the wall and subsidence on the clay soil, cracks have appeared running from the footings to the eaves.

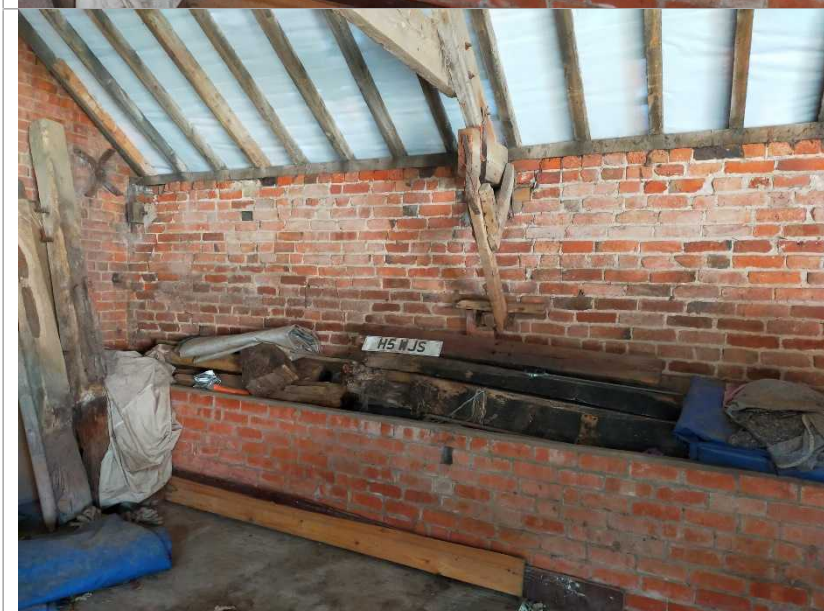
Photo 02 –

Due to subsidence at the north east corner of the two-storey barn a restraining bar has been placed just below first floor level through the external wall to stop the larger opening on the southeast elevation widening, putting the two channel beams, which span the opening to support the gable end wall above, at risk of failure.

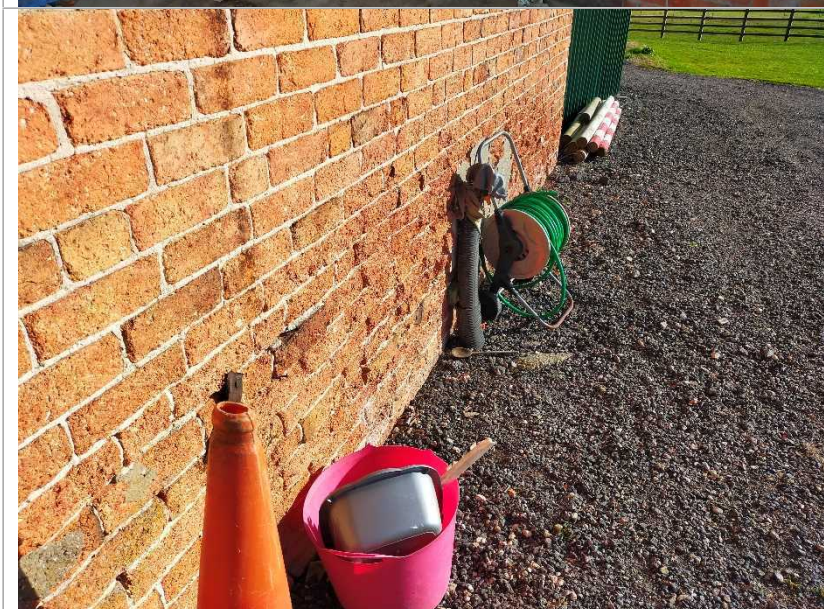
Photo 03 –

Rising damp, frost damage and weathering has perished the brickwork on the southwest gable end.

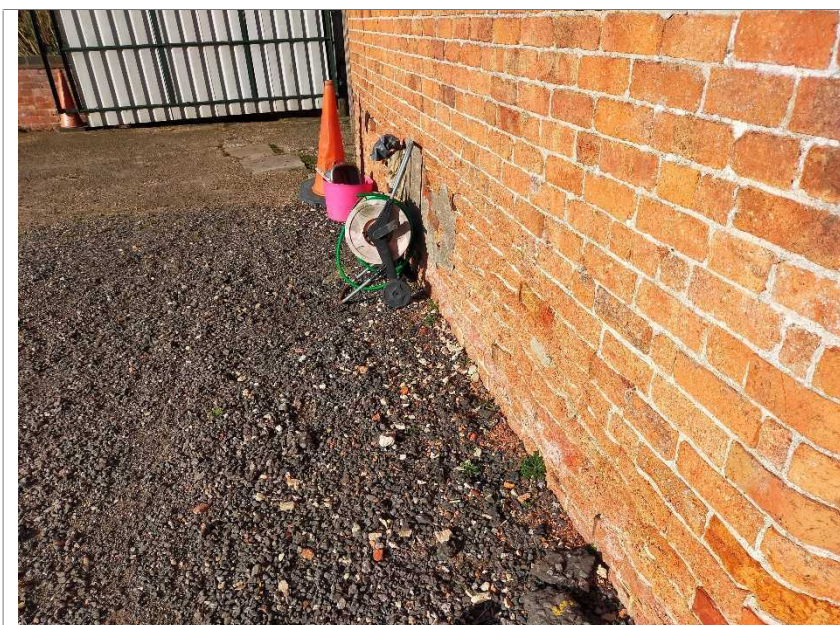
Photo 04 –

Rising damp, frost damage and weathering has perished the brickwork on the southwest gable end.

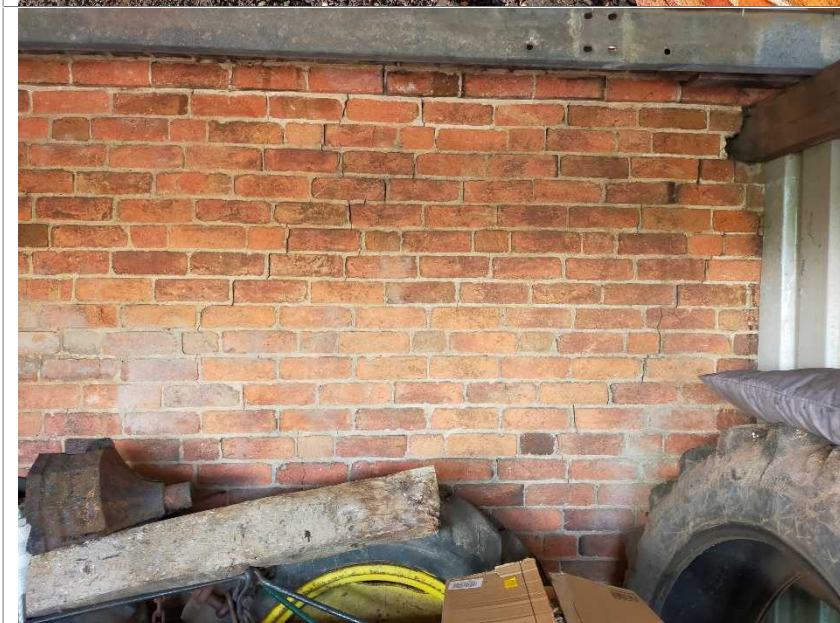
Photo 05 –

Due to a lack of footings at the base of the wall and subsidence on the clay soil, cracks have appeared running from the footings to the eaves on the southeast side wall of the single storey barn cart shed.

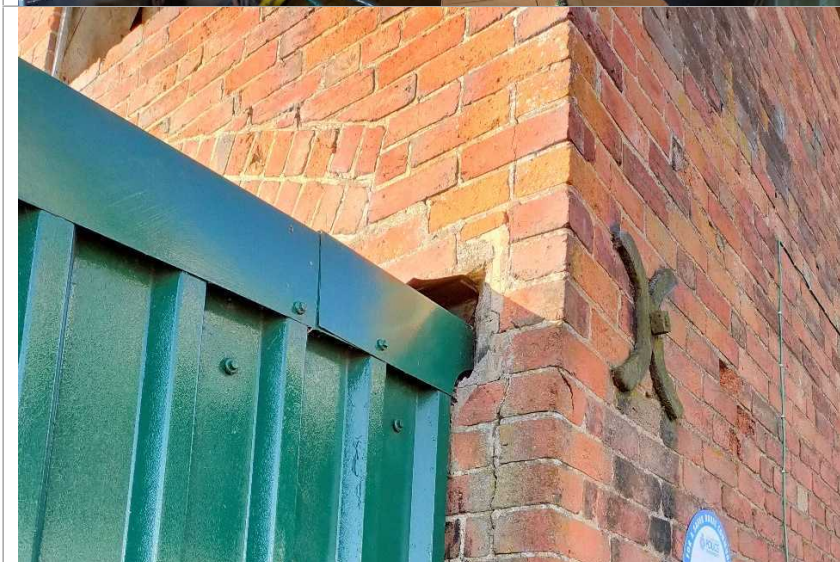
Photo 06 –

Due to subsidence at the north east corner of the two-storey barn, a restraining bar has been placed just below first floor level through the external wall to stop the larger opening on the southeast elevation widening, putting the two channel beams, which span the opening to support the gable end wall above, at risk of failure. The opposite end can be seen in Photo 02.

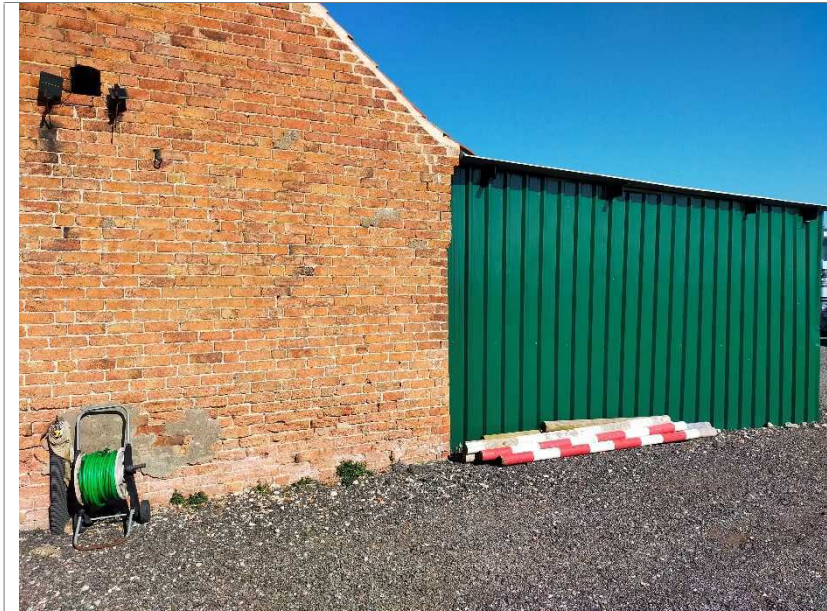
Photo 07 –

Rising damp, frost damage and weathering has perished the brickwork on the southwest gable end wall.

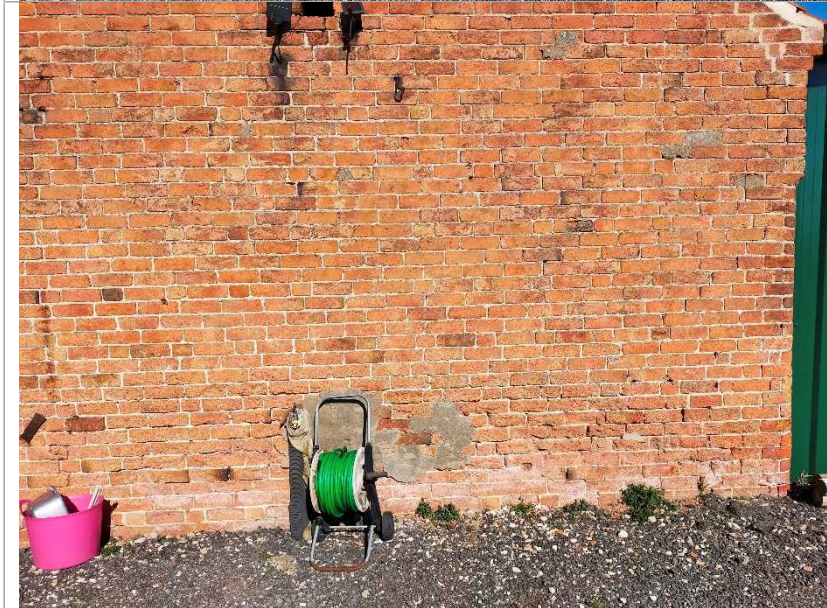
Photo 08 –

Rising damp, frost damage and weathering has perished the brickwork on the southwest gable end wall.

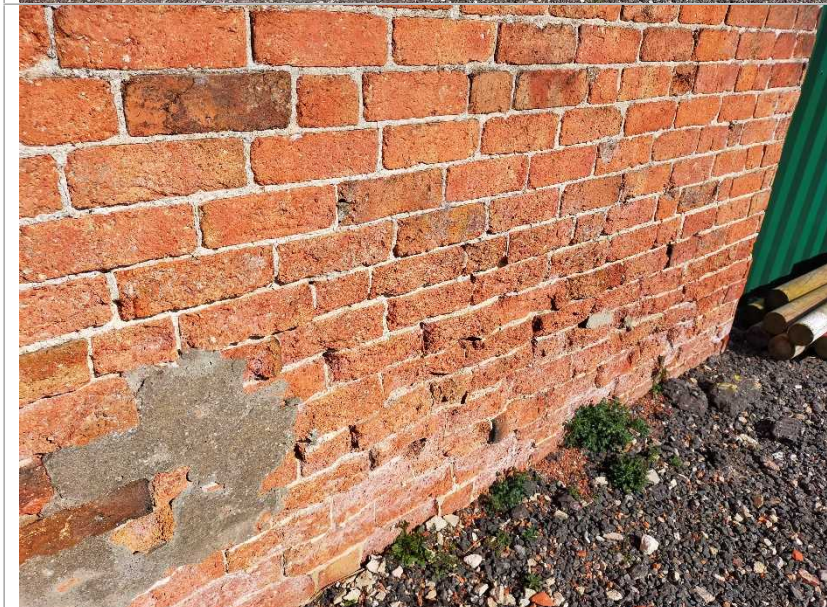
Photo 09 –

Rising damp, frost damage and weathering has perished the brickwork on the southwest gable end wall.

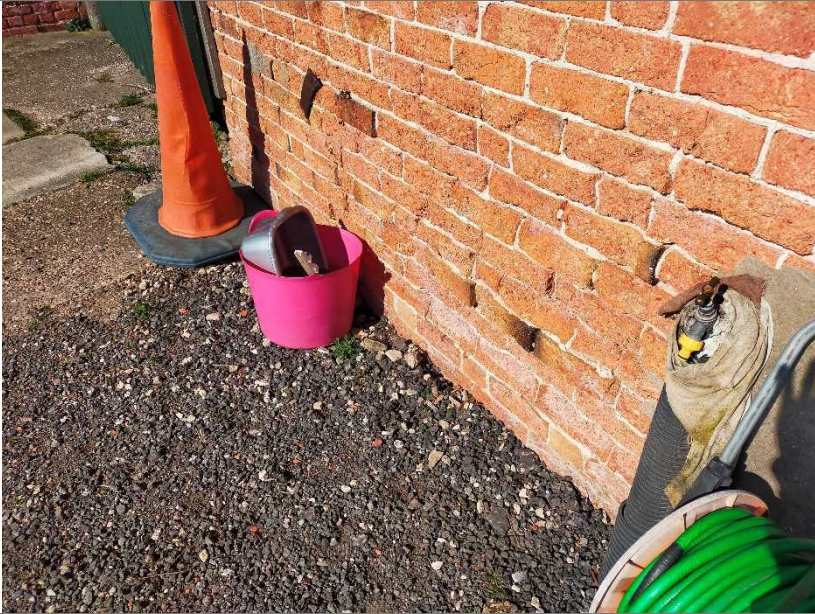
Photo 10 –

Rising damp, frost damage and weathering has perished the brickwork on the southwest gable end wall.

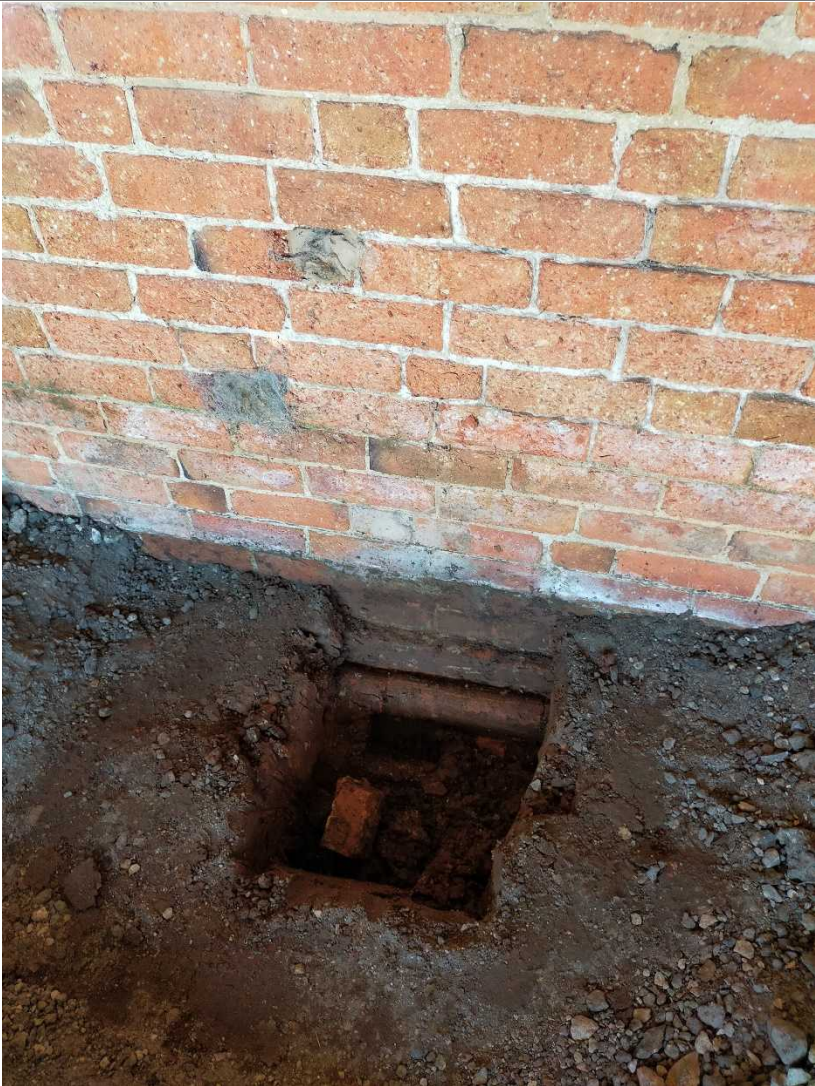
Photo 11 –

As can be seen, the load bearing wall to the single storey barn only continue 225mm below ground level finish before the footings start and the footing do not continue further any more than three brick courses deep. Due to a lack of footings at the base of the wall and subsidence on the clay soil, cracks have appeared running from the footings to the eaves on the southeast side wall of the single storey barn cart shed.

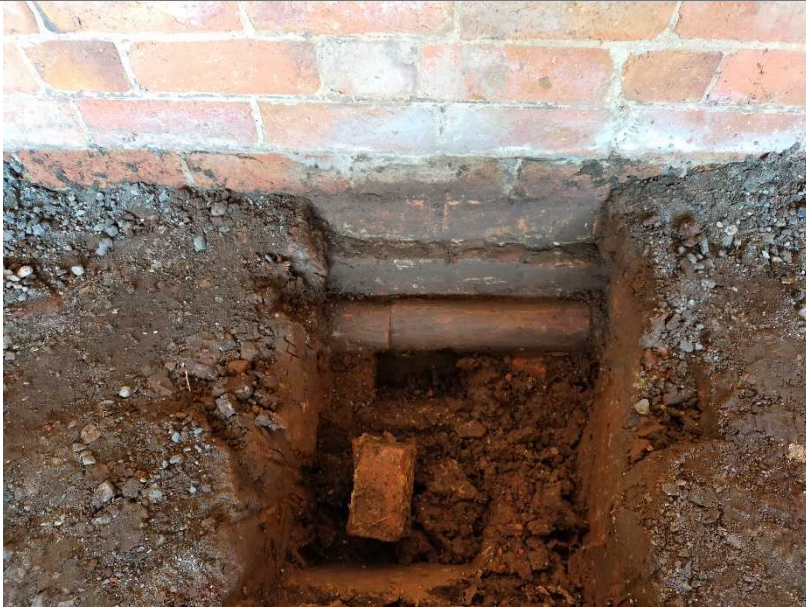
Photo 16 –

As can be seen, the load bearing wall to the single storey barn only continue 225mm below ground level finish before the footings start and the footing do not continue further any more than three brick courses deep. Due to a lack of footings at the base of the wall and subsidence on the clay soil, cracks have appeared running from the footings to the eaves on the southeast side wall of the single storey barn cart shed.

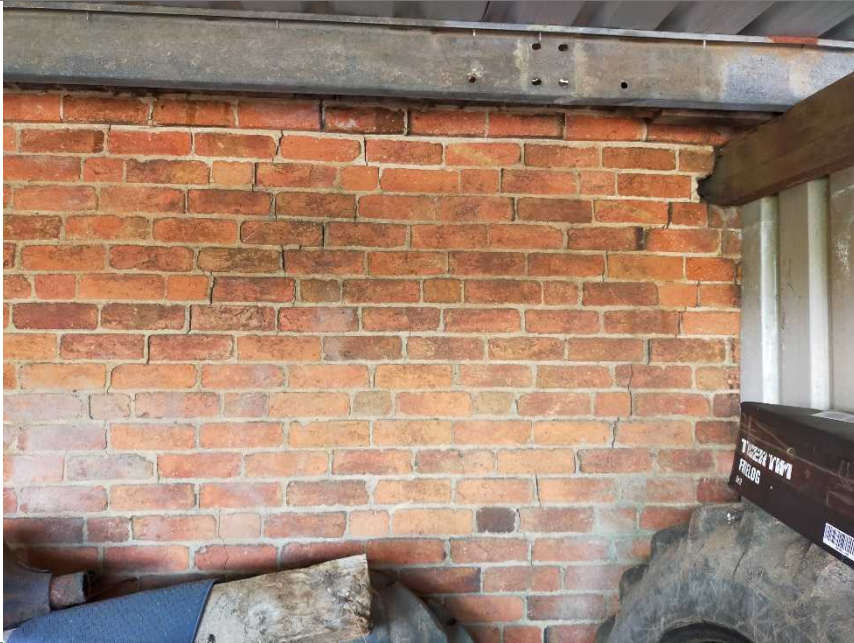
Photo 21 –

Untreated timber roof joists have been placed on the external masonry wall of the single storey barn and steel circular posts at the front of the cart sheds. These timber are in need of replacement as they have rotted away at both the front and back of the cart sheds.

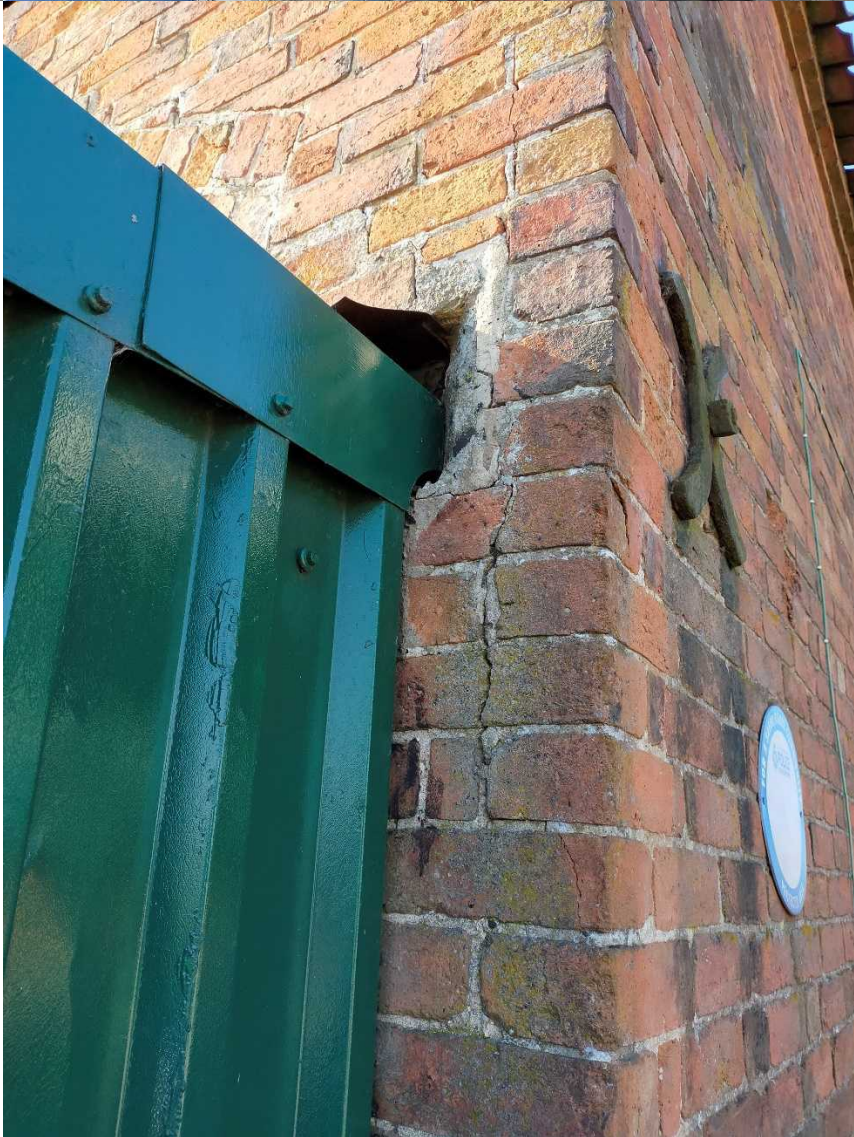
Photo 22 –

Cracks can be seen where the two channel beams, which span the ground floor barn grain store opening, sit on the external wall brickwork by less than 75mm. All of the bricks and mortar joints below the beams have cracked in half. Therefore, the wall is at risk of failure and is in need of being rebuilt.

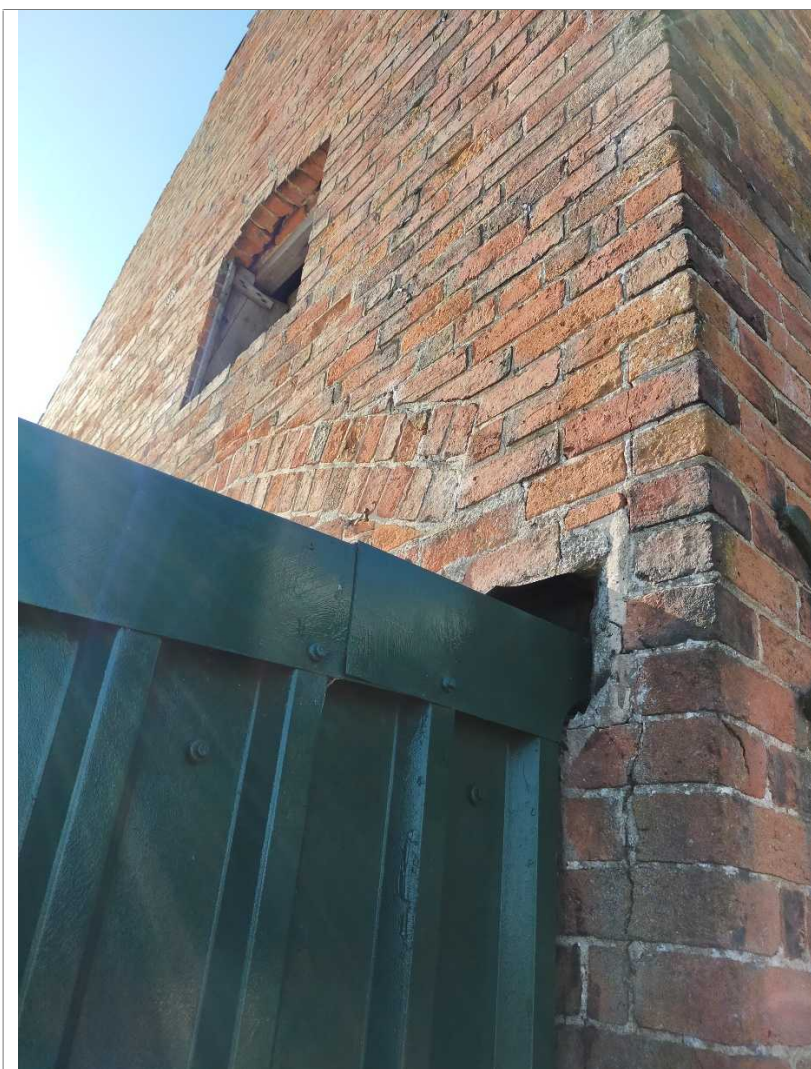
Photo 23 –

Cracks from where the brick piers have bowed outwards, due to subsidence and the load from the steel channel beams, have continued up the wall to the first floor window, then continued from the top of the window opening further up the wall to the roof line. Therefore, the gable end is in need of been taken down and being rebuilt.

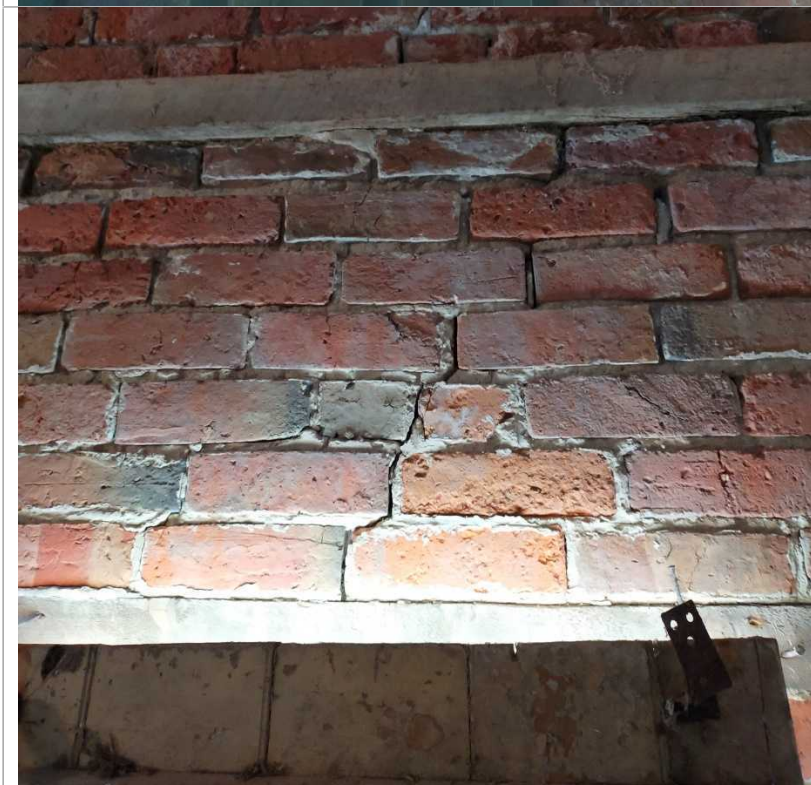
Photo 24 –

Cracks from where the brick piers have bowed outwards, due to subsidence and the load from the steel channel beams, have continued up the wall to the first floor window, then continued from the top of the window opening further up the wall to the roof line. Therefore, the gable end is in need of been taken down and being rebuilt.

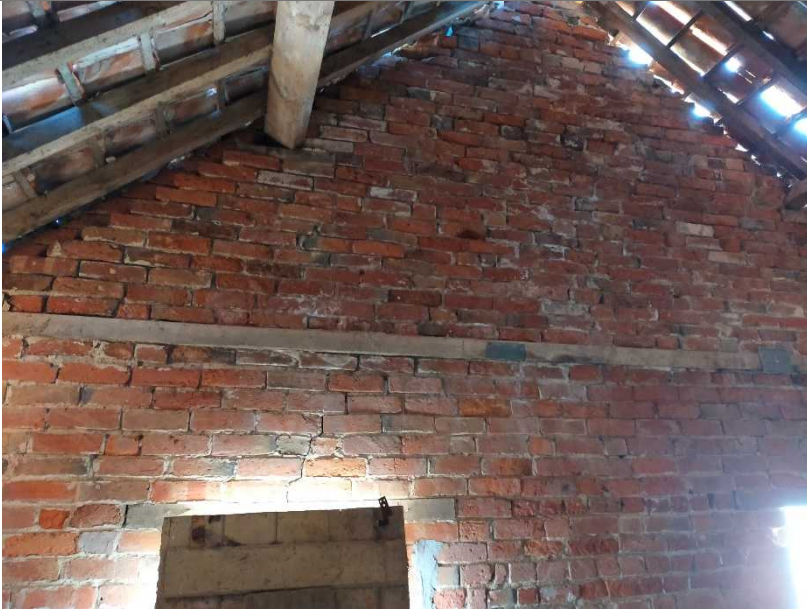
Photo 25 –

Cracks from where the brick piers have bowed outwards, due to subsidence and the load from the steel channel beams, have continued up the wall to the first floor window, then continued from the top of the window opening further up the wall to the roof line. Therefore, the gable end is in need of been taken down and being rebuilt.

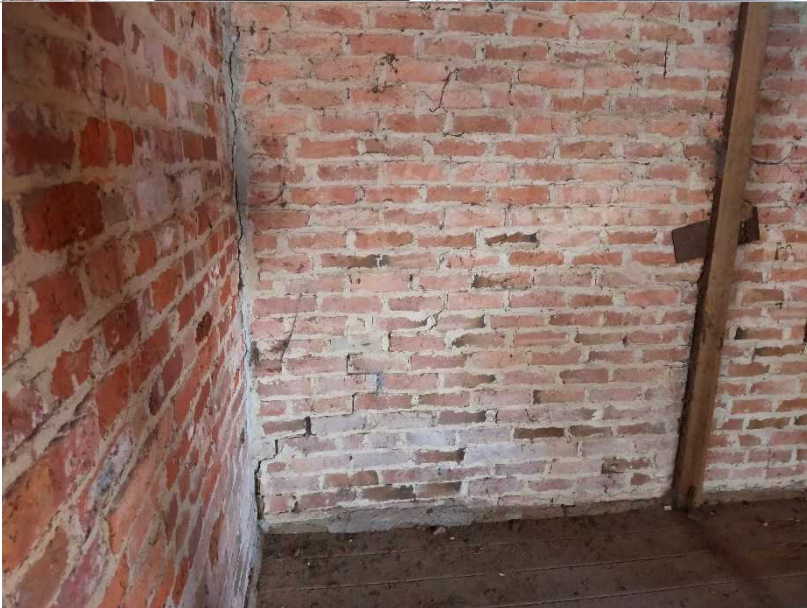
Photo 26 –

Cracks can be seen on the internal first floor barn wall, stretching from first floor level at the south west side, up to the roof line above the purlin on the opposite side.

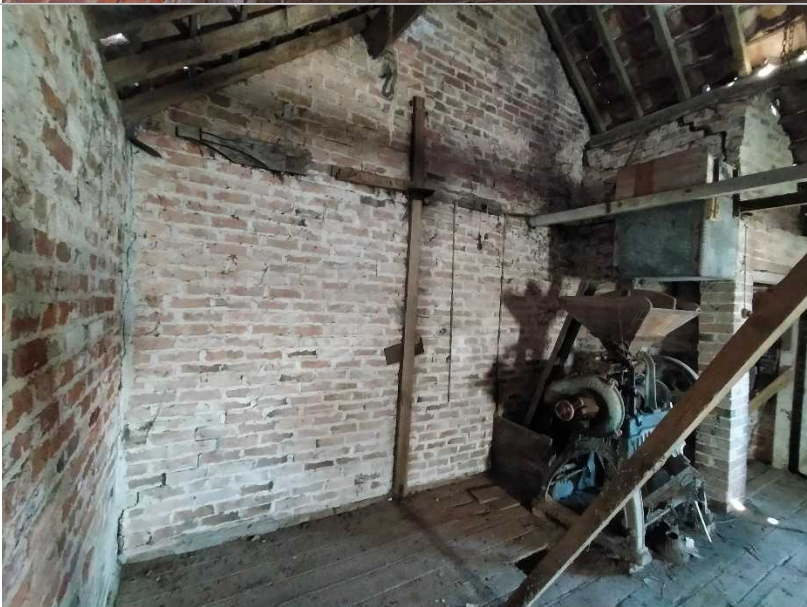
Photo 27 –

Cracks can be seen on the internal first floor barn wall, stretching from first floor level at the south west side, up to the roof line above the purlin on the opposite side. The wall at the top of the stairs also has structural cracks excess of 30mm wide at the top of the wall behind the mill tank. This is due to deterioration of the timber post supporting the beam which hold the wall up at Grd flr level. See Photo 30.

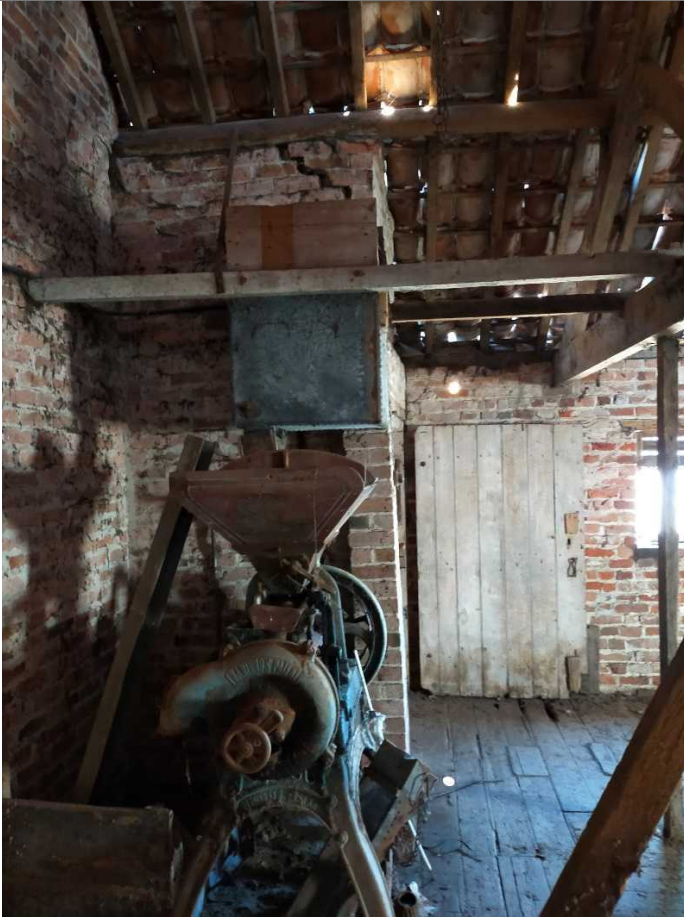
Photo 28 –

Cracks can be seen on the internal first floor barn wall, stretching from first floor level at the south west side, up to the roof line above the purlin on the opposite side. As can be seen, the wall at the top of the stairs also has structural damage with cracks excess of 30mm wide at the top of the wall behind the mill tank. This wall also supports the barn roof purlin. As can be seen, the walls are no longer square, plumb or level. The cracks are due to deterioration of the timber post supporting the beam which hold the wall up at ground floor level. See Photo 30

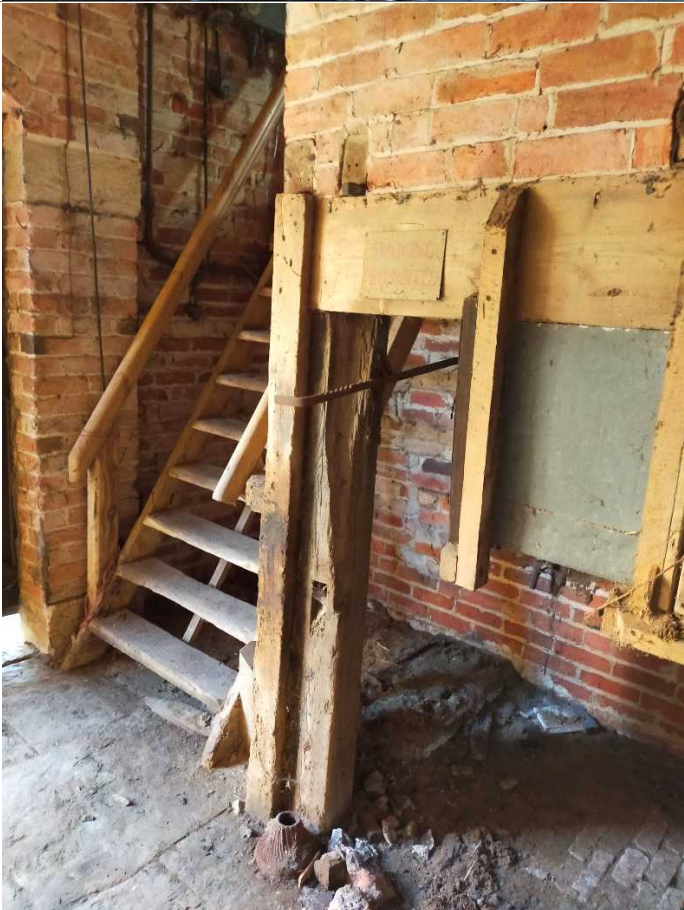
Photo 30 –

The timber post, which supports the beam holding the wall up above up to roof level. Has deteriorated in condition, showing signs of wood warm and rot. The post is simply sat on top of the York stone slab floor, not fixed to or recessed into it at all. Therefore, the post is structurally unstable, and could be knocked out of position very easily.

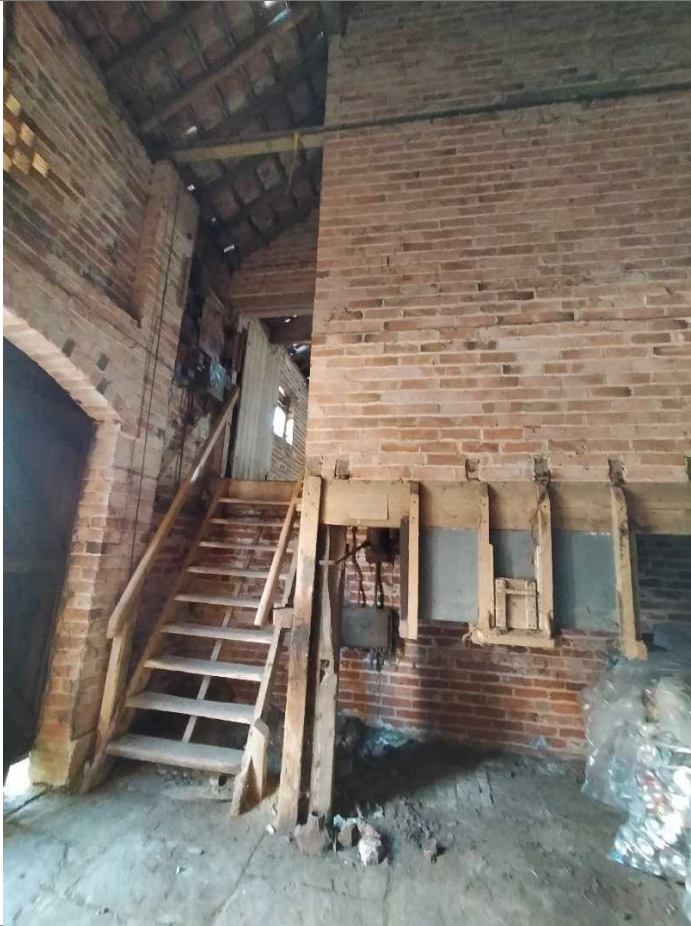
Photo 31 –

The timber post, which supports the beam holding the wall up above up to roof level. Has deteriorated in condition, showing signs of wood war and rot. The post is simply sat on top of the York stone slab floor, not fixed to or recessed into it at all. Therefore, the post is structurally unstable, and could be knocked out of position very easily. This wall needs taking down!

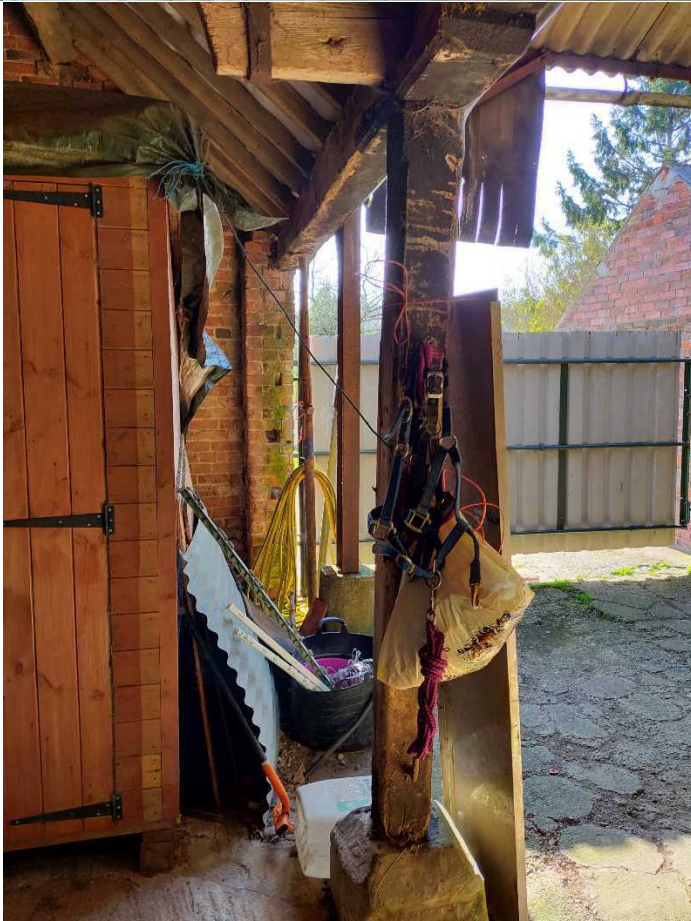
Photo 33 –

The structural timber posts supporting the single storey barn trusses have seriously deteriorated in condition due to water penetration – water running out of the blocked / sagged gutters above, weathering and wear & tear from the cattle live stock which used to be located in the shed. At the base of the timber posts, they show signs of failure and are in need of replacement / demolition.

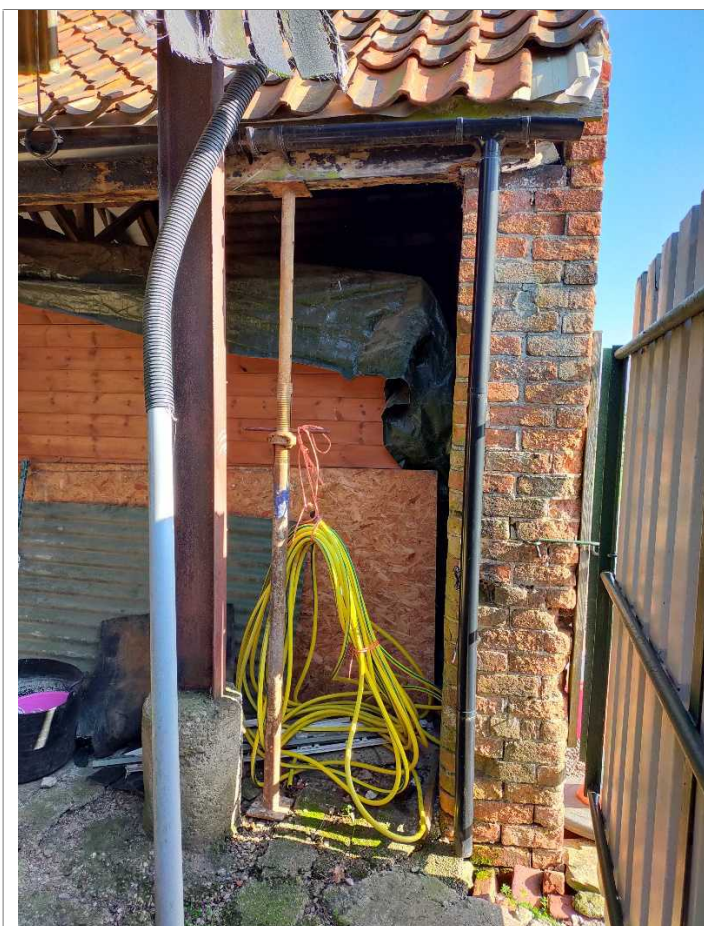
Photo 34 –

Due to subsidence the gable end wall is no longer supporting the timber eaves beam which supports the single storey barn roof. The beam is now been held up by an adjustable acrow prop. Gaps can be seen at the top how much the wall has moved by where the timber beam (which is in a poor condition itself) used to sit on the wall.

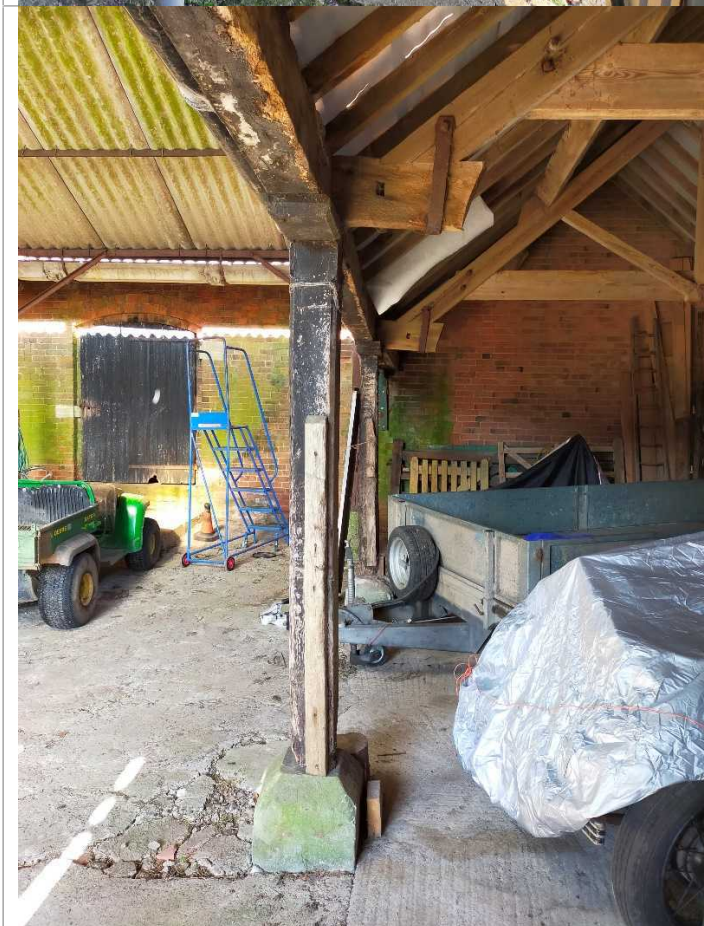
Photo 35 –

The structural timber posts supporting the single storey barn trusses have seriously deteriorated in condition due to water penetration – water running out of the blocked / sagged gutters above, weathering and wear & tear from the cattle live stock which used to be located in the shed. At the base of the timber posts, they show signs of failure and are in need of replacement / demolition.

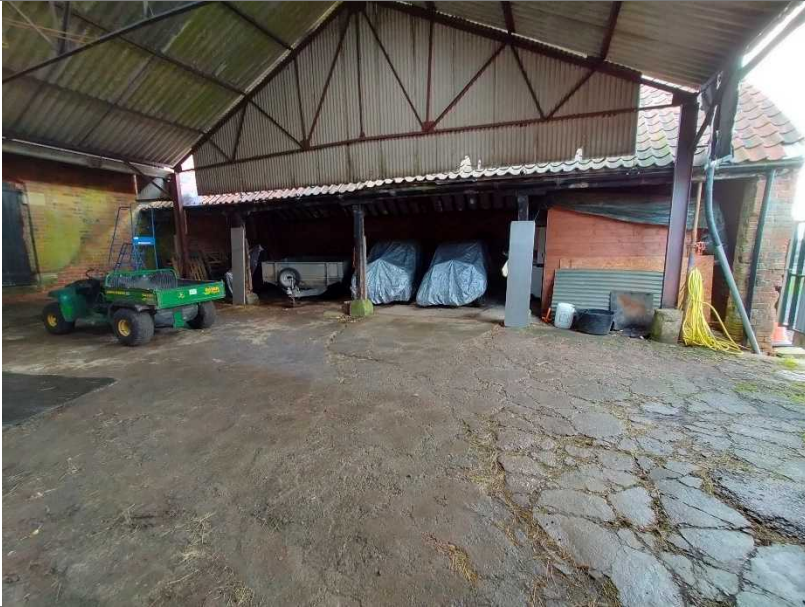
Photo 36 –

Covers have been tied to the timber structural posts to stop water running off the roof, down the posts and deteriorating the base of the posts.

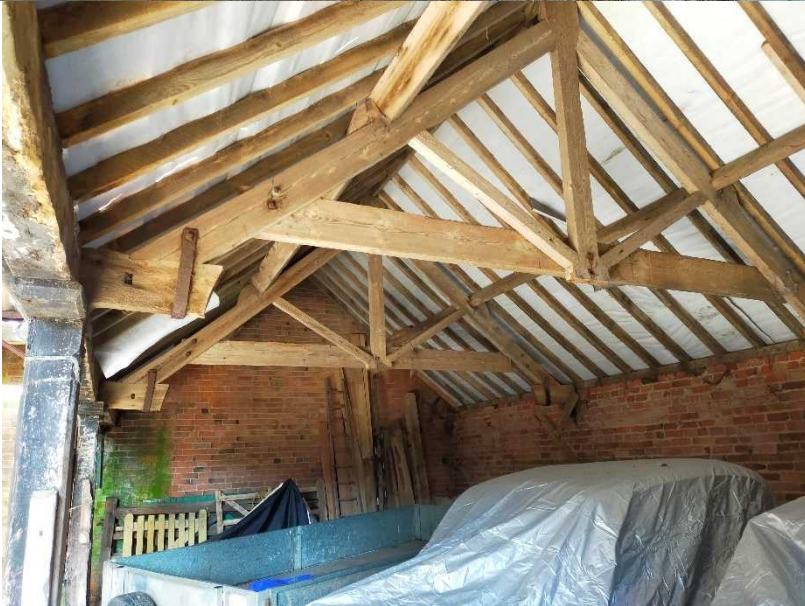
Photo 37 –

Excess of 60 years, to access to cart shed by tractor, the king trusses were structurally deformed by raising the height of the bottom timber. These trusses are structurally unsound and are in need of replacement.

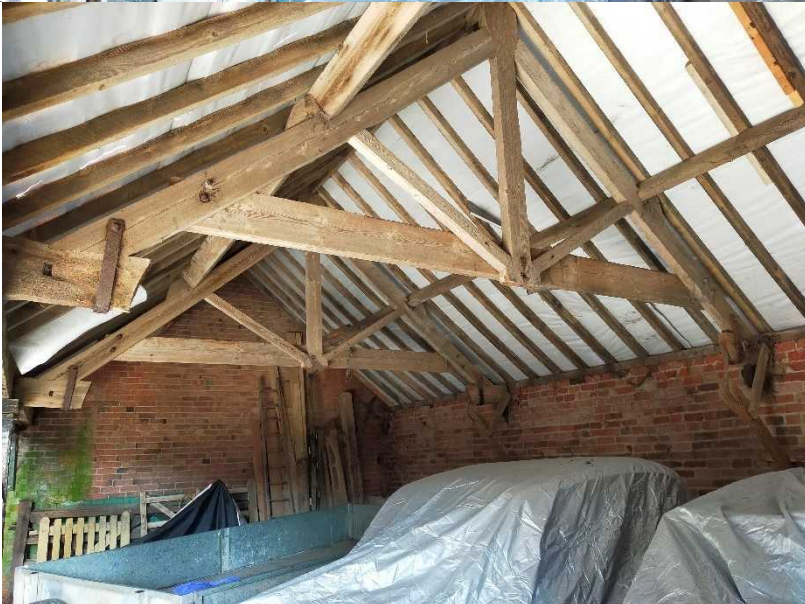
Photo 38 –

Excess of 60 years, to access to cart shed by tractor, the king trusses were structurally deformed by raising the height of the bottom timber. These trusses are structurally unsound and are in need of replacement.

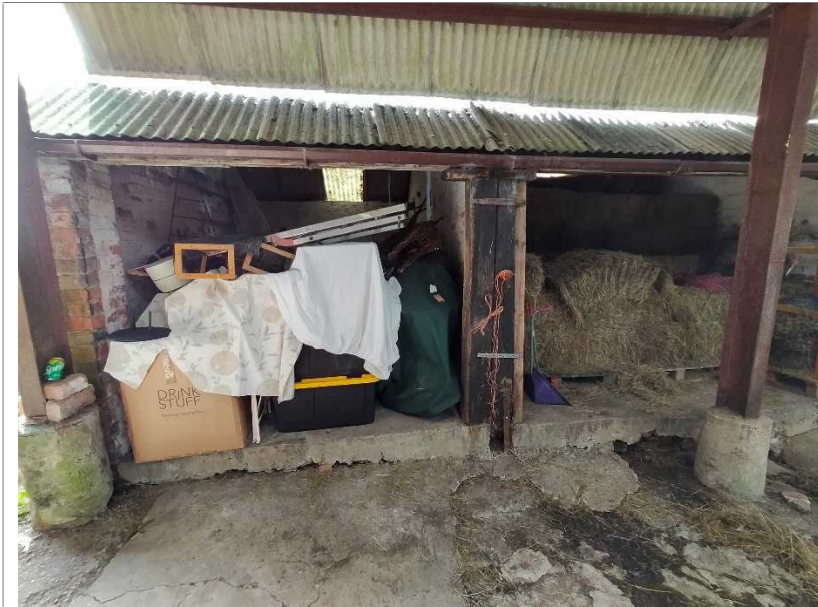
Photo 39 –

Due to the change in floor level, the former pig stable sheds are not accessible to Building Regs standard by vehicle or pedestrian foot.

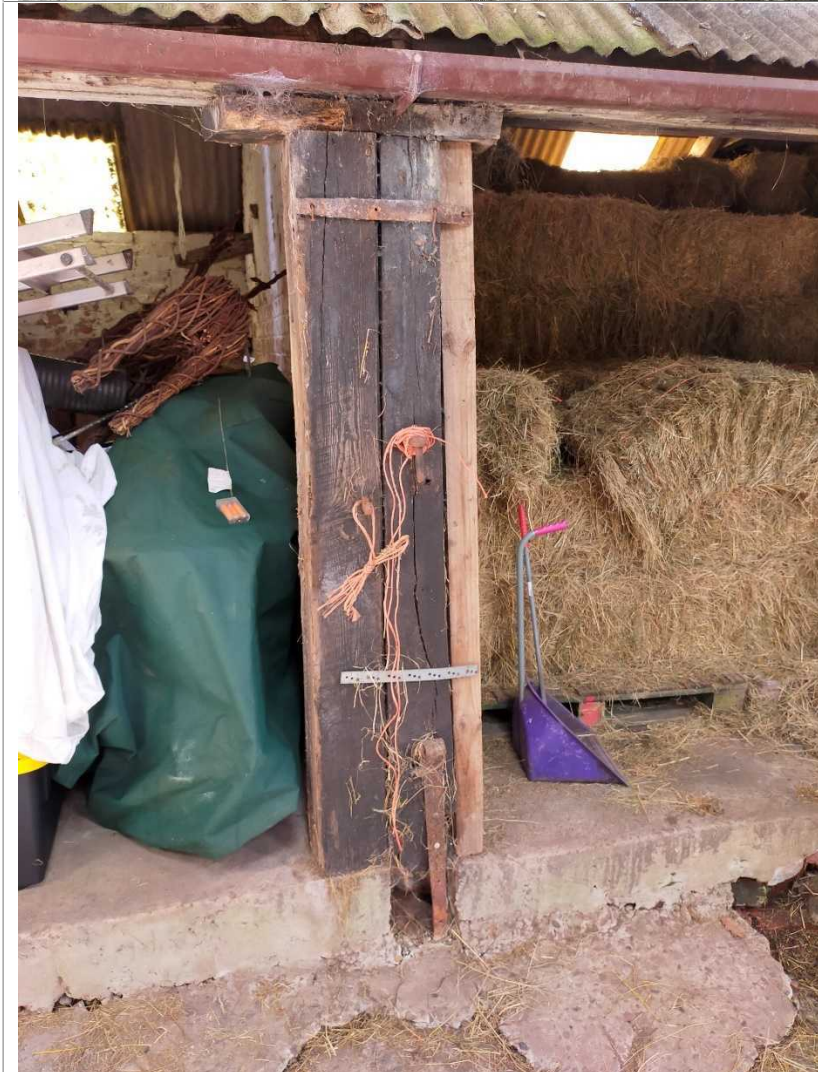
Photo 40 –

Where the original structural timber posts met the ground level, the timbers have rotted away and are currently being supported on both sides by addition timber posts, which are sat on top of the concrete floor slab, which was formed at a much later date.

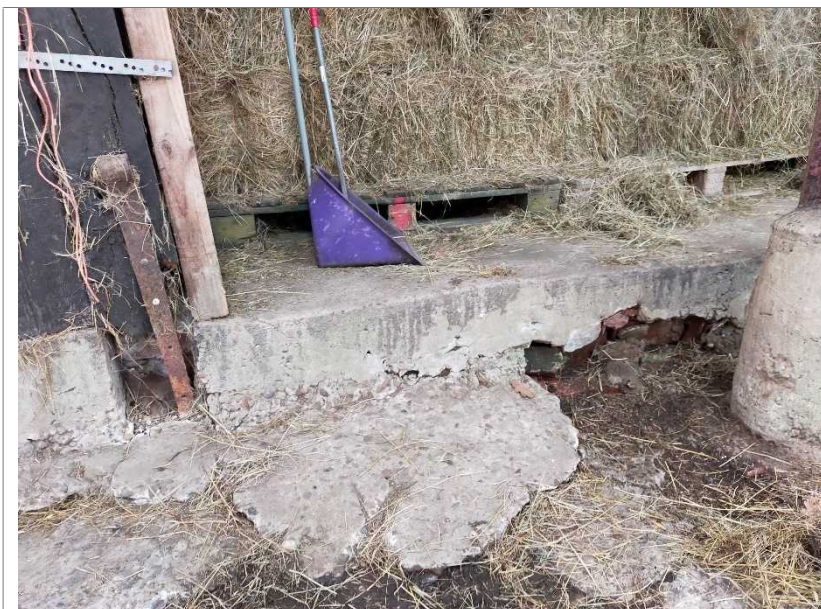
Photo 41 –

Due to subsidence, earth movement and poor construction, cracks can be seen stretching from the front to the back of the stable shed floor slab.

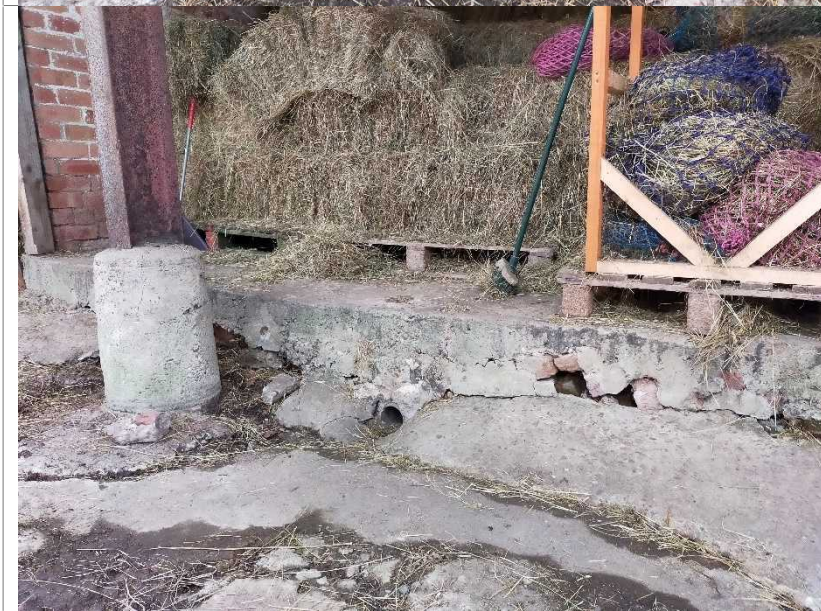
Photo 42 –

Due to subsidence, earth movement and poor construction, cracks can be seen stretching from the front to the back of the stable shed floor slab. Soak-away drains run underneath the floor slab in line with the direction of one of the floor slab cracks. Due to the change in floor level, the former pig stable sheds are not accessible to Building Regs standard by vehicle or pedestrian foot.

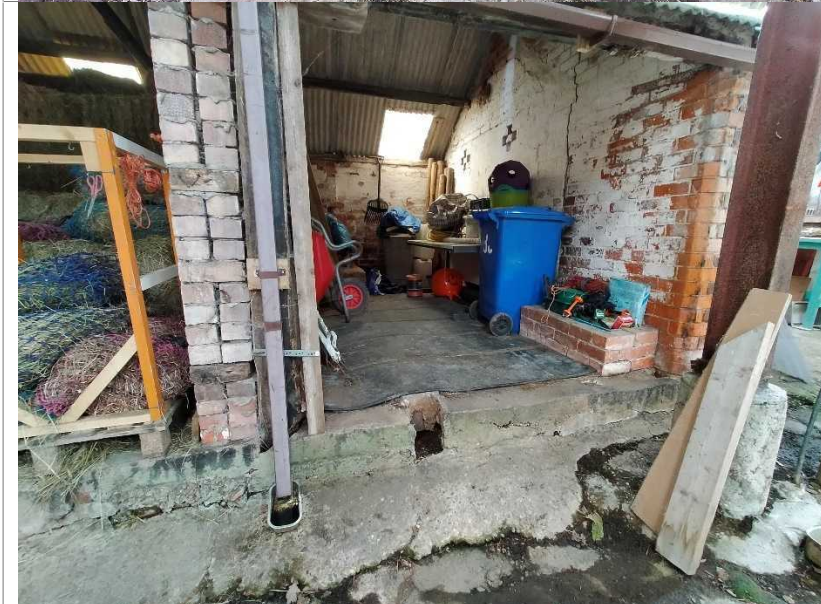
Photo 43 –

The internal walls, which were extended at a later date and built on top of the floor slab, display cracks running the full height of the walls. These walls have been poorly constructed and the brickwork is not tied into the adjoining brick leaves.

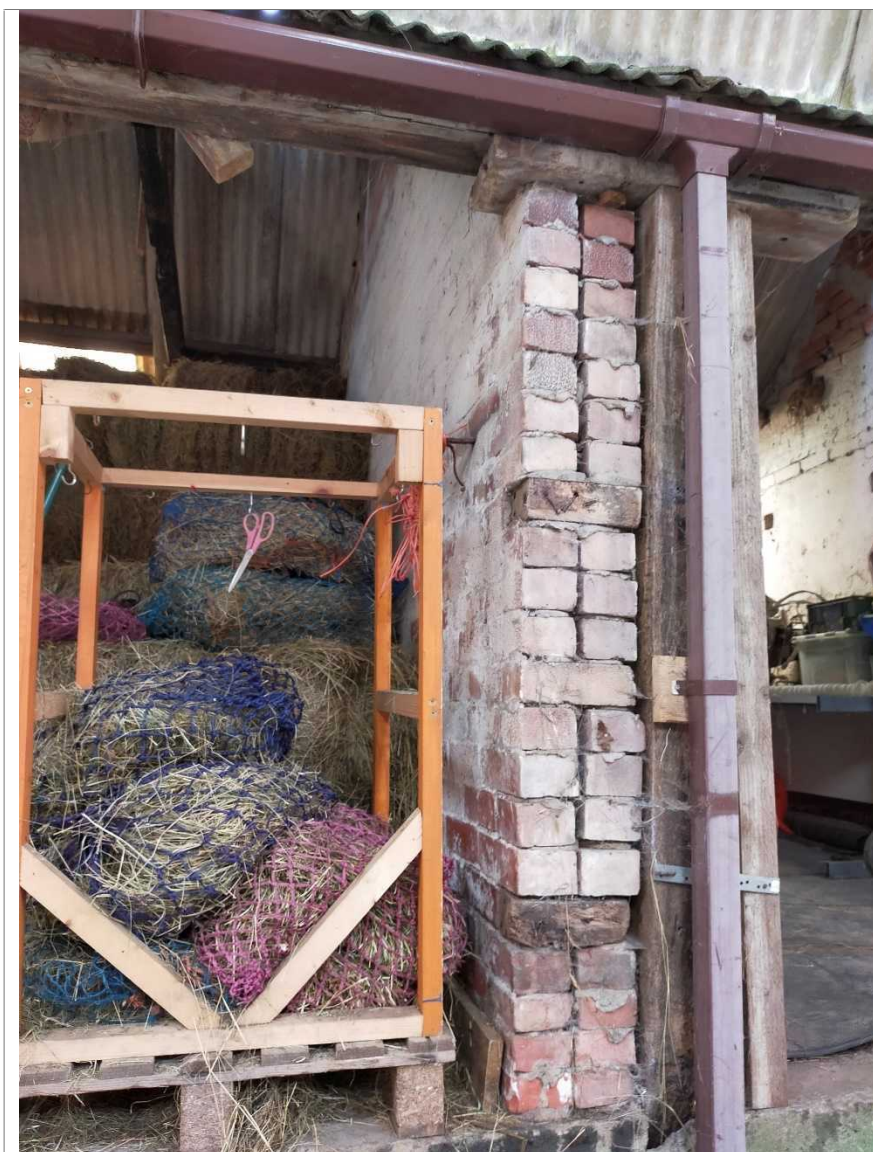
Photo 44 –

The internal walls, which were built and extended at a later date were built on top of the floor slab. These walls display cracks running the full height of the walls. These walls have been poorly constructed and the brickwork is not bonded into the adjoining brick leaves. Where the timber beams which support the roof above are supposed to be supported by the internal walls, additional timber posts have been applied. This is due to subsidence of the walls, deterioration of the timber horizontal beams and the original timber posts being relocated.
