2021/24 BELL
EXISTING BARN AND STABLES
STRUCTURAL DEFECTS AUDIT

PROPOSED CONVERSION OF REDUNDANT
AGRICULTURAL FARM OUTBUILDINGS TO FORM ONE
DWELLING UNIT FOR OWNER TO OCCUPY AND ONE
DWELLING UNIT FOR RENTAL ACCOMMODATION.

FORWOOD FARM, TRESWELL

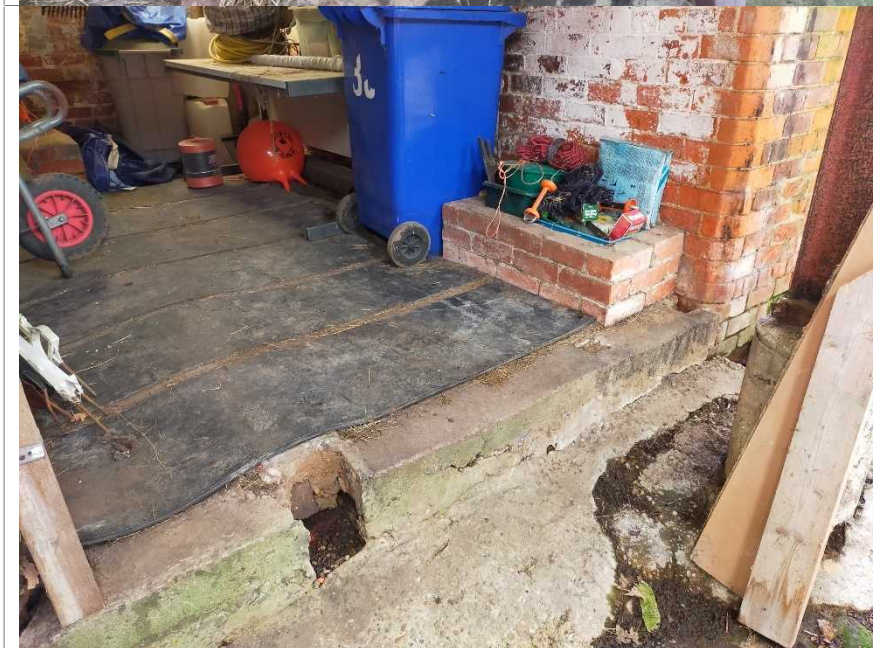
Photo 45 –

Cracks due to earth movement can be seen in the concrete floor slab.

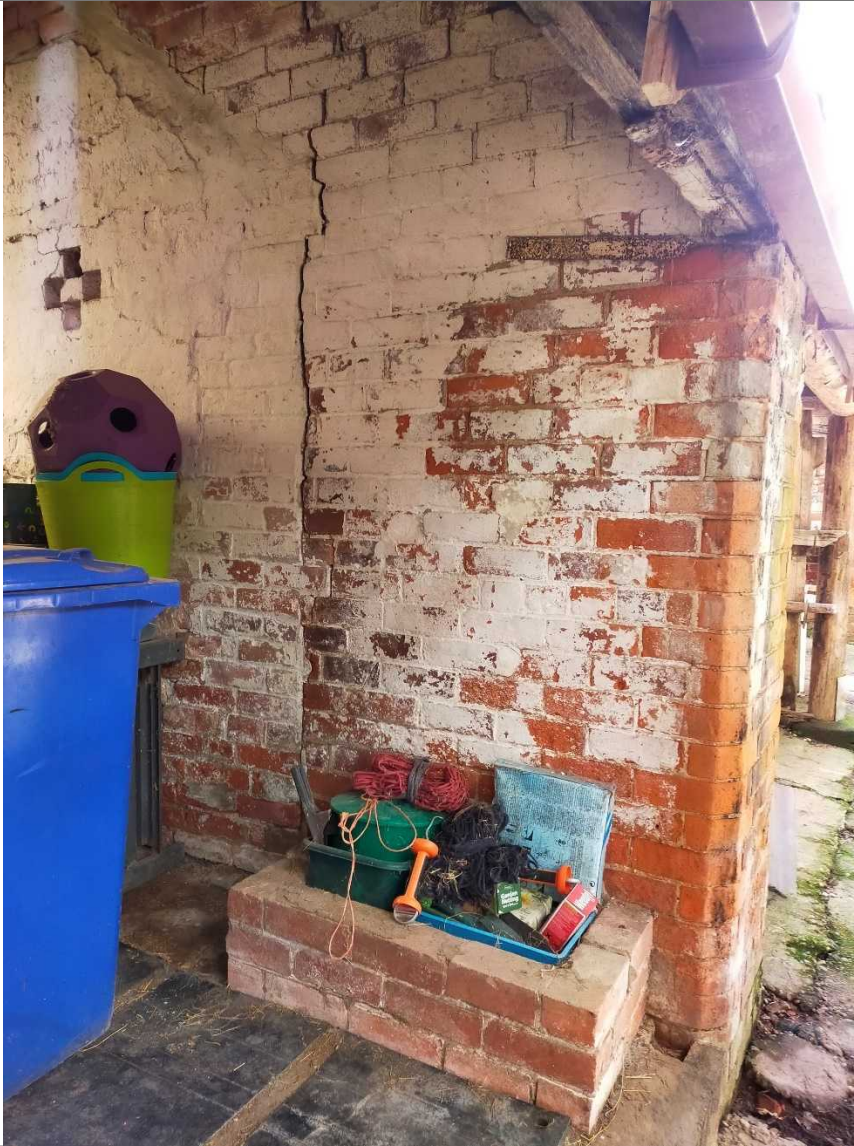
Photo 46 –

The internal walls, which were built and extended at a later date and built on top of the floor slab, display cracks running the full height of the walls. These walls have been poorly constructed and the brickwork is not bonded into the adjoining brick leaves.

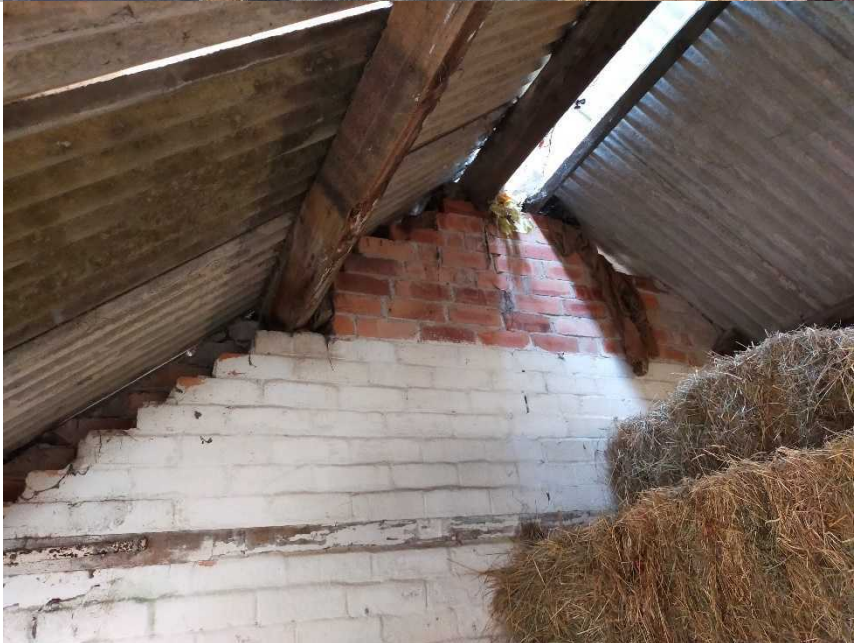
Photo 47 –

The pig stable building structural roof timbers are in need of replacement due to weather deterioration / water penetration.

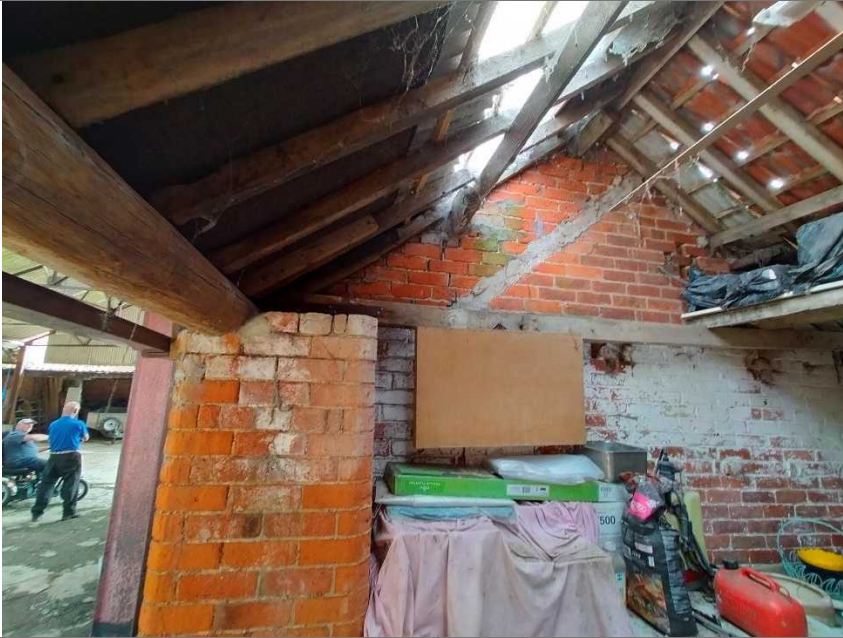
Photo 48 –

The internal walls, which were built and extended at a later date and built on top of the floor slab, display cracks running the full height of the walls. These walls have been poorly constructed and the brickwork is not bonded into the adjoining brick leaves.

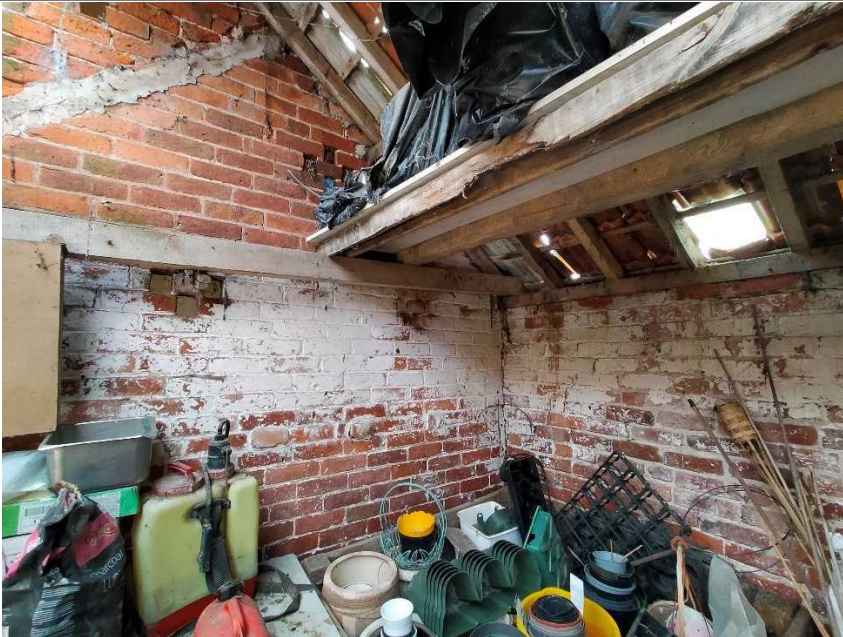
Photo 49 –

The internal walls, which were built and extended at a later date and built on top of the floor slab, display cracks running the full height of the walls. These walls have been poorly constructed and the brickwork is not bonded into the adjoining brick leaves.

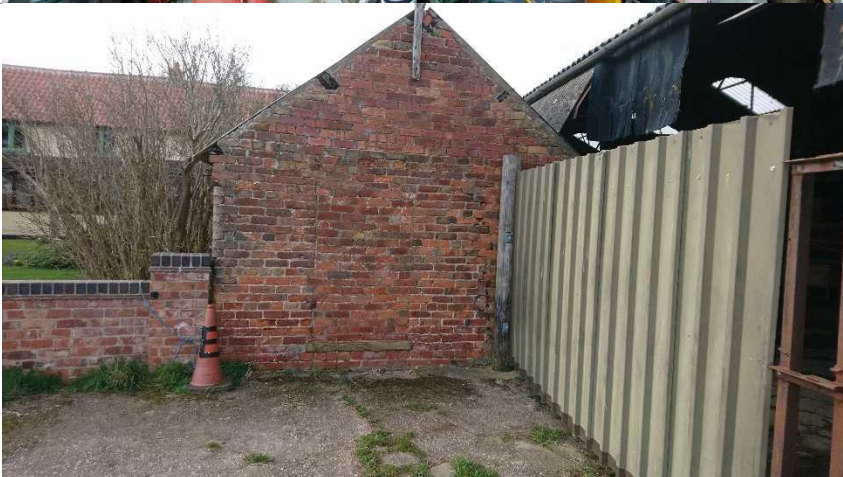
Photo 50 –

The pig stable building structural roof purlins and ridge beam timbers are in need of replacement due to weather deterioration / water penetration.
