Contaminated Land Phase One Desk Study for proposed conversion of a barn at Higher Gibfield Farm, Manchester Road, Burnley, BB11 5NS.

November 2021

Introduction

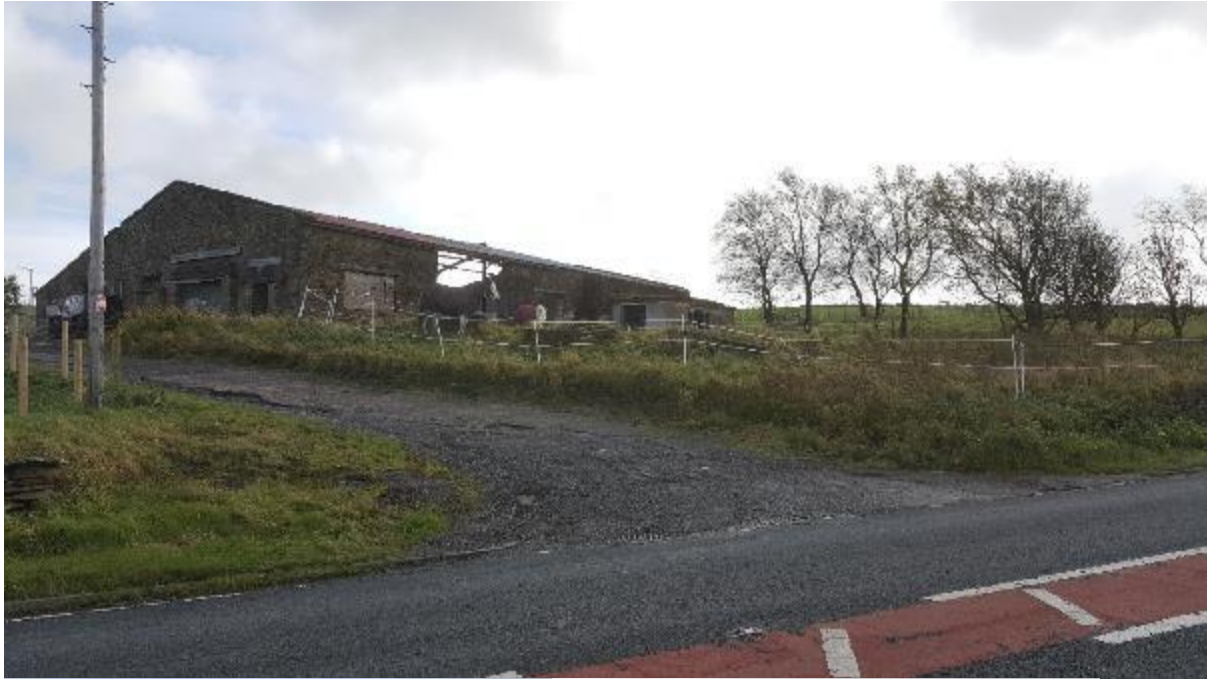
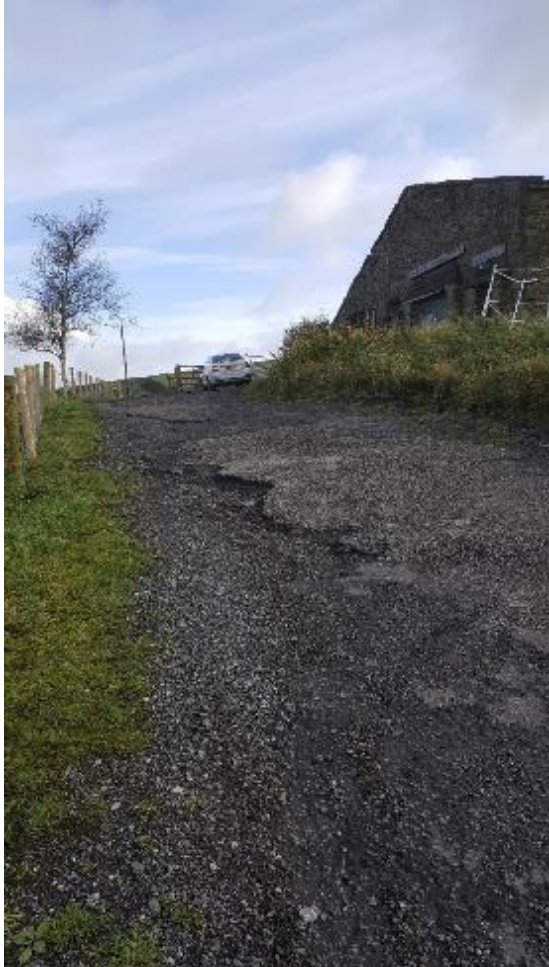
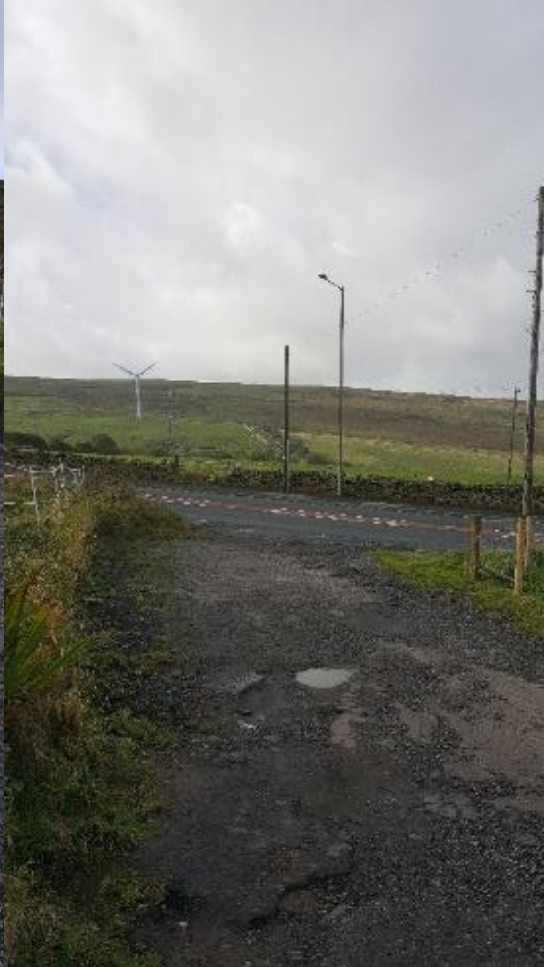
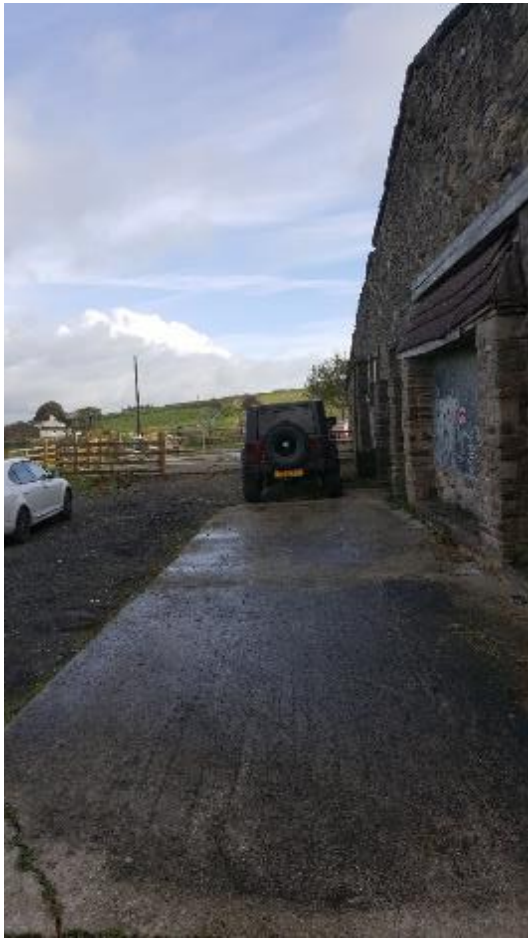
The site is accessed from the main road via a shared track leading to Higher Gibfield Farm. The development site fronts onto the main road.

Along the northern boundary is the shared access road to the Higher Gibfield. This is a rough asphalt drive which extends slightly into the site and then meets a concrete base to the side of the building. This wraps around to the front and rear of the building forming the yard to the rear. An area of rough ground with some 'crush and run' material lies to the very rear of the site which has been used as a midden.

The access from the main road and shared drive.

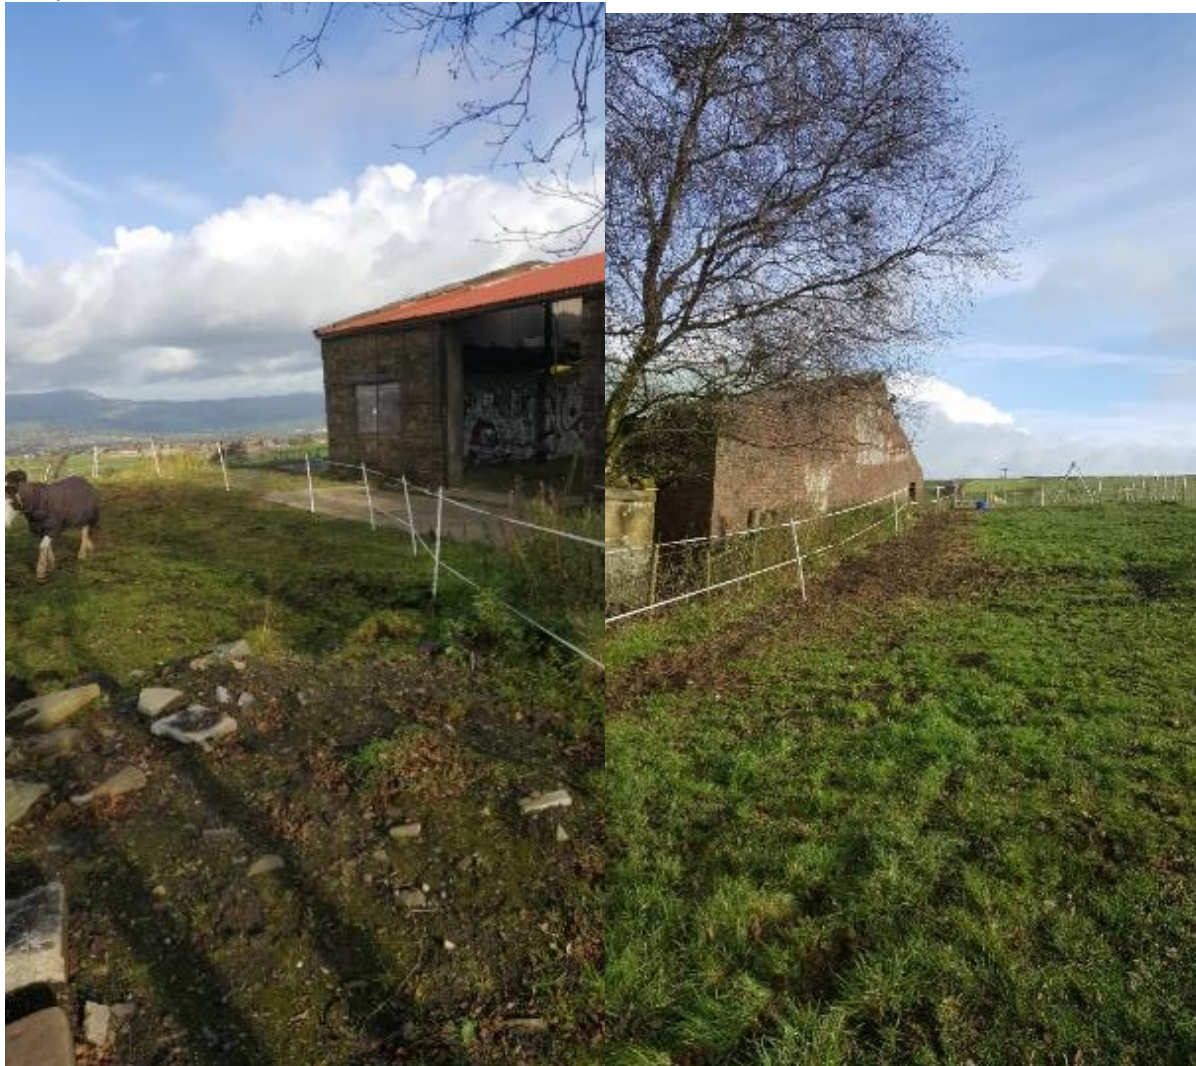
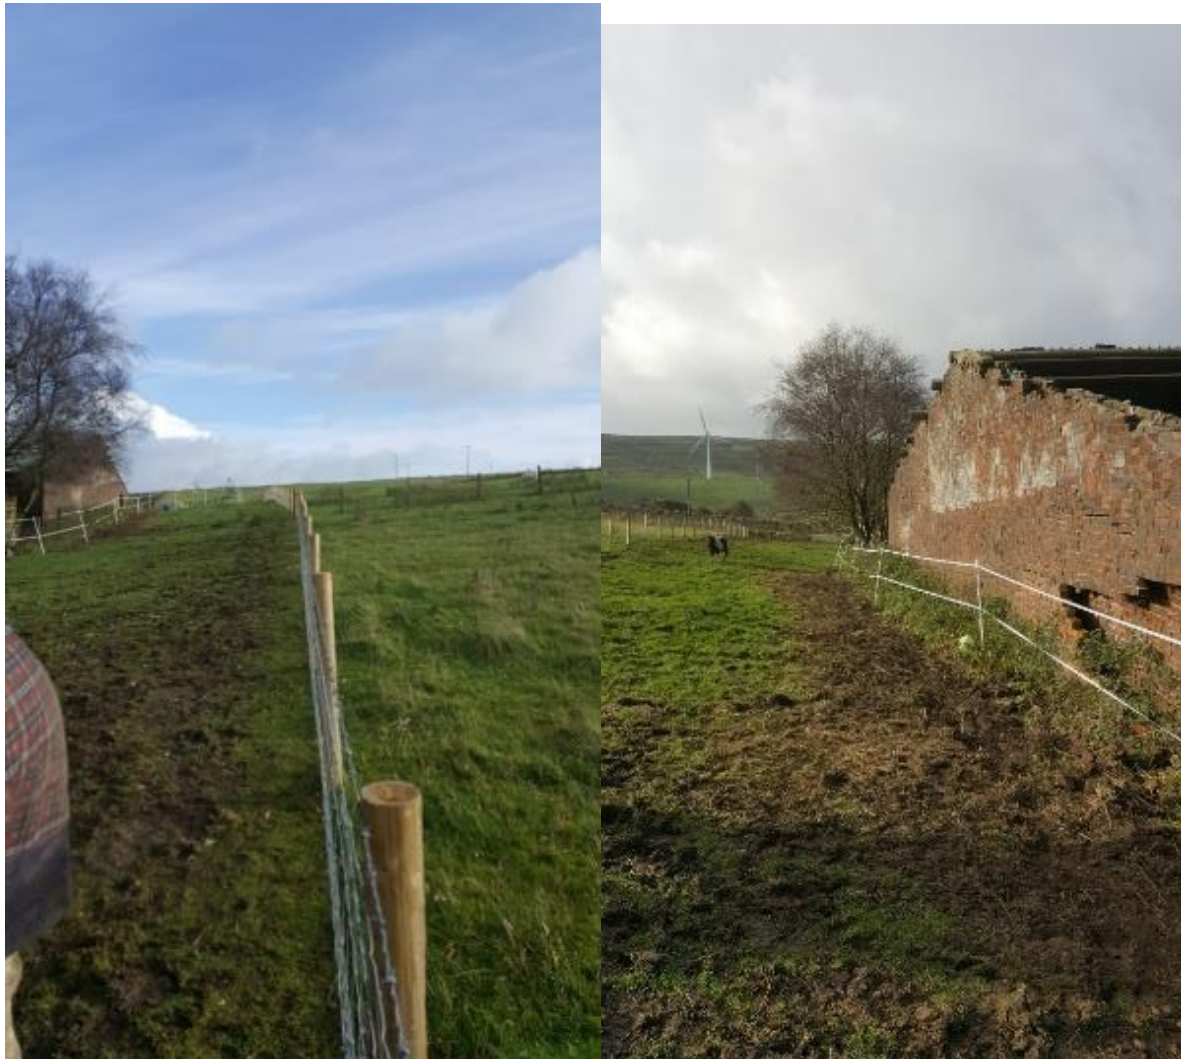
To the front, west of the site is an open paddock raised slightly from the road, this wraps around the building to the south where the ground is approx. 2m higher than the yard to the rear of the building. The base of the building being dug into the ground and the wall raised adjacent to it.

The paddock

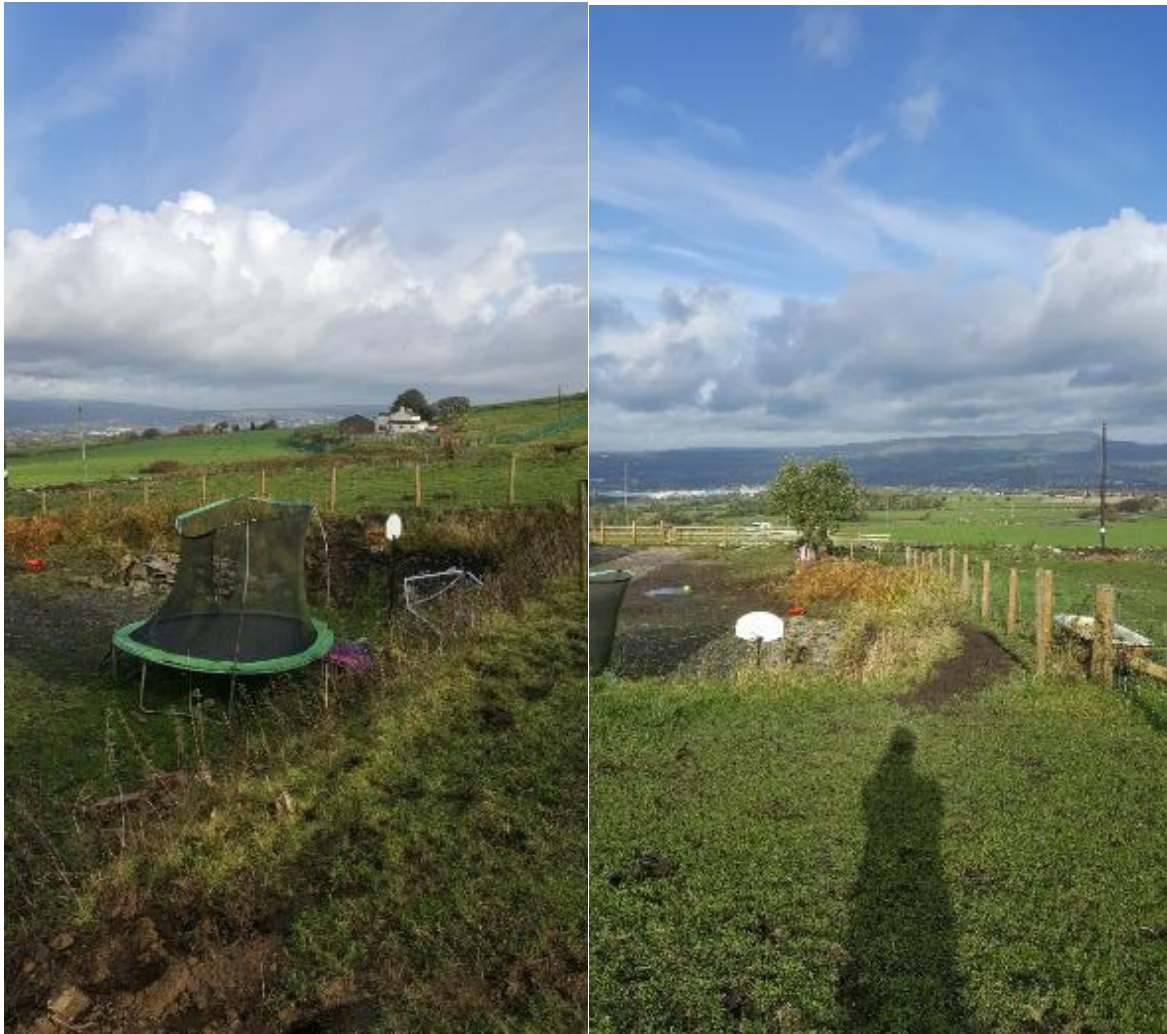
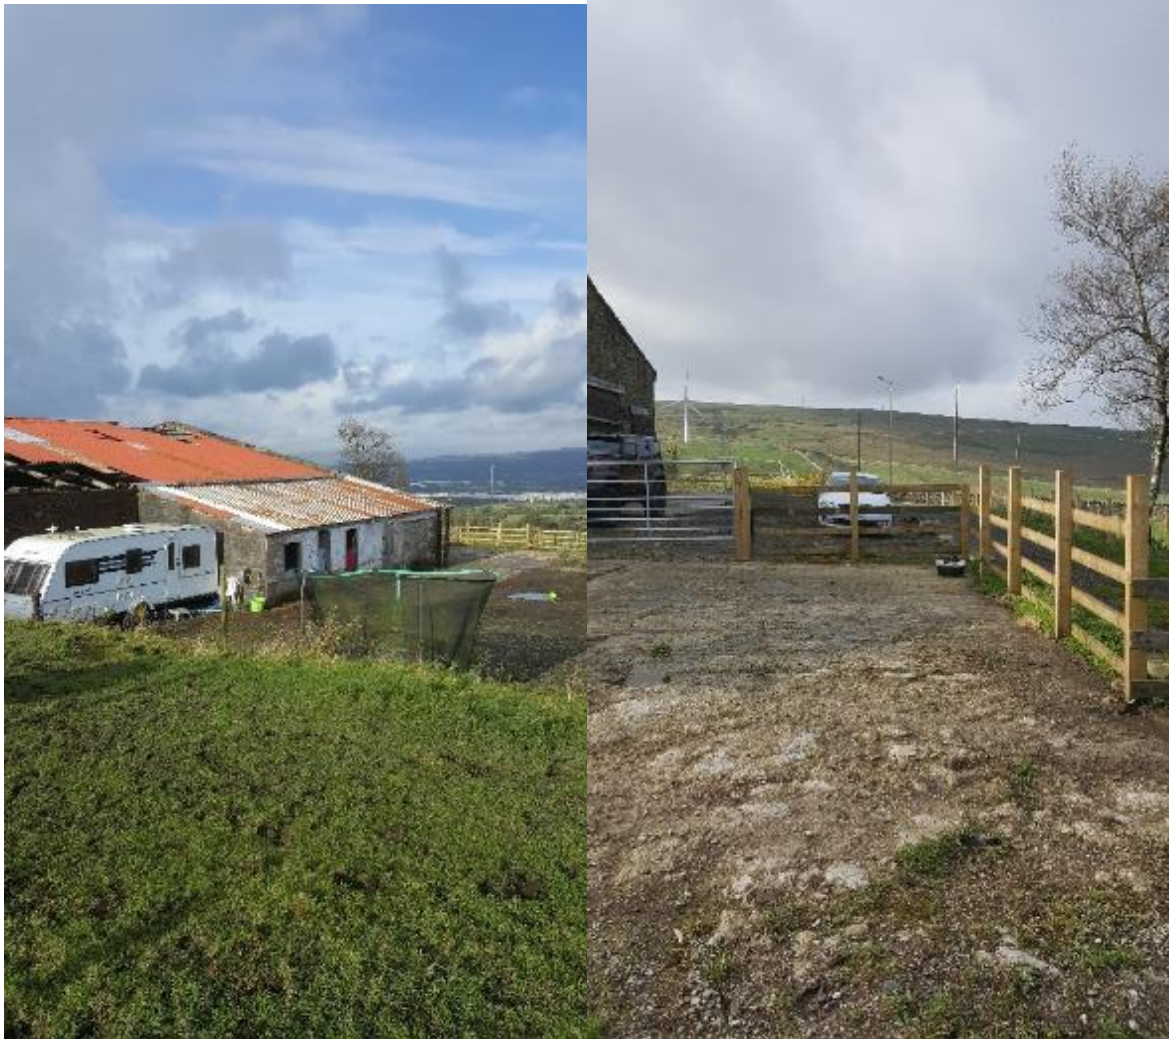
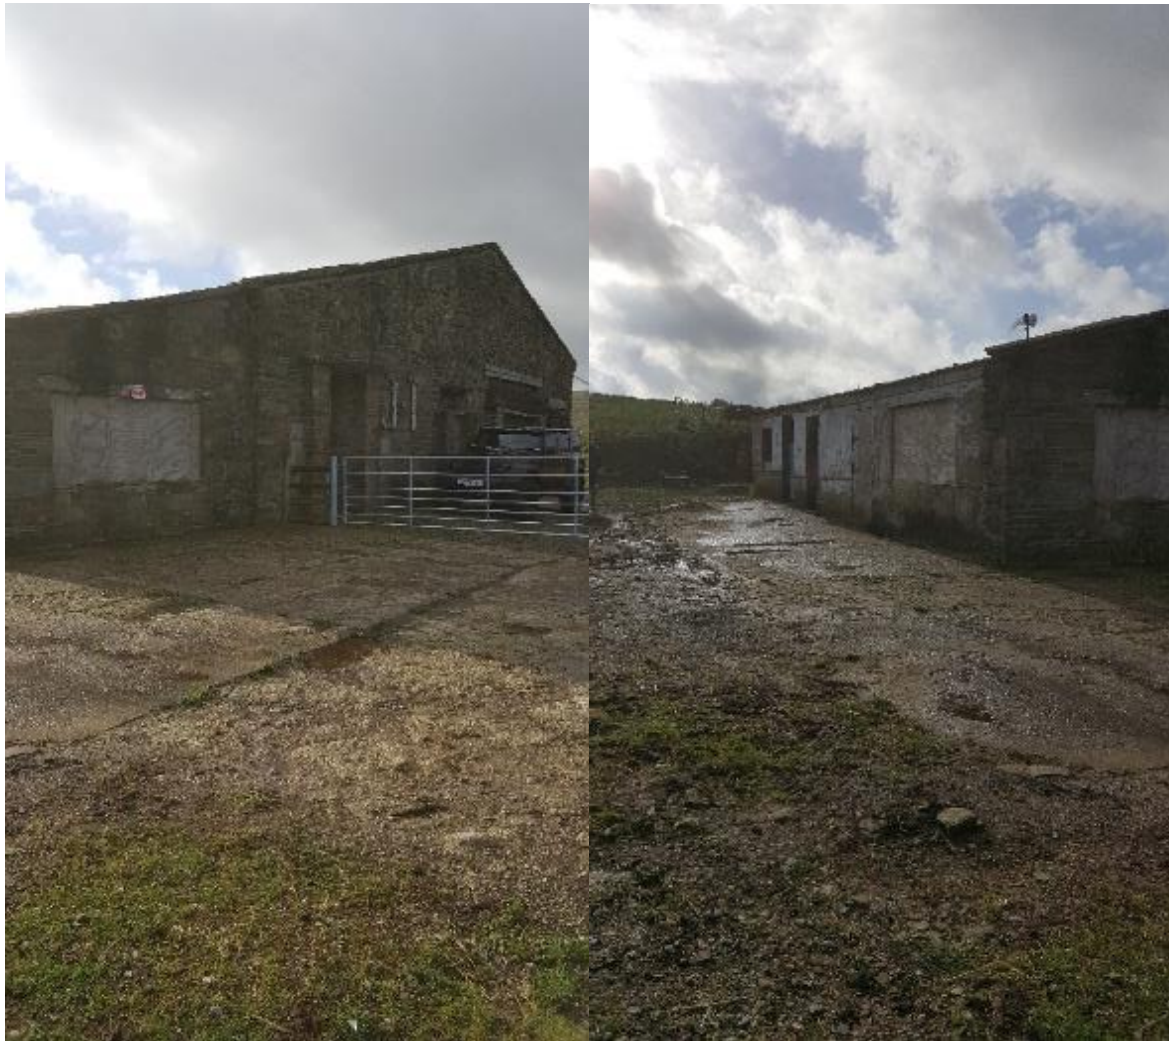
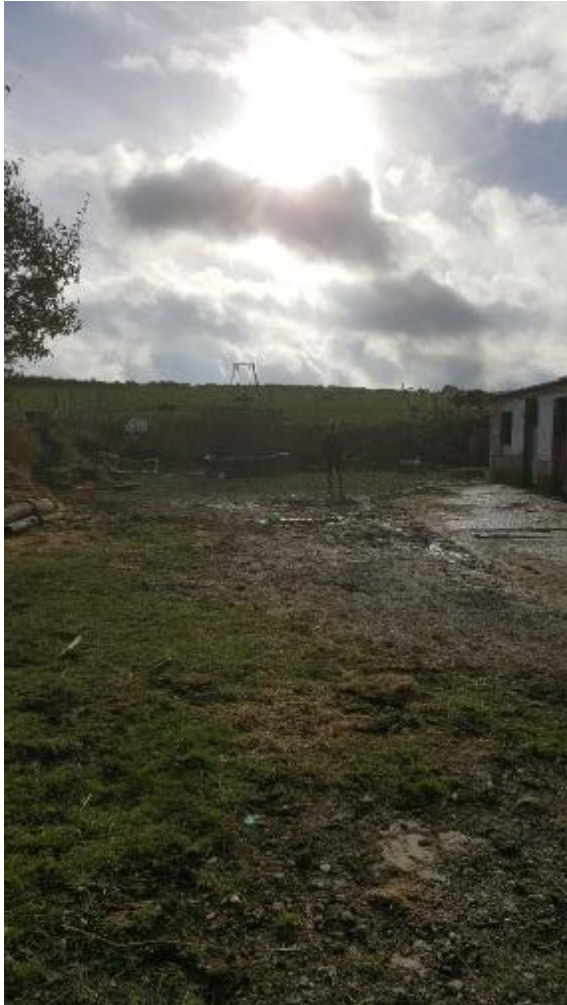
The rear yard, and drop from the paddock.

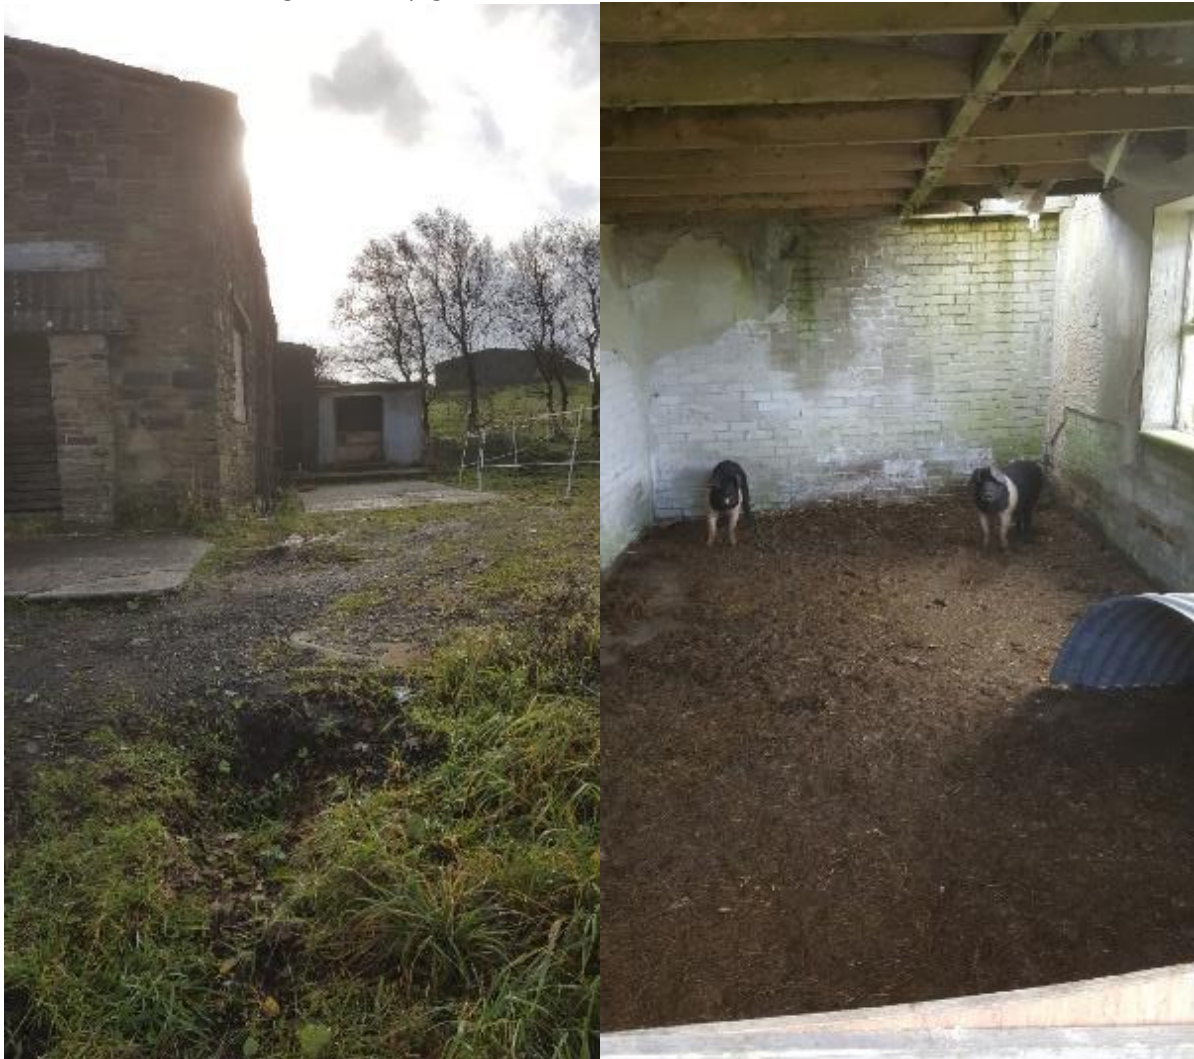
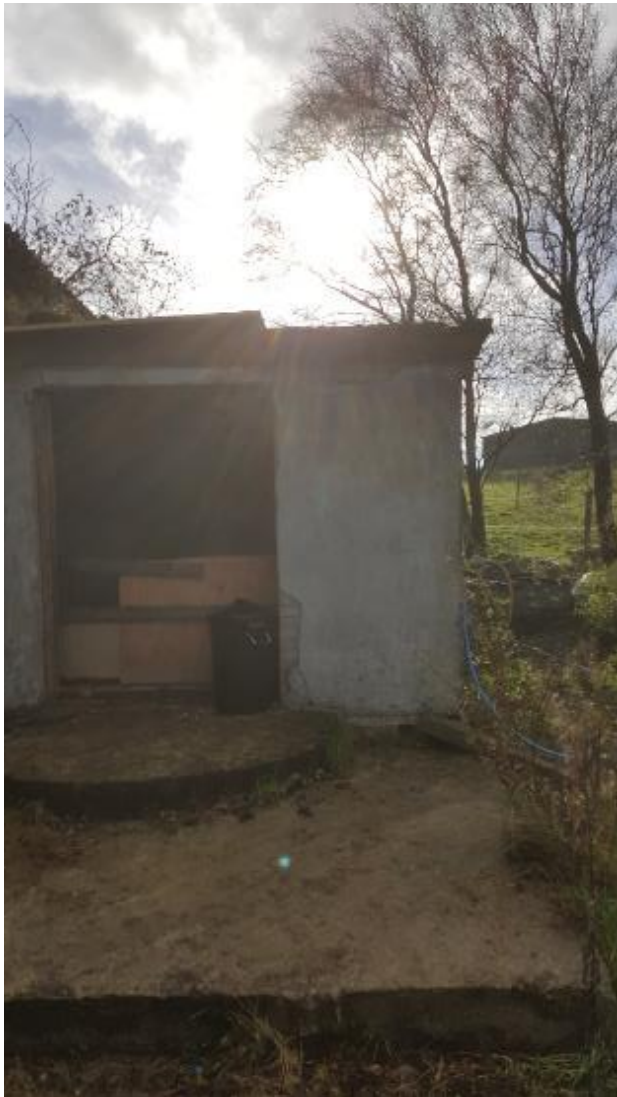
To the front another small brick enclosure containing a couple of pigs.

The front of the building with the pigs.

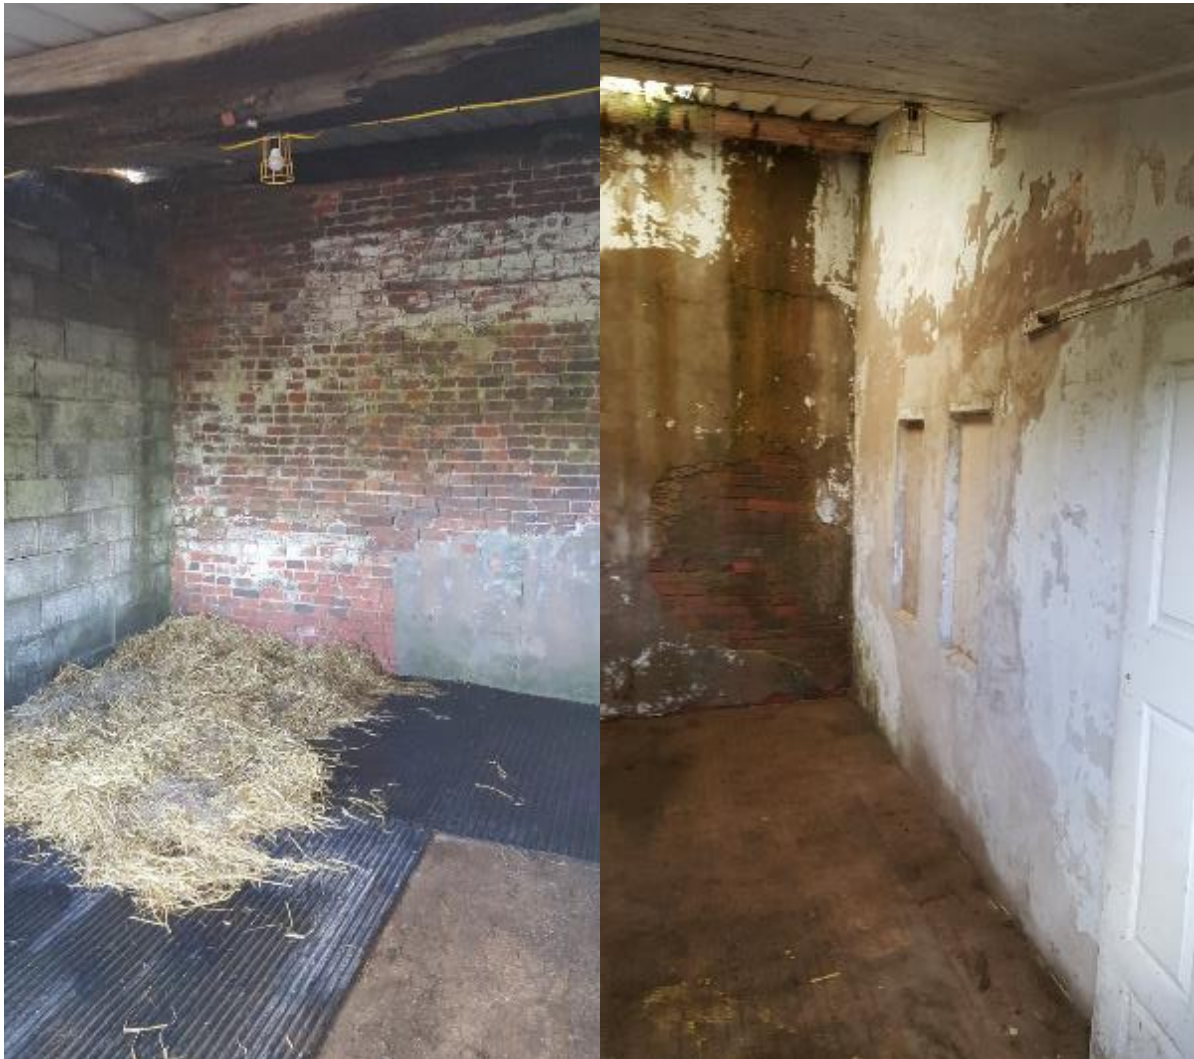
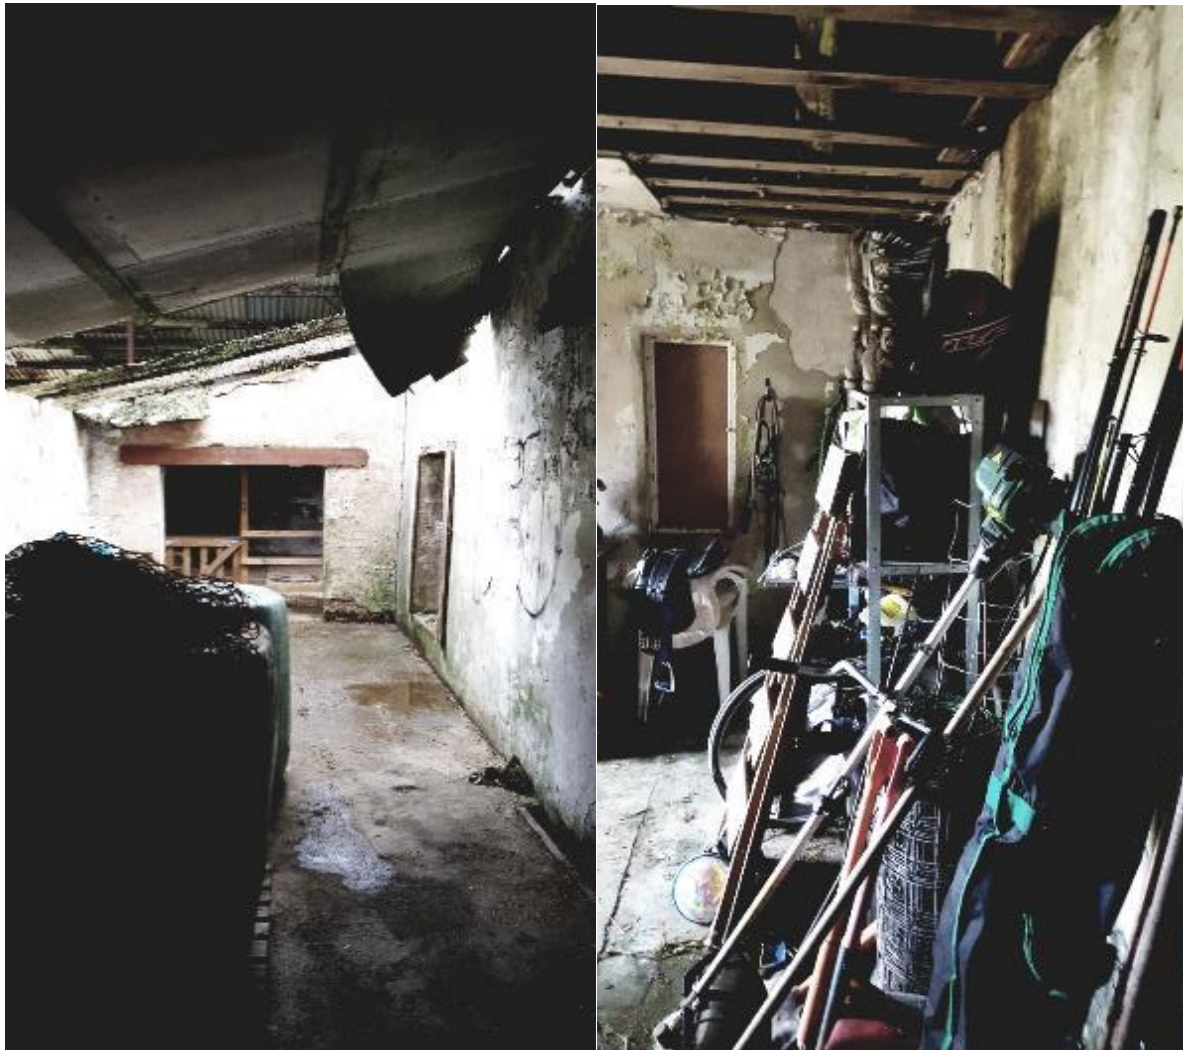
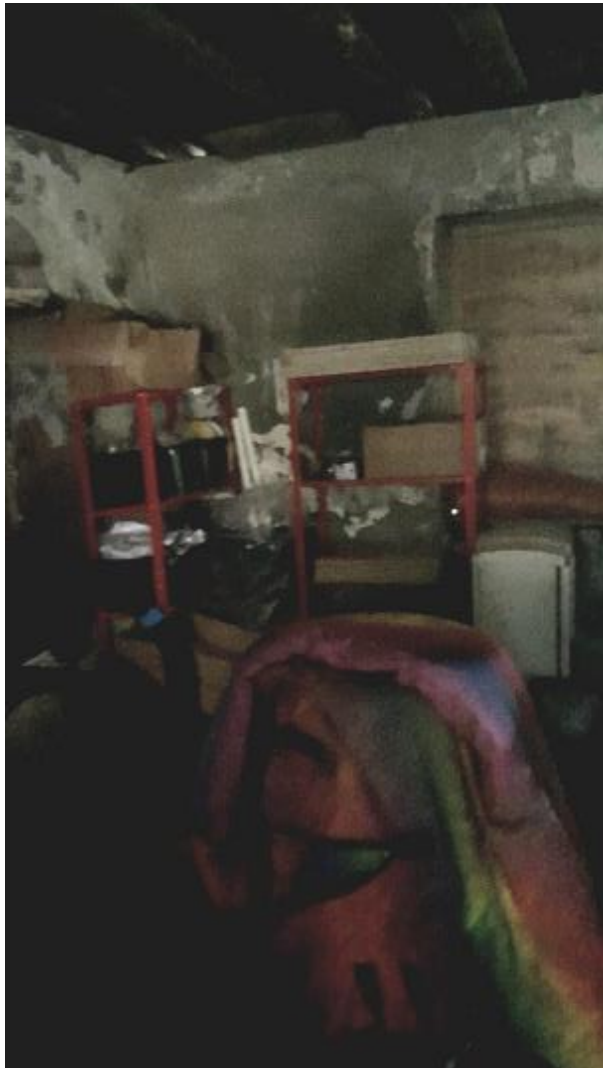
The rear of the building is intact and used as stables, consisting of a concrete floor, brick rendered walls and metal corrugated roof. To the northern end the room runs the full length of the building and the north eastern corner used as a tack room.

The stables to the rear and tack room

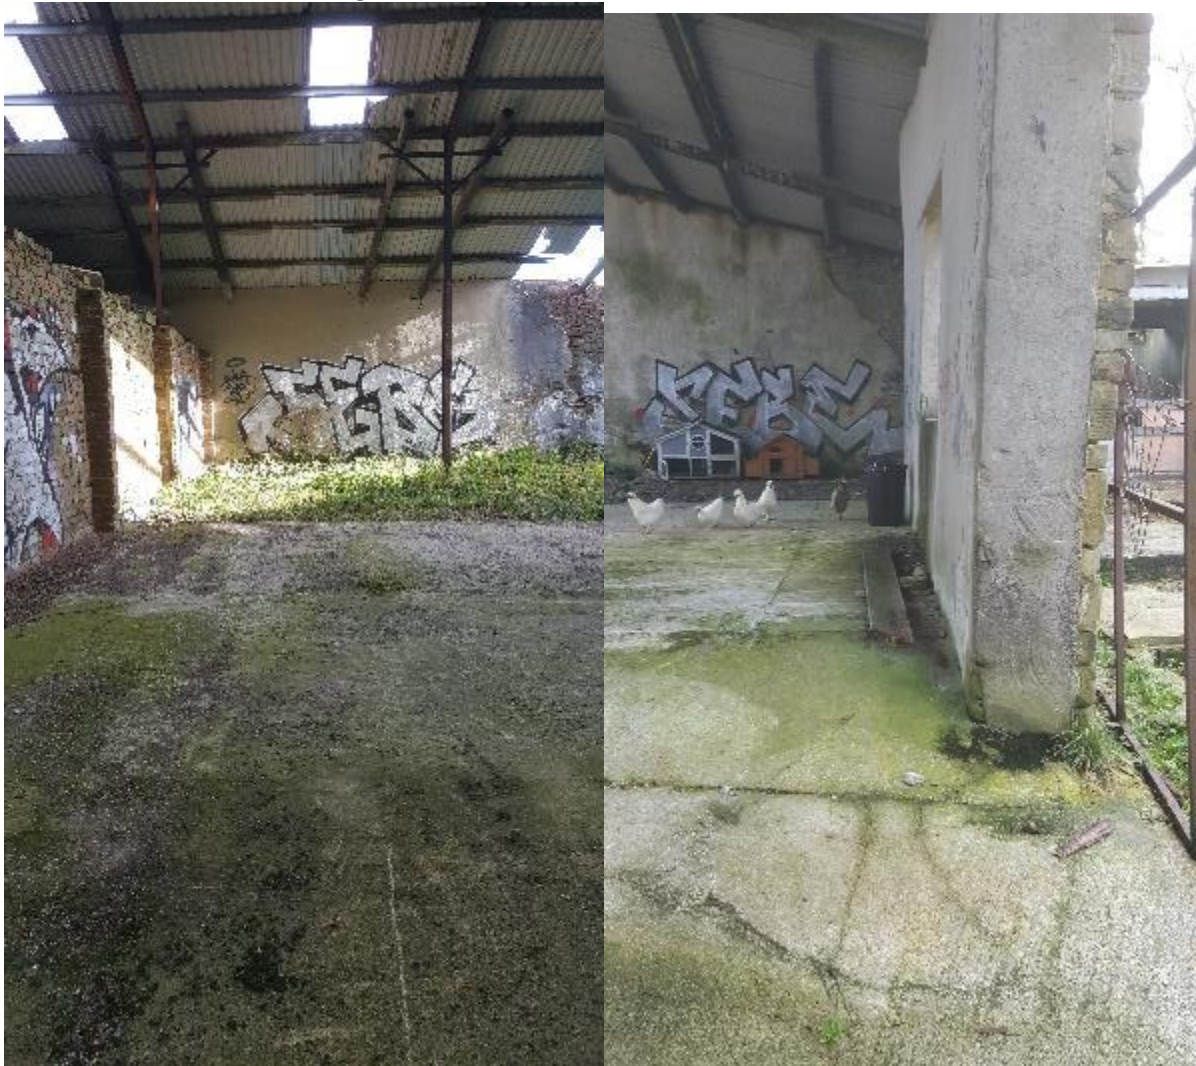
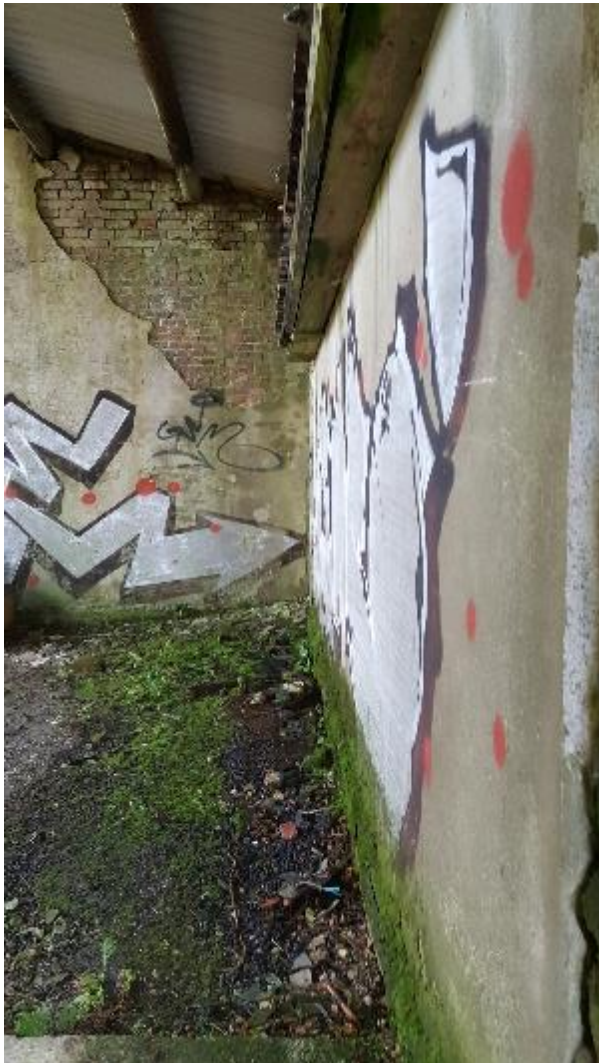
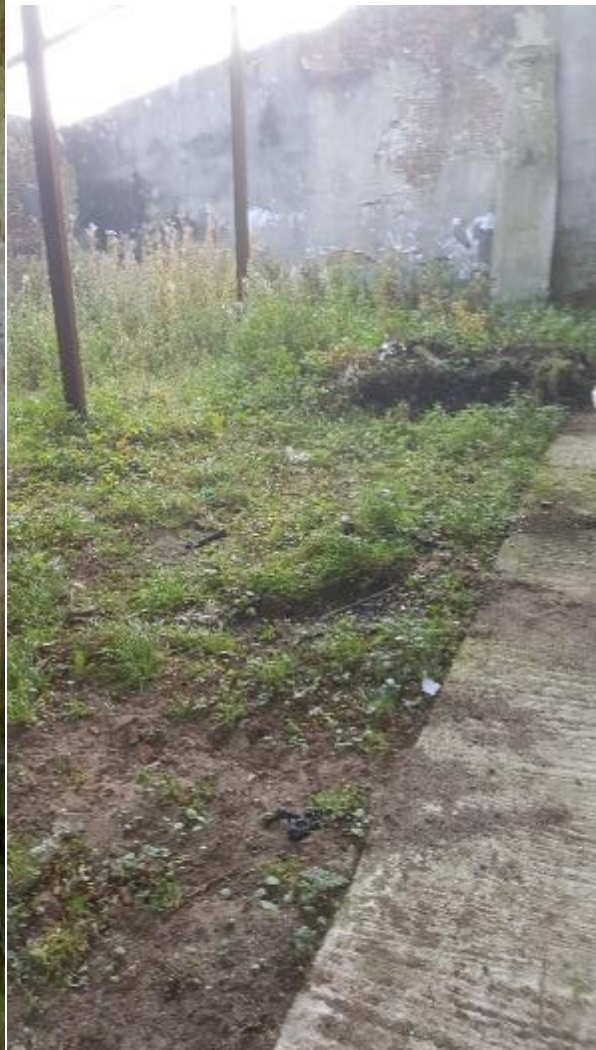
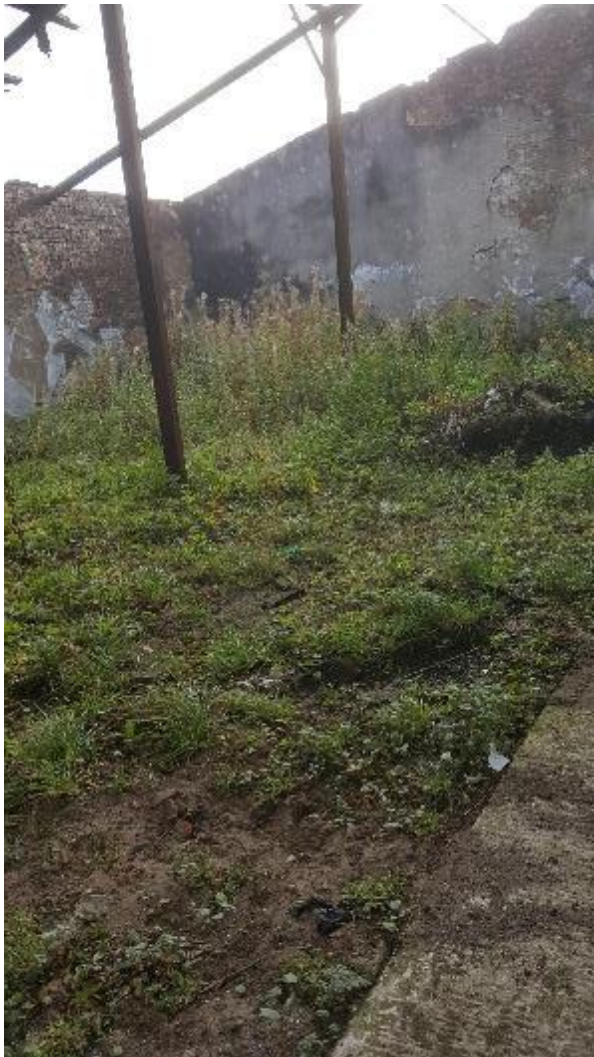
The main section of the main is partially open to the elements, consists of brick rendered walls, some metal supports to the roof, a concrete base covers the front half of the area and the roof is metal corrugated sheeting.

Inside the front of the building
