## Appendix B Photo Log

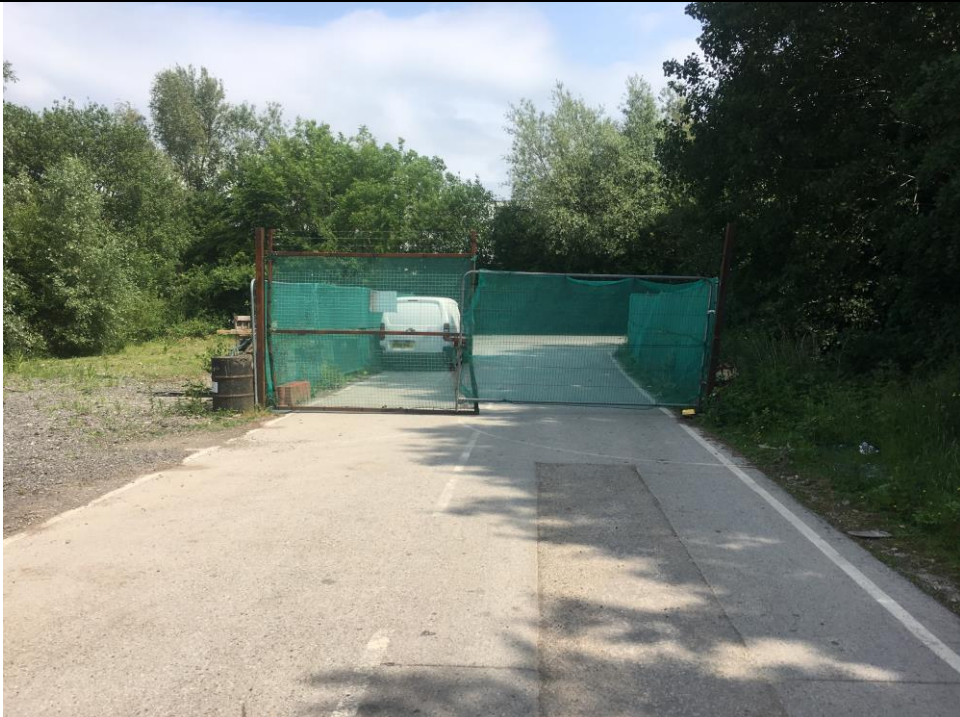
No 1

Looking north from the site access road towards Wilmslow Old Road.

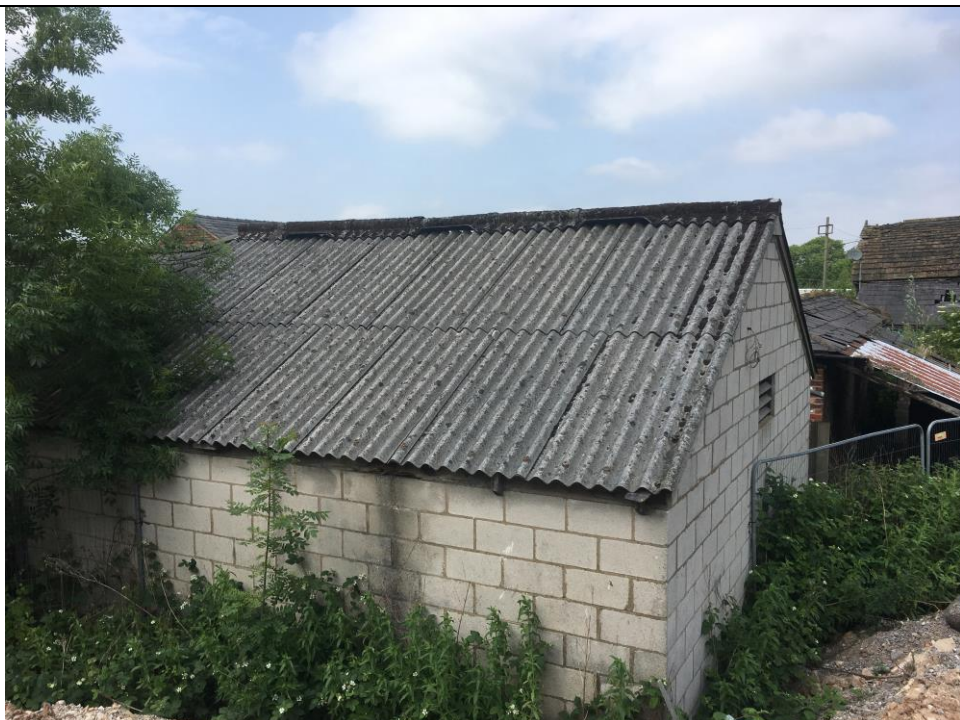
No 2

Looking south west towards the previous farming buildings, showing vegetation out-break and potential asbestos cement roofing.

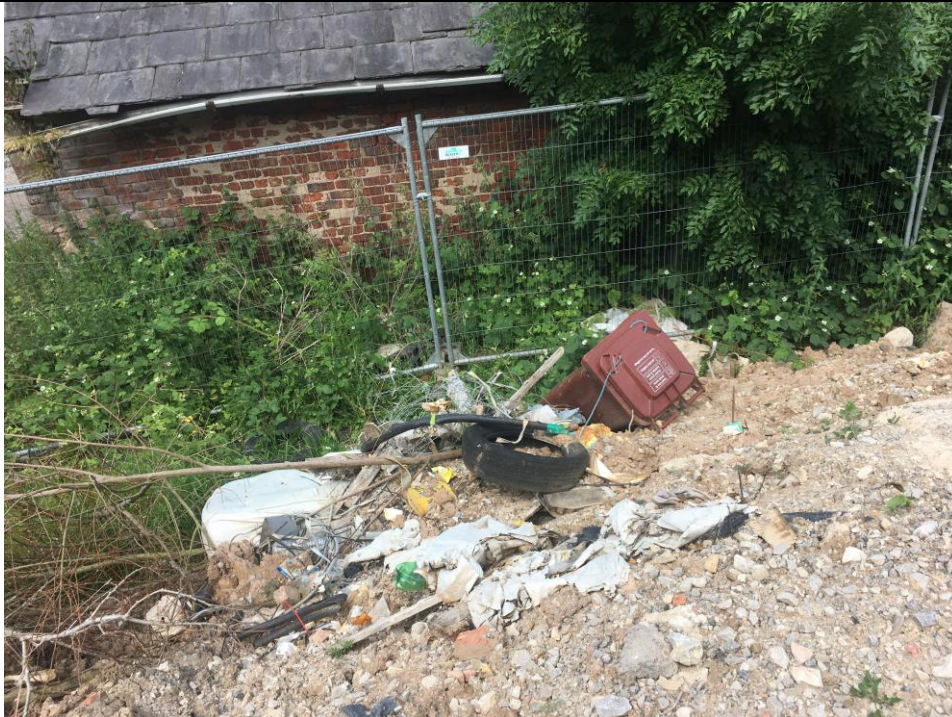
No 3

Ad-hoc fly tipping against the eastern wall of the listed farm building.

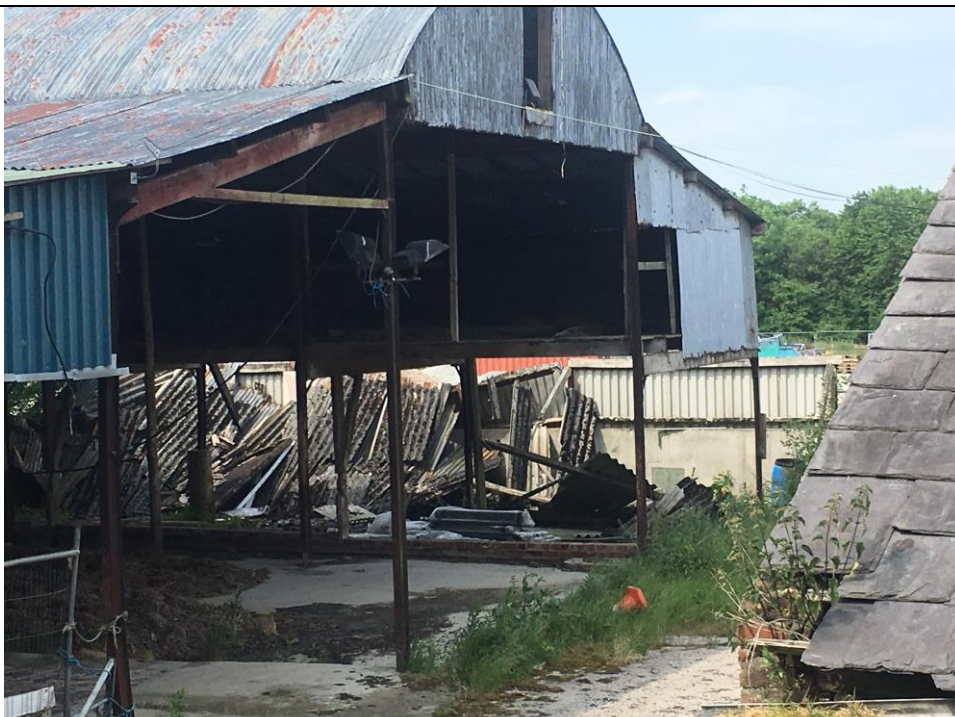
No 4

Looking east into the central area of the farm buildings, showing construction debris and a mix of corrugated iron, plastic and asbestos cement roofing. Unidentifiable agricultural waste observed within the building structure.

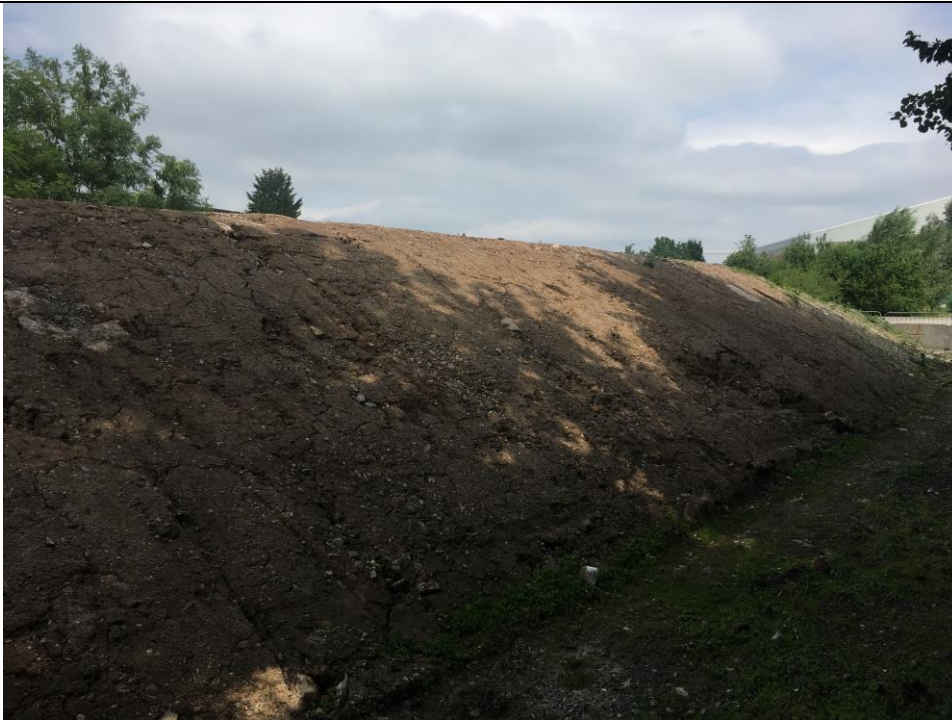
No 5

Stockpile of unidentified waste on the north-eastern boundary of the listed farm house, looking north-west.

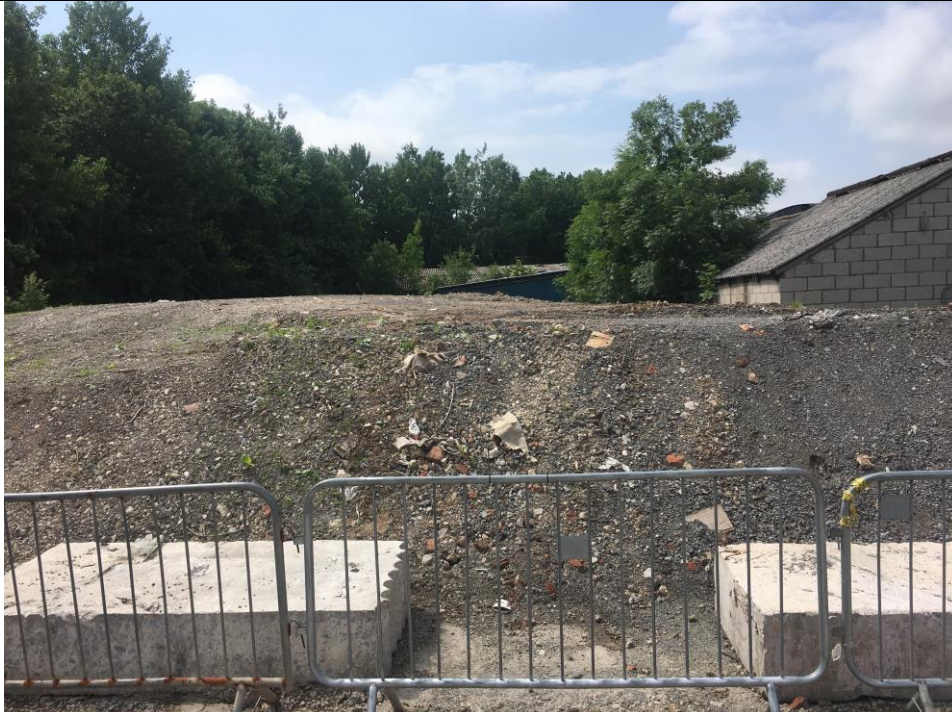
No 6

Stockpile of unidentified waste (No 5) looking south. Evidence of construction debris and larger fragments.

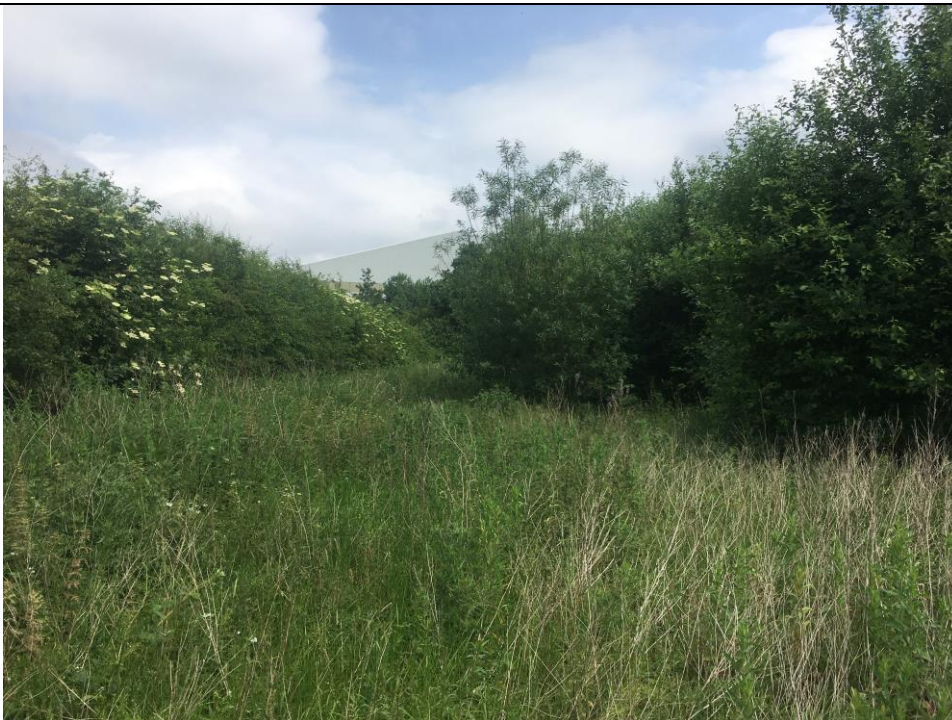
No 7 | Looking north from the listed farm house showing current land and vegetative state.

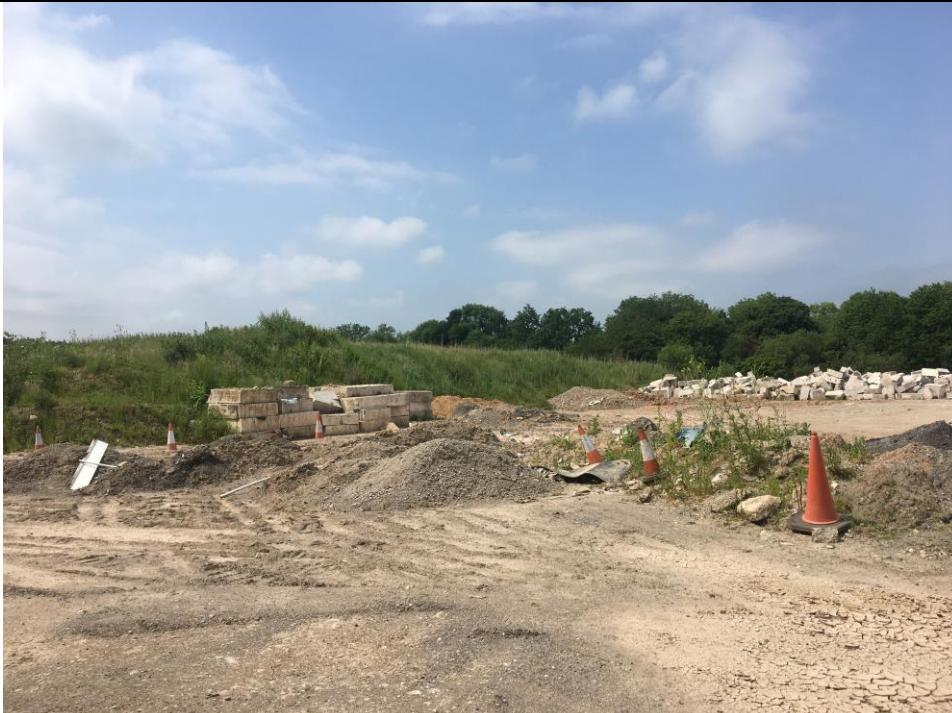
No 8 | Stockpile of unidentified waste on south west boundary of listed farm house. Material has been previously sorted, however evidence of broken tarmac and mixing is present. Grass mound is previously covered construction waste (No 10), looking west.

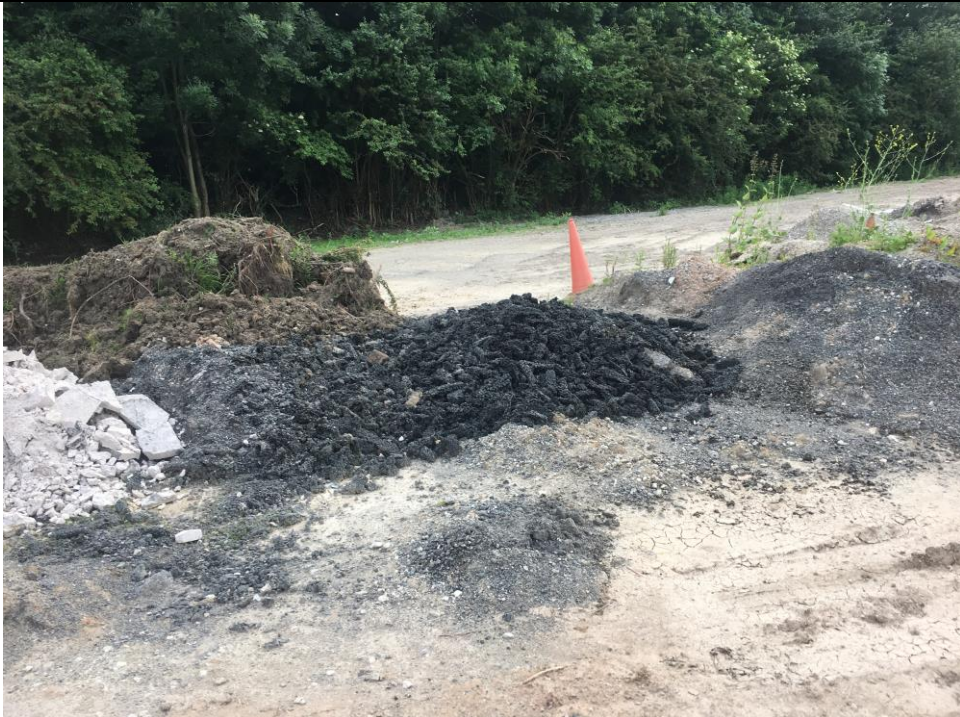
No 9 | Broken tarmac within the stockpile (No 8).

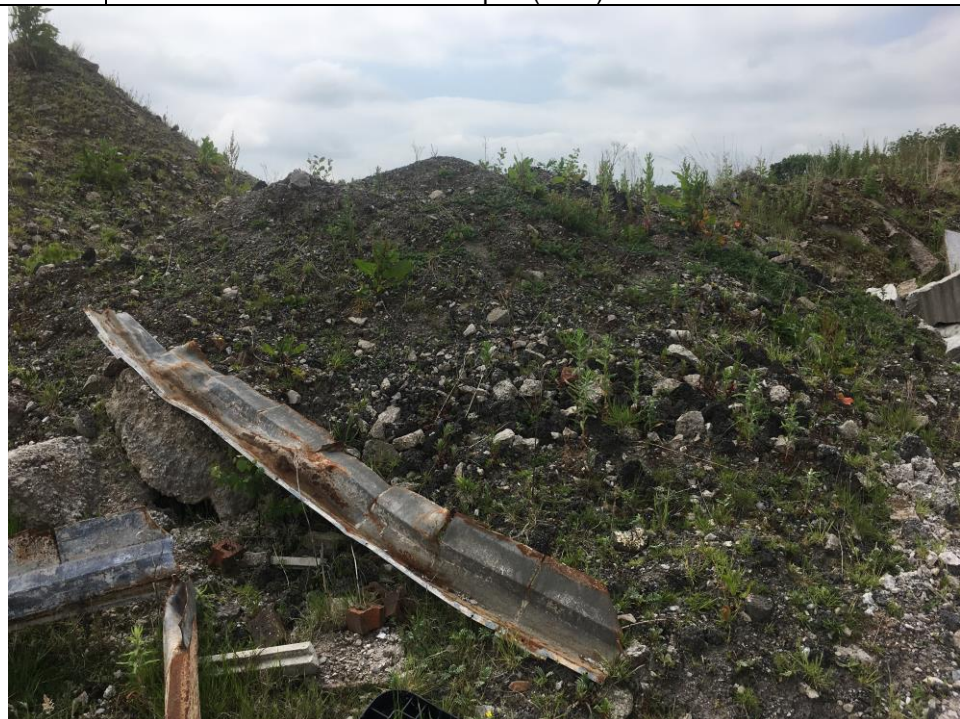
No 10 | Previously covered construction waste (No 8), looking east.

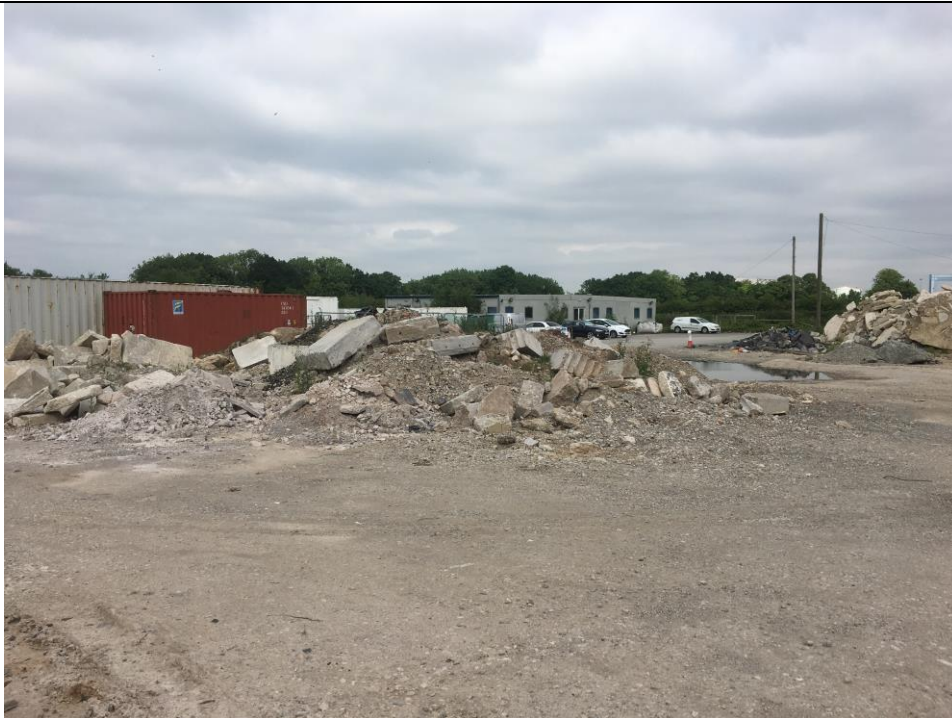
No 11

Numerous stockpiles of unidentified material, looking north east from No 8. Overhead powerlines present.

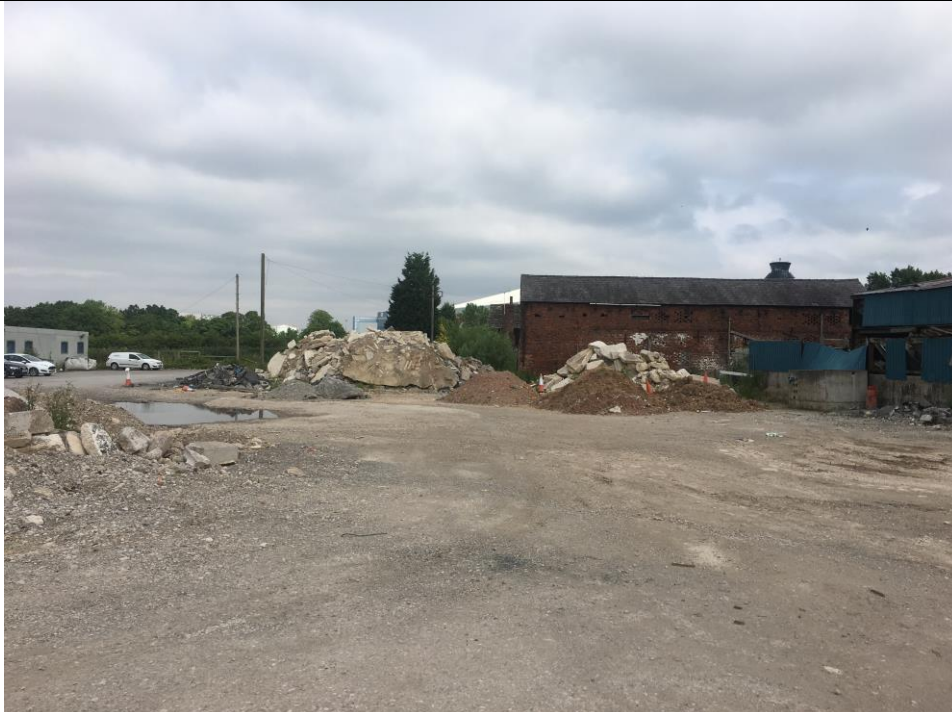
No 12

Numerous stockpiles of unidentified material, looking north from No 8. Overhead powerlines present.

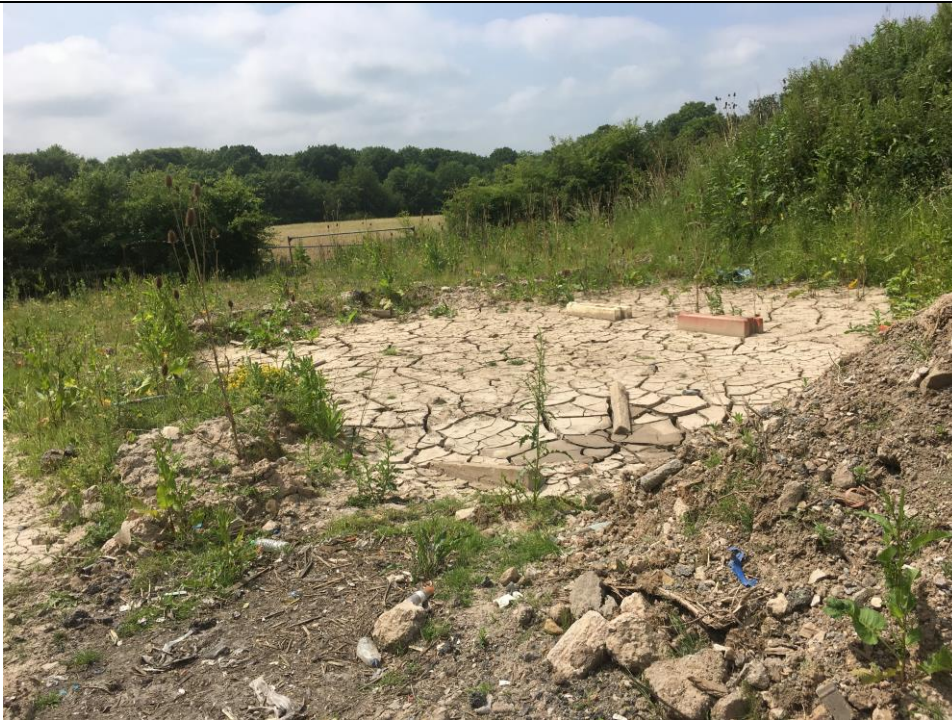
No 13

South east behind the stockpile (No 8), potentially infilled pond / depression of unconsolidated and mixed material. Strong odour.

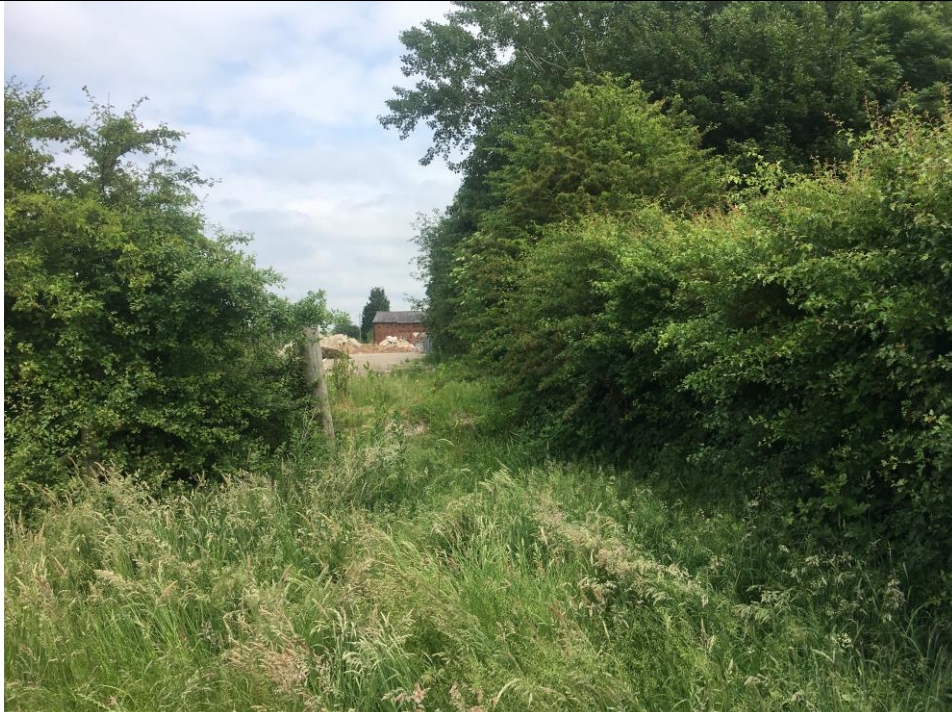
No 14

Access to the southern portion of the site from the listed farm house visible in the distance, looking north.

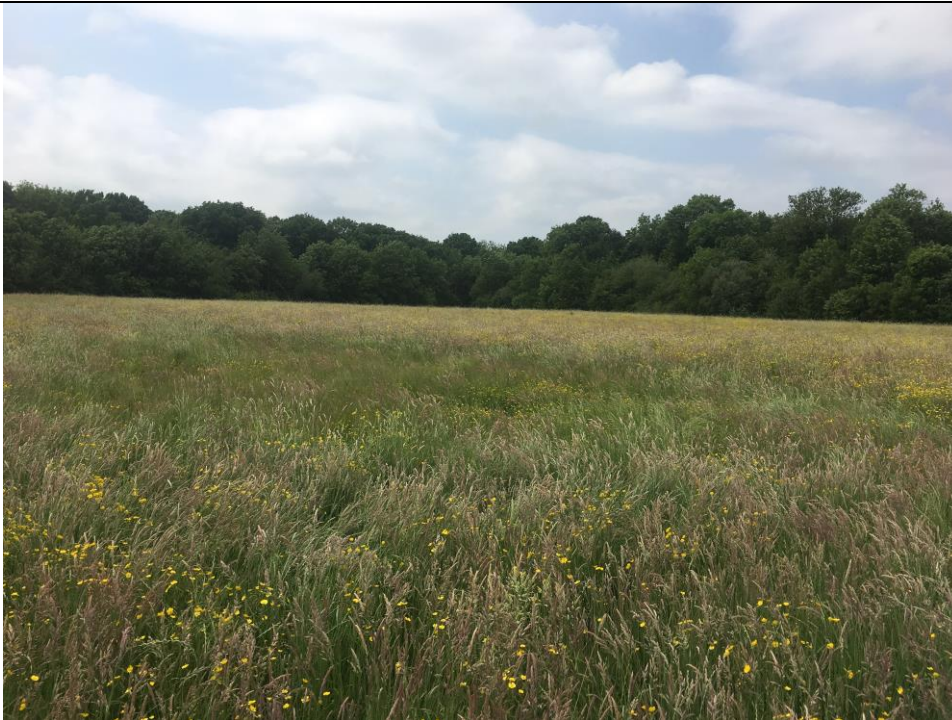
No 15

Looking south towards the southernmost boundary of the site. Land is predominantly undeveloped grass land.

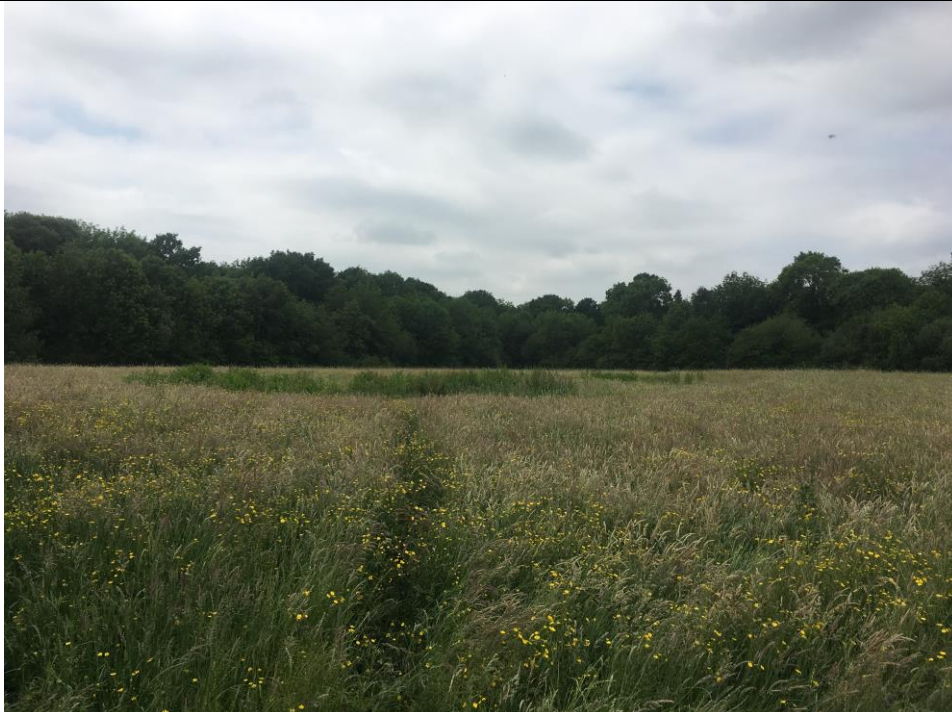
No 16

Potentially infilled pond identified by differing vegetation within the southern portion of the site, looking south.

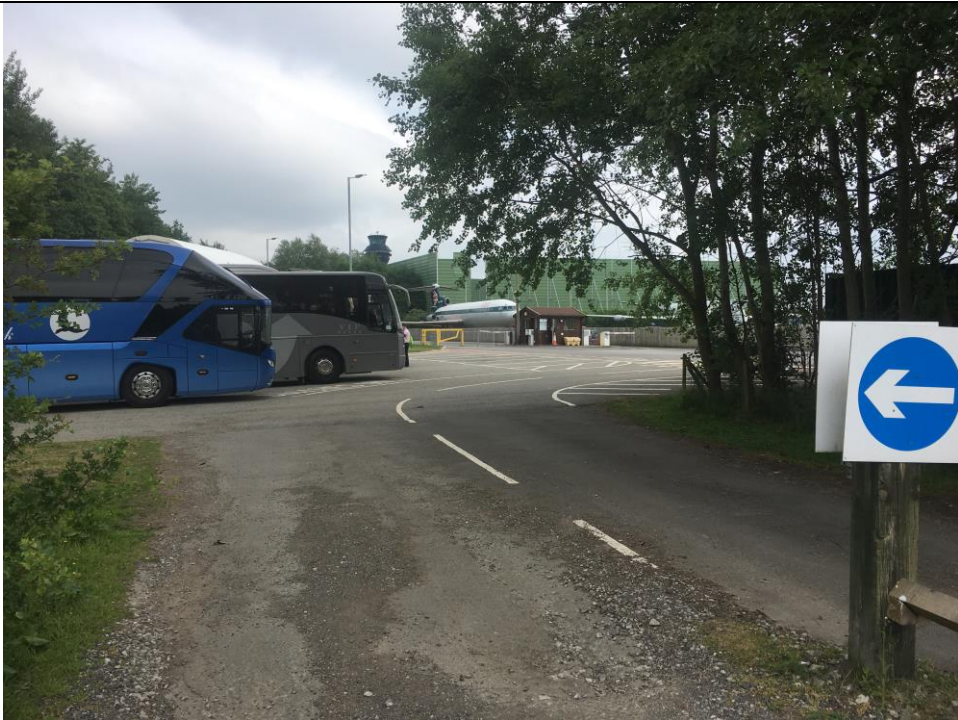
No 17

Access to the RVP Events Field from the Manchester Airport Viewing Park, looking north.

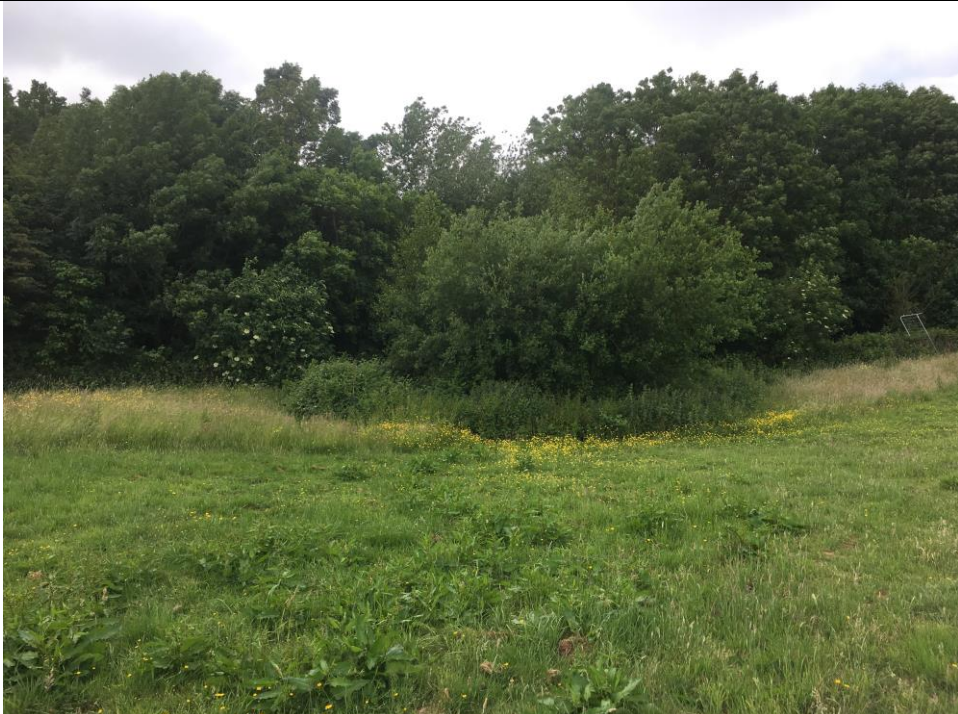
No 18

Potentially infilled pond / depression on the southern boundary of the RVP Event Field.

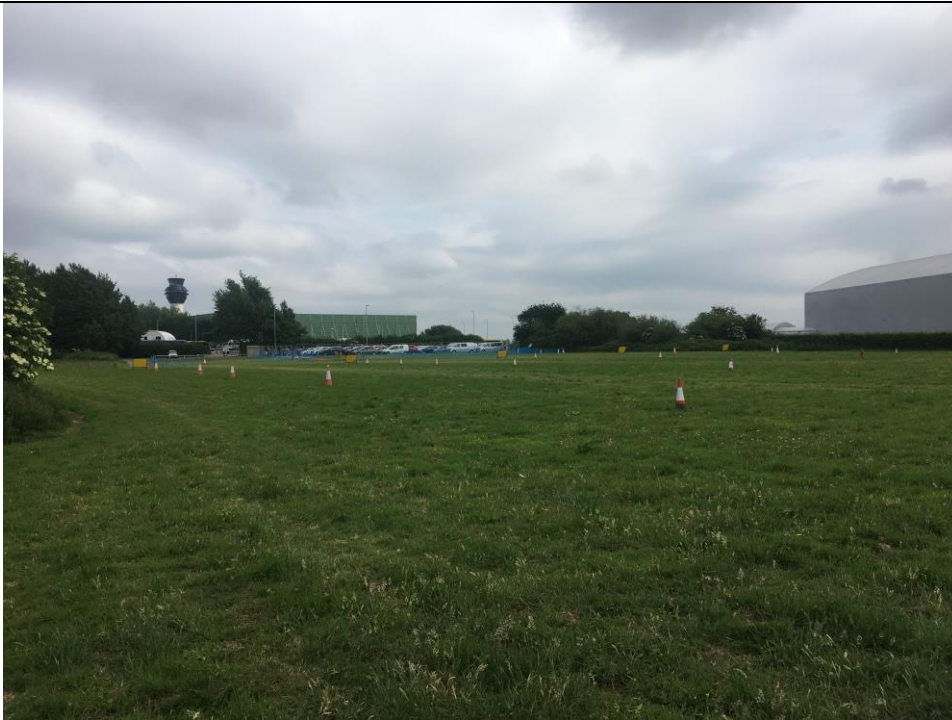
No 19 | RVP Events Field, looking north east.

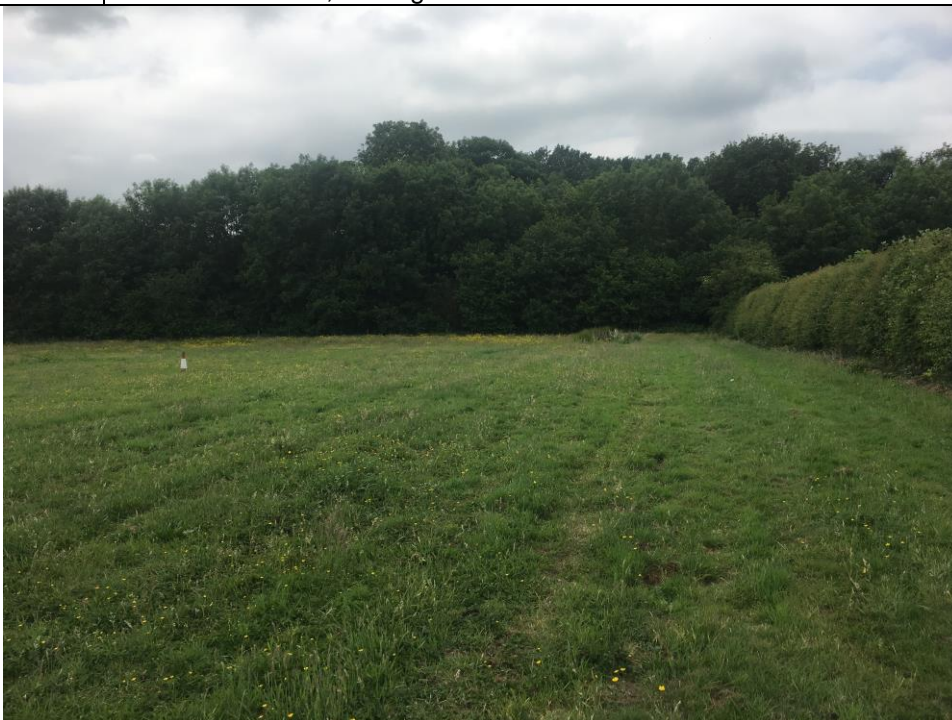
No 20 | RVP Events Field, looking south.

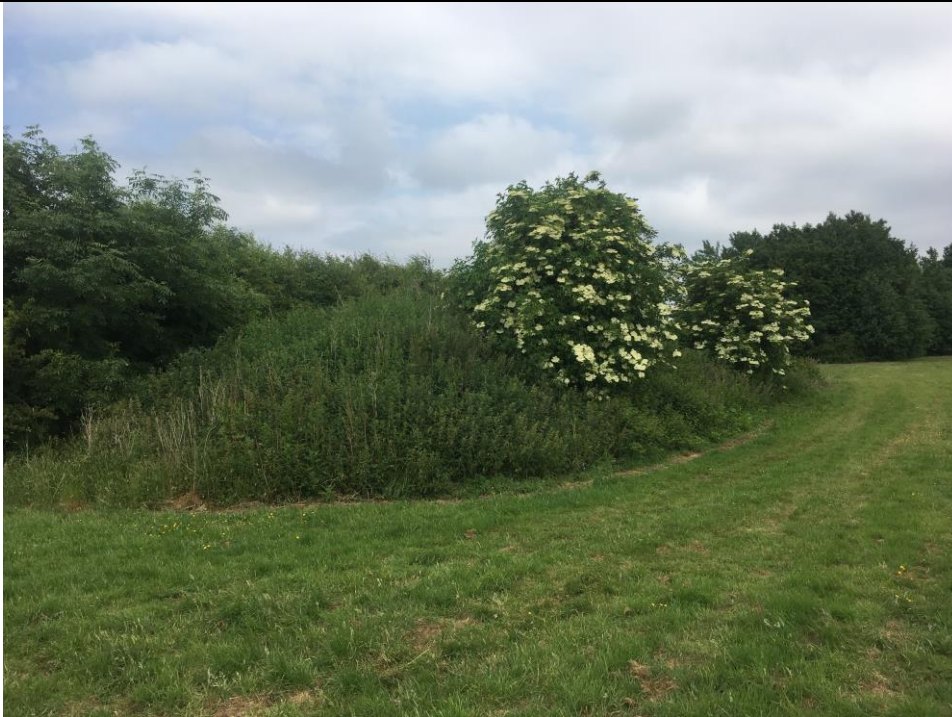
No 21

Grassed mound covering potential previous waste on the western boundary of the RVP Event Field. Vegetation growing on the mound is different to surrounding vegetation.

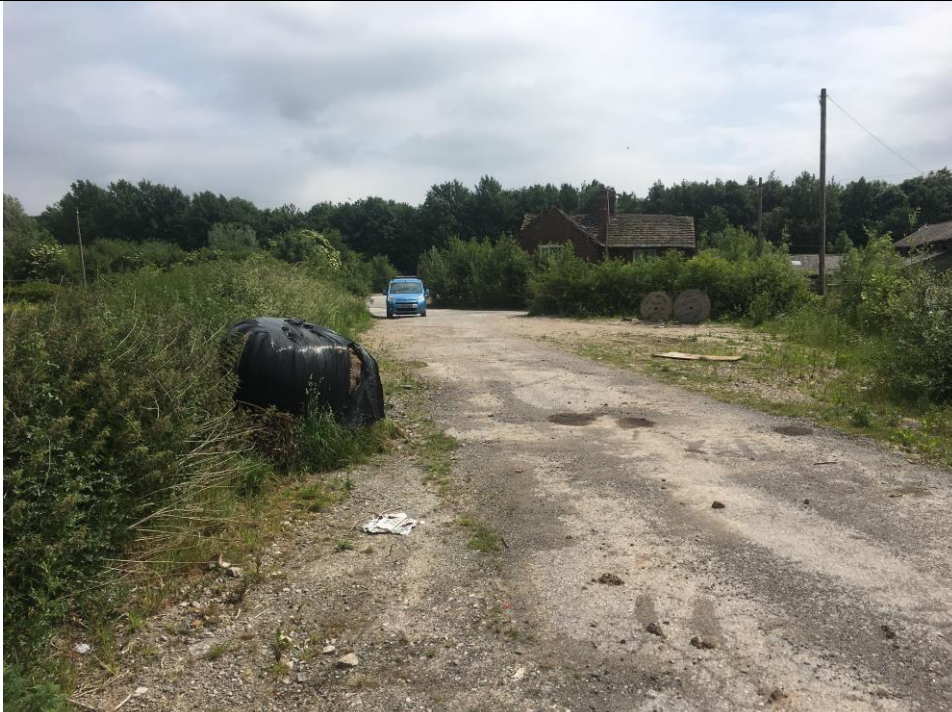
No 22

Broken and discontinuous made ground and access road, looking east towards the listed farm building. Overhead powerlines present.

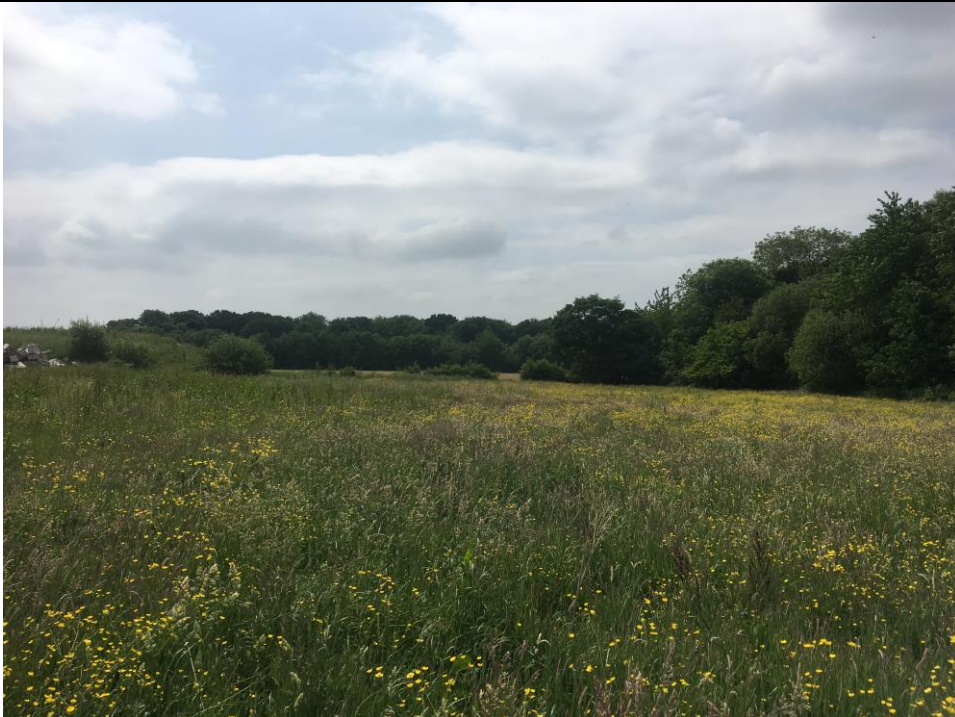
No 23 | Western portion of the site, looking south.

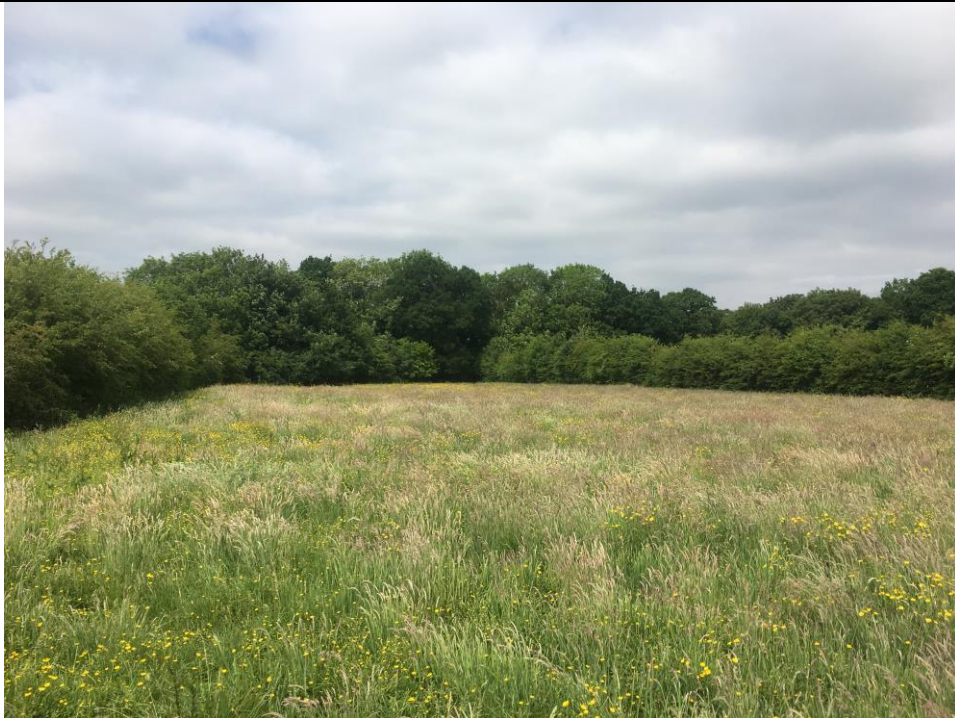
No 24 | Northern portion of the site, separated by two hedgerows, looking west.

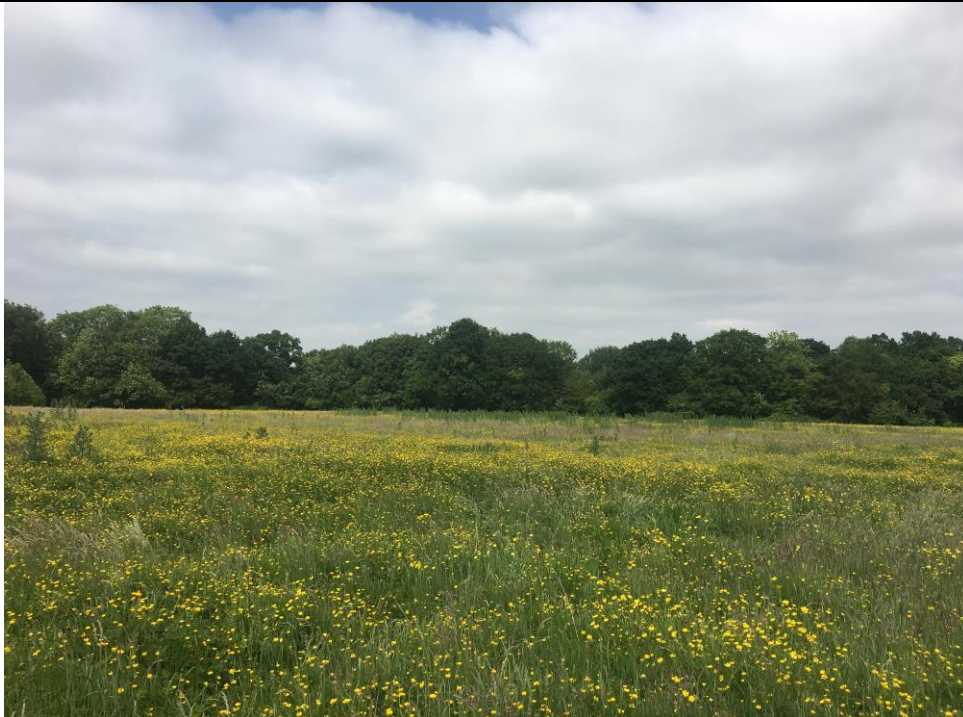
No 25

Northern most portion of the site, looking north west towards the Cotteril Clough Brook boundary.

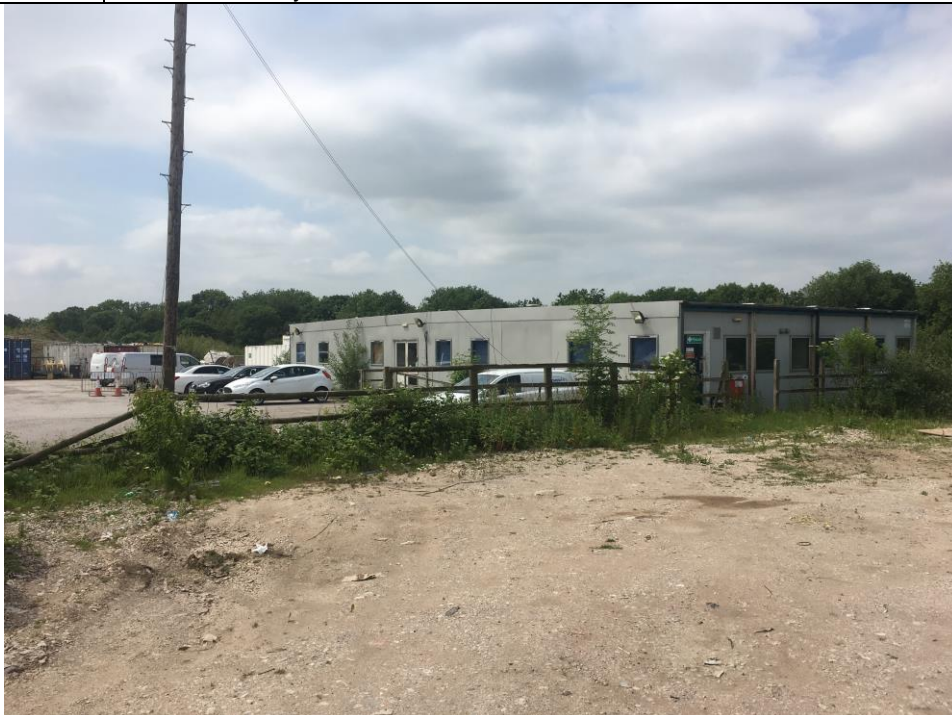
No 26

Previously abandoned industrial units and semi-permanent buildings to the west of the listed farm building, looking south west. Overhead powerlines present.
