REPORT ON THE STRUCTURAL CONDITION OF
THE OLDE BARN, MAIN STREET, FLINTHAM ESTATE,
NG23 5LG

1.1 This report is on an existing outbuilding called The Olde Barn, Main Street, Flintham Estate, NG23 5LG.

1.2 This report follows a visual inspection that took place on Wednesday the 22nd July 2020, on instructions received from The Art of Building Ltd.

1.5 The report is to assess the suitability for reinstatement and change of use to residential.

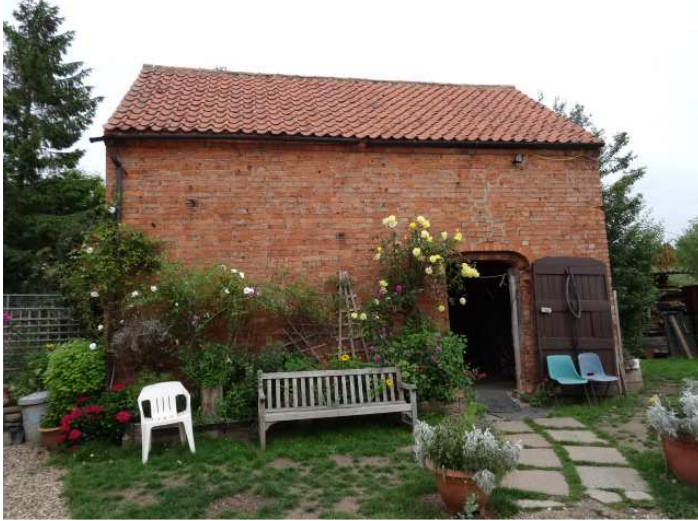
1

2.2 The roof is pitched and covered with clay bold rolled tiles (Photograph 1). The tiles are supported on timber battens on felt on 50mmx75mm common rafters. The rafters are supported on the front and back walls and one line of rafters on each slope (Photograph 2).

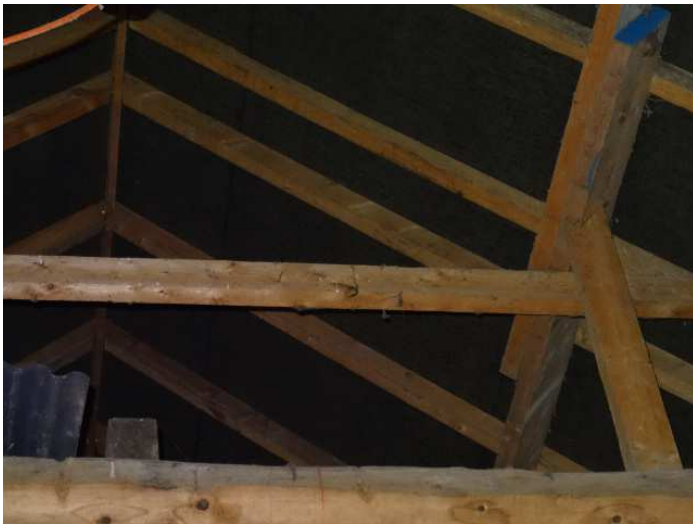
2

3.5 The roof timbers appear to be generally in reasonable condition and are all fairly new. There was, however, some evidence of woodworm and the whole roof should be checked for rot and infestation.

4.6 The roof timbers should be inspected for rot and infestation by a specialist contractor and any recommended work undertaken. Strapping between the roof structure and the walls should be installed

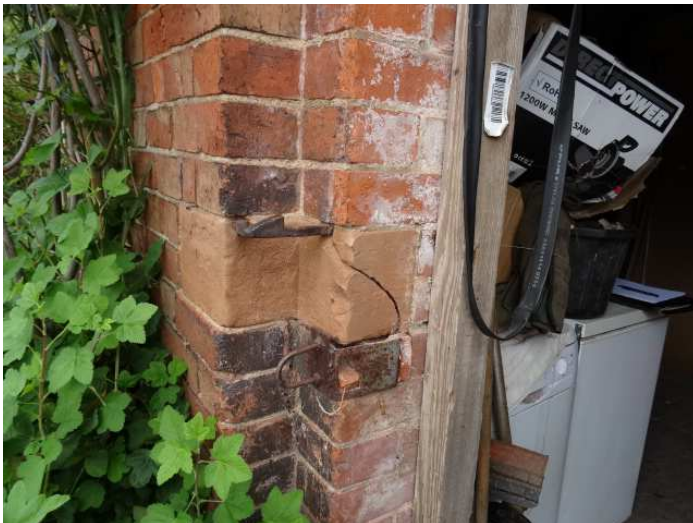
3

2.3 The external walls are solid brick 114mm thick with an internal pier on all four walls. The walls are recessed 120mm and thickened to 228mm around the openings on the front and back walls (Photograph 3) with flat topped arches over the openings (Photograph 4).

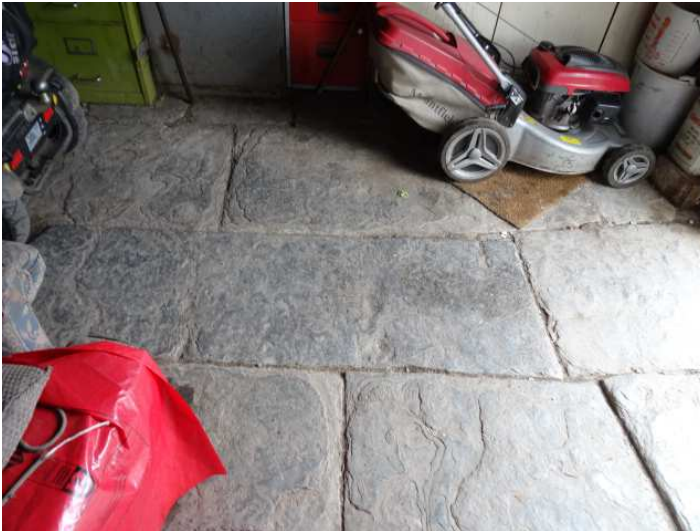
2.4 The ground floor is half in stone flags and half in brick pavers (Photographs 5 & 6).

3.6 The ground floors are fairly level but will need to be replaced if used as part of a dwelling.

4.7 The ground floor will have to be taken up and replaced to make it level and to introduce insulation to comply with Building Regulations.

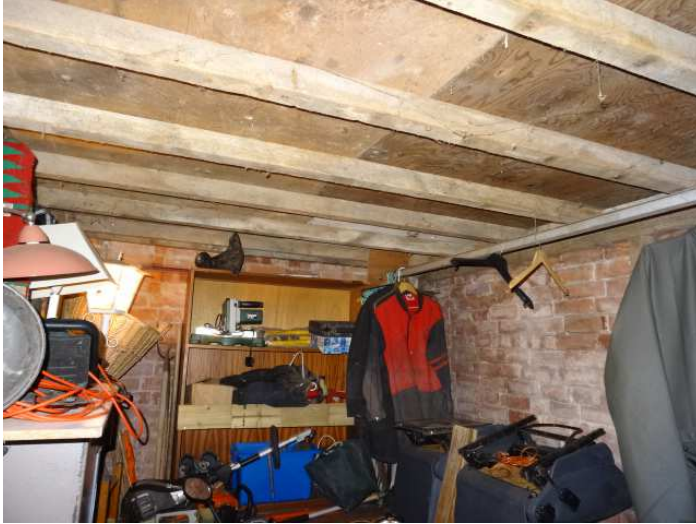
7

2.5 There is a mezzanine floor over the left half of the building (Photograph 7). This consists of ply boarding on 60mmx75mm joists. The joists bear on timbers bolted to the front and back walls and a 63mmx178mm timber beam bearing on 100mmx100mm timber posts bearing on the brick floor.

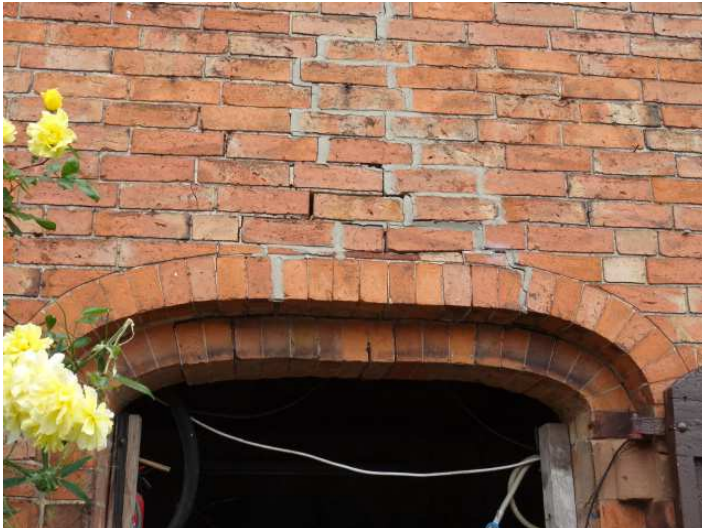
3.3 At both the wall openings, the flat-topped brick arch has dropped with cracking in the brickwork over (Photographs 8 & 9).

4.4 The brick flat-topped arches with need to be cut out rebuilt and reinforced with brick reinforcement or purpose made lintols. The cracking in the walls should be raked out and repointed incorporating stainless steel reinforcing bars set in a resin mortar.
