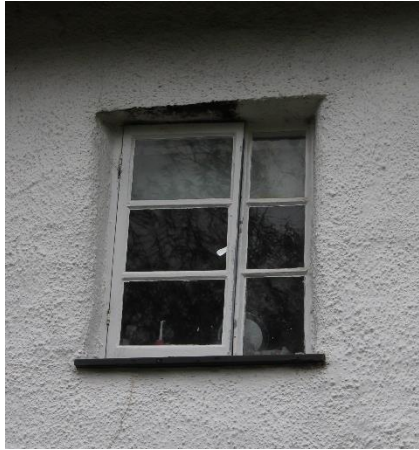
Upper left hand window to rear elevation serving bathroom. Window constructed in softwood with timber cill. Single opening casement with fixed panes glazed directly into frame jambs. Opening light fits poorly and has been poorly modified since installation leading to significant draughts. Despite ongoing repairs, there is rot to the inside of the frame due to continuous condensation.

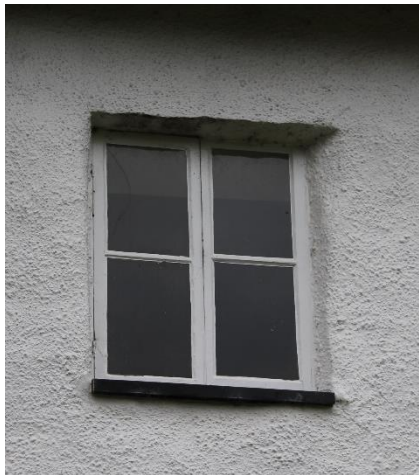
Upper right hand window to rear elevation serving bedroom. Window constructed in softwood with timber cill. Single opening casement with fixed panes glazed in to matching fixed light. Due to historic building movement there are large gaps around the opening light which fits poorly. Regular condensation necessitates regular ongoing maintenance. This is the pattern of window it is proposed to use for the 3 replacement windows.

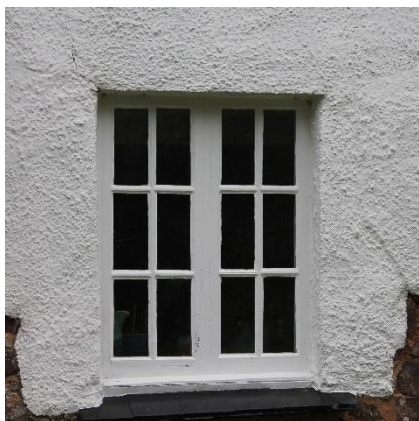
Lower right hand window to rear elevation serving kitchen. Window constructed in softwood with tile cill. Both lights fixed as window inaccessible from inside of property due to kitchen worktop and reveal depth. Most recent localised repairs to window undertaken in 2018. Magnetic secondary glazing fitted to internal frame to reduce heat loss and condensation.
