Visual structural inspection report of agricultural building for conversion to residential use

Mike Frost
Barn 1, Bower Farm
Thurleston Lane
Akenham, Suffolk
IP1 6TQ

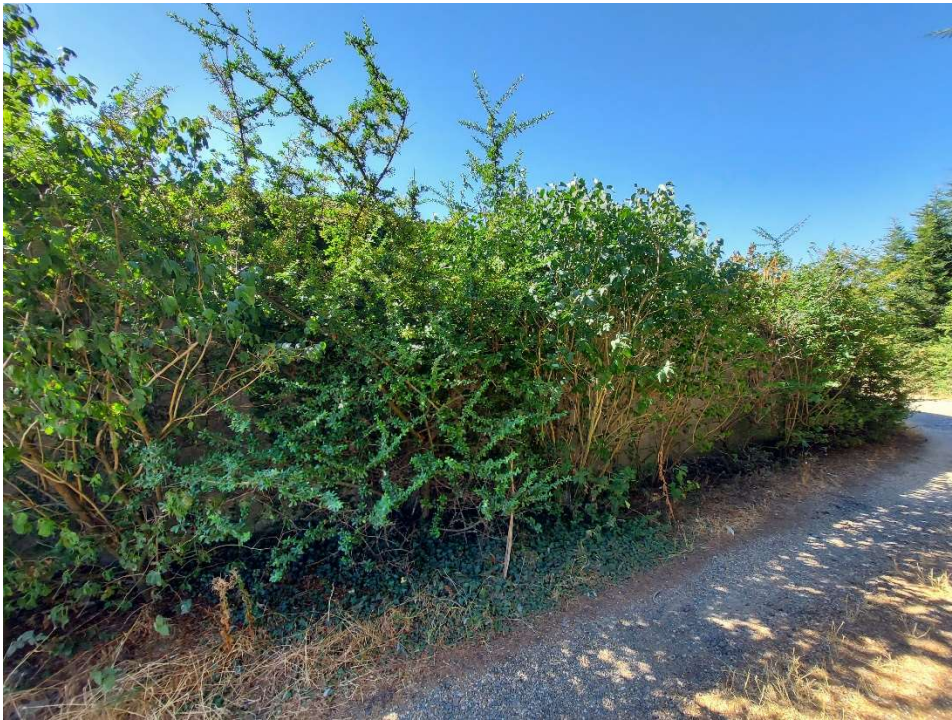
- 4.20 There was significant vegetation present in close proximity to the barn including mature coniferous trees approximately 6.0m from the North elevation. To the South elevation a mix of mature Ash and Hawthorn trees were present. A large fig tree and laurel was present adjacent the West elevation.

7.1 North elevation of barn obscured by vegetation

- 5.13 General works would also include clearing vegetation and removing moss and algae growth from blockwork and repair/repoint block walls as required.
- 5.14 It would be standard practice for any conversion scheme of this type to comply with Building Regulations, which would have certain implications upon foundation design, roof design, any additional loadings to the fabric etc. which would need to be reviewed during the detailed design stage.

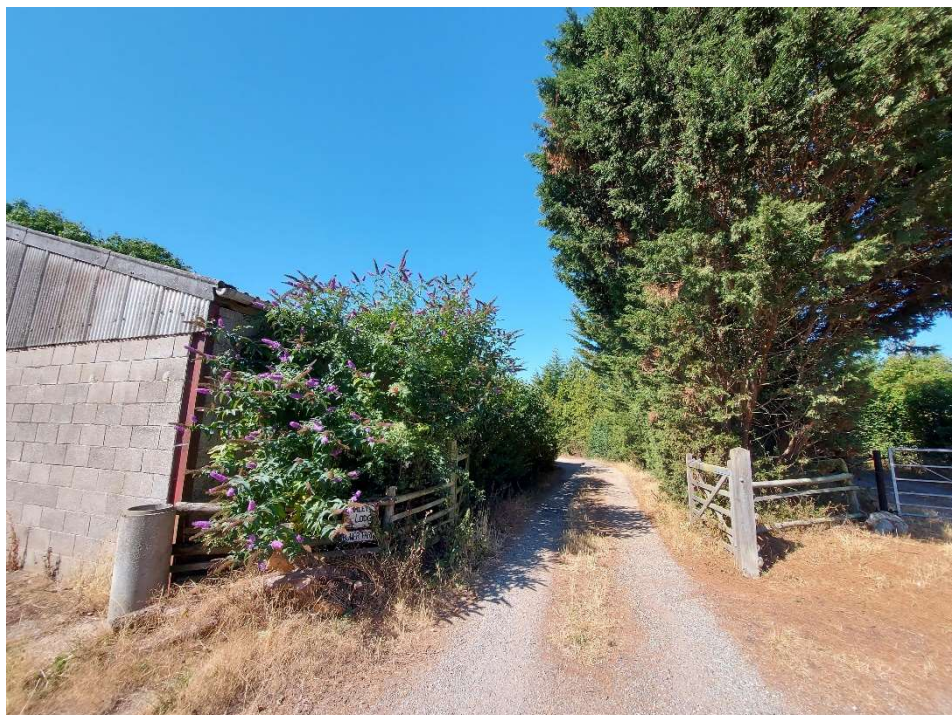
7.2 North East corner of barn showing proximity of vegetation

- 5.9 The building is located within an area of anticipated Clay subsoils with numerous trees.
- 5.10 Consideration should be given to the design of new foundations and suspended floor construction if the existing slab is removed given the presence of mature trees in close proximity to the barn and the effect these will have on the underlying Clay subsoils.

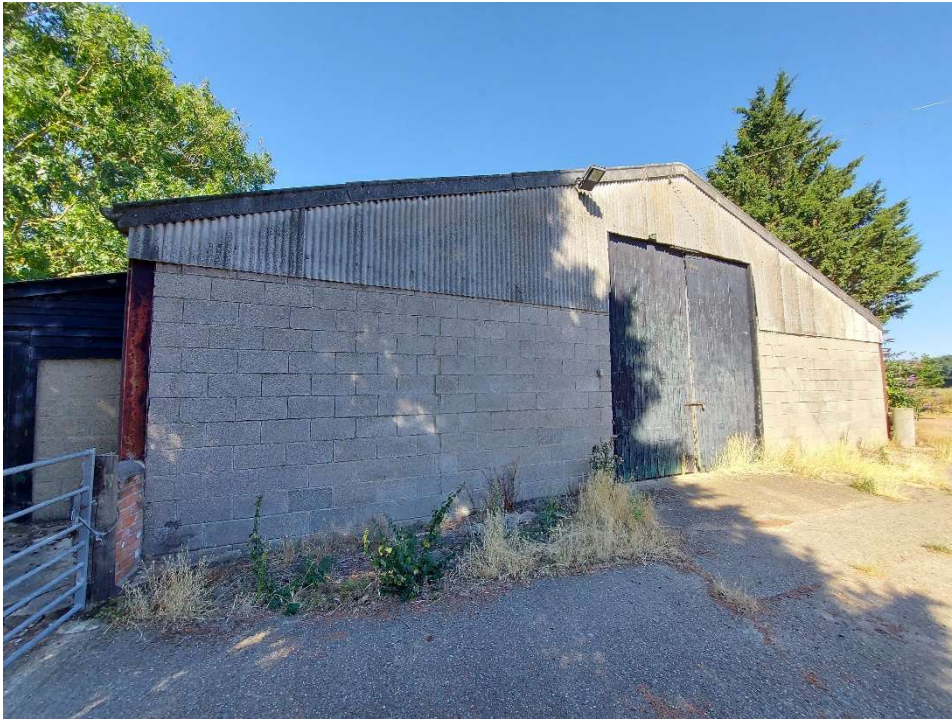
- 4.9 To the East elevation a 100mm wide x 120mm deep timber lintel and 70mm x 90mm timber post frames the large door opening. There was no protection to these timbers.

- 4.14 Generally, with the exception of the points noted above the walls are in good condition and no significant cracking was observed.
- 4.15 A vertical crack was noted in the East elevation blockwork wall, South of the double door opening. There appears to have been historical repairs carried out to this crack externally, however does not appear to have been repaired internally.

7.3 East elevation

- 5.7 All rainwater goods will require replacement.
- 5.8 General blockwork repairs will be required where localised cracking has occurred. Repairs should be carried out by restitching using Helibar reinforcement. We consider the gable framing to be minimal and the lateral stability of these walls should be supplemented, e.g. by the buttressing of new internal walls during the conversion works.

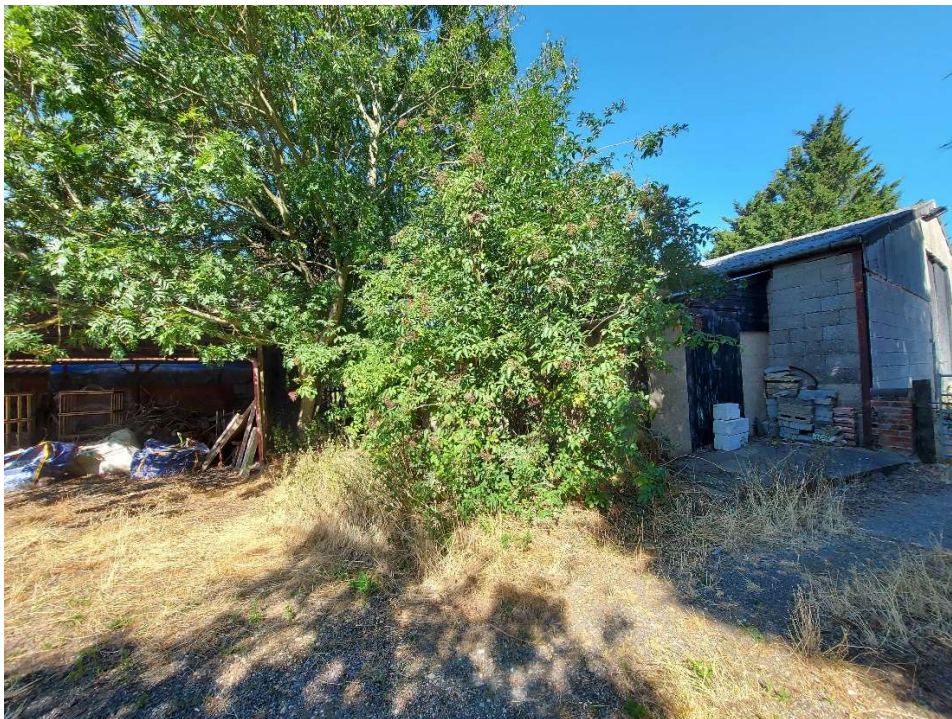
- 4.19 The single storey lean-to structure that would be demolished as part of the conversion works comprises blockwork walls with a mono-pitch roof. A timber telegraph post is built within the blockwork at the South East corner. During the inspection the ground bearing floor slab in the lean-to structure had cracked and settled to the South West area.

7.4 South elevation showing lean-to and existing vegetation

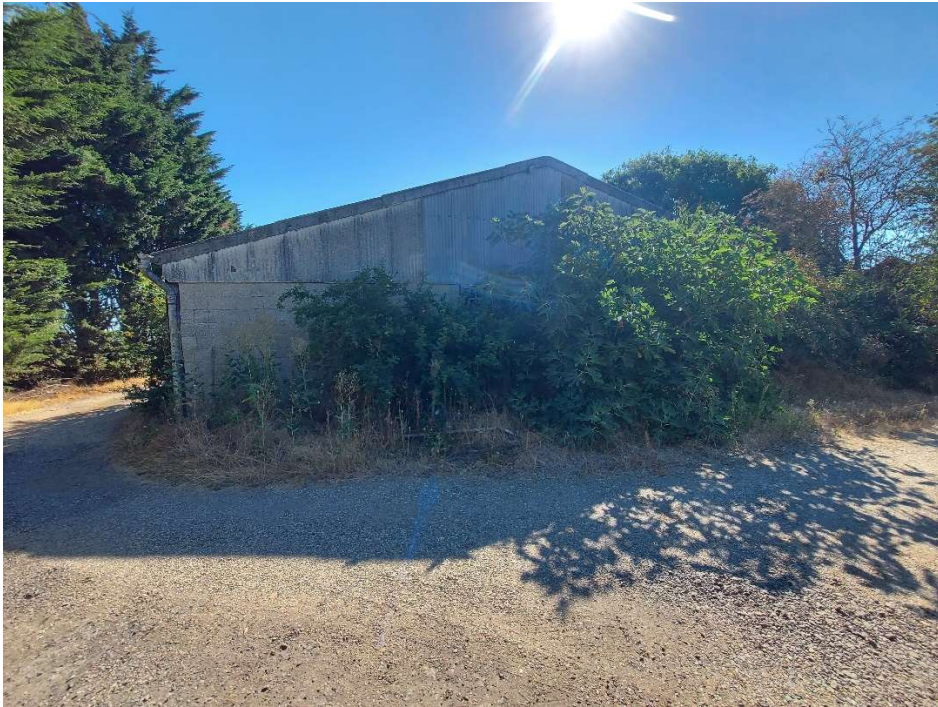
7.5 West elevation

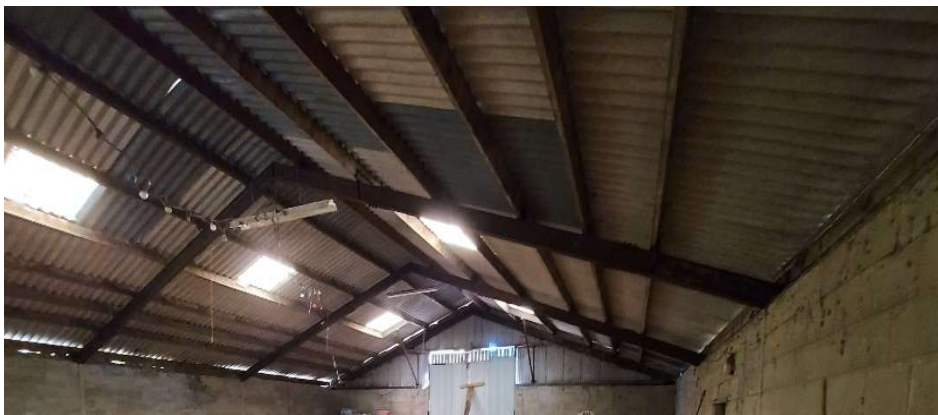
7.6 General internal view of barn structure looking East

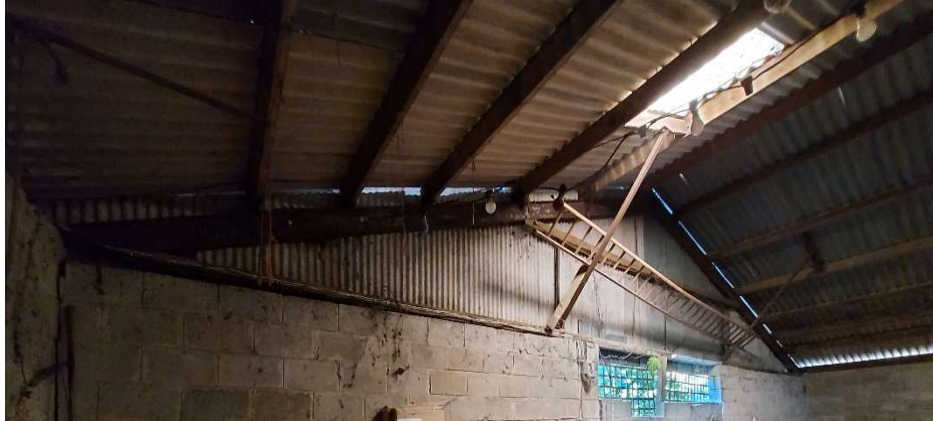
- 4.10 The original opening in the West elevation has been infilled with concrete up to a height of approximately 0.9m high with three to four blocks placed above. There is an element of horizontal displacement amongst the blocks.

7.7 Internal view of West gable elevation showing original opening partially infilled

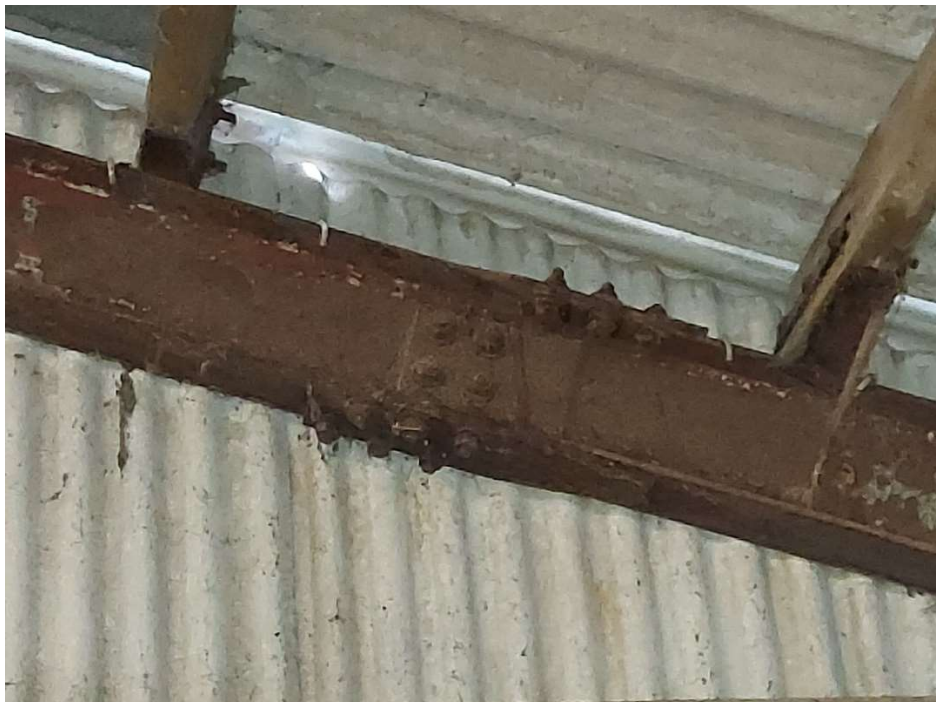
- 4.4 The steelwork columns appeared to have been painted with red oxide primer and the coating was flaking with evidence of rust beneath both internally and externally however there appeared to be no loss of section. The existing steel rafters appeared to have no paint coating and had two spliced connections.

7.8 Detail of existing splice to steel rafters

- 5.1 The structural integrity of the building is sufficiently sound to facilitate the proposed end use.
- 5.2 The steelwork frame where visible from ground level appears sound with only surface rust present which would be addressed with wire brushing and repainting insitu with a rust inhibitor to promote longevity and prevent corrosion. However, some of the steelwork is encased by walls so there is a slight possibility that localised severe corrosion is present where not exposed.

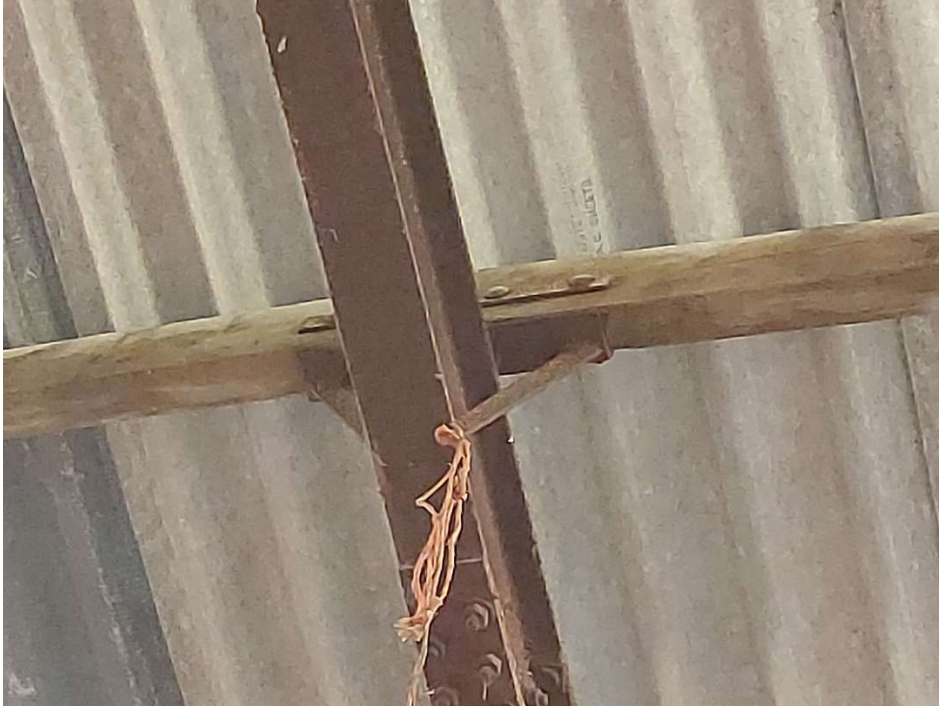
- 4.8 The timber purlins are jointed over some steel frame rafters with a bolted steel splice and fixed with a diagonal brace to the bottom flange of the rafter.

7.9 Detail of existing rafter and timber purlin connection

- 5.3 The existing timber purlins are in a fair condition and suitable for the current use.
- 5.4 The overall stability of the frame will need to be reviewed in accordance with the proposed conversion works once a preliminary design scheme is produced. We would anticipate the existing structural elements to be tied to the new internal structure as this will further tie the frame and ensure that lateral deflections are limited to those acceptable for brittle finishes associated with a residential dwelling. Alternatively, subject to design calculations the steel frame may require strengthening to comply with current building regulations.

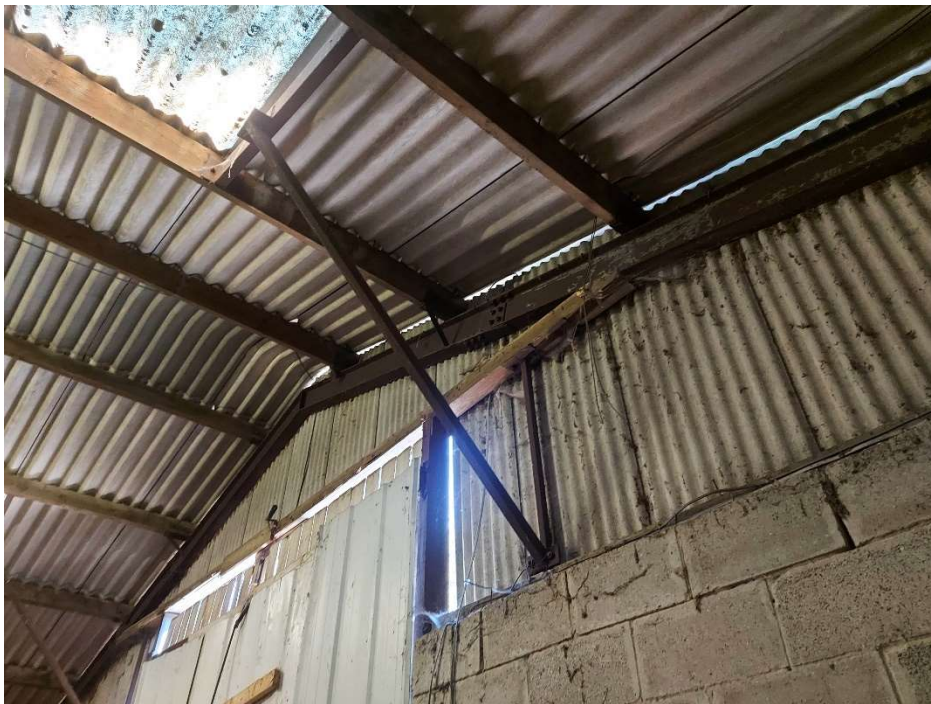
- 4.7 There are four steel box section braces spanning diagonally from the gable elevation timber wall plate to a steel tie spanning between two of the timber roof purlins. At the interface between the diagonal brace and wall plate there is a vertical steel box section connecting the gable wall plate to the underside of the timber lintel over the door openings.

7.10 Detail of diagonal brace to East elevation (similar detail opposite end)

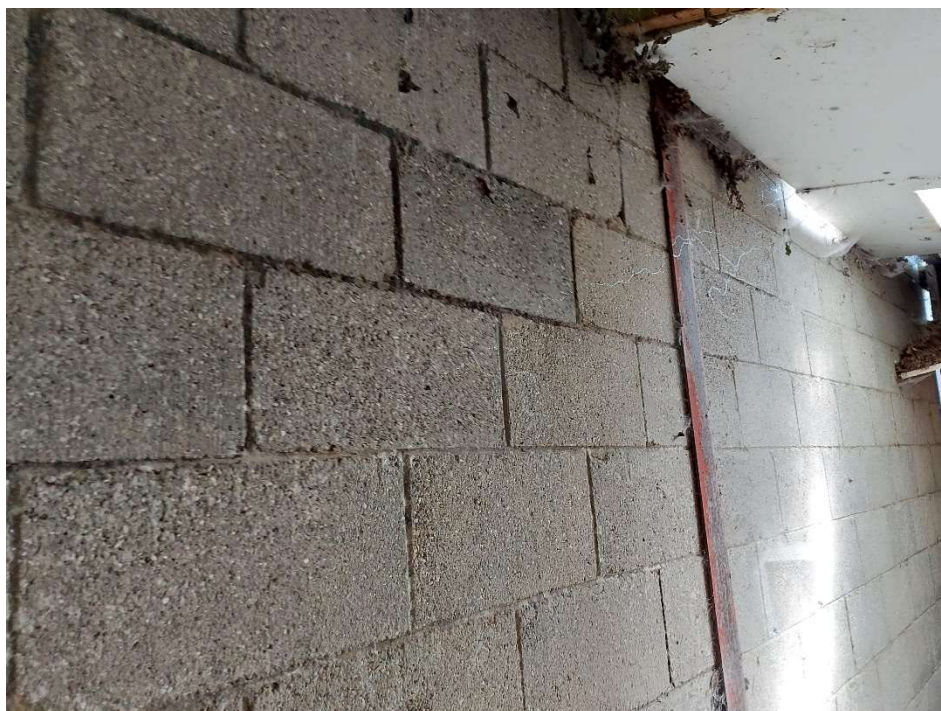
- 4.13 The barn walls are 3.0m high and comprise 215mm thick hollow blockwork which appear to be partly built tight into the web of the steel columns. It appears this provides the longitudinal stability for the building as no standard bracing is present to the side elevations. Internally the blocks have been notched to accommodate the column and a mortar infill has been cast at the inside face to the recessed column flange to achieve a flush wall finish.

7.11 External view of blockwork built into steel column on South elevation

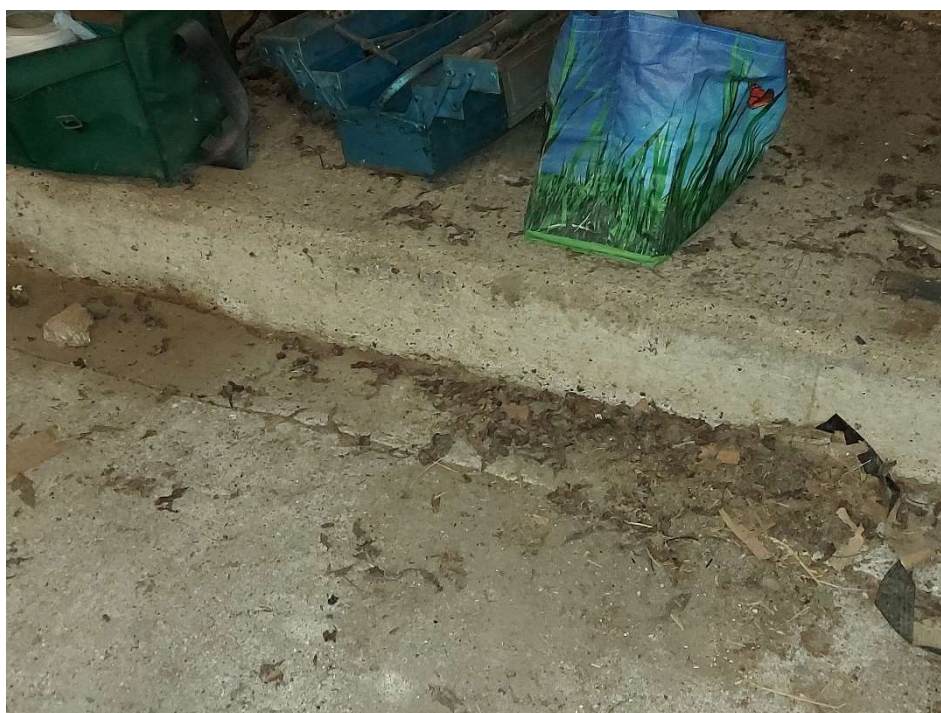
- 4.16 The ground floor construction appears to comprise a ground bearing concrete slab cast in four long strips. The slab is approximately flush with adjacent ground level. There is also a narrow concrete slab strip spanning between opposing columns. There were a number of random cracks, although these did not appear to be significant and we presume are associated with shrinkage. A large area was covered with stored materials therefore the area could not be fully surveyed. To the South elevation where there are two doors, there is a raised concrete plinth slab of approximately 200mm thick with a projection of 1.3m from the Southern blockwork wall.

7.12 General view of existing internal slab and plinth upstand to South elevation of barn

- 5.12 The floor slab is in reasonable condition and likely to be satisfactory for overlaying with screed and insulation. If the upstand adjacent the South elevation were constructed on top of the floor slab, it may be possible to break out without damage to the slab beneath. If this was constructed monolithically with the floor slab, it is

unlikely that this could be reused without significant damage to the slab, therefore requiring replacement.
