Barry Hillman-Crouch
Design & Recording Services

Phasing and Discussion

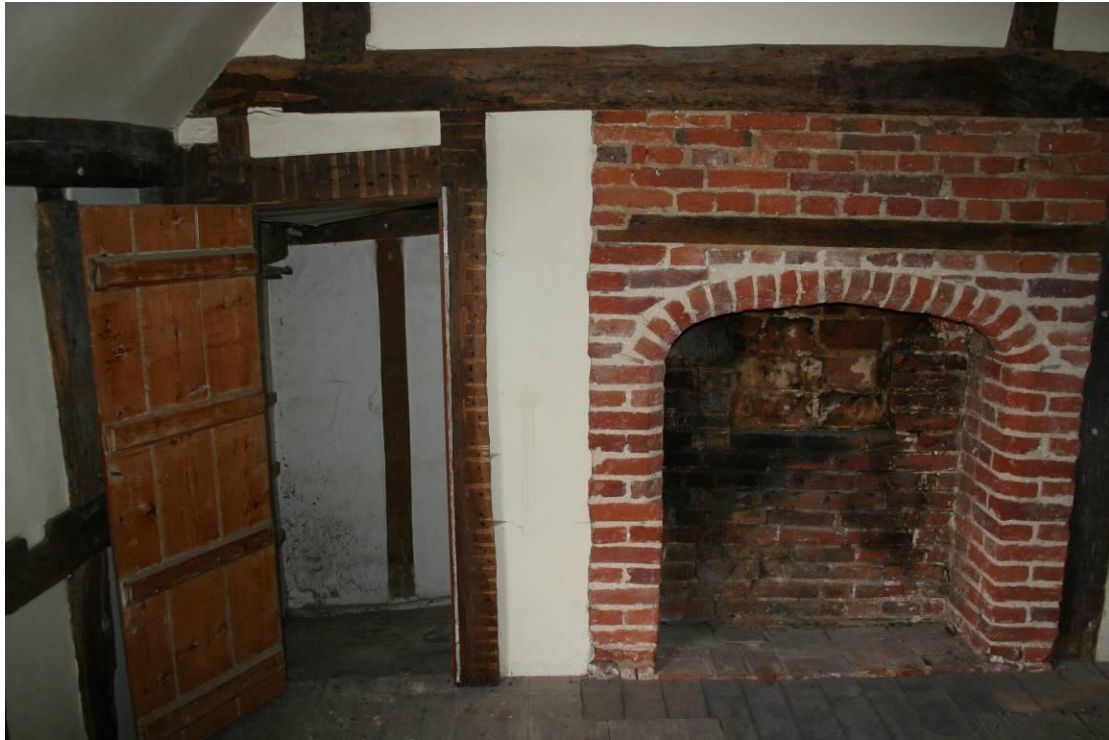
Closet with EC19th door.

There is a small closet with EC19th vertically boarded door to the east of the firestack. Inside it can be seen that the top-pate for the cross-wing has been sawn off to insert the firestack. This would also indicate that the hall frame and the cross-wing are separate frames. A c.1800 wrought iron strap has been attached to the hall storey post.

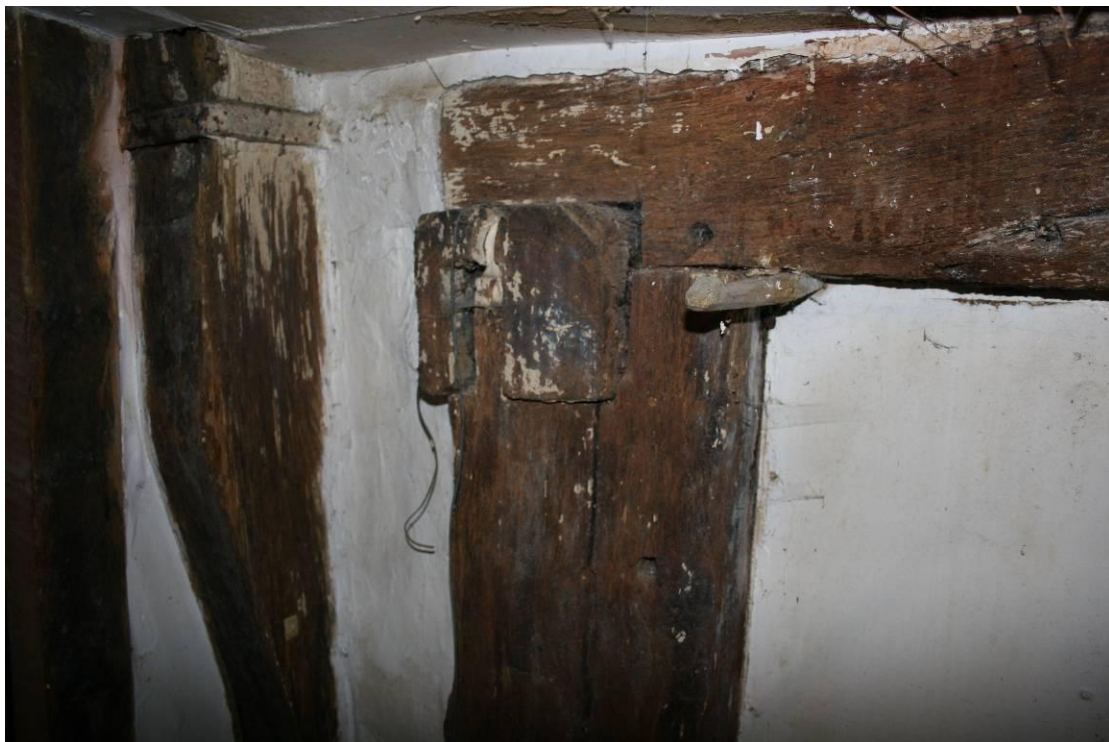
The cross-wing frame has been sawn off to insert the firestack.

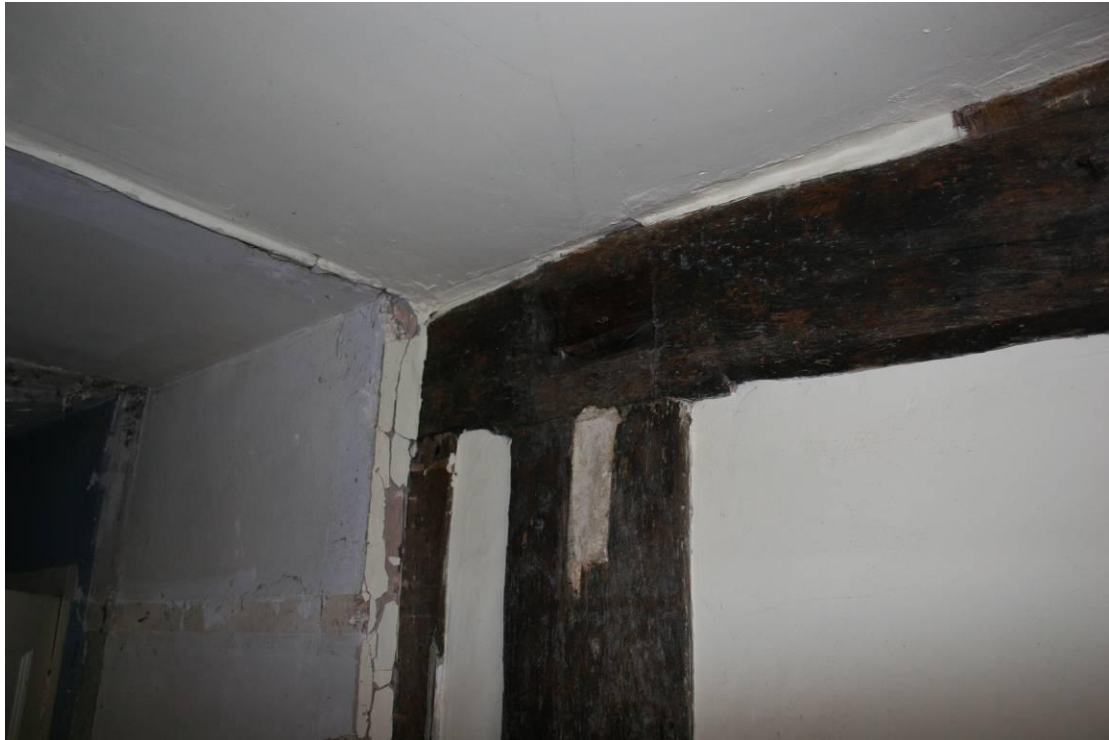
Redundant mortices in the tie-beam and storey post.

The storey post in the north partition wall has a redundant mortice as though for bracket and the cambered tie-beam has a an empty mortice for an axial main joist. This would indicate an older ceiling has been removed and the current one put in at a higher more comfortable height. The first floor frame can be seen correctly pegged with 6in flat joists. The oak boards have riven laths applied with a thick lime mortar between the joists.

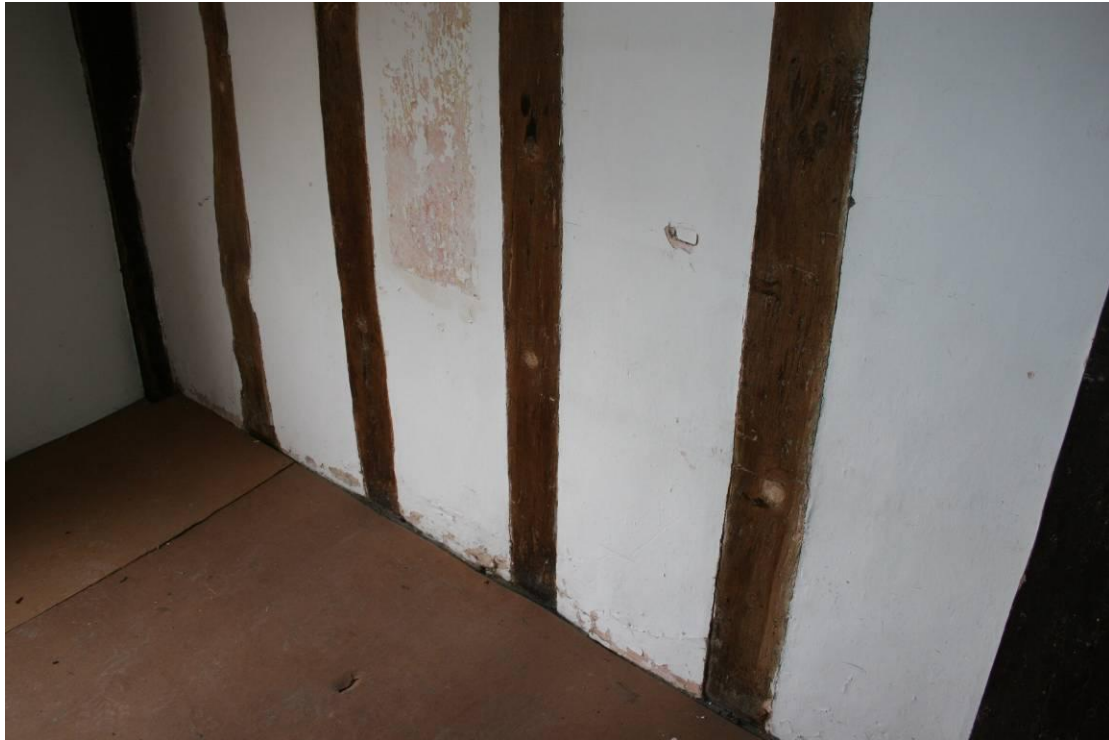
Fixture holes and multiple taper burns.

Both walls have a series of 1.25in diameter fixture holes at two levels. These could be for benches, desk, shelves or other furniture. The partition wall has multiple taper burns concentrated in two places and this usually indicates that someone has repeatedly read by candlelight at a desk. The north wall has a single taper burn mark and these are usually considered as apotropaic.

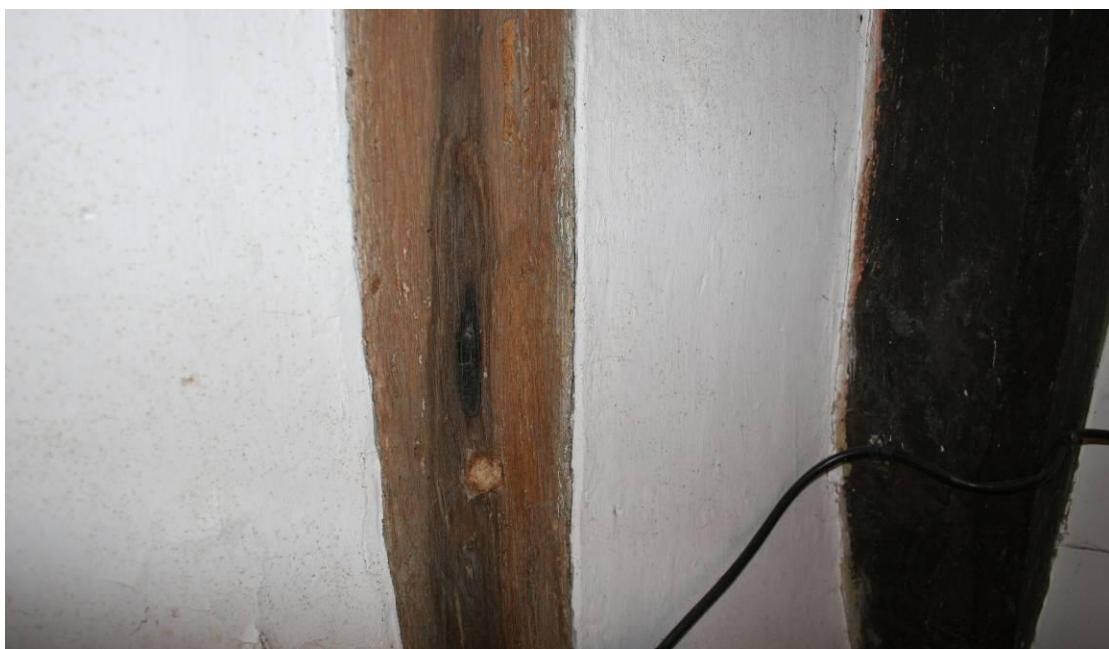
A single large taper burn by the NE storey post.

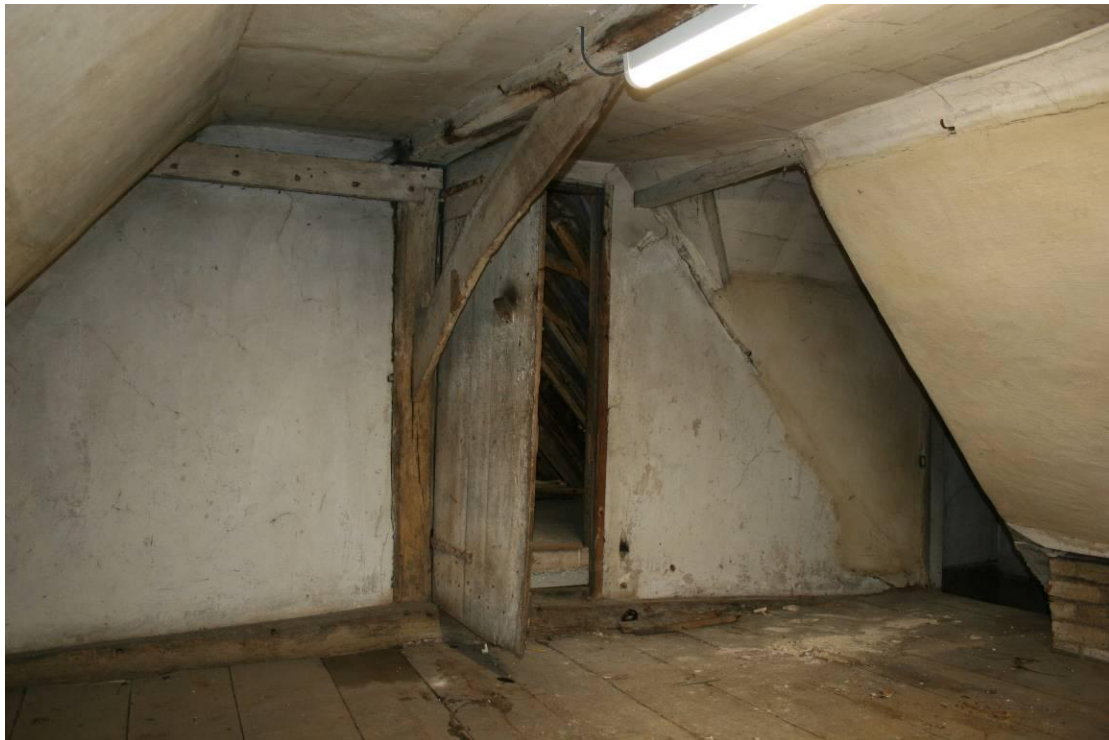
Looking S in the Attic Room. Note the crown post roof.

The Attic Room was made habitable in the EC19th c.1800 by plastering the walls and skelings and creating a ceiling on the soffits of the collars to a crown post roof. One brace was left in place while the other by the north wall was removed. There are now serious structural issues with the north wall which is falling outwards.

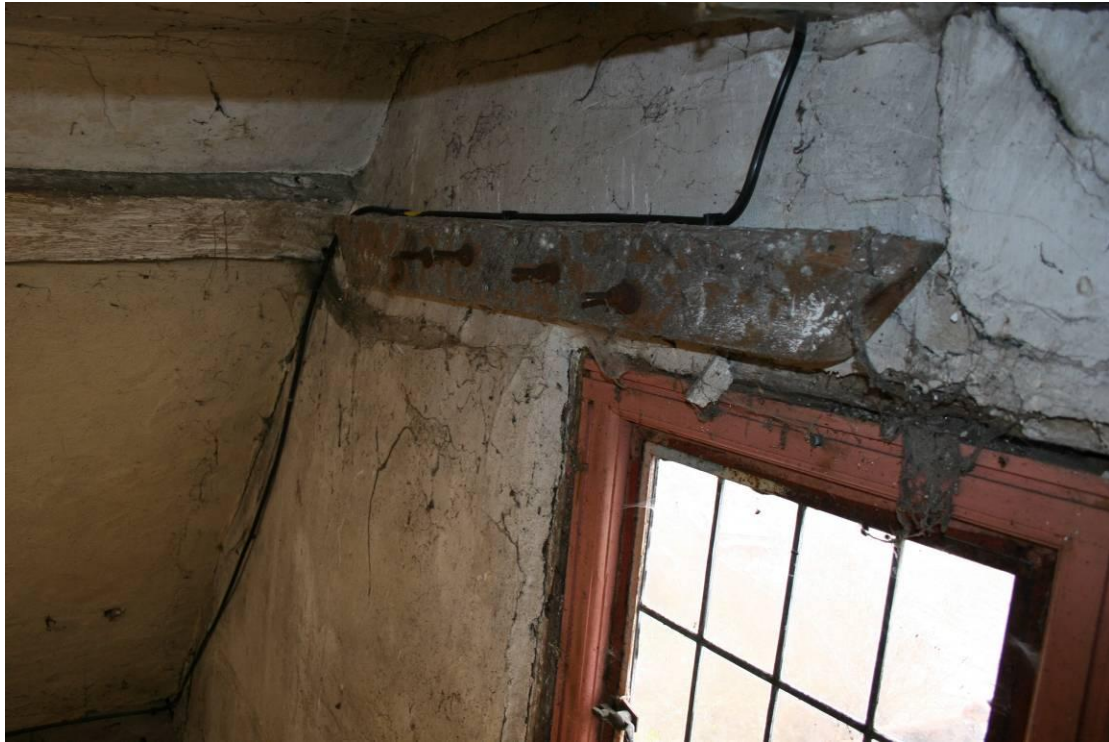
Historic repairs to the north wall.

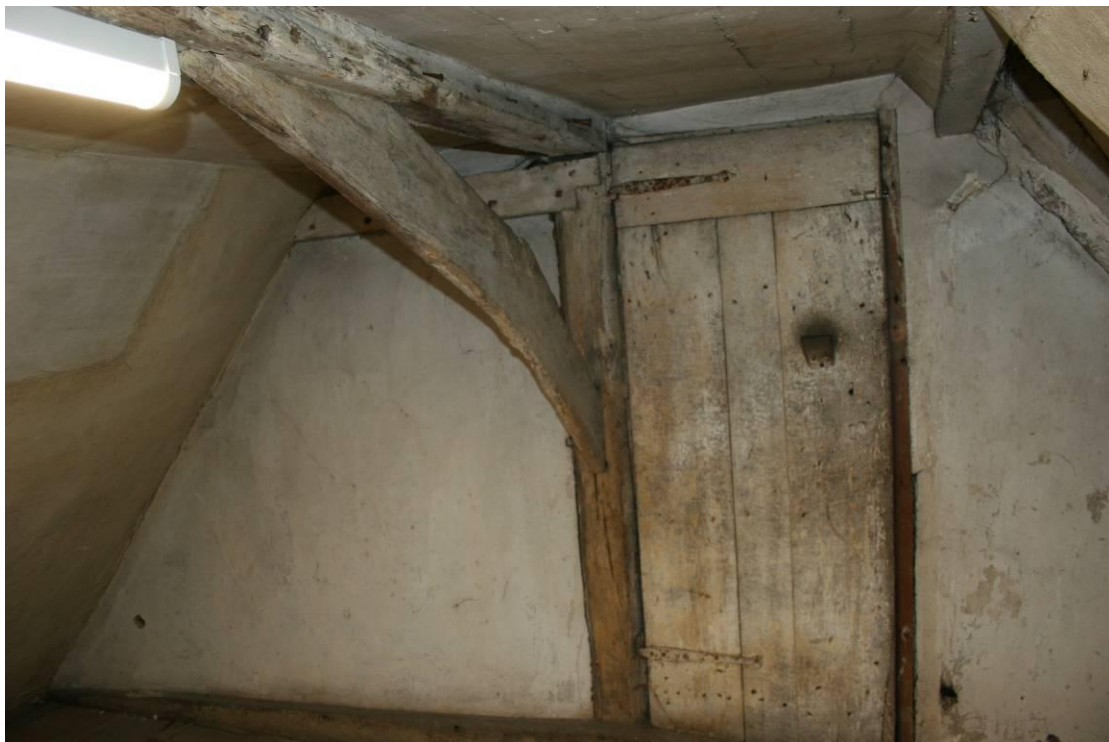
Detail of the crown post and the door into the main roof.

The door into the roof appears C17th in style and fabric. It is a nailed and clenched vertically boarded door that has been extended upwards to fit the doorway. It is hung on two different pintle hinges and has a distinctive C17th wooden door handle nailed in place. There are four blocked keyholes to attest to its age.

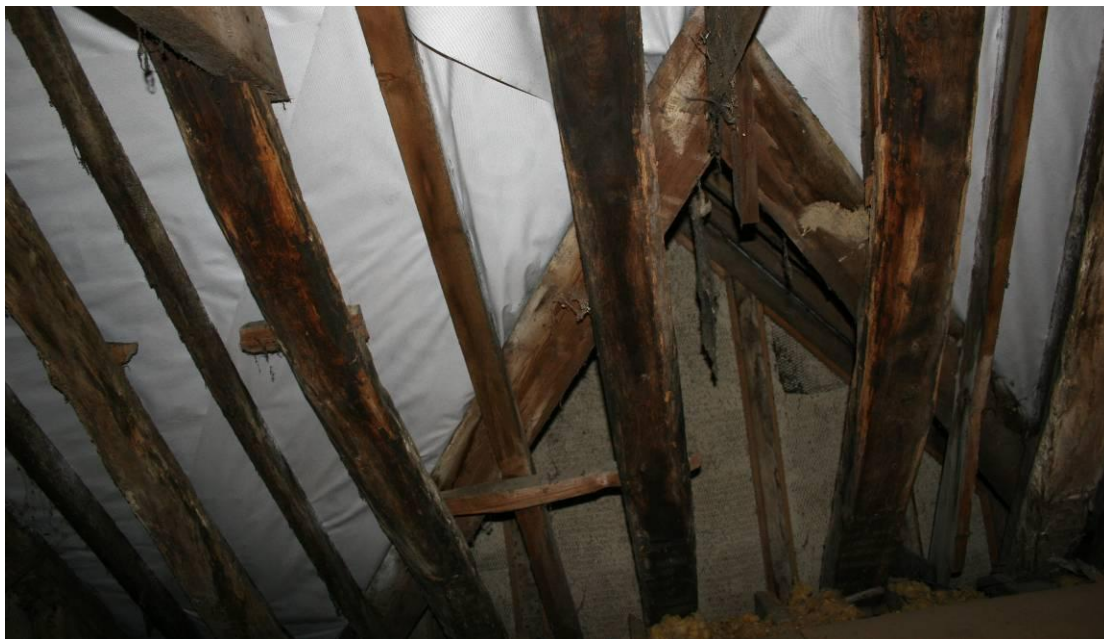
Original flat rafters with C20th gable beyond.

The original flat rafters are paired with side lapped collars resting on the collar purlin which has broken its back historically and has several ad hoc repairs. The rafters are blackened as would be seen in an open hall. The roof space has been crowded by C18th, C19th and C20th ad hoc repairs and insertions including EC20th side nailed plank collars. The collar purlin has been cut short and hipped struts inserted to prevent it rotating. These look Georgian but are also reinforced with E-MC20th machined struts. The two gables on the eastern elevation are M-LC20th structures made from machined softwood and rendered with EML. They replace Victorian additions of which only a few timbers remain.

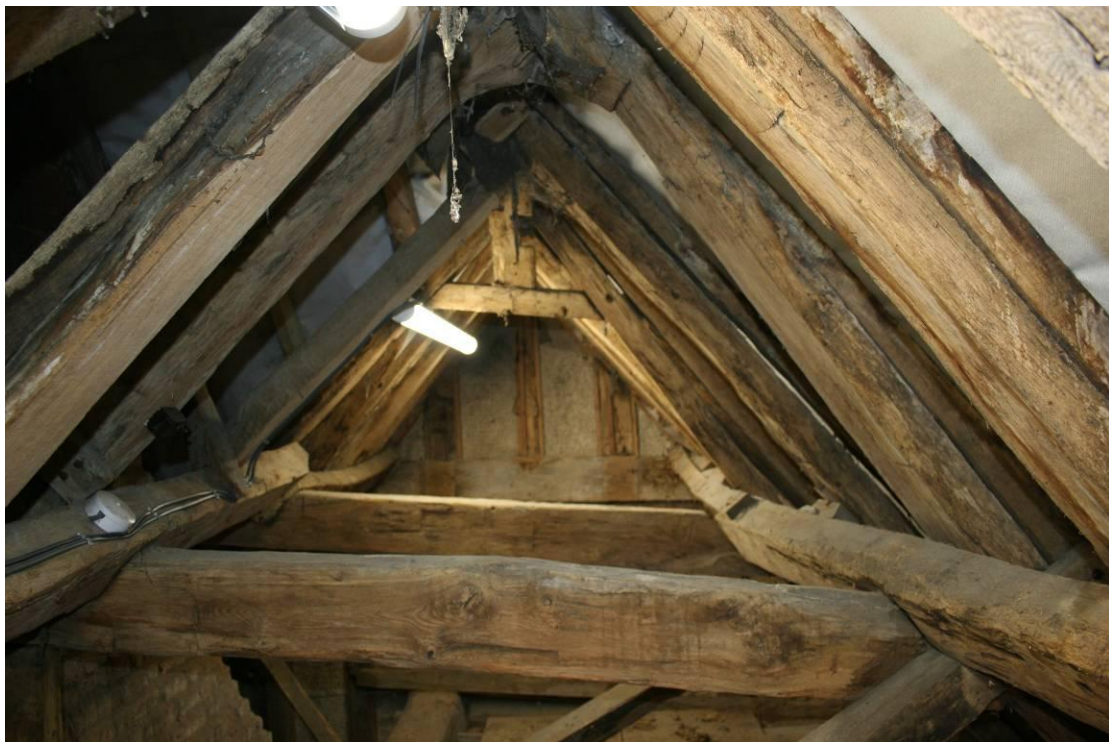
Looking NE in the Cross-wing over Bedroom 3. Above the collars.

The cross-wing has a clasped side purlin roof with heavy, slightly cambered collars and deep section purlins with simple scarves that have split apart. The paired rafters are numbered in sequence and there are several hand hewn blocks nailed in as gussets with heavy C18th style clout nails. The rafters are set on edge which would suggest they are C17th or later.

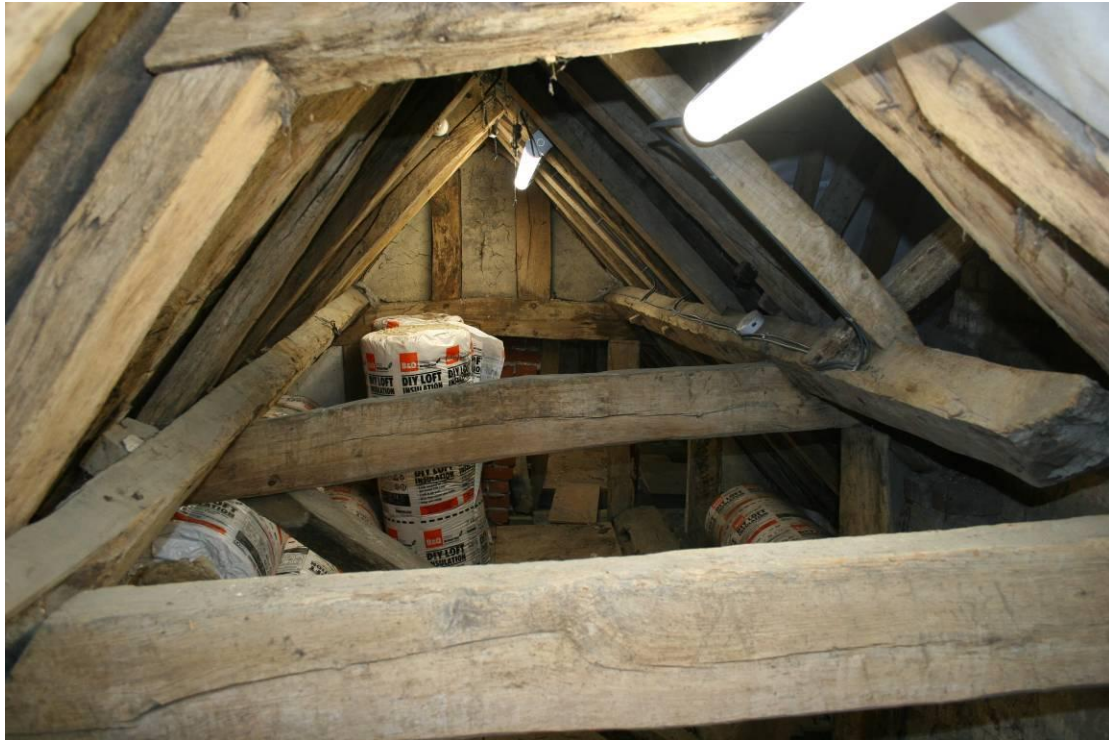
Looking SW in Cross-wing over Bedroom 3. Note the fall of the frame.

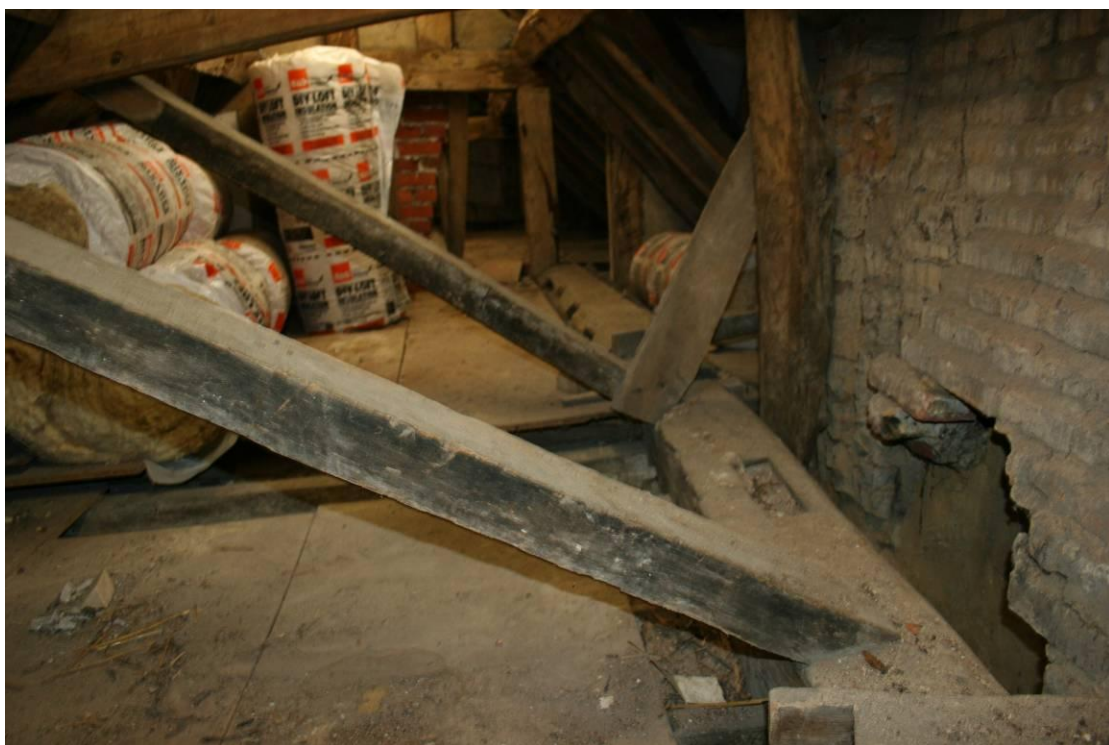
Two reused main beams have been used to make up the ceiling frame.

Two reused main beams have been inserted to make up the frames for the ceilings above the cross-wing rooms. One has a central mortice for a crown post with two pegs. The other is morticed on both sides for common joists. The ceiling itself has scantling common joists and must be C18th or later.

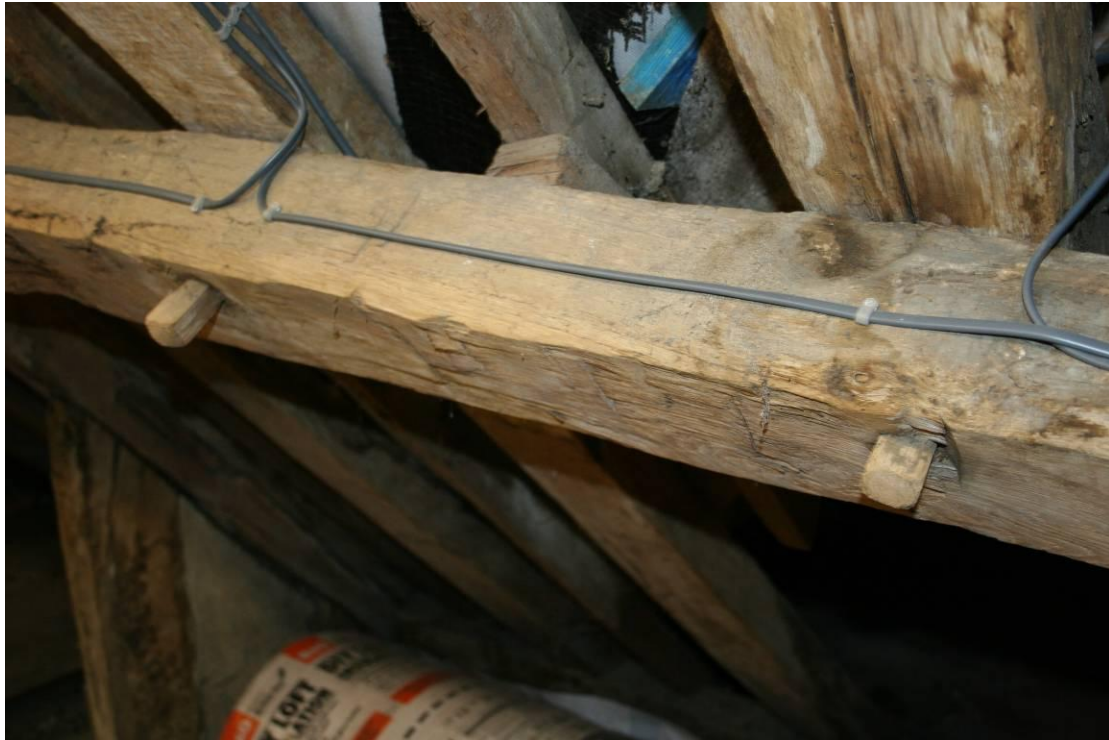
Bolt headed pegs in the purlin.

There are some bolt headed pegs in the purlins of varying patterns which must be part of later repairs. Bolt headed pegs are normally seen in frames of the C15th or older.

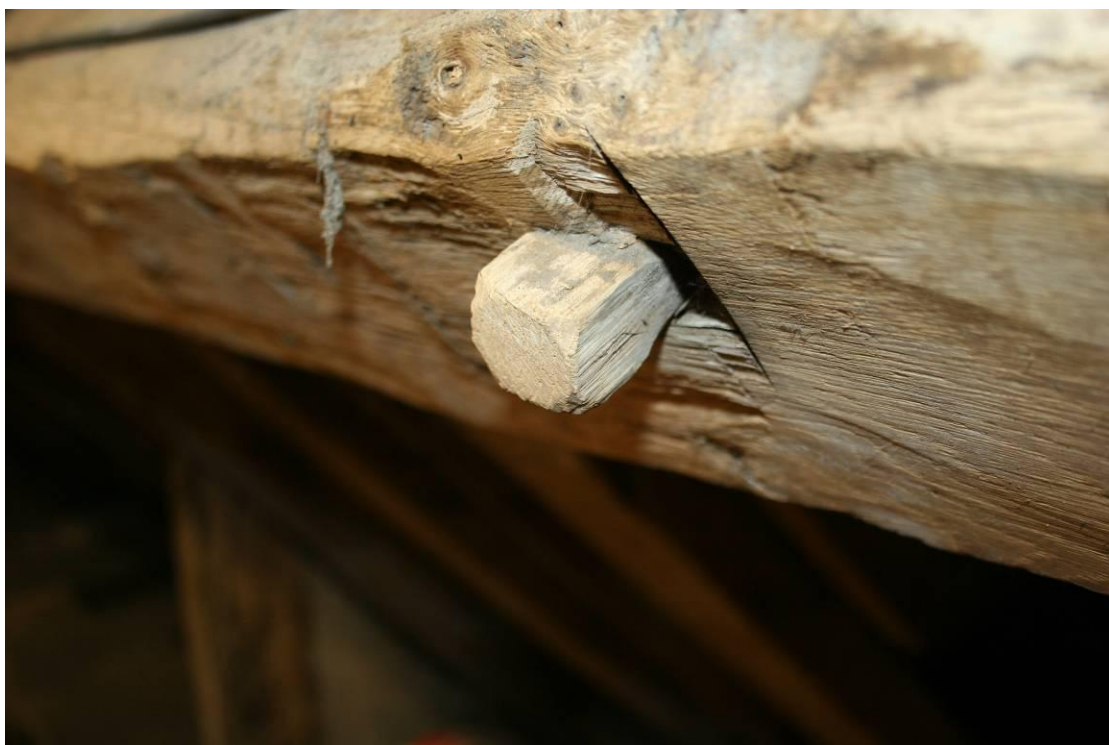
Detail of a bolt headed peg.

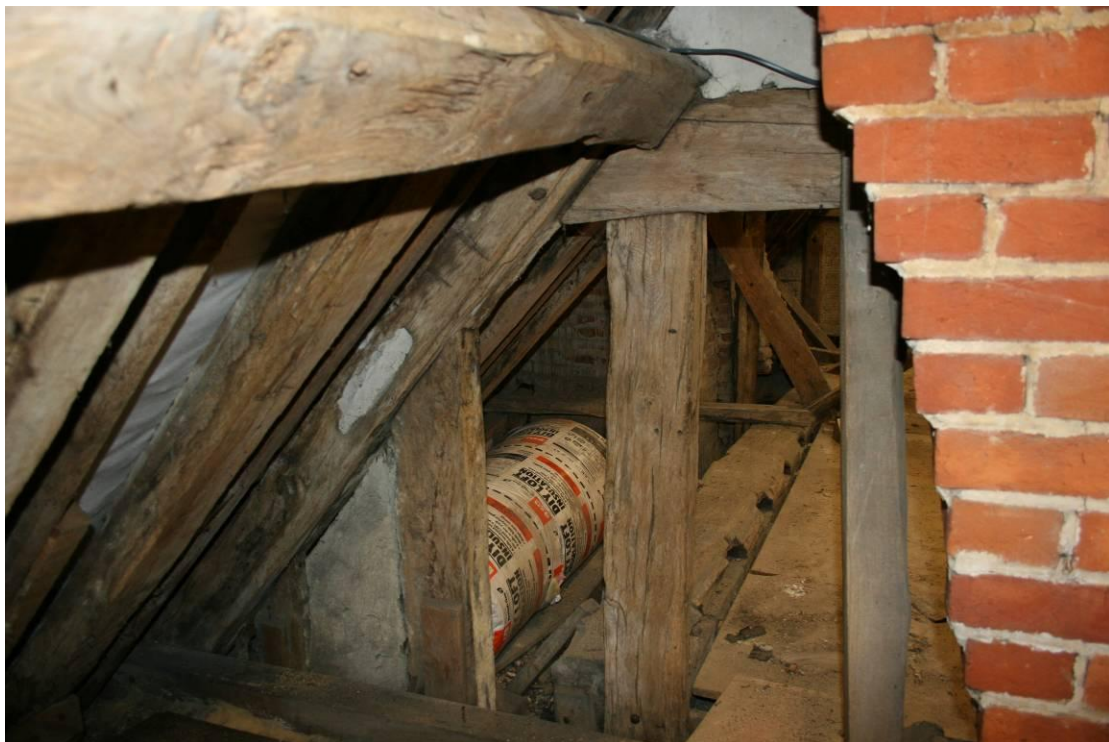
Looking E in the roof over the Rear Cross-wing Bedroom 5.

There is a fully framed partition between the east and west bays of the cross-wing. Parts of the frame were removed to add the chimney which cants over to the ridge in C19th style. The gable end has been rebuilt with side nailed studs in Georgian style and the exterior finished with hard render on EML.
