Ancells in the Hole, Braintree Road, Shalford, Essex. CM7 5JA.
Historic building recording of the Summer House. Recorded 20 01 2021.

1. Summer House – completely collapsed.

This report is an extract from the original report: Ancells in the Hole, Braintree Road, Shalford, Essex. CM7 5JA. Historic building recording of the Outbuildings. Recorded 20 01 2021. This report is to support the removal of the collapsed building.

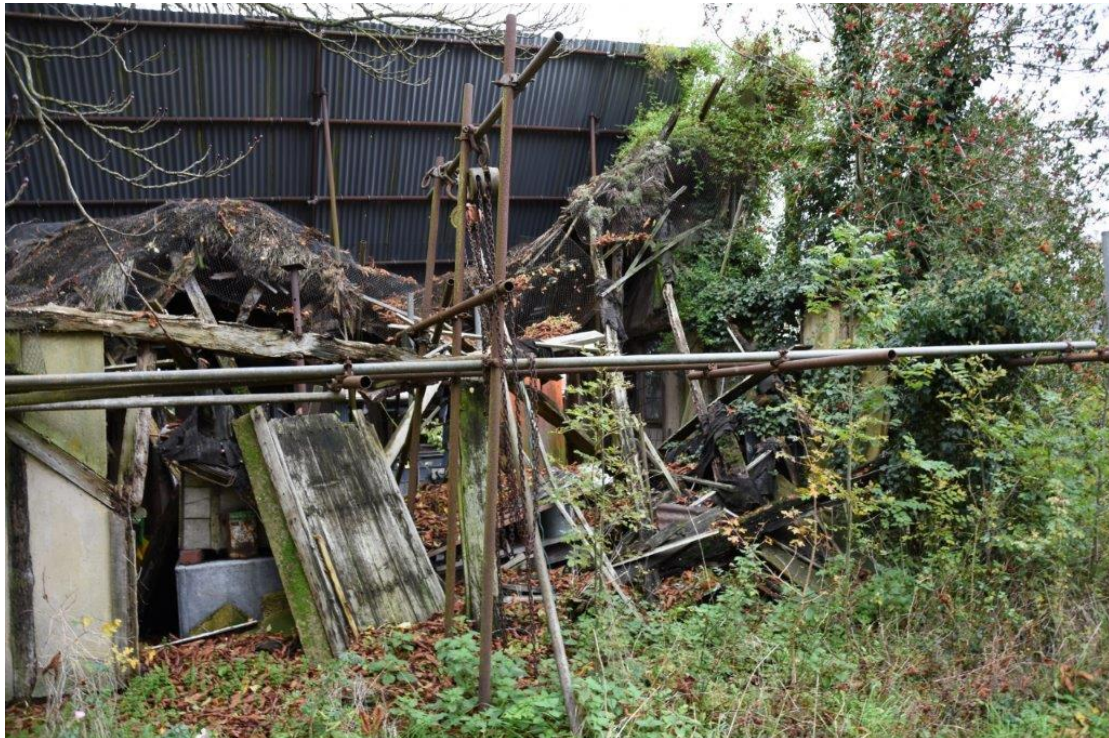
2020. The north elevation of the Summer House before the failed scaffolding was removed.

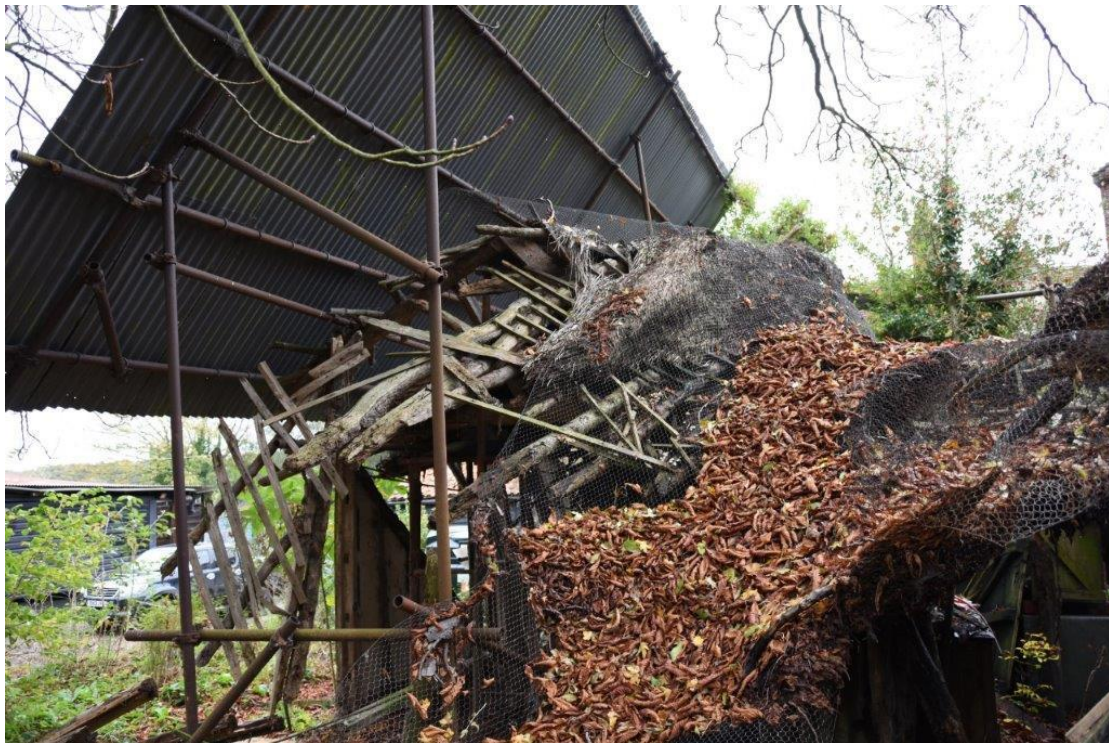
2020. The east elevation of the Summer House before the failed scaffolding was removed.

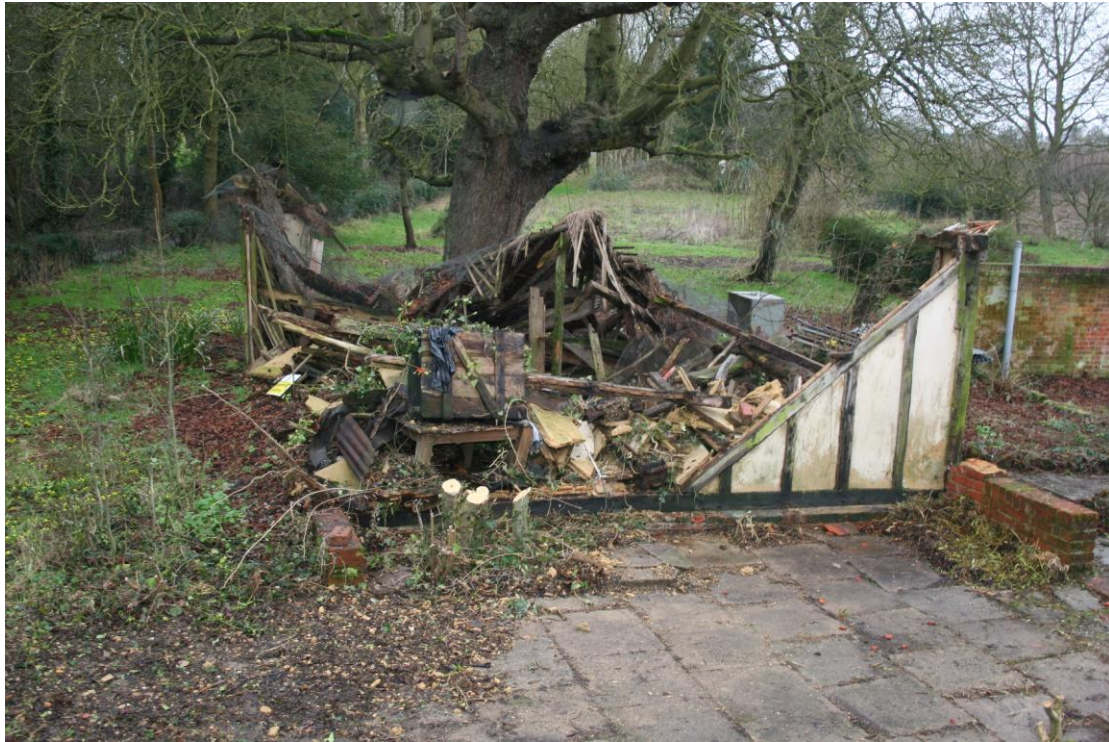
2021. Looking W across the Summer House ruins.

The Summer House is a MC20th timber-framed building that has been allowed to collapse under its own weight and failing fixings. Anecdotally, the author has passed by this building many times in the last 25 years and it was always ruinous. Aerial photography shows it in good condition in the 1970's but by the 2000's it was being supported by an armature of scaffolding and by the 2010's the roof had collapsed.

The frame was made of reused elm and softwood timbers fixed with wire nails with exposed primary bracing and interrupted studwork. The infill panels were plasterboard and the floor concrete. The roof was made from pole rafters in fresh condition and still clad entirely with bark. The battens are machined softwood fixed with wire nails. The thatch was only 12in thick at most.

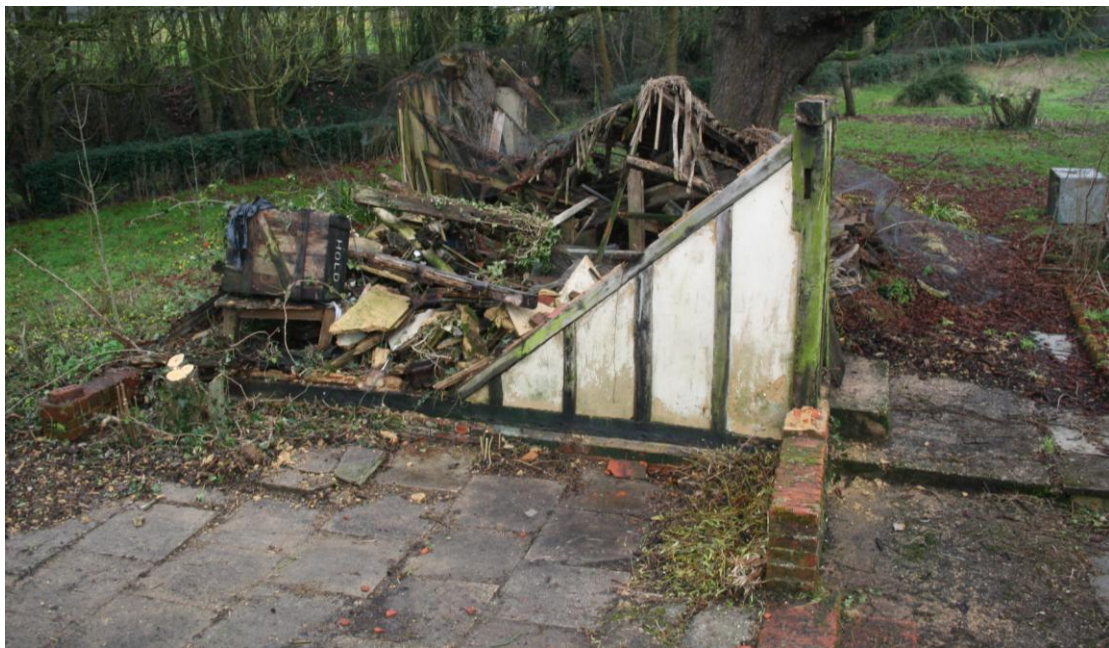
2021. The east elevation of the Summer House.

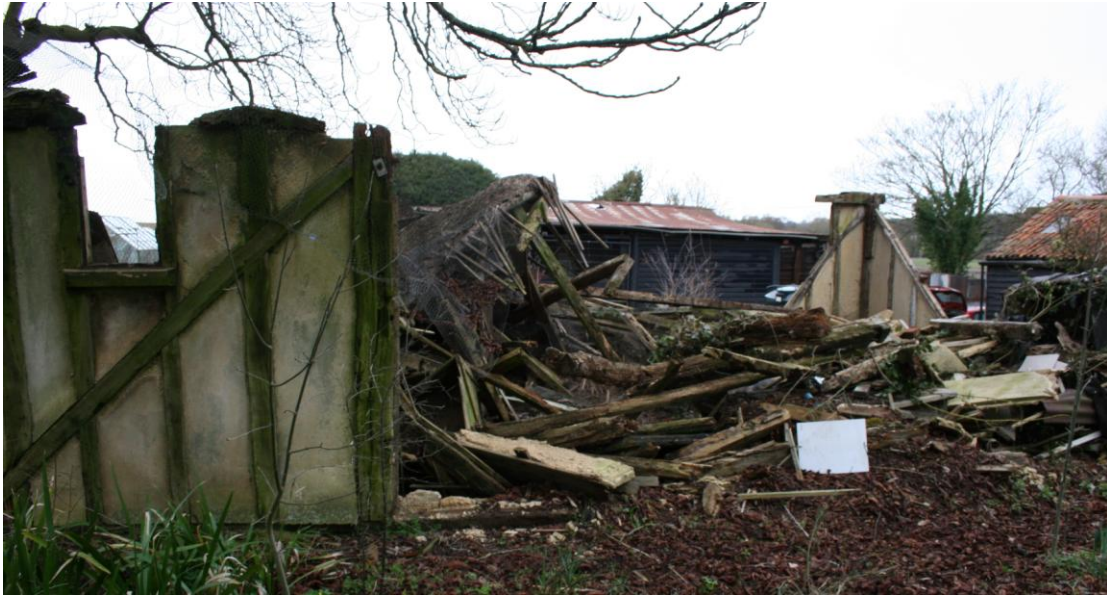
2021. The south elevation of the Summer House.

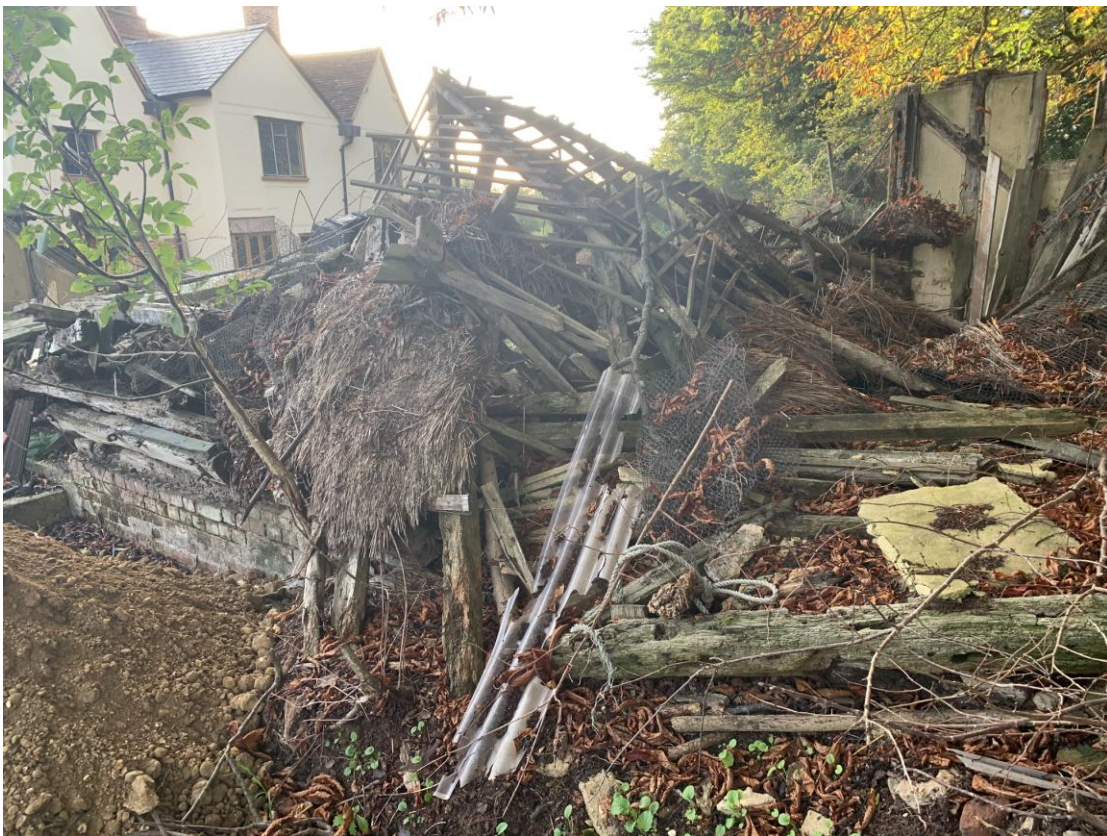
2022. Looking SE at the Summer House. Andrew Stevenson Associates.

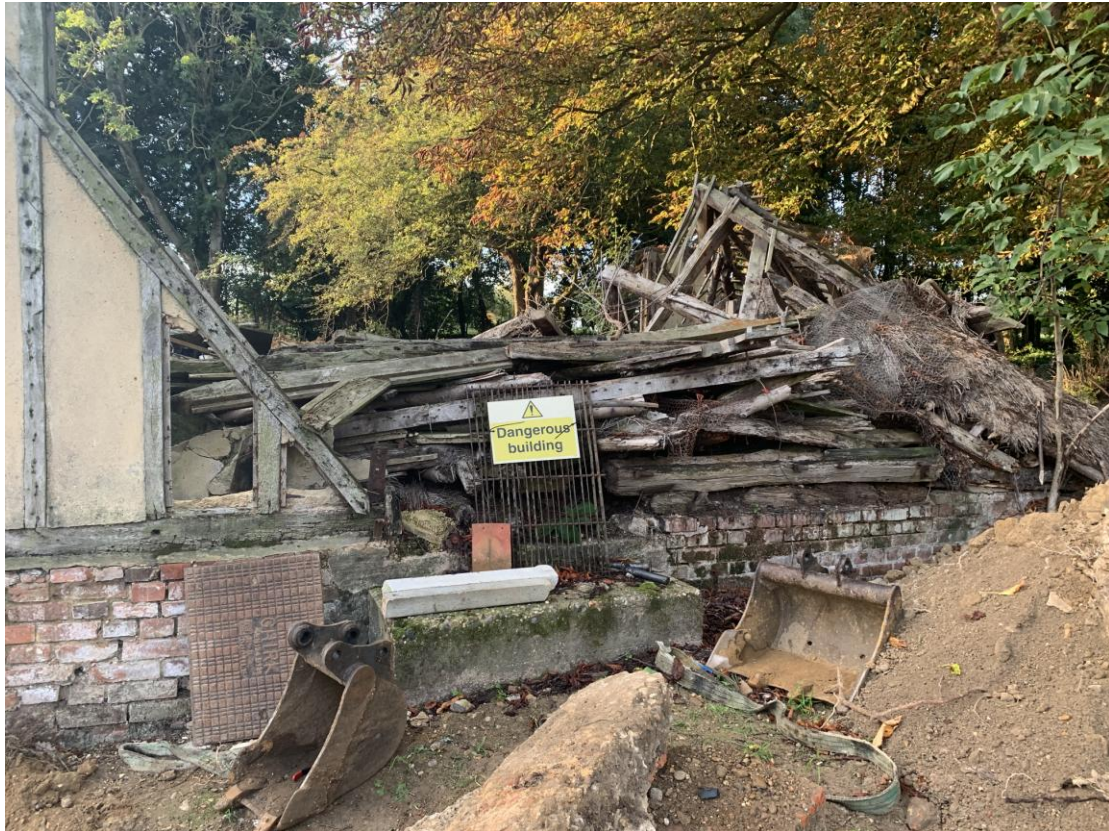
2022. The east elevation of the Summer House. Andrew Stevenson Associates.

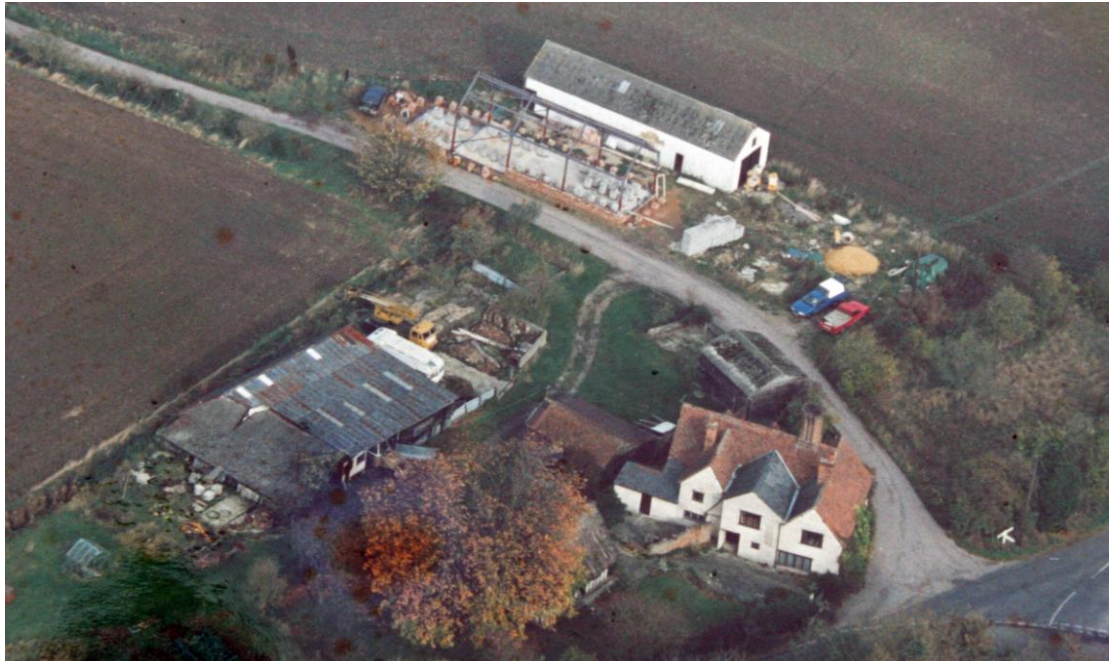
2000's (undated). Ancells from the SW. The Summer House has deteriorated.

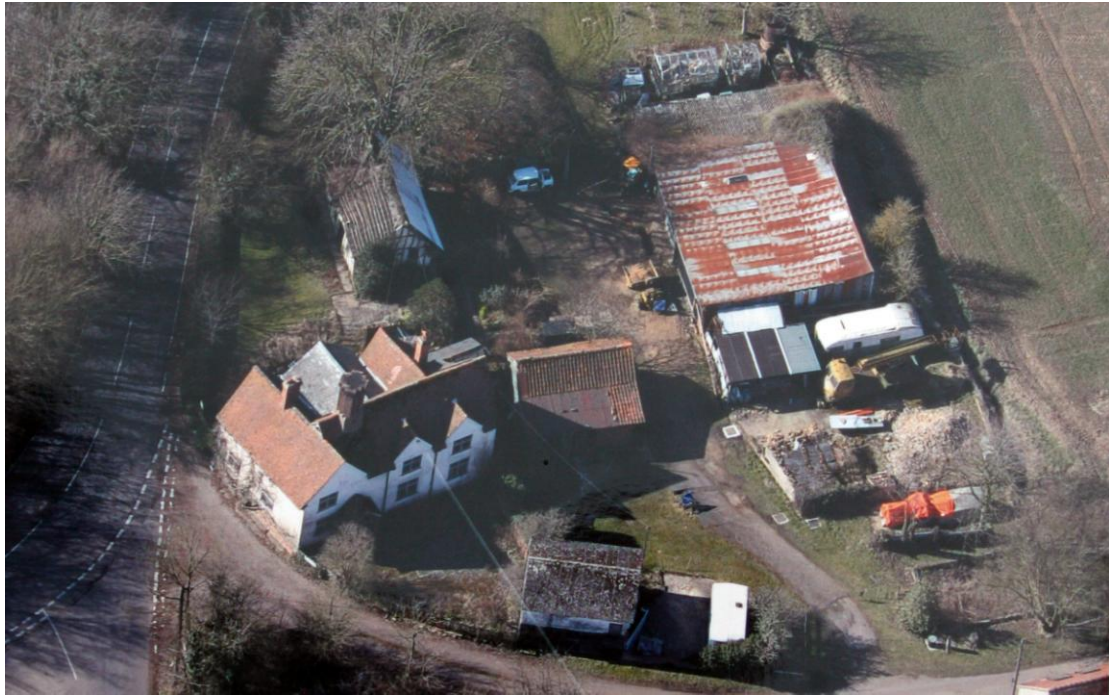
2000's (undated). Ancells from the east. The Summer House has lost its thatched roof.
