BARNS Q and R Report on a Visual Inspection of Proposed Barn Conversions Under Permitted Development (Class Q) at Rose Farm, Shapwick Road Westhay, Glastonbury, BA6 9TU for the T W Willcox Will Trust

- Version 2
- 26 September 2022

MBE REF-MBE-2021-025-Rose Farm Barns – QR – v2

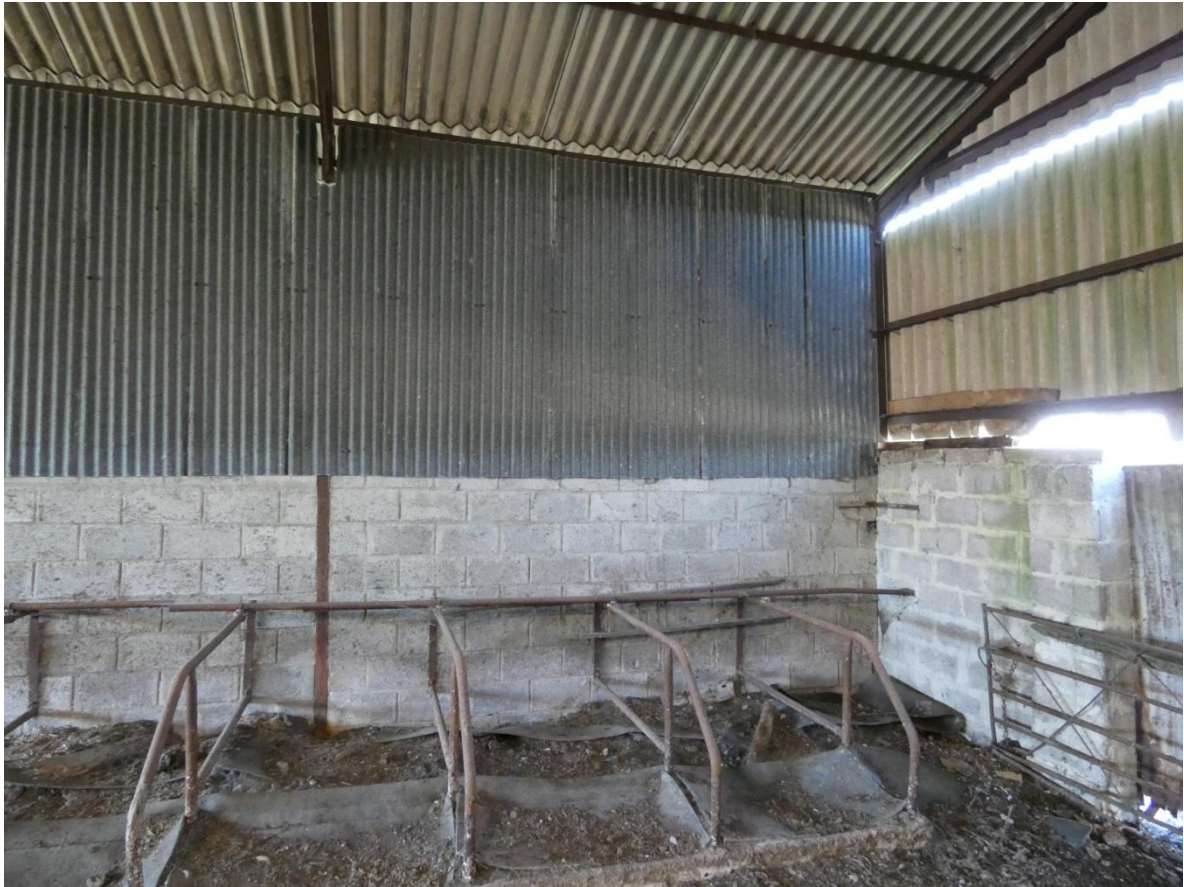
Photo 21 – Interior view Barn R – Left hand elevation cont'd from Photo 20

For enlarged image of movement see below

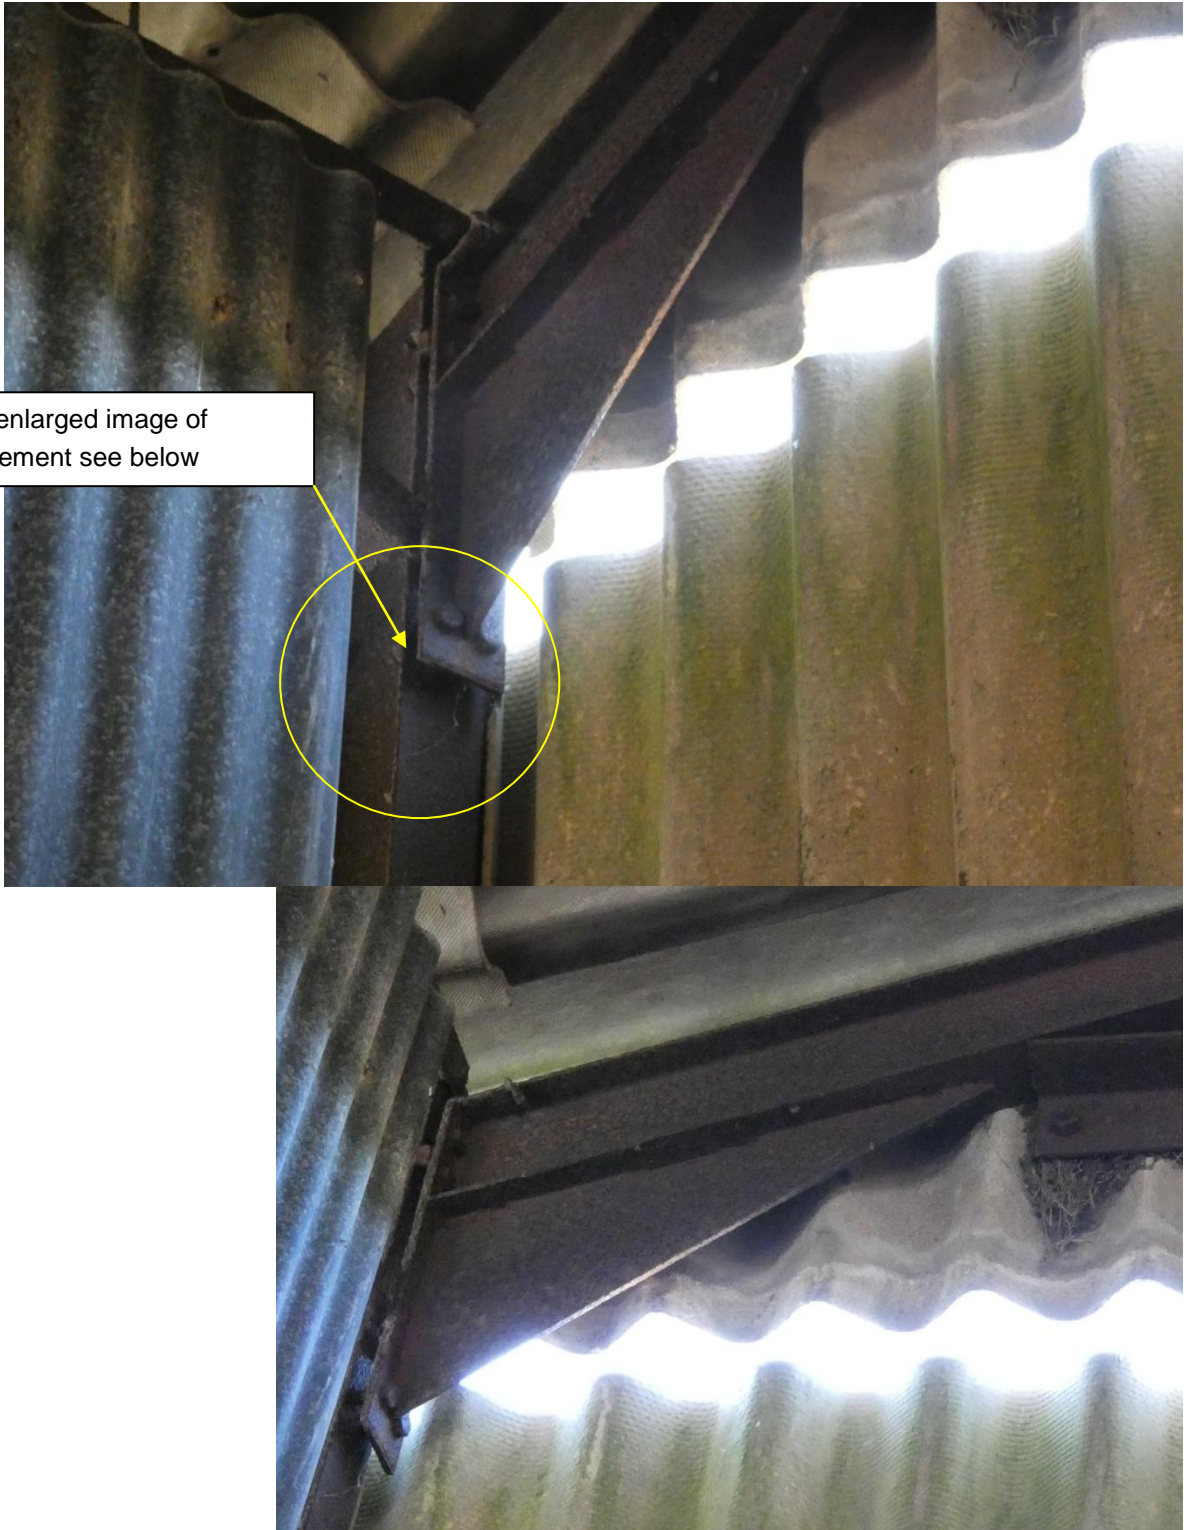
- 3.5.4 All visible steelwork was inspected from ground level and, with the exception of some movement at grid line B / 5 (see Photo 22 in Appendix A), no significant structural defects were observed in the form of either excessive corrosion, distortion, distress, deflection or the like. The frame would appear to be in reasonable condition.
- 3.5.5 A significant portion of the right hand elevation is overgrown with vegetation and self seeded trees that have established and are within influencing distance of the building.
- 3.5.6 The envelope has no thermal value and will need to be upgraded by the inclusion of a suitable lining internally.

- 4.1.1 In general the building appears to be in reasonable condition, with the exception of a displaced joint located at the rear left hand corner of Barn R (intersection of grids B / 5. The rafter appears to have slipped away from the supporting column by about 25mm. The cladding to the upper portion of the gable is not tightly secured to the frame either and a large gap is evident between the joints in the asbestos cement sheeting in the uppermost panel of the rear gable between grids B and C.

- 4.1.2 The cause of the movement is unknown and may either be due to an accidental impact or lack of fit (or even poorly tightened or fatigue failed bolts). In essence the movement observed does appear to be historic and it would appear as though the structure has not suffered from further distress or a local collapse.

Photo 22 – Interior view Barn R – Rear left hand frame column – Frame movement

- 4.1.3 Provided the frame is locally repaired and the integrity of the rafter / column connection restored this would allow the column / rafter to be re-used in the conversion. Given the likely age of the steel frame we would recommend that the joints are generally overhauled and the primary steel cleaned and protected, so the steel coatings and bolts were renewed.

- 6.4.1 The damage in the main barn (Barn R) is generally restricted to the connection between the column and rafter at grid intersection B / 5. The displaced joint and steel frame should be locally taken down and re-assembled with a new bolted joint, once the cladding is safely removed.
- 6.4.2 In general the steelwork joints should be overhauled and new bolts provided to ensure tightness of fit and the frame checked to ensure it is true and square.
- 6.4.3 The existing steelwork should be thoroughly cleaned and protected with a suitable protective paint system.
- 6.4.4 The roof and wall cladding should be entirely replaced with a new system of cladding that is commensurate in weight and ideally the roof should drain to gutters that feed into down pipes that should discharge into a dedicated drain and not release water onto the ground near the outside walls of the barn.
