# **BARN N**

## **Report on a Visual Inspection of Proposed Barn Conversions Under Permitted Development (Class Q) at Rose Farm, Shapwick Road Westhay, Glastonbury, BA6 9TU for the T W Willcox Will Trust**

- Version 2
- 26 September 2022

**MBE REF-MBE-2021-025-Rose Farm Barns – N – v2**

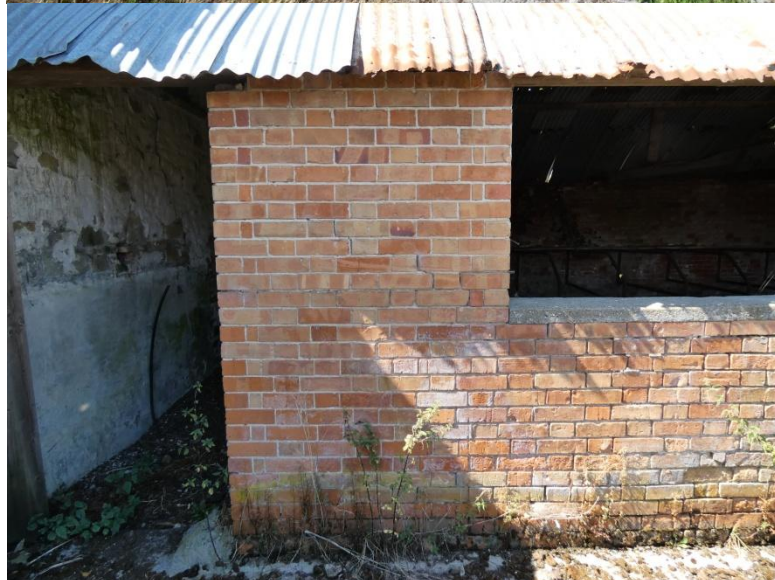
Photo 1 – East elevation (front) – Viewed from yard

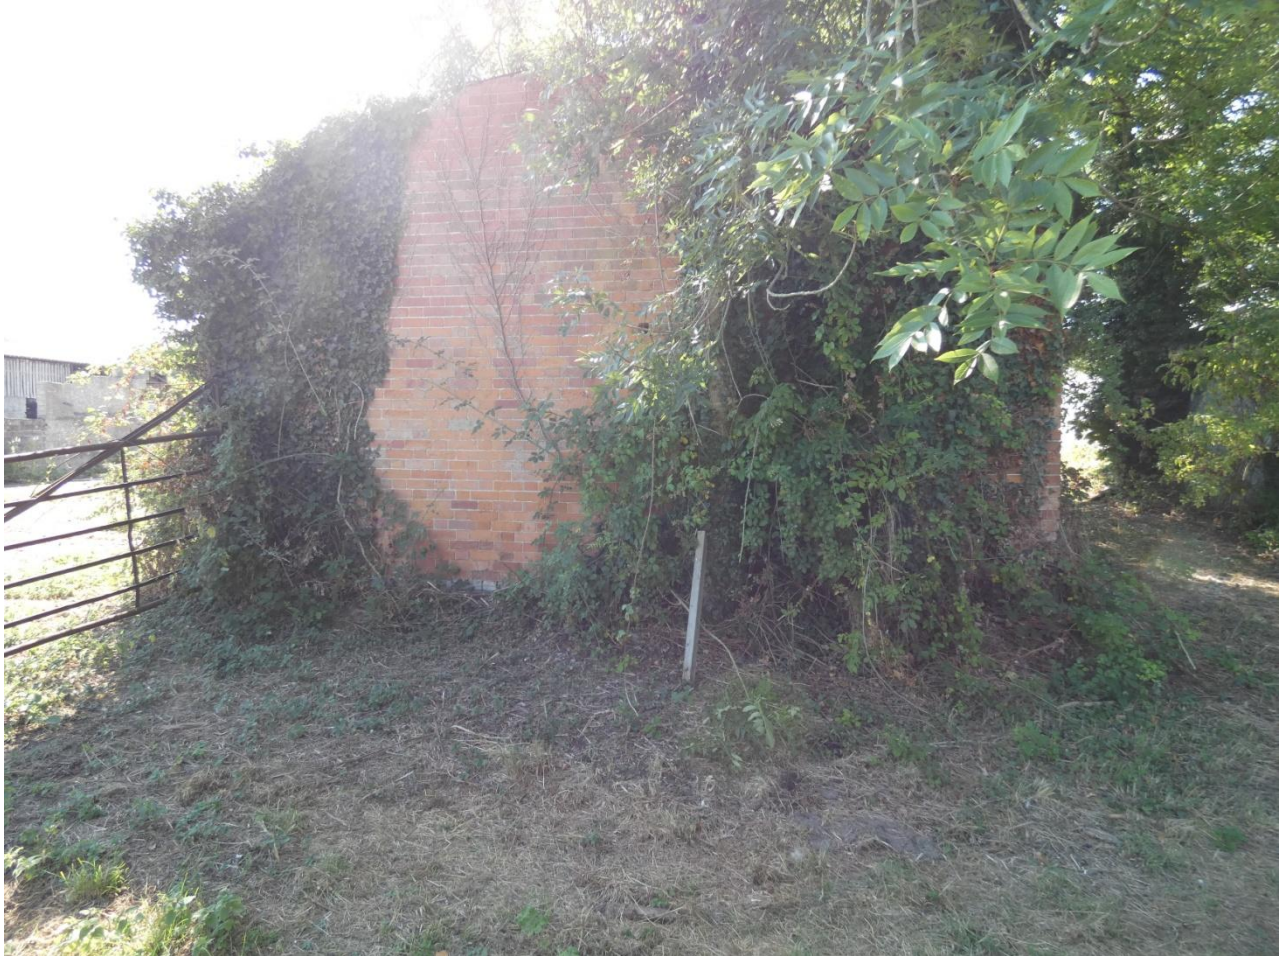
Photo 2 – North gable (right hand side) – Looking south

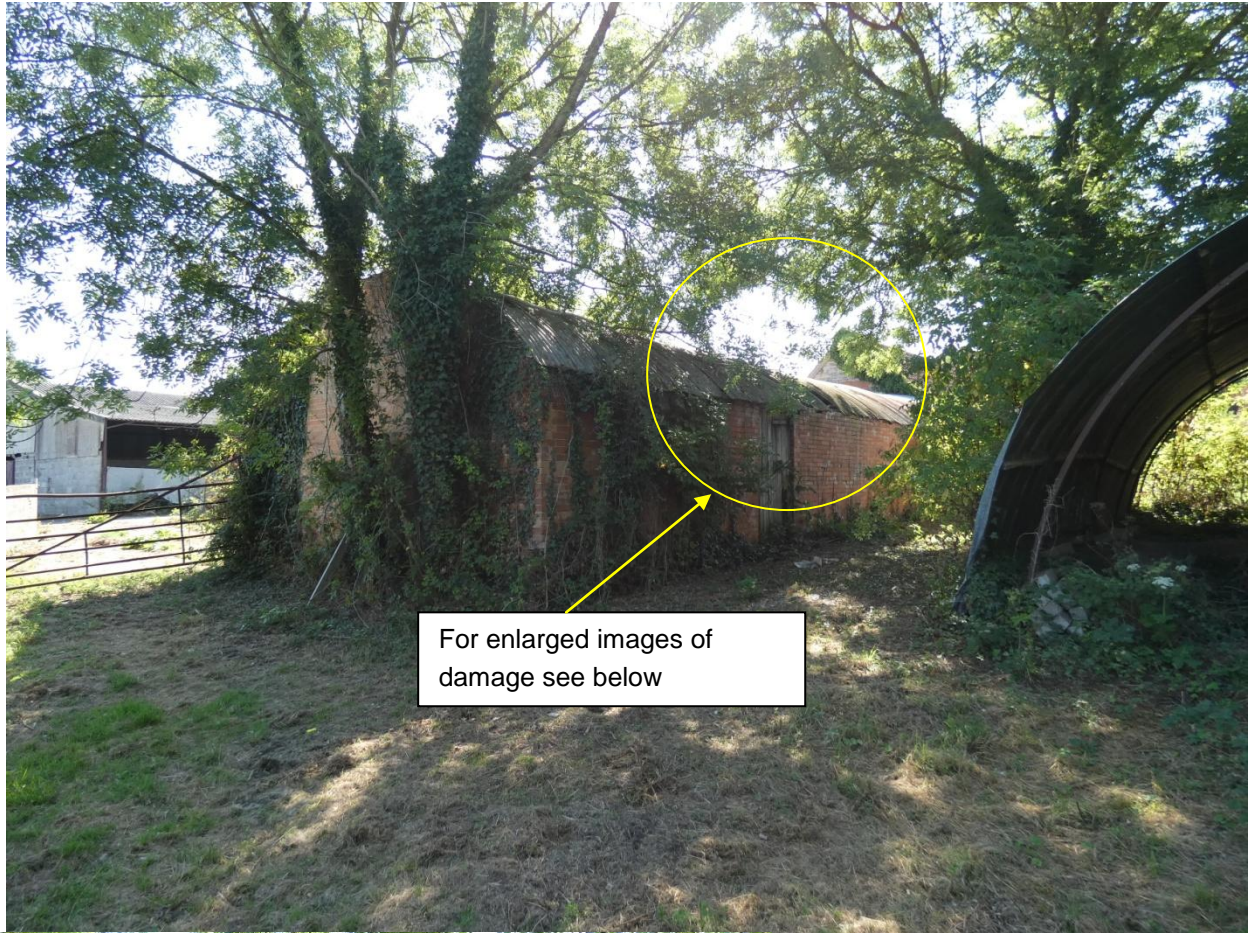
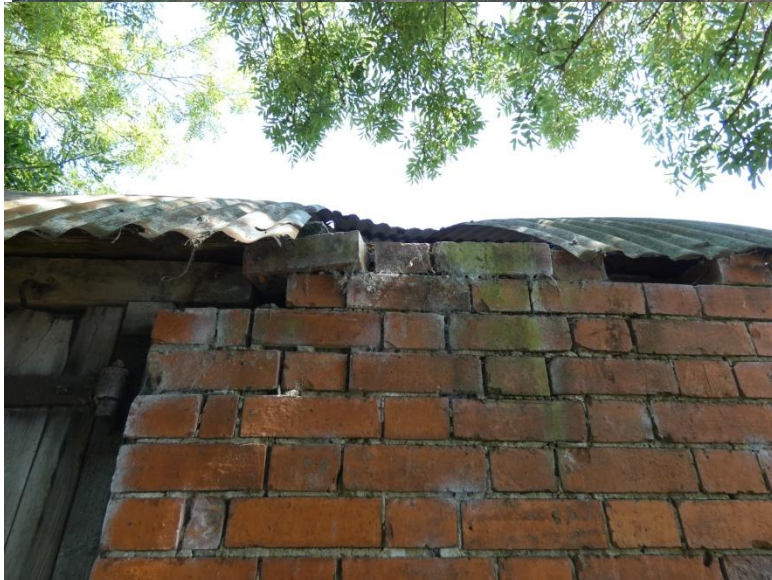
- 3.5.10 The masonry adjacent the bearing of a roof beam and timber lintel has locally failed (see Photos 3 and 20 in Appendix A)
- 3.5.11 Dampness is rising through the walls and this has led to the loss of some internal render (see Photos 13 and 14 in Appendix A).

Photo 3 – West (rear) elevation – Viewed from rear right hand side looking south east

- 6.4.8 Where the masonry has locally failed at beam bearings and has displaced (near the north gable) the wall should be locally taken down and reconstructed.

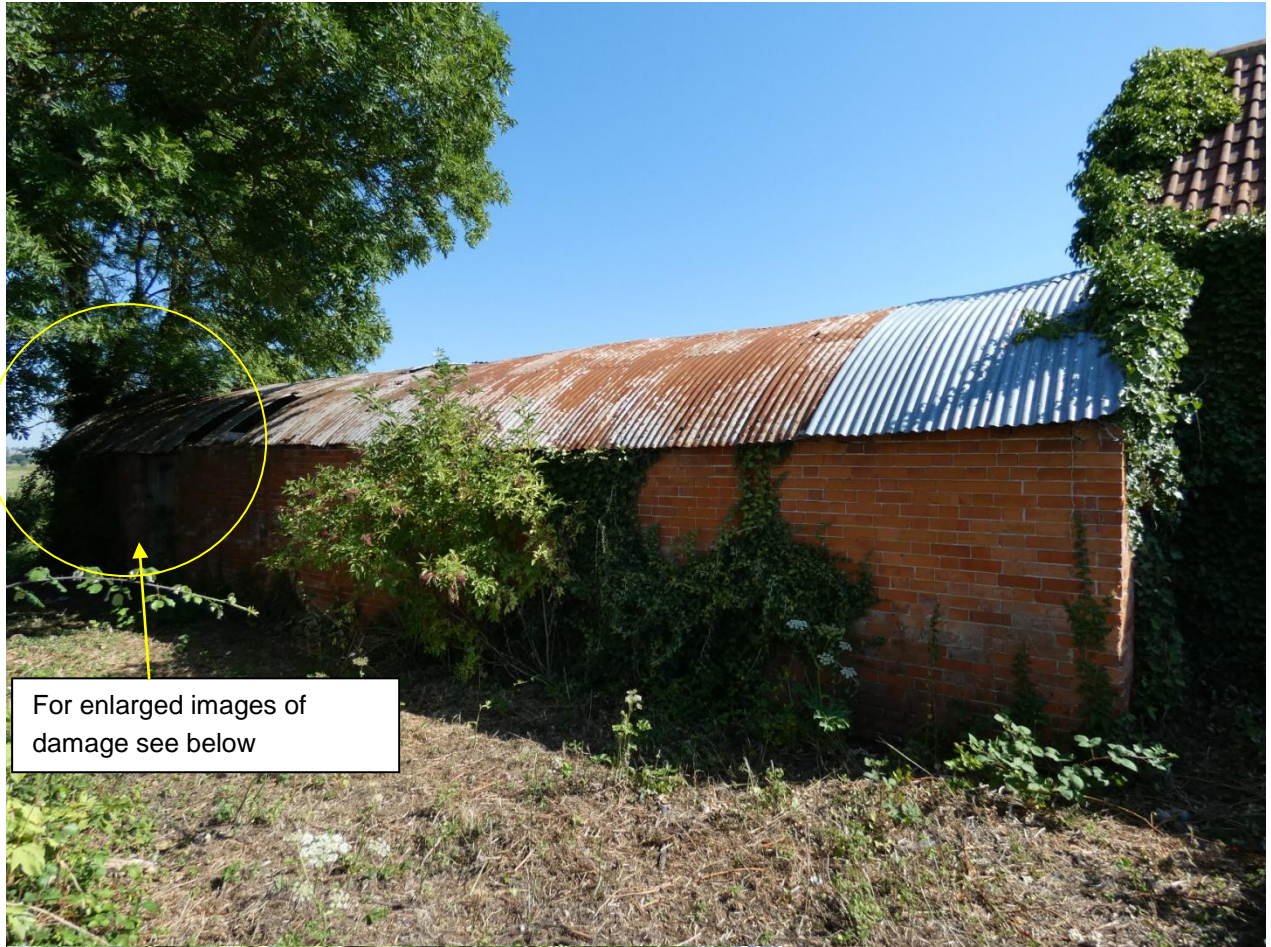
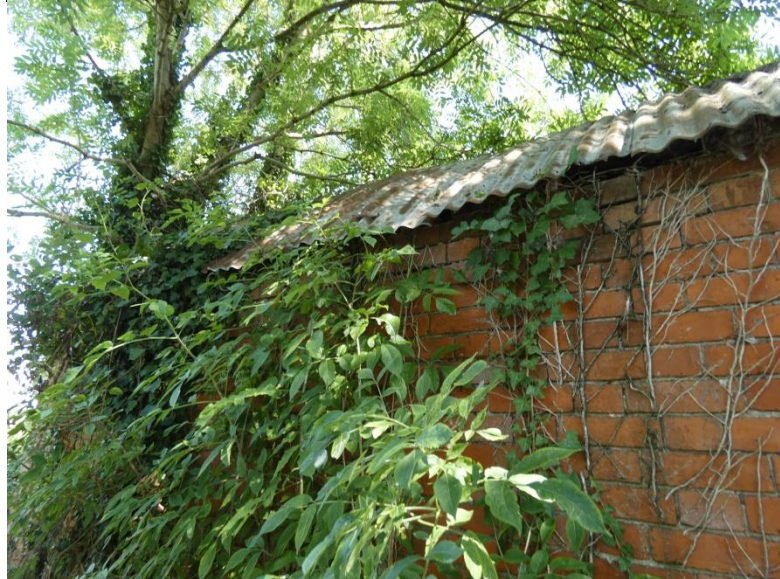
Photo 4 – West (rear) elevation – Viewed from rear left hand side looking east

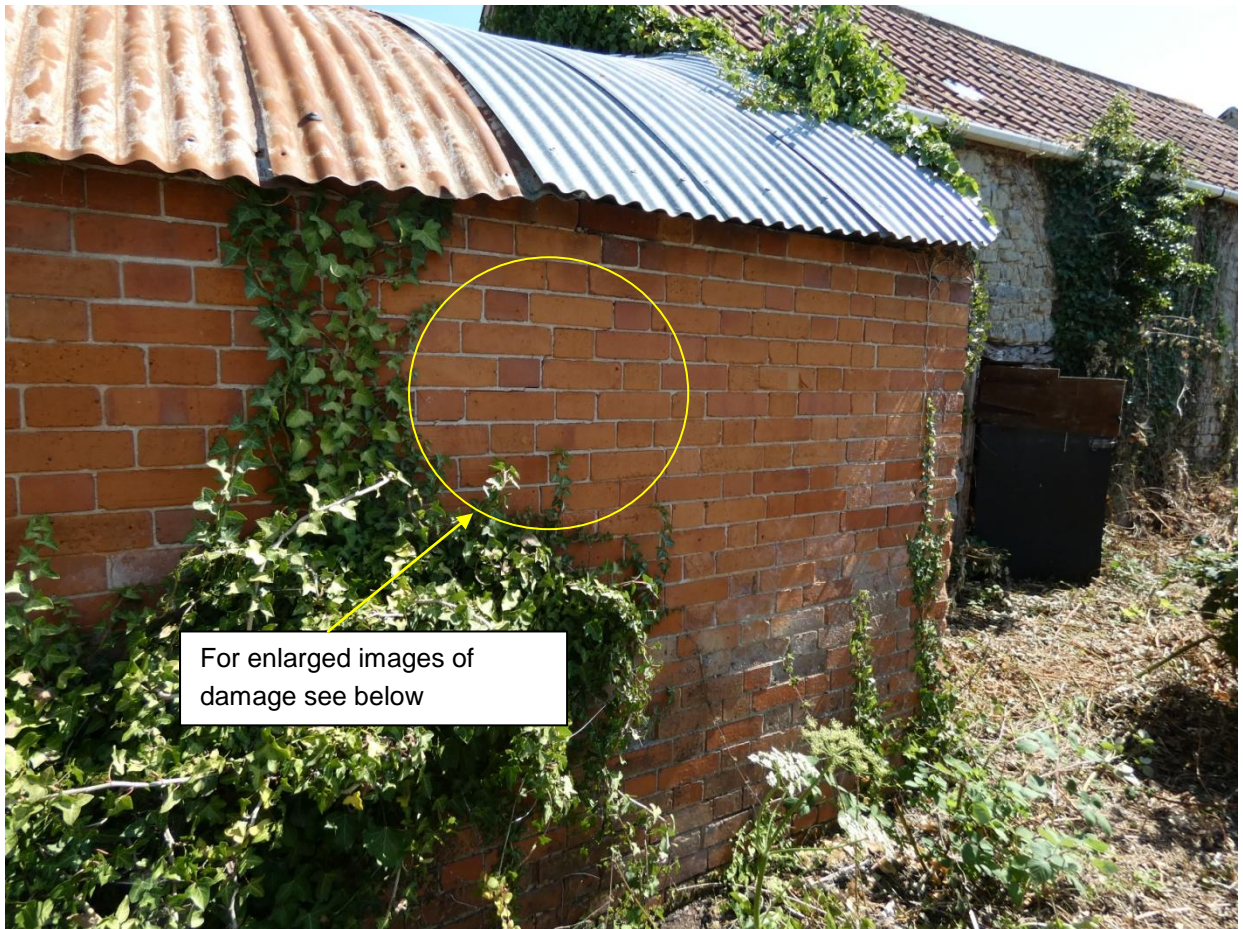
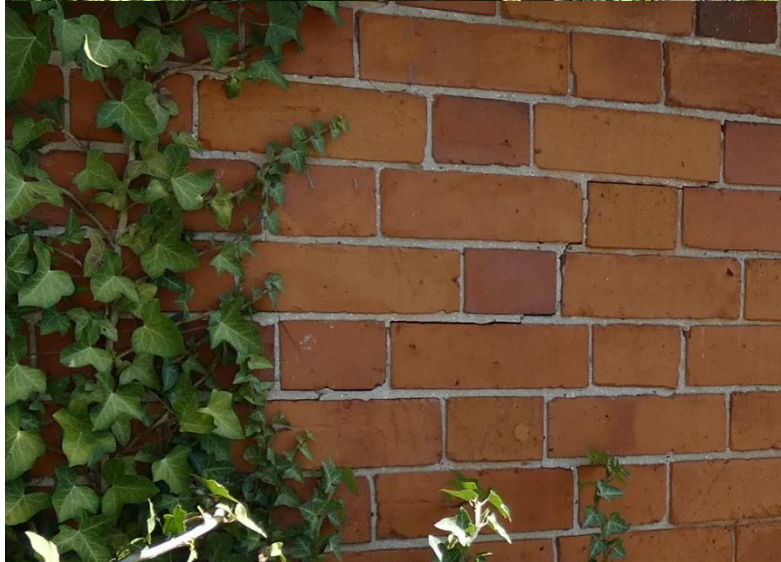
- 3.5.7 There is also evidence of foundation related movement linked to Barn L, where stepped tapered cracking has occurred to the south west corner to track across the facade of Barn N where the external wall meets Barn L (see Photos 5, 11 and 12 in Appendix A). The movement is reflected internally and extends from ground level, with cracks generally being wider at the top. The south west section of wall has parted from the junction with Barn L.

- 4.1.6 The pattern of damage around the south west part of the barn is evident of foundation related movement that has resulted in cracking around the external walls, extending from ground level, which is broadly wider at the top and narrower at the bottom. This damage is probably due to subsidence.

Photo 5 – South west corner – Stair stepped cracking

- 6.4.4 External wall panels have to resist both vertical load and lateral load. On this basis the structural integrity of the south west section of wall (where it abuts Barn L) should be fully restored using masonry reinforcement (Helifix bars or equivalent) in accordance with paragraphs 6.4.5 to 6.4.7. Similar repairs may be used where the wall is cracked through the whole section.

- 6.4.6 Cracked joints should be chased out to depths of c50mm and c 6 – 8 mm diameter stainless steel threaded bars (Helifix or similar) inserted with at least 225 mm of the bar placed either side of the crack (450 mm long bars). The joints should then be re-pointed with “Helibond” mortar or equivalent.

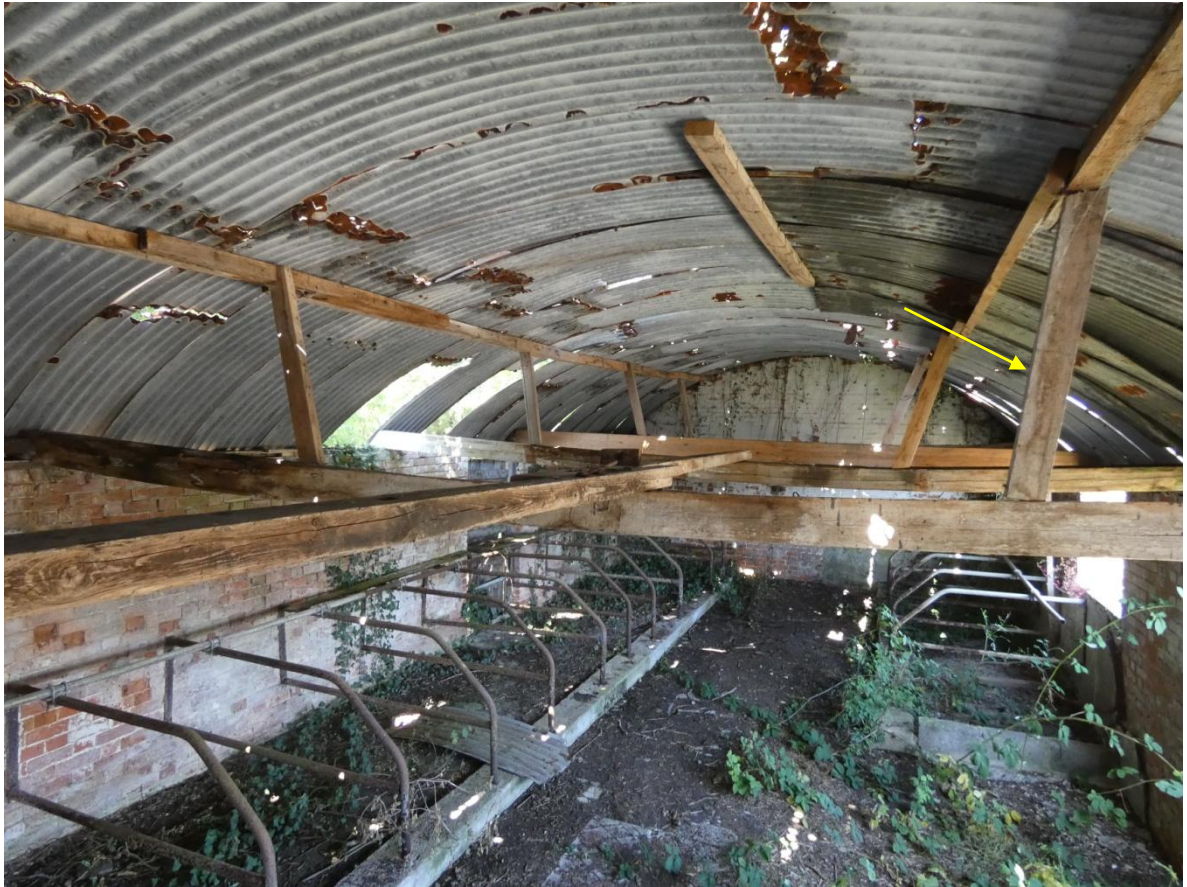
- 3.5.4 Unfortunately large sections of the corrugated roof have corroded and some panels of roof decking are missing. Furthermore the spacing of the purlins exceeds the spanning capacity of the corrugated roof profile; depending on the actual profile used in the roof, sheeting of this type would normally be supported at a closer spacing than the c3.3m distance between the two lines of existing support.

Photo 10 – Interior view – Damaged / missing roof sheets and sagging beams

- 6.4.1 The damage in the main barn is generally restricted to the roof and local areas of damage to the facade (as noted on Figure 1 in Appendix B).
- 6.4.2 The existing roof support beams are sagging too much and are inadequate to support additional loads (due to plastered finishes or other superimposed dead loads) and should either be strengthened (with fitch plates and the like) or replaced with new trusses / beams to replicate the existing load paths.

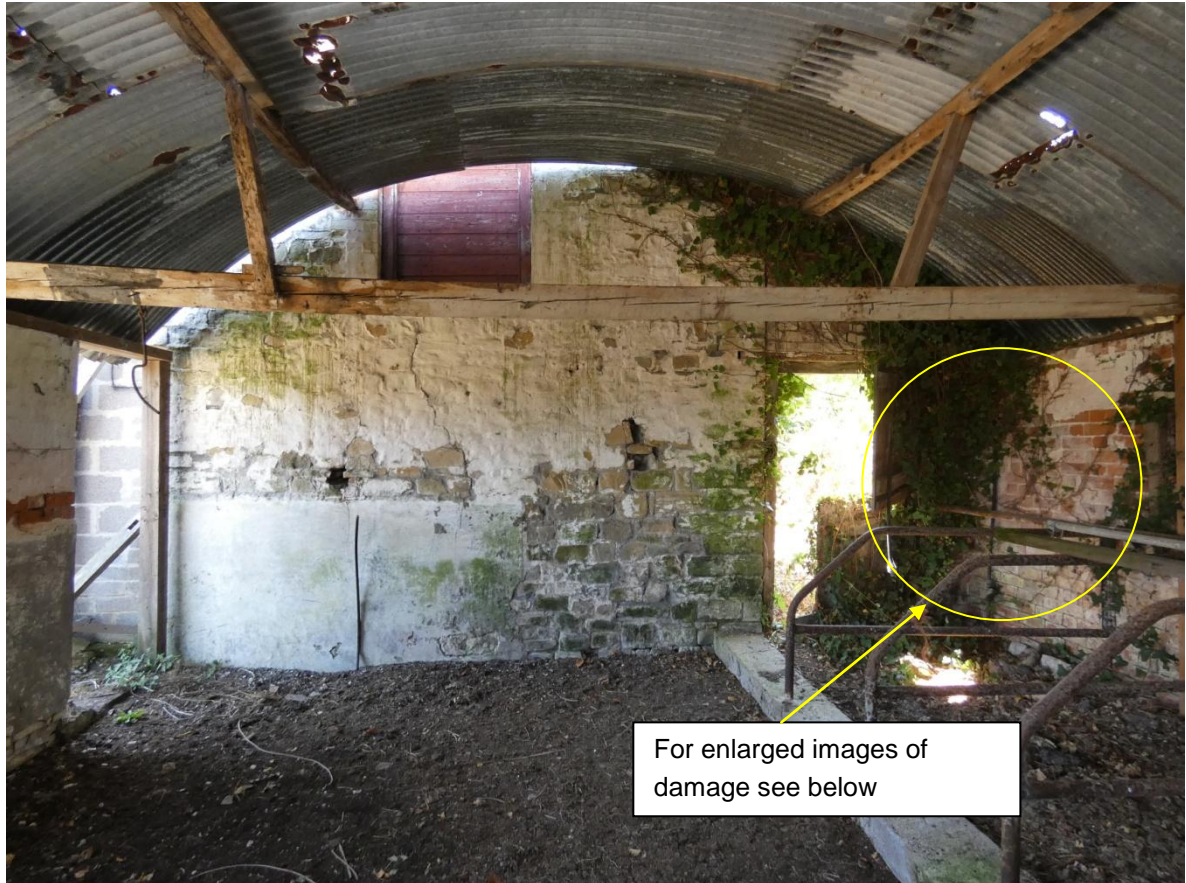
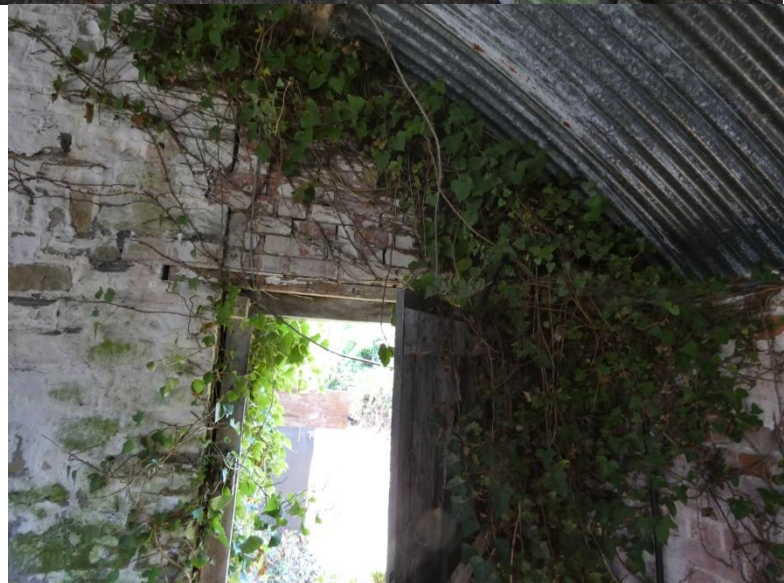
Photo 11 – Interior view – Internal partition - Viewed front toward rear - Inset haunch view

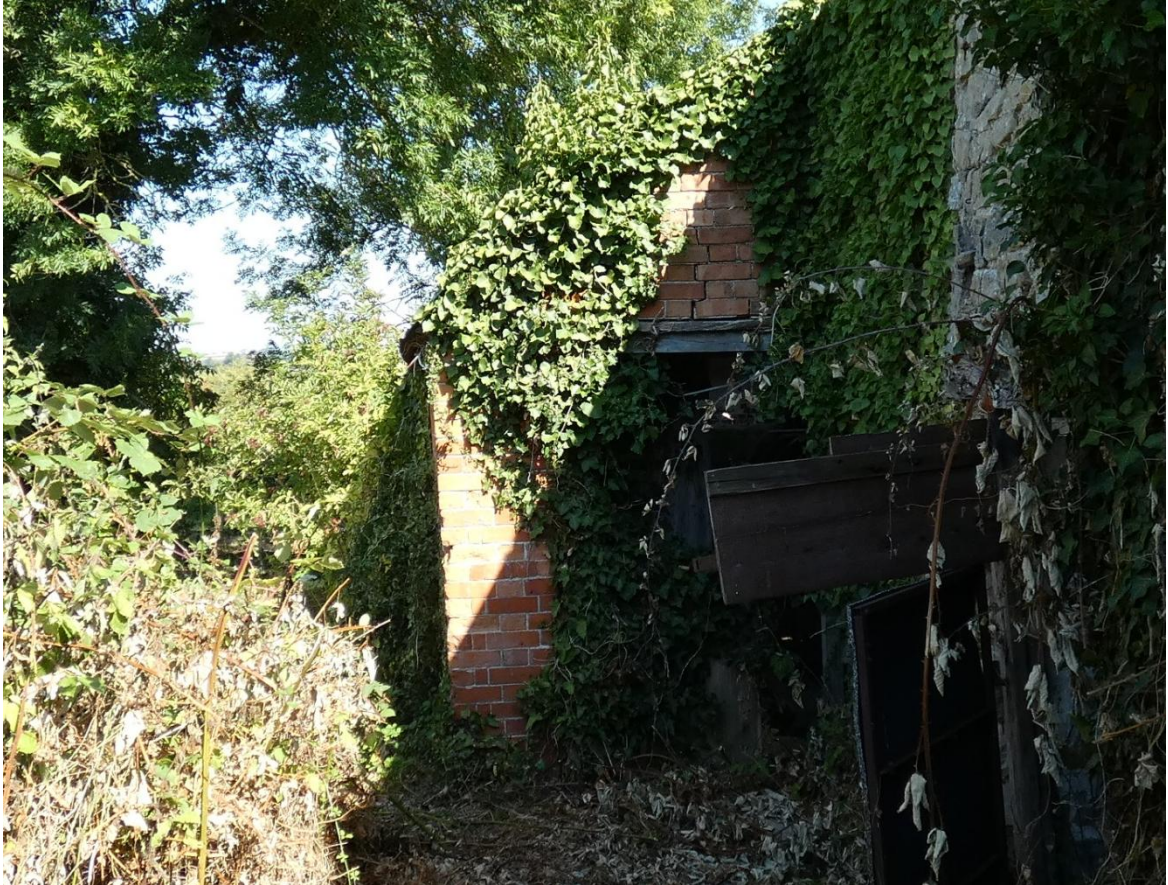
Photo 12 – Exterior view – South east corner cracking around door against Barn L

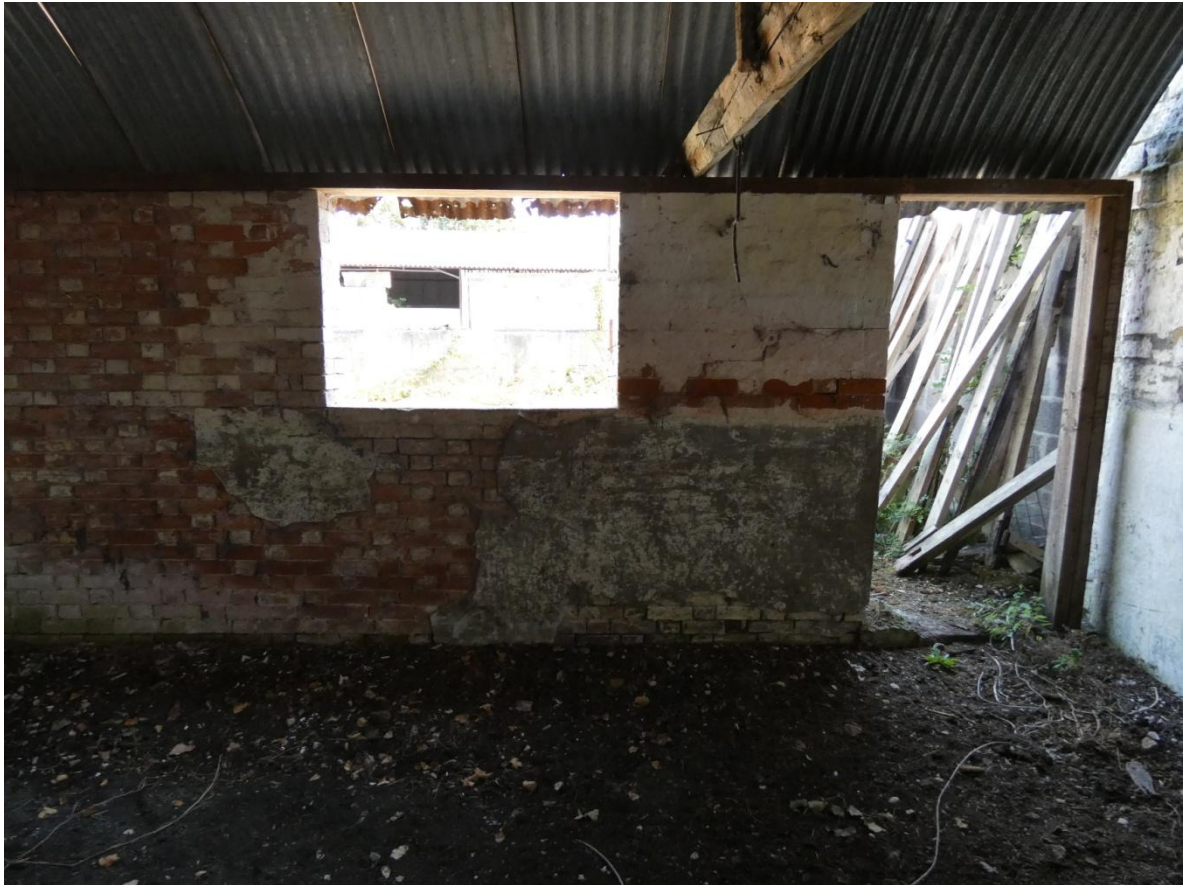
Photo 13 – Interior view – East elevation - Entrance near south east corner

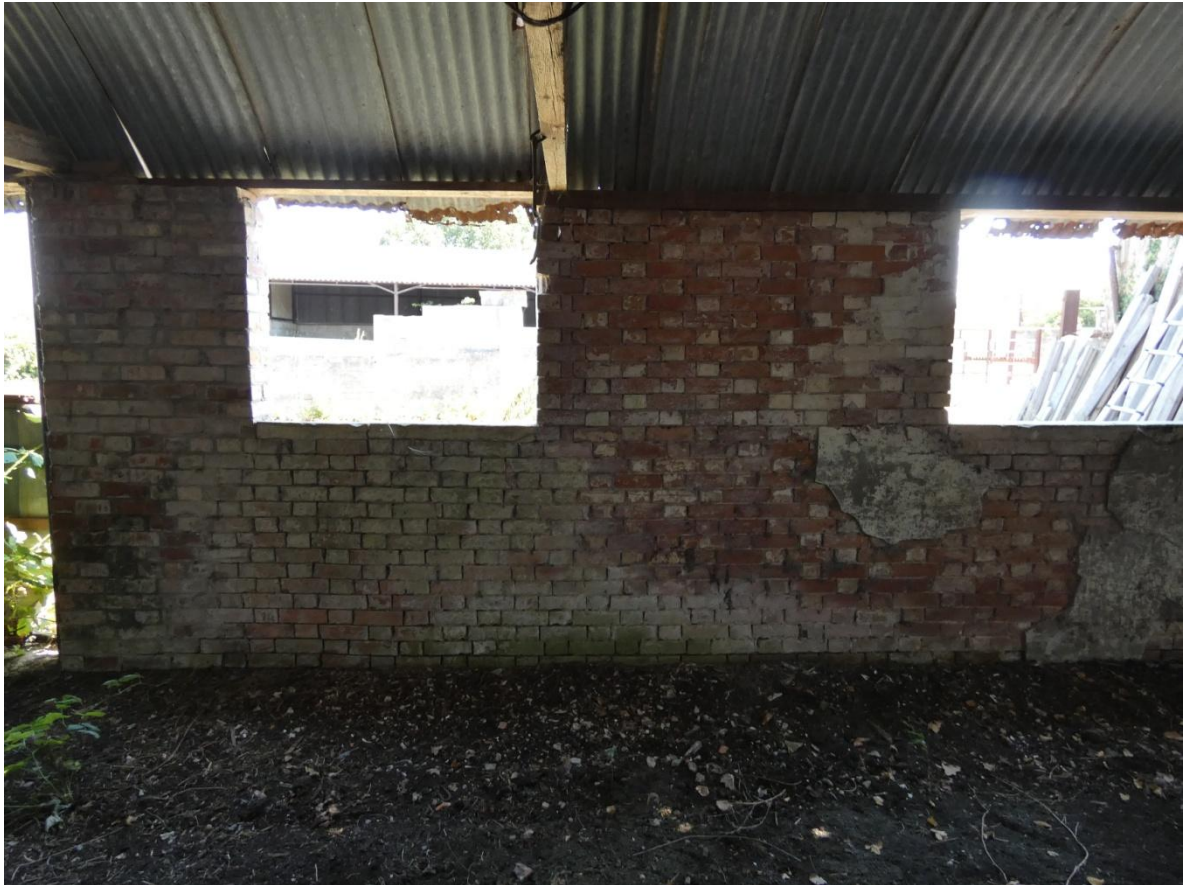
Photo 14 – Interior view – East elevation – Continued from Photo 13

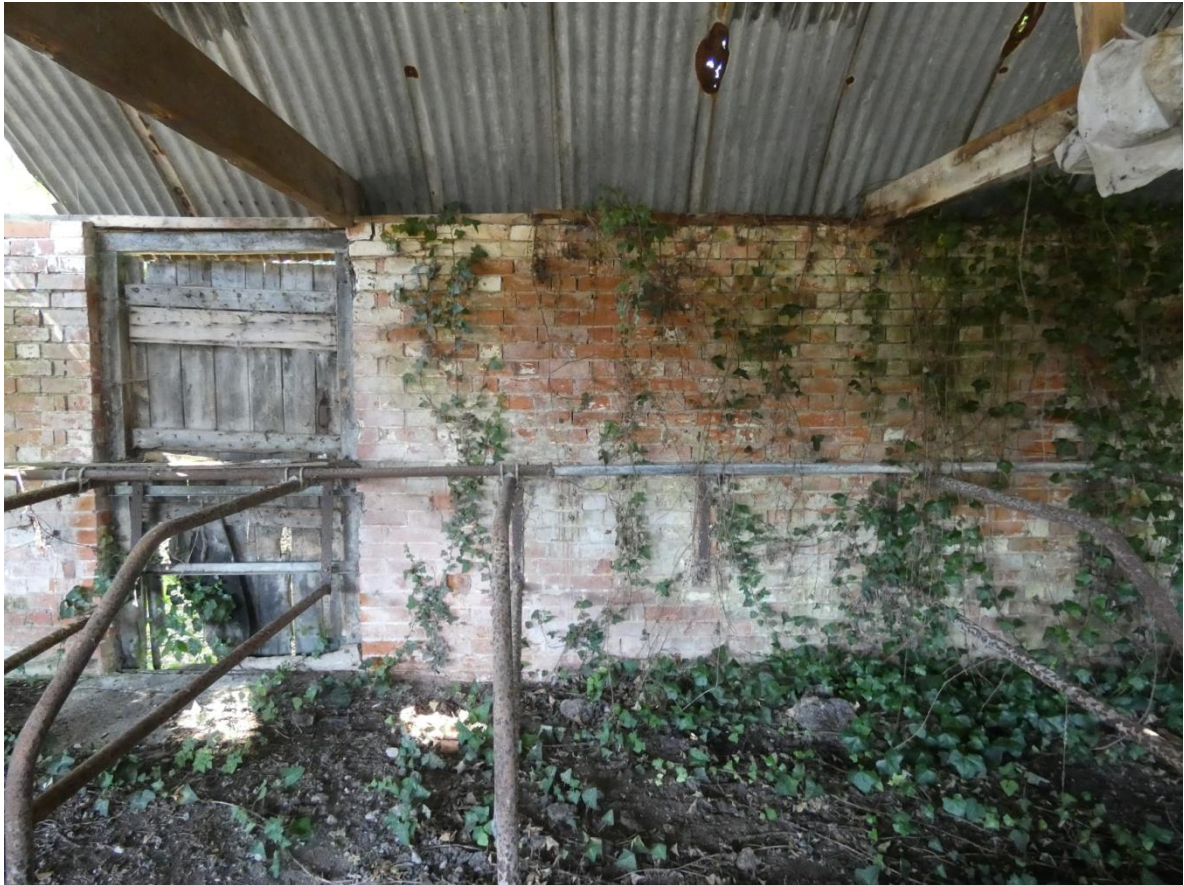
Photo 20 – Interior view – West elevation – Continued from Photo 19
