BARNS K, L, and M Report on a Visual Inspection of Proposed Barn Conversions Under Permitted Development (Class Q) at Rose Farm, Shapwick Road Westhay, Glastonbury, BA6 9TU for the T W Willcox Will Trust

- Version 2
- 26 September 2022

MBE REF-MBE-2021-025-Rose Farm Barns – KLM – v2

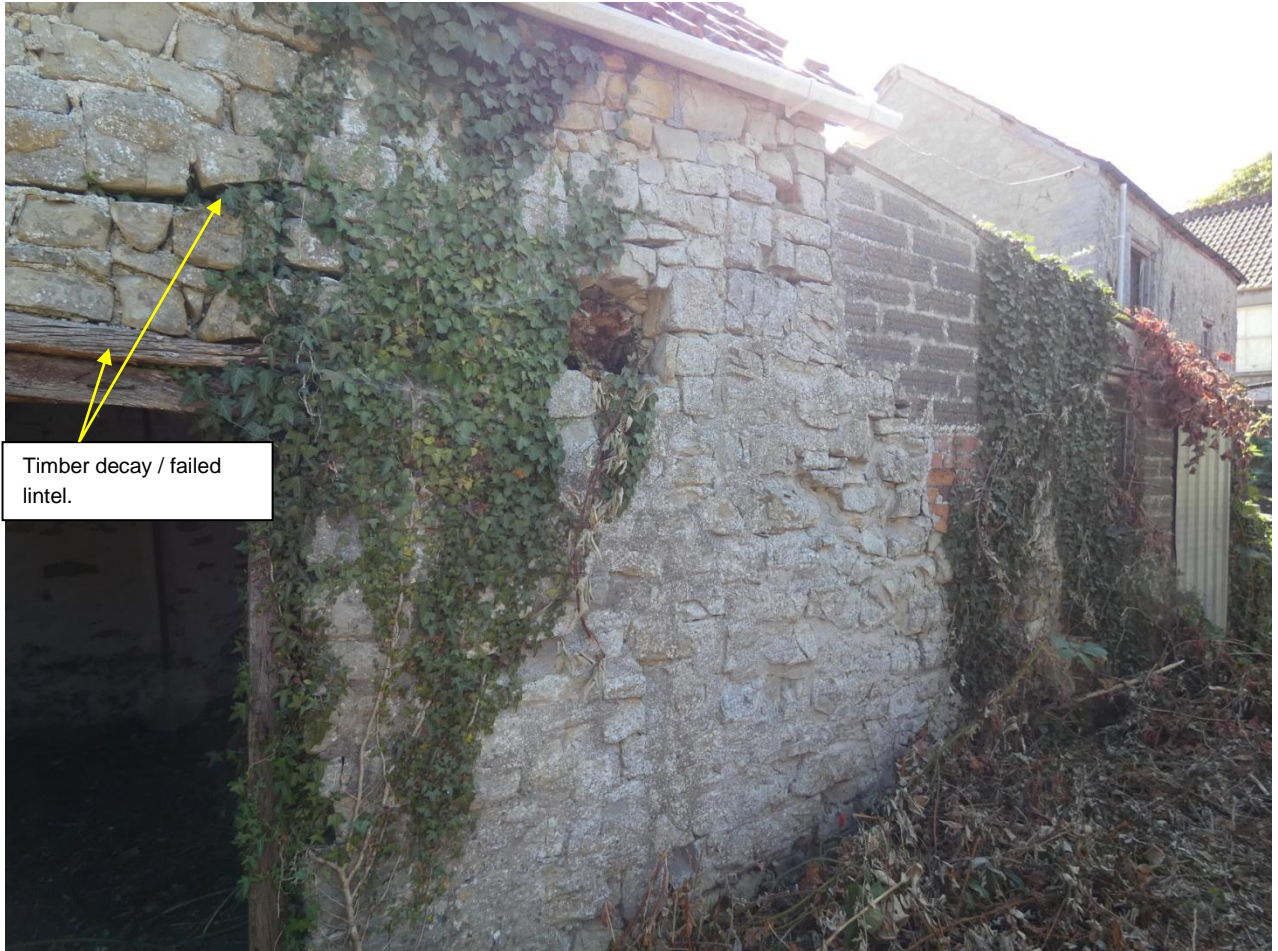
Photo 6 – Barn K / L – South west elevation - Looking south

Timber decay / failed lintel.

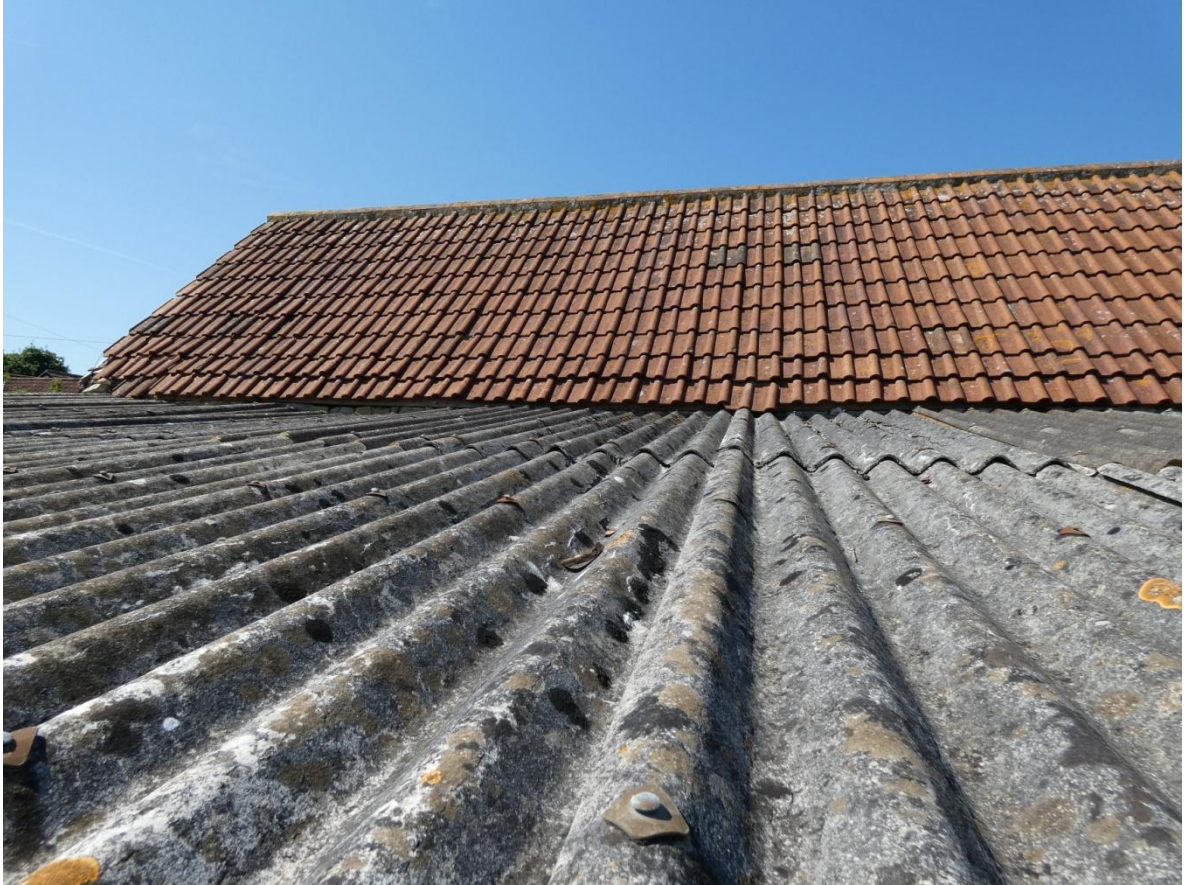
Photo 9 – Barn L / M roof – Viewed from east elevation of Barn M looking west

- 3.5.14 The roof timbers are generally showing signs of insect attack and timber decay. Some portions of the roof have collapsed where the lathings / battens carrying the roof tiles have decayed as shown on Photos 9 and 23 in Appendix A.

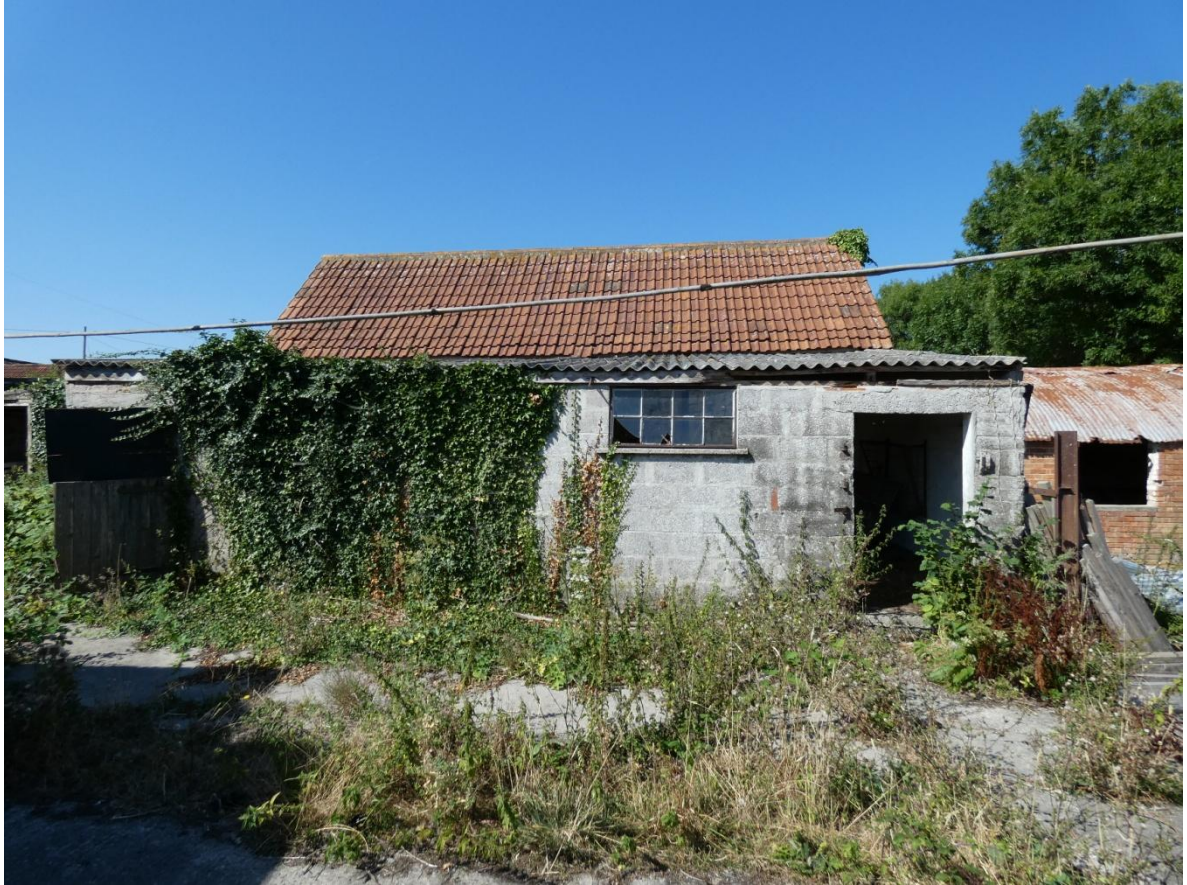
Photo 11 – Barn M east elevation – Viewed from yard looking west

- 3.5.19 A significant portion of the east elevation is overgrown with climbers that have established and damaged the roof and the masonry.
- 3.5.20 A c5mm wide vertical crack is evident in a blockwork pier located roughly midway along the west elevation. The damage may be reflected externally though the facade was cloaked with dense vegetation so it was not possible to confirm at the time of the inspection, as illustrated in Photos 11 and 31 in Appendix A.

- 3.5.22 The roof timbers are generally showing signs of insect attack and timber decay to the west elevation, near the north west corner. A lintel supporting a rafter over the northernmost window has locally failed. The fascia is rotten and almost completely decayed as shown on Photos 11 and 30 in Appendix A.

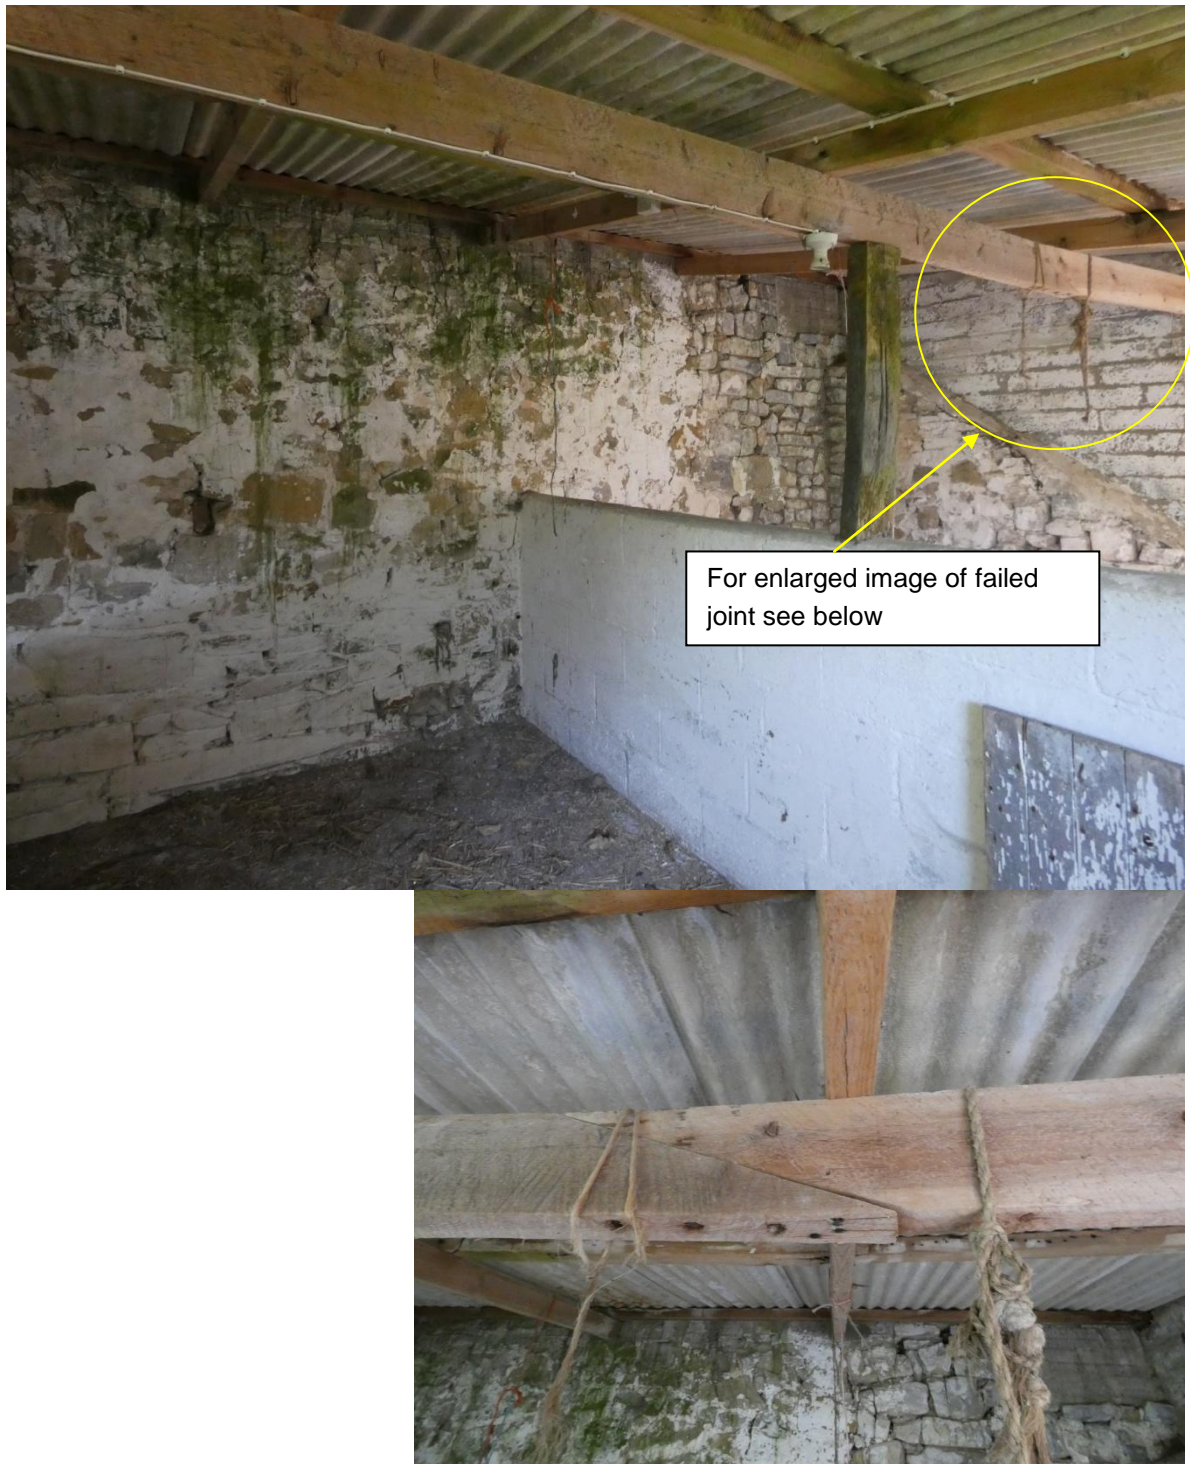
Photo 13 – Barn K interior – Looking to north east corner of Barn K

For enlarged image of failed joint see below

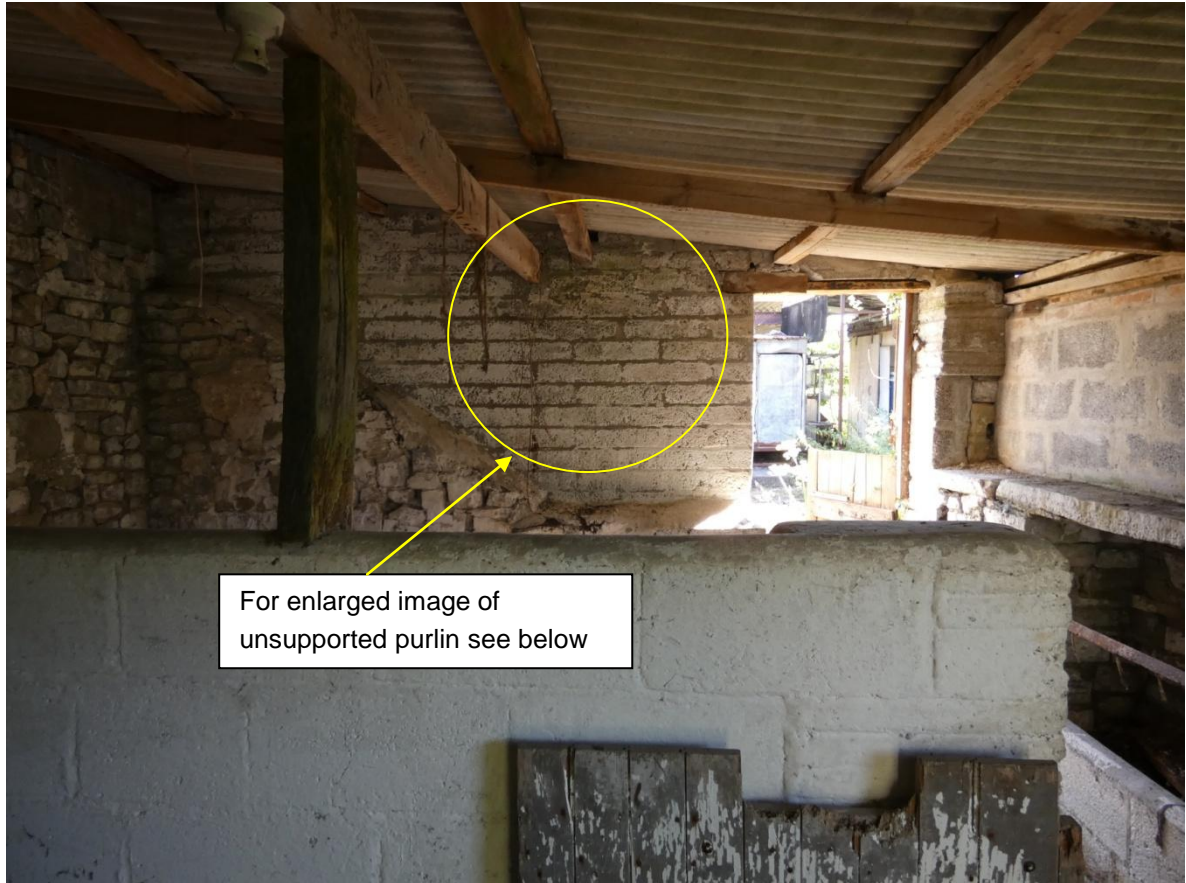
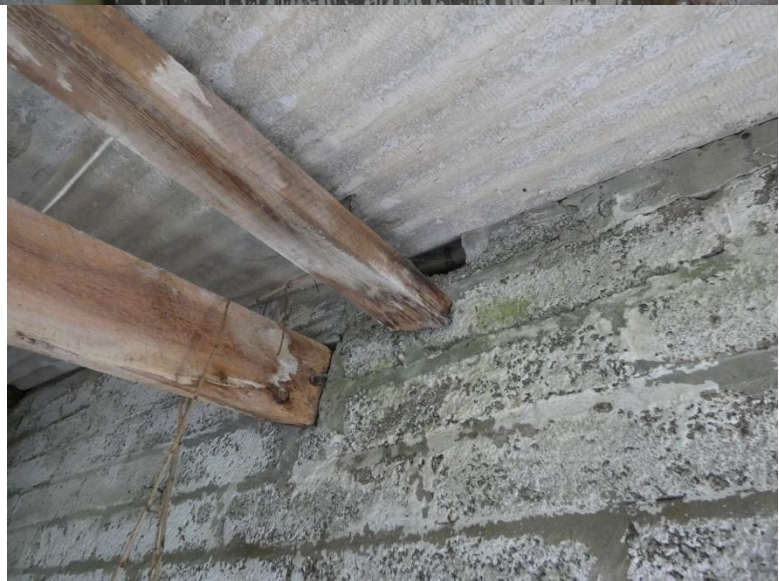
Photo 14 – Barn K interior – Looking to east elevation of Barn K

For enlarged image of unsupported purlin see below

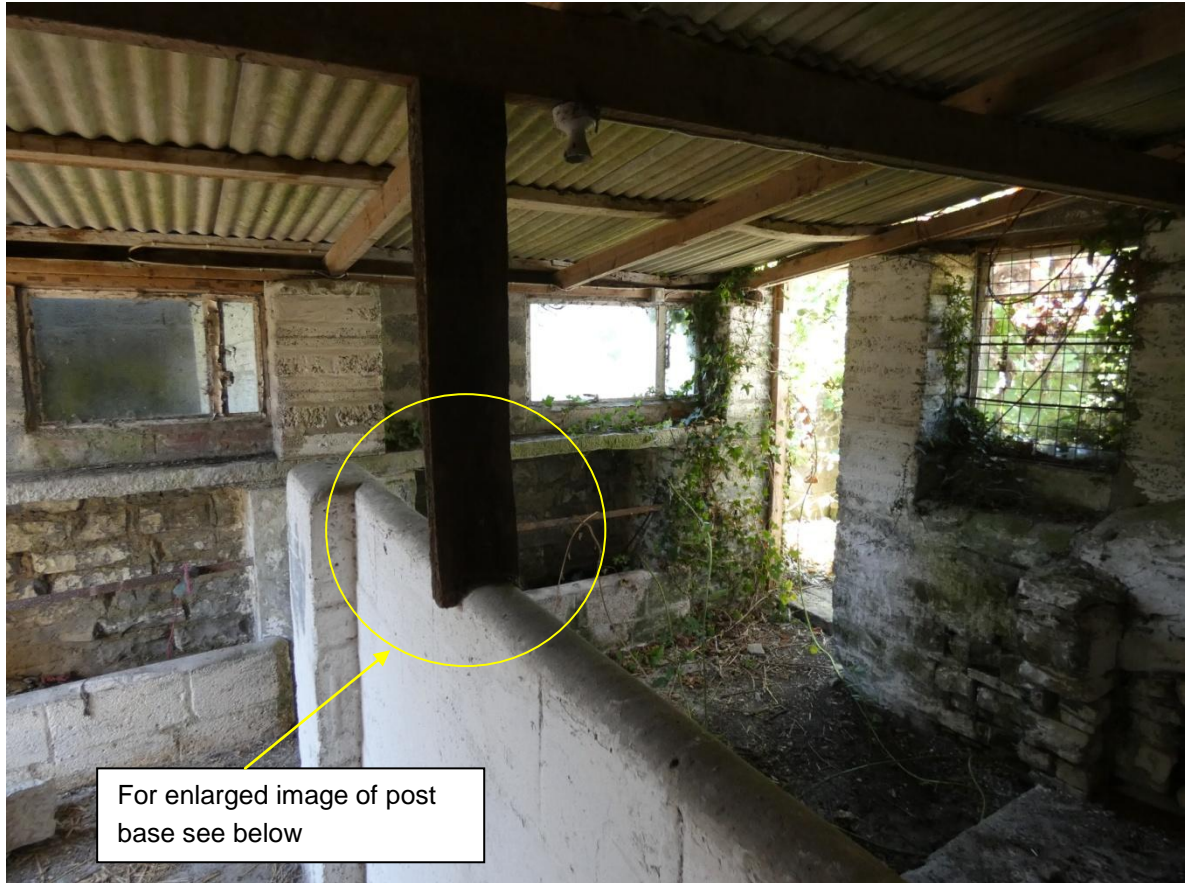
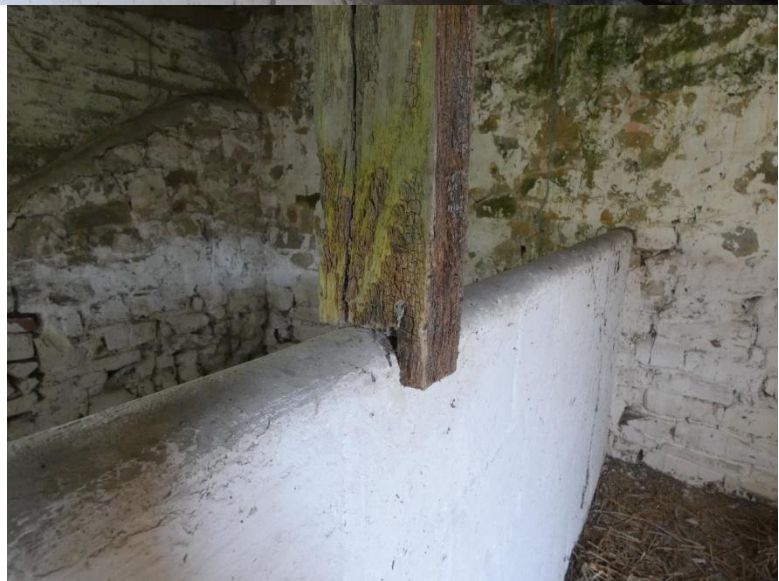
Photo 15 – Barn K interior – Looking to south west corner of Barn K

- 3.5.4 The intermediate post is inadequately restrained at the base where it is supported off the dwarf blockwork wall.
- 3.5.5 Generally the timber lintels have suffered from decay and insect attack and have failed.

For enlarged image of post base see below

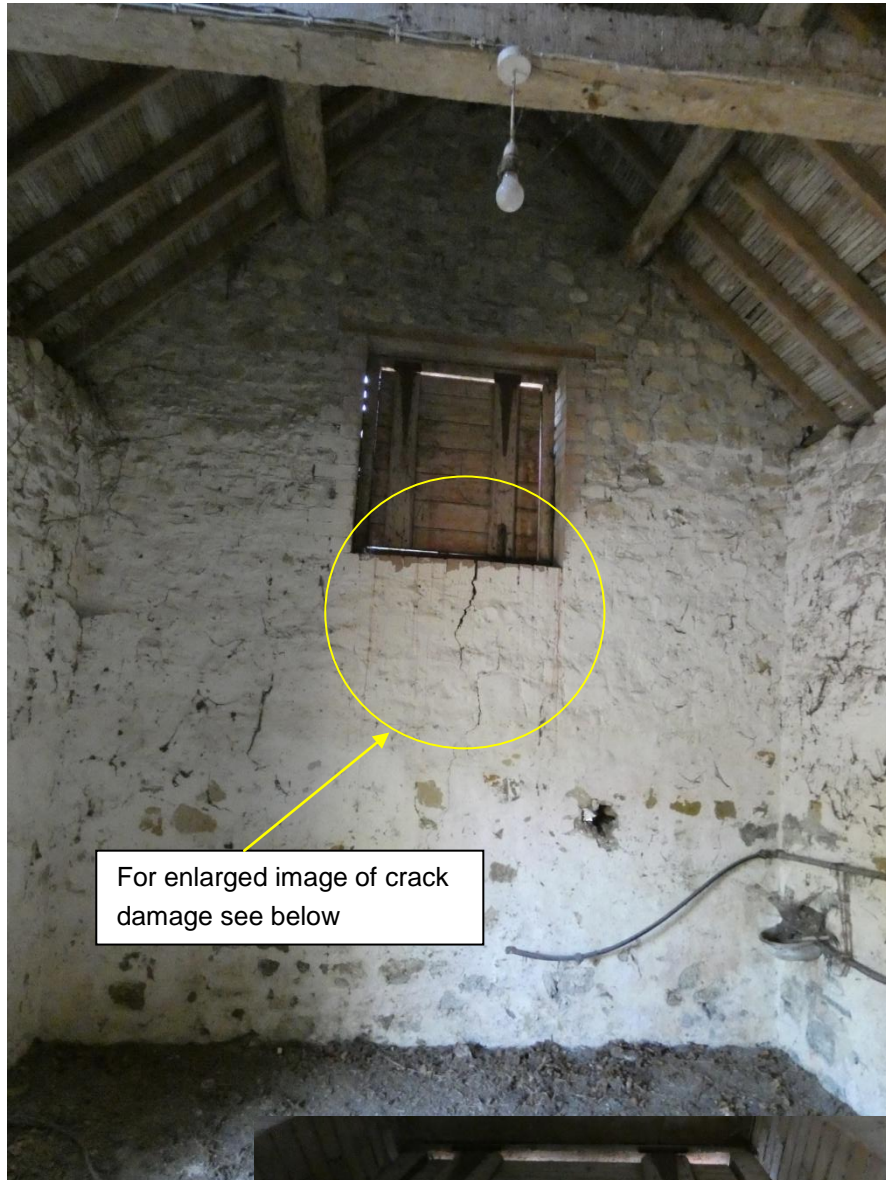
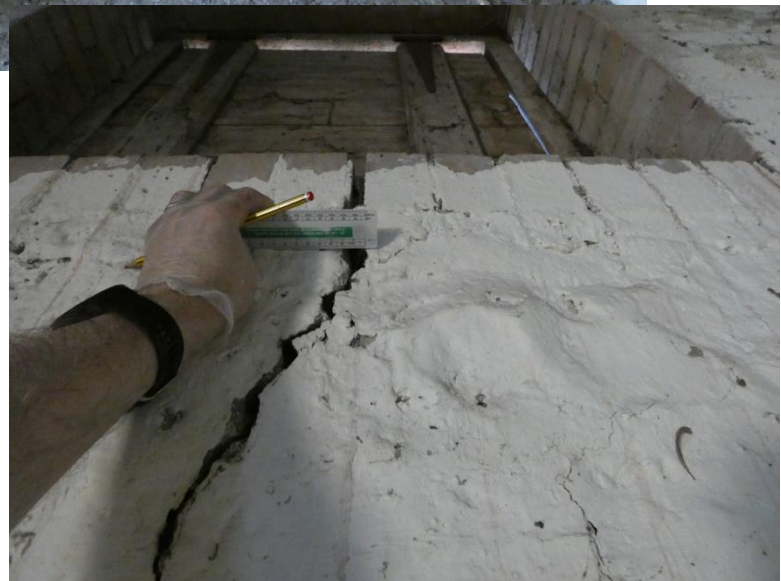
- 3.5.12 Crack damage to the walls is a maximum of 20 mm width through the stones and brickwork lining to the window located on the northern gable at high level and taper towards ground level where they are narrower (see Photo 20 in Appendix A). The magnitude of the crack damage would be categorised as being Category 4 (severe) in accordance with Table 1, of the Building Research Establishment Digest 251⁽¹⁾, which describes the damage in buildings by crack width.

Photo 20 – Barn L interior – North gable of Barn L – Suspected foundation related movement

- 5.2.10 The movement is such that the integrity of the walls is locally compromised and sections of the wall should have the joints raked out and cracks stitched together and some units locally replaced; especially where masonry is displaced and bulging.

- 5.2.11 The cracks to the walls should be stitched together with stainless steel helical masonry reinforcement to reinstate the structural integrity.
- 5.2.12 The soil state should be checked prior to repair. Recovery (reduction in crack widths) might occur, though heave can be a slow process; the ground conditions should therefore ideally be checked to see if there is a persistent moisture deficit in the soils below the foundations at locations around the left hand corner of the barn, prior to repair. Underpinning may be required.

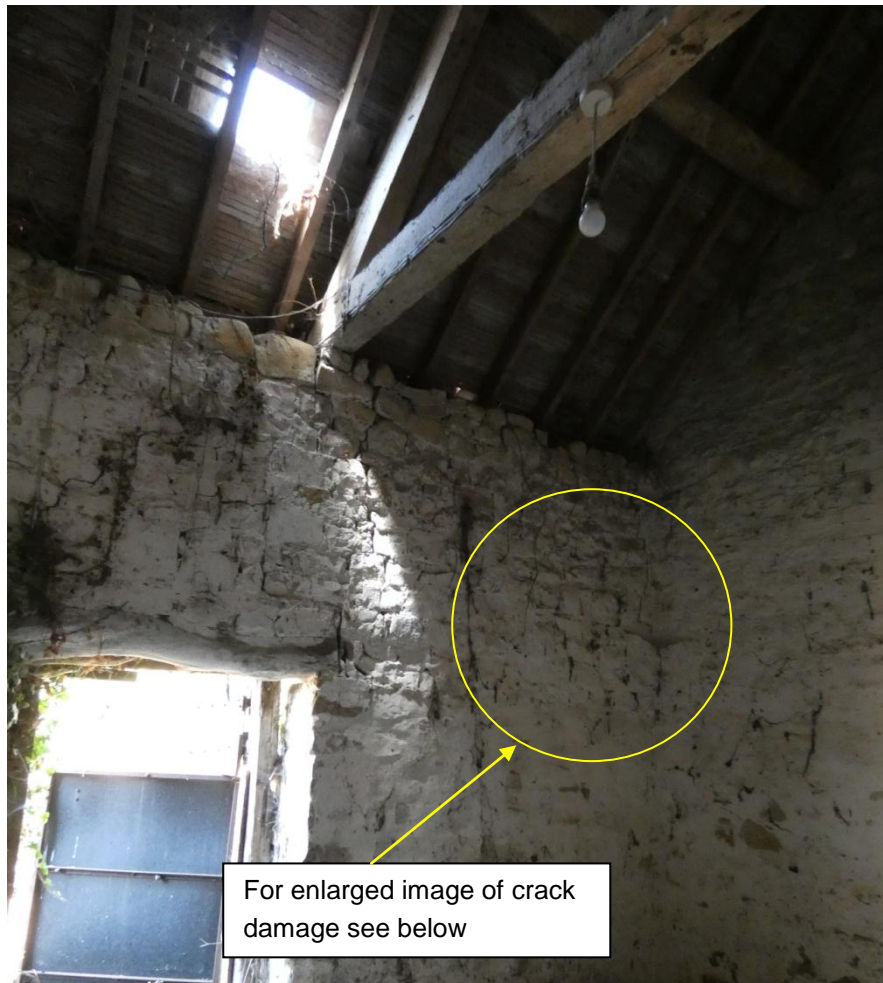
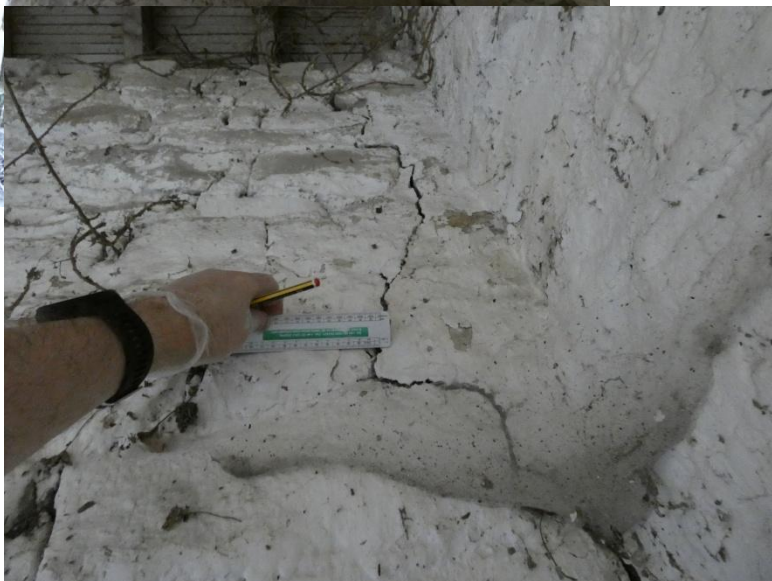
Photo 23 – Looking to north west corner of Barn L – Suspected foundation related movement

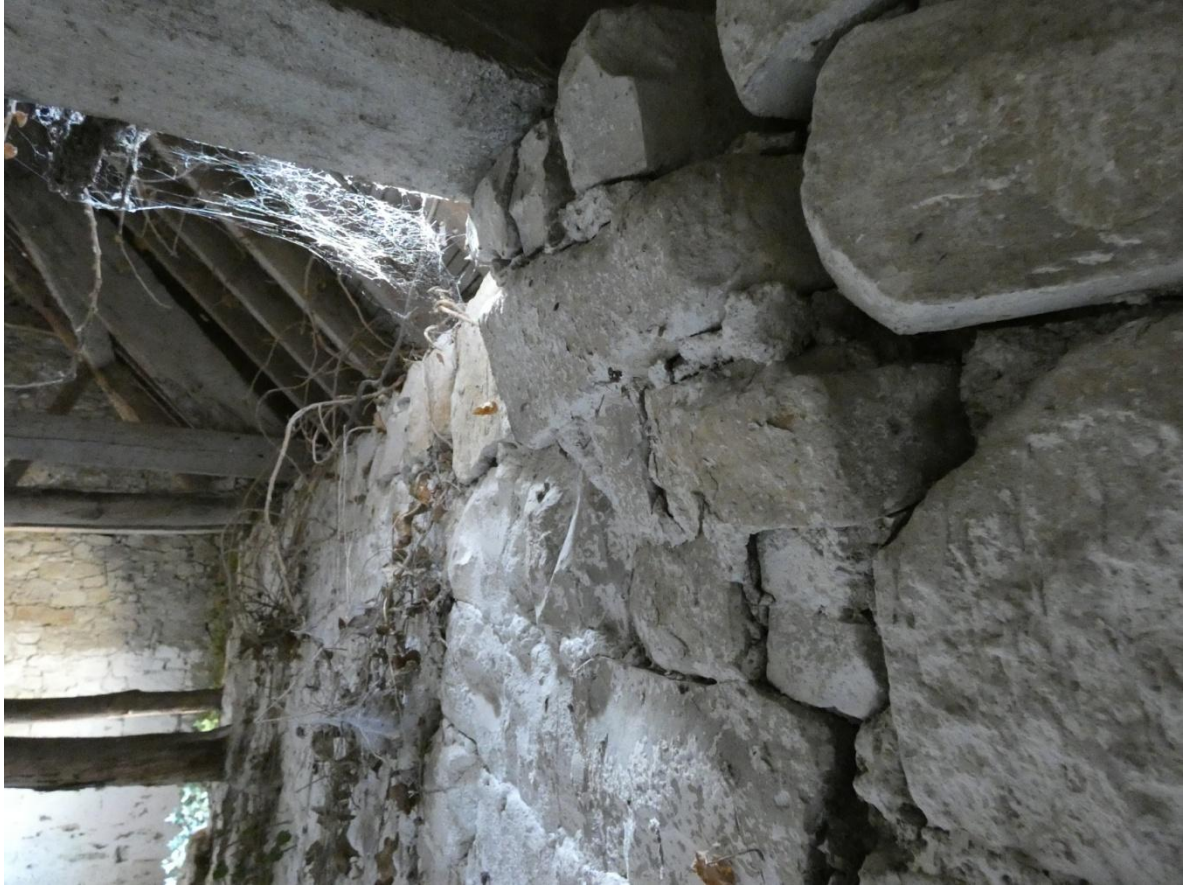
Photo 24 – Barn L – Truss bearing adjacent north west corner – Masonry displaced
