SOLVING CHIMNEY PROBLEMS

Job Reference: 2022136ii

Ref: Rossley Manor, London Road, Cheltenham. GL54 4HG

CCTV Inspection
at
Rossley Manor
London Road, Cheltenham. GL54 4HG

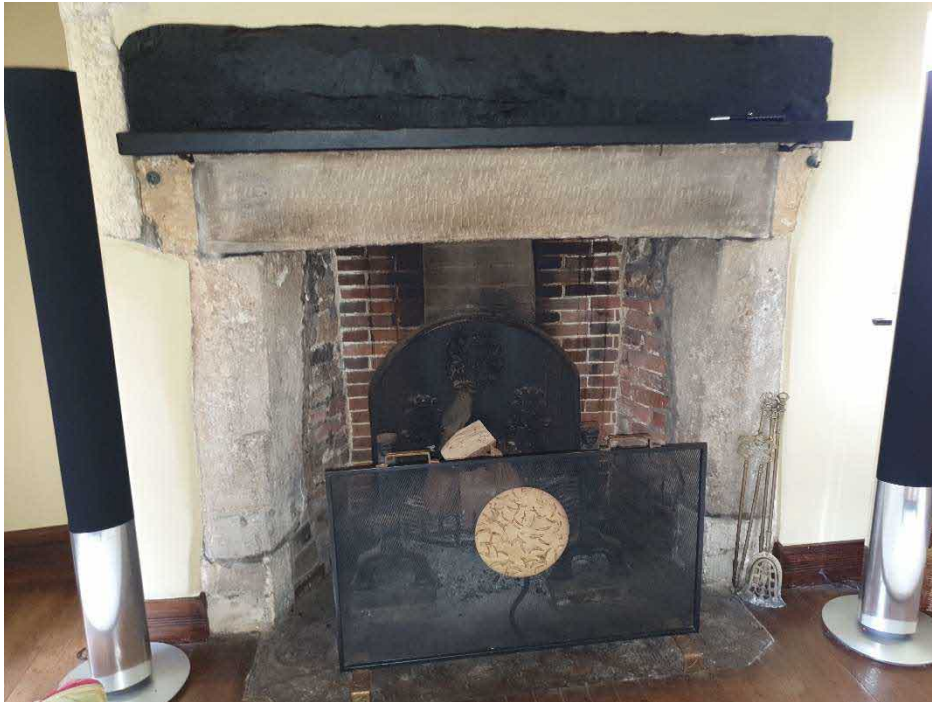
1. Drawing Room 1

- 08:43:01 There is a small section of creosote that has run down the rear of the fireplace.
- 08:43:16 The top of the chimney outlet can be seen, shown as a small circle of light. This gives an indication of how straight and unobstructed the flue is.

- 08:43:40 The CCTV camera has entered the base of the flue, measuring 1120x512mm. Due to the large size of the flue this gives a poor view for the CCTV camera. The Flue is in an original unlined condition.

- 08:44:21 There are loose carbon waste deposits lining the flue wall.
- 08:44:37 There are creosote deposits lining the flue wall.
- 08:45:23 The mortar joint has failed and receded into the masonry creating a significant hole.

- 08:46:25 There is an original, wrought iron hang nail in the flue wall. This is 3000mm from the base of the flue.
- 08:47:12 The flue wall is broken and uneven with large depressions and cavities in the masonry.

- 08:48:35 There is a deposit of creosote on the flue wall.
- 08:52:07 The CCTV camera has reached the top of the flue measuring 7910mm in length. There is a type of electronic fan installed on the exterior of the chimney stack.

Although it is reported that the flue has been recently swept there are still significant deposits of tar and creosote in the flue wall. This will require properly clearing prior to any future lining or re-use of the flue.

Currently there is a chimney fan fitted to the head of the flue. However the size of the flue in the external chimneystack is such that the fireplace should draw naturally without the aid of a fan. It is our belief that the fan was fitted at the flue was restricted as it passes through the capping at the head of the flue. Therefore if this fan is removed, and the capping altered for a suitable liner there is a very good probability the fireplace will draw naturally.

The condition of the flue is unlined, and the original masonry and mortar joints are exposed. These are failing in areas and therefore it is recommended that the flue is relined with a suitable liner for safe re-use.

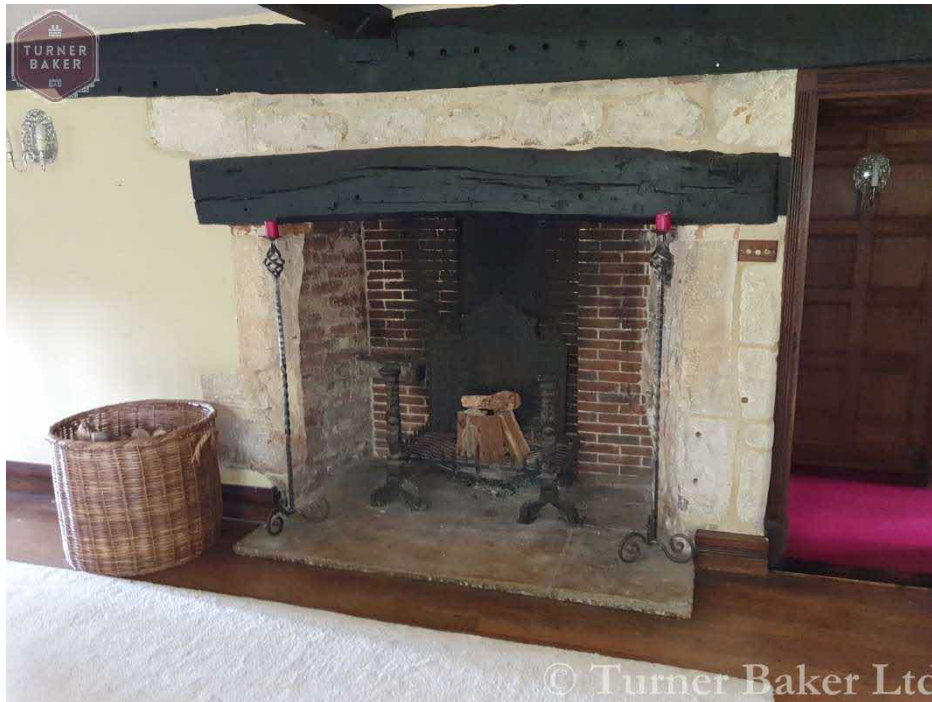
2. Drawing Room 2

- 09:45:33 The bottom right side of the fireplace/flue has signs of structural movement. The blockwork is loose and can easily be pulled out with some masonry missing already.

- 09:46:01 The CCTV camera has entered the base of the flue, measuring 1450x600mm. Due to the large size of the flue this gives a poor view for the CCTV camera. The Flue is in an original unlined condition.

- 09:46:35 The flue wall is broken, uneven and showing signs of age-related wear. There are creosote deposits on the flue wall throughout this whole area.

- 09:49:23 The flue outlet is significantly reduced in size compared to the dimensions of the flue. estimated at 350x350mm.
- 09:54:16 The CCTV camera has reached the top of the flue outlet with the CCTV camera measuring 8020mm from the ground floor level.

Although it is reported that the flue has been recently swept there are still significant deposits of tar and creosote in the flue wall. This will require properly clearing prior to any future lining or re-use of the flue.

The condition of the flue is unlined, and the original masonry and mortar joints are exposed. In areas there is loose masonry that will need to be removed or stabilised before any remedial work is undertaken. Once this is done it is recommended that the flue is relined with a suitable liner for safe re-use.

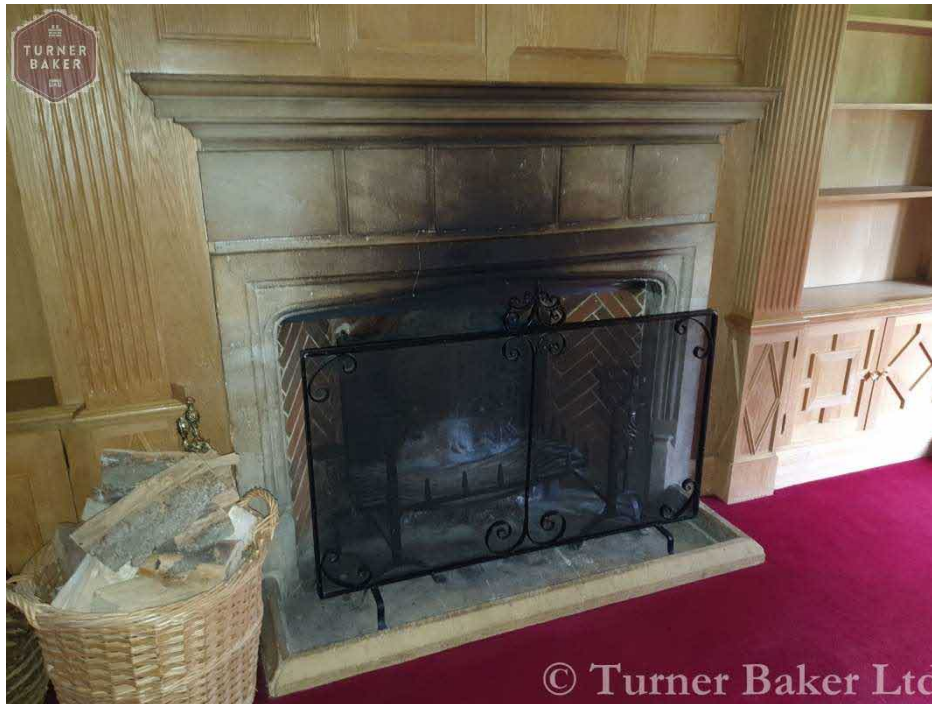
3. Sitting Room

- opening, this is to aid in the draw of the fireplace by reducing the opening measurements of the fireplace.
- 10:37:40 The top of the chimney outlet can be seen, shown as a small circle of light. This gives an indication of how straight and unobstructed the flue is.
- 10:37:42 The flue is unlined and in an original condition, The flue dimensions reduce to 277x277mm. There are multiple small creosote deposits visible on the flue wall.
- 10:39:27 The flue wall is showing signs of age-related change and deterioration. There is a build-up of carbon waste on the flue wall.
- 10:41:29 There is a build-up of carbon waste and creosote on the flue wall.
- 10:42:22 The CCTV camera has reached the top of the chimney outlet. Measuring 7810mm from the ground floor level. There is a rotary stainless-steel cowl installed used to aid in the draw of the fireplace.

Although it is reported that the flue has been recently swept there are still significant deposits of tar and creosote in the flue wall. This will require properly clearing prior to any future lining or re-use of the flue.

At the head of the flue there is a 200mm dia pot and rotating cowl fitted. This pot and cowl arrangement is too small for the existing opening size and is the probable cause of the visible spillage from the open fire. It is therefore recommended that these are removed, and the head of the flue opened up back to its original size. There is a high probability that if this is done, in conjunction with a large diameter liner the fireplace will draw naturally.

The condition of the flue is unlined, and the original masonry and mortar joints are exposed. There is visible damage to this structure over the length of the flue and therefore it is recommended that the flue is relined with a suitable lining process before the flue is reused.

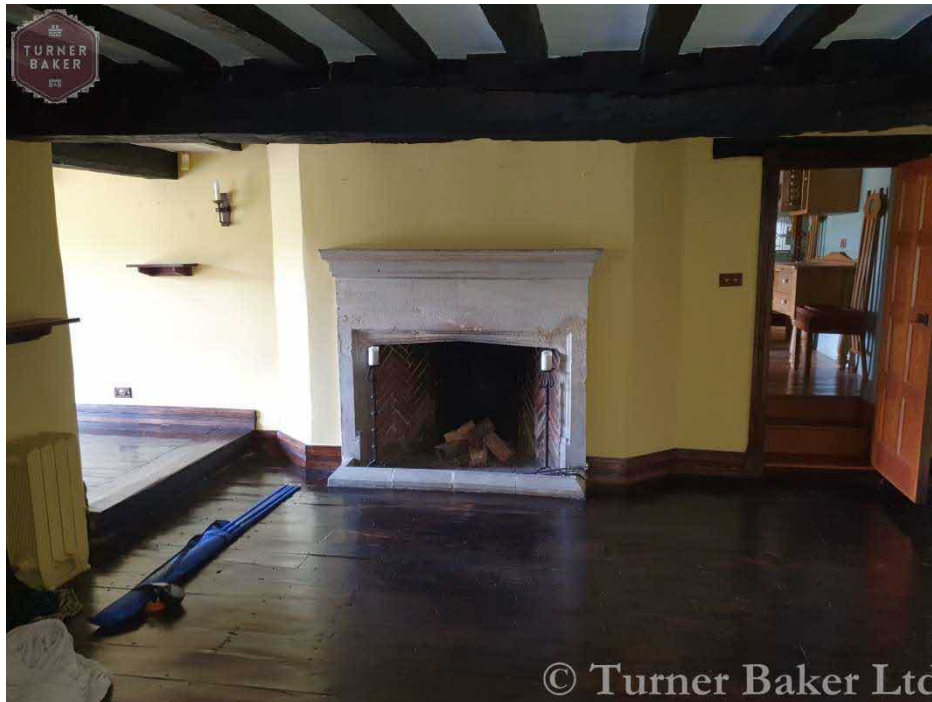
4. Dining Room

- 11:12:55 The flue is unlined and in an original condition. The flue dimensions reduce to 427x389mm.
- 11:13:13 The top of the chimney outlet can be seen, shown as a small circle of light. This gives an indication of how straight and unobstructed the flue is.
- 11:15:05 There is a build up carbon waste and detritus deposits on the flue wall. Very little of original masonry flue can be seen through the build-up of waste.
- 11:18:27 The CCTV camera has reached the top of the chimney outlet, measuring 9170mm from the ground floor level The masonry is exposed over this section with recessed mortar joints. The top of the flue outlet has a stainless-steel mesh installed to stop bird access into the flue. There is nothing to reduce water ingress into the flue.

Although it is reported that the flue has been recently swept there are still significant deposits of tar and creosote in the flue wall, which made the inspection of the flue difficult. These deposits will require properly clearing prior to any future lining or re-use of the flue.

The condition of the flue is unlined and the original masonry and mortar joints. Where visible at the head of the flue, are exposed. There is visible damage to this structure, and it is assumed the condition is the same over the remaining length of the flue, and therefore it is recommended that the flue is relined with a suitable lining process before the flue is reused.

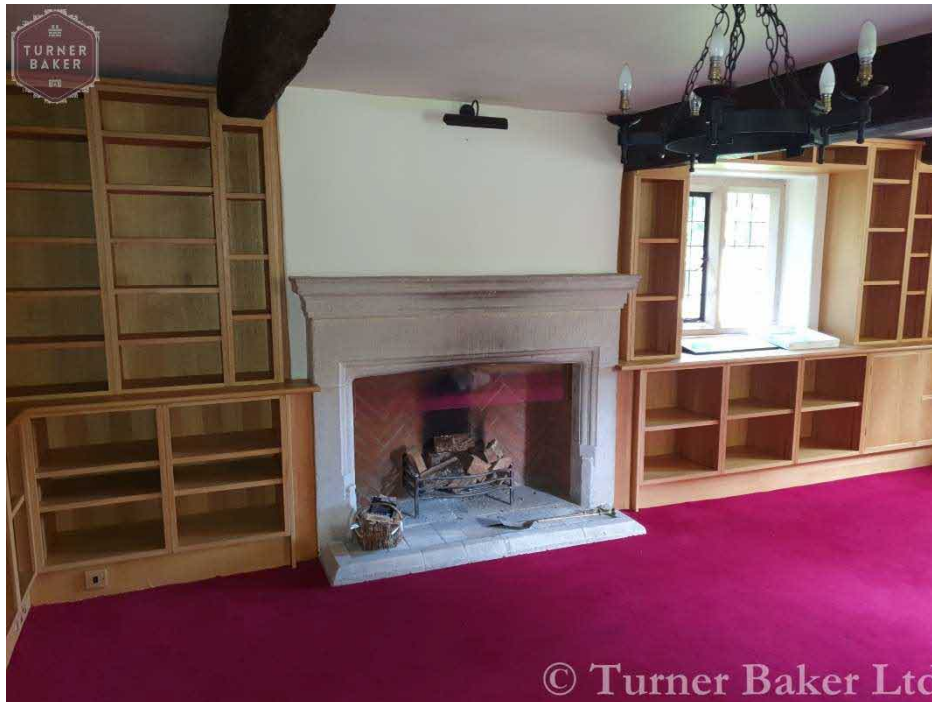
5. Library

- 12:22:03 There are 255mm diameter clay liners installed into the masonry flue. The age of the clay flue liners is unknown.
- 12:22:14 The connection between the base of the flue liners and the gather is heavily damaged with a clear breach to the exterior of the flue liners.

- 12:22:39 Severe damage to the connection between the base of the flue liners and the gather.
- 12:25:14 The mortar joint connecting the two liner pieces has failed and fallen away.

- 12:26:23 The mortar joint is poor and receding, although still intact.
- 12:26:39 The mortar joint connecting the two liner pieces has failed and fallen away.

- 12:27:05 The mortar joint is poor and receding, although still intact.
- 12:28:49 The clay liners do not run the full length of the masonry flue and so is only partially lined.

- 12:30:51 The CCTV camera has reached the top of the chimney outlet. Measuring 8120mm from the ground floor level. The top of the flue outlet has a stainless-steel mesh installed to stop bird access into the flue. there is nothing to reduce water ingress into the flue.

The flue is currently lined using 225mm i/d clay liners. these liners are poorly installed with gaps visible between the liners. the liners also do not extend to the head of the flue, leaving an unlined section at the head.

The liners are too small for the existing fireplace and will cause the fire to spill, even with the glass reducer in place.

It is therefore recommended that the existing liners are mechanically removed, which would leave a void approx. 275mm in dia. This void could then be lined with a larger diameter liner. However even with a flue diameter of 275mm there is a risk that the fire will spill, and a chimney fan may have to be considered.
