D22089 Window Condition report School House Ninebanks, Hexham NE47 8DB
4 no Dormer Window Frames to the first floor of Front and Rear Elevations

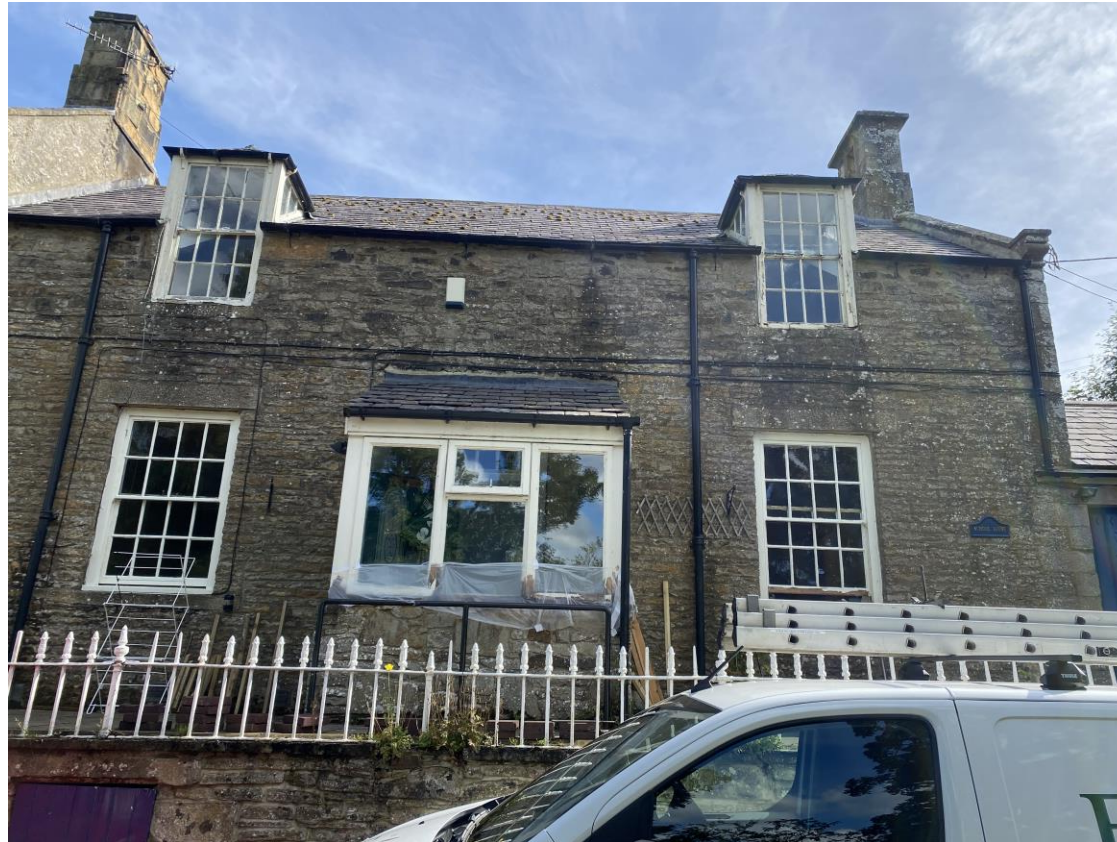
Front Elevation 2 no Dormer Windows

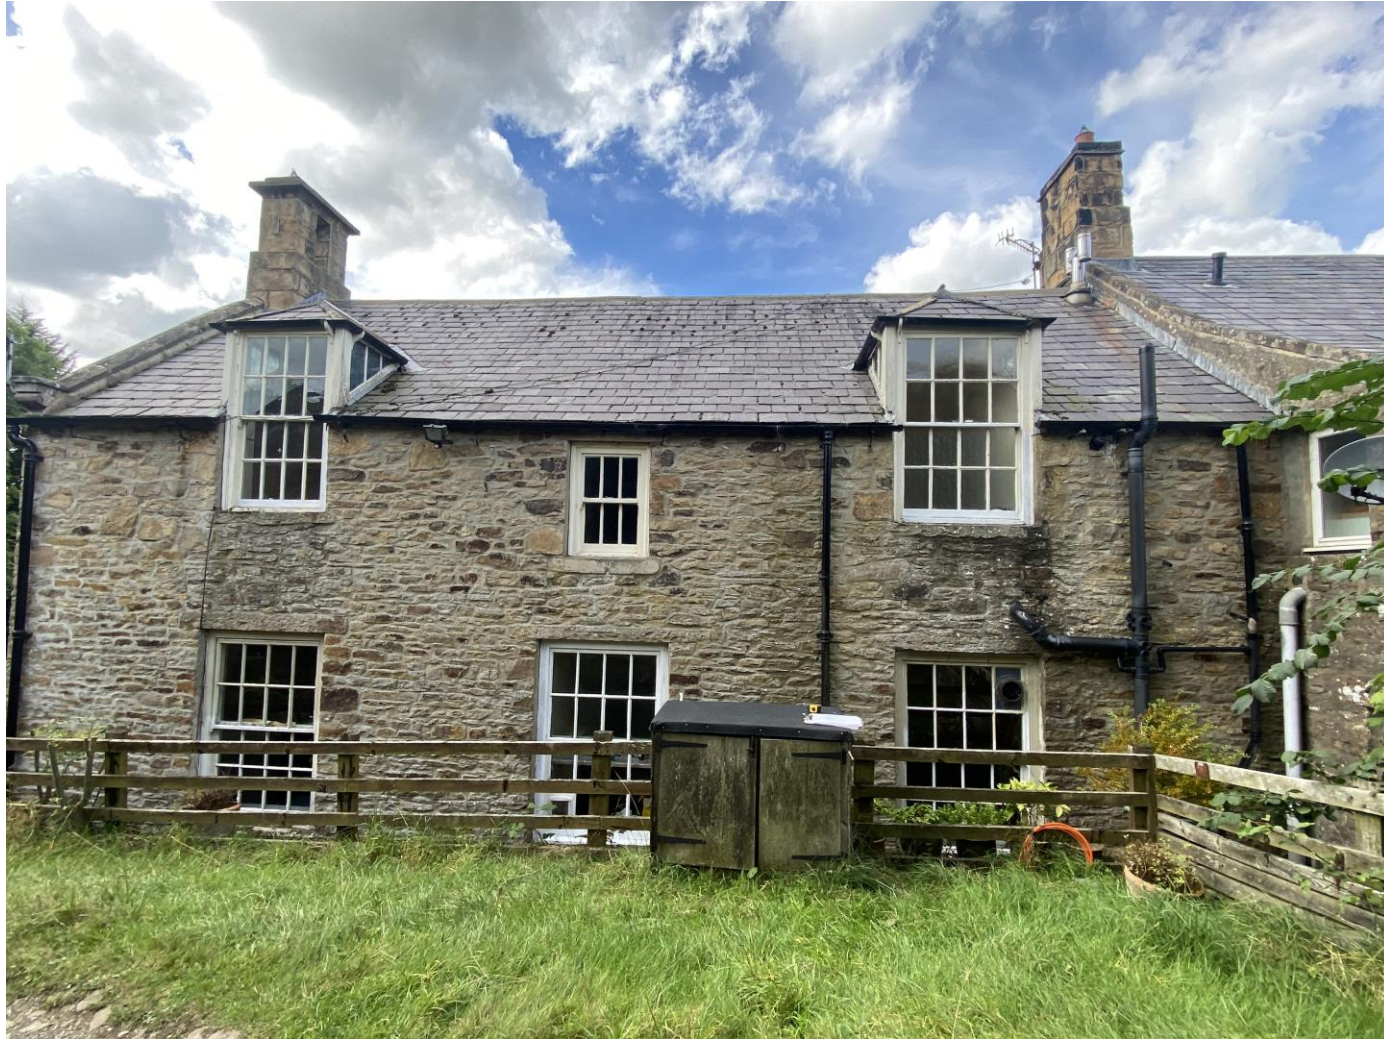
Rear Elevation 2 no Dormer Windows

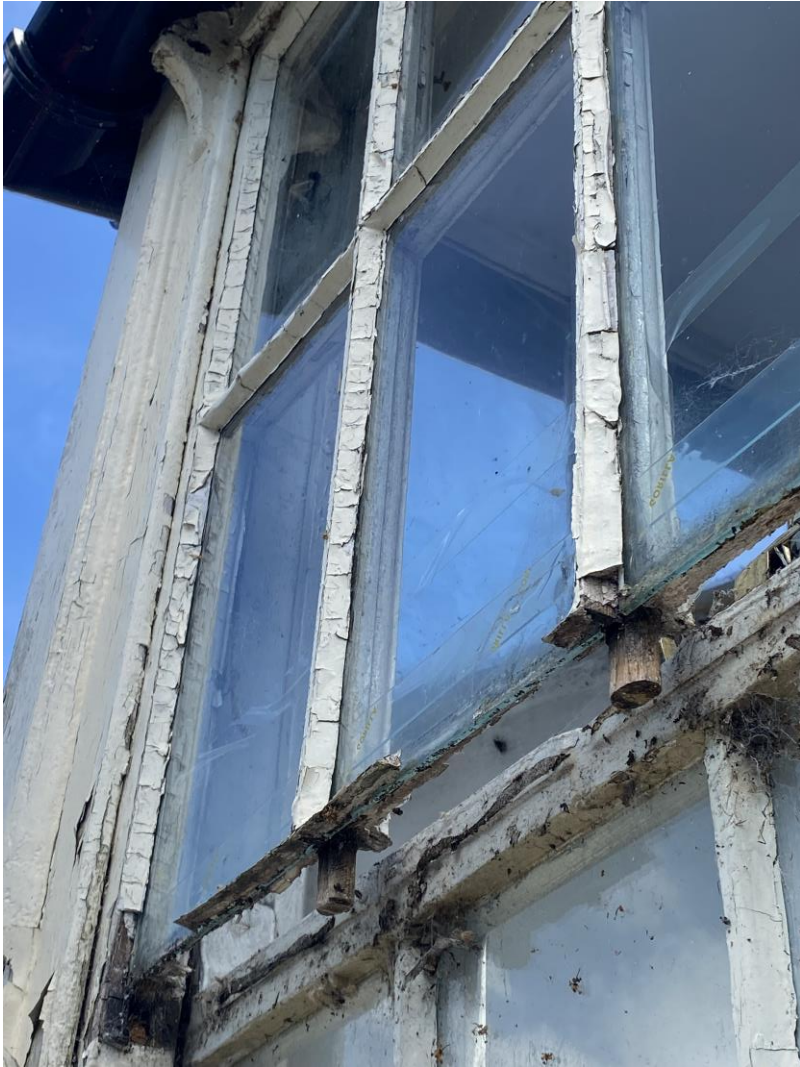
Missing bottom rail of top sash caused by water ingress and wet rot due to poor maintenance and repairs.

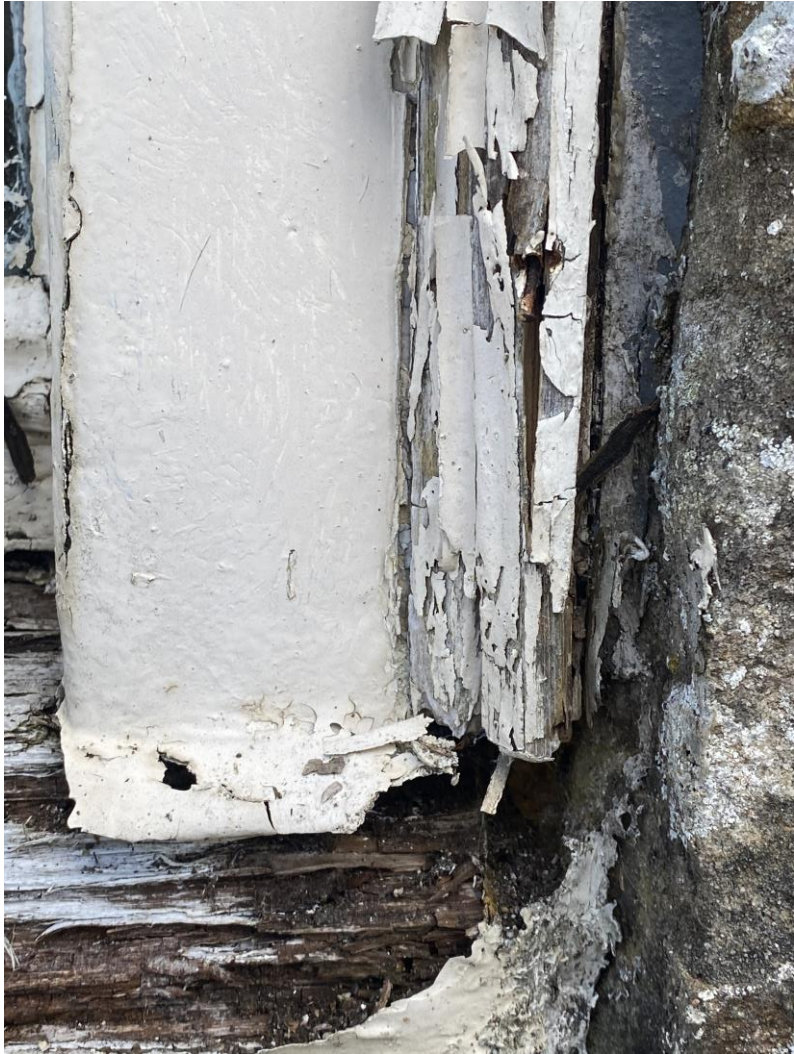
Decayed outer cheek and external sill

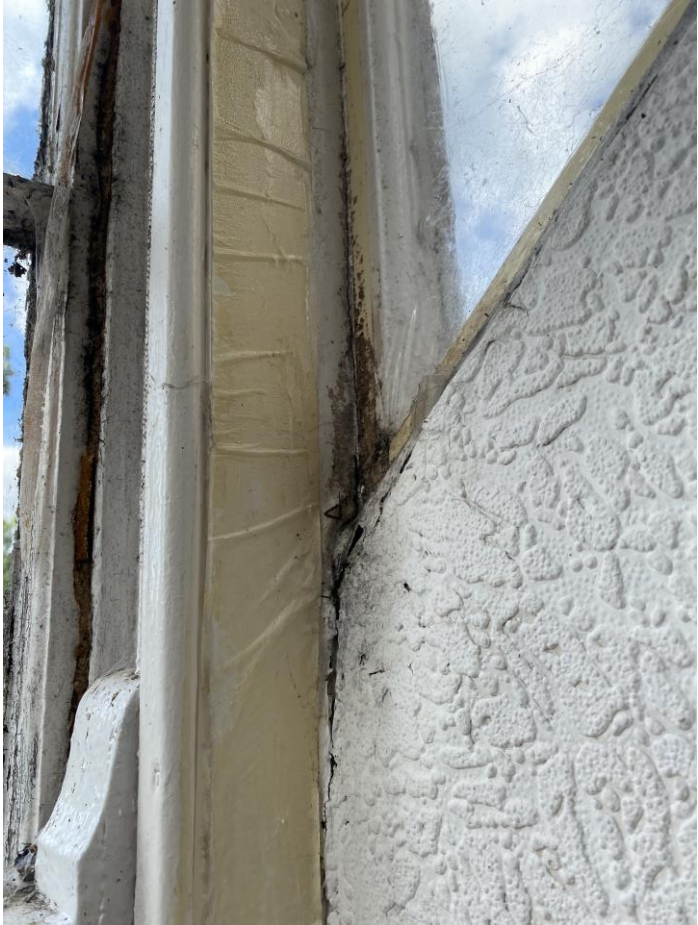
Failed tenon joints to the lower sections of side returns due to water ingress

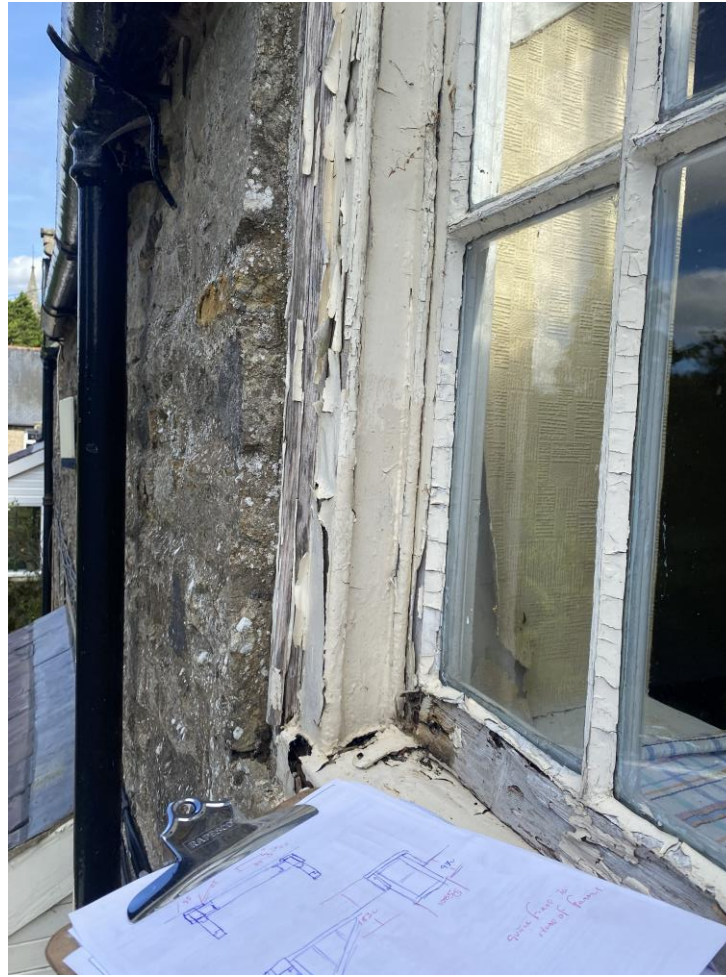
Outer cheek, sill and bottom rail of sash showing decay. Failed tenon joints on bottom sash. Lower section of outer cheek missing.

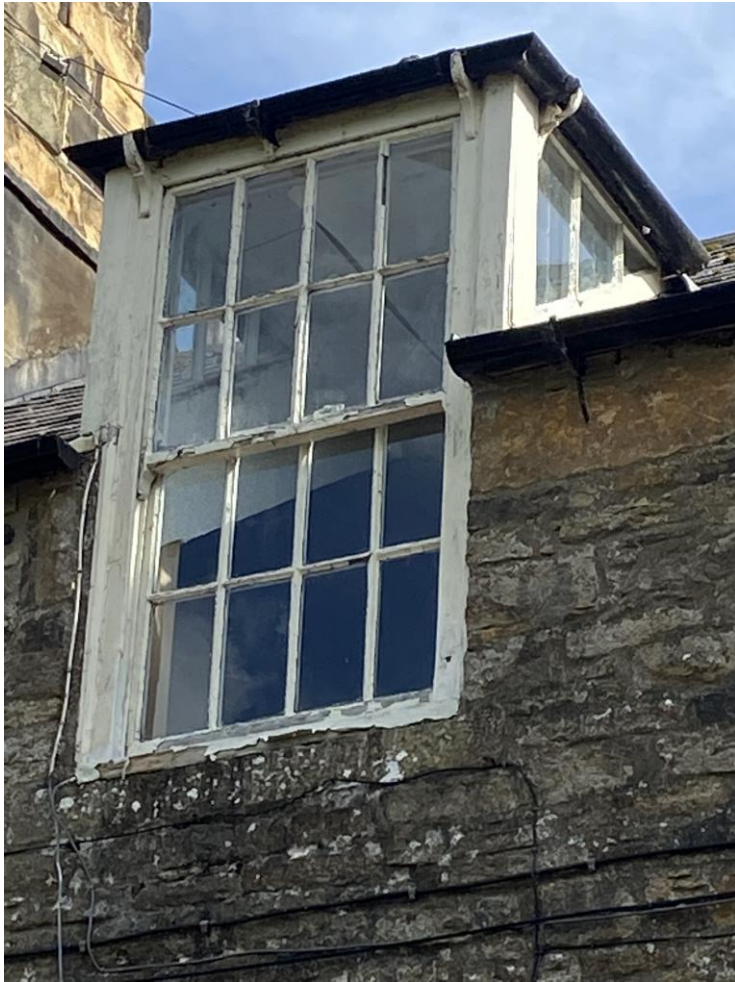
Missing putty on glazing bars has caused water ingress and further damage to glazing bars. Sill has failed due to lack of paint.

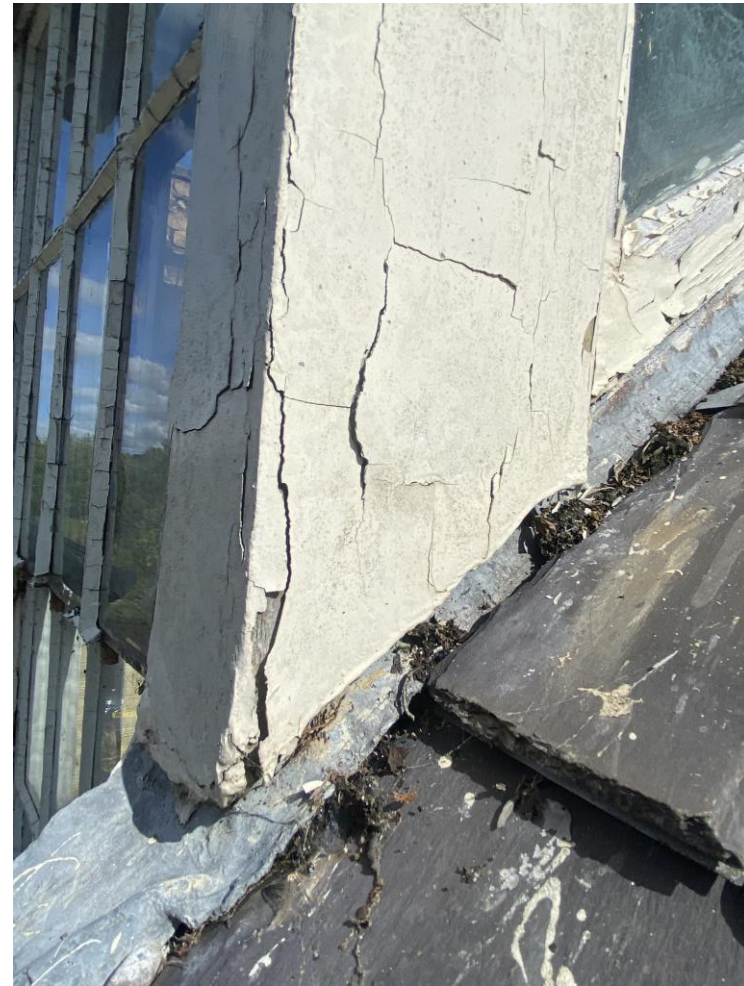
Decay at base of Corner supporting post

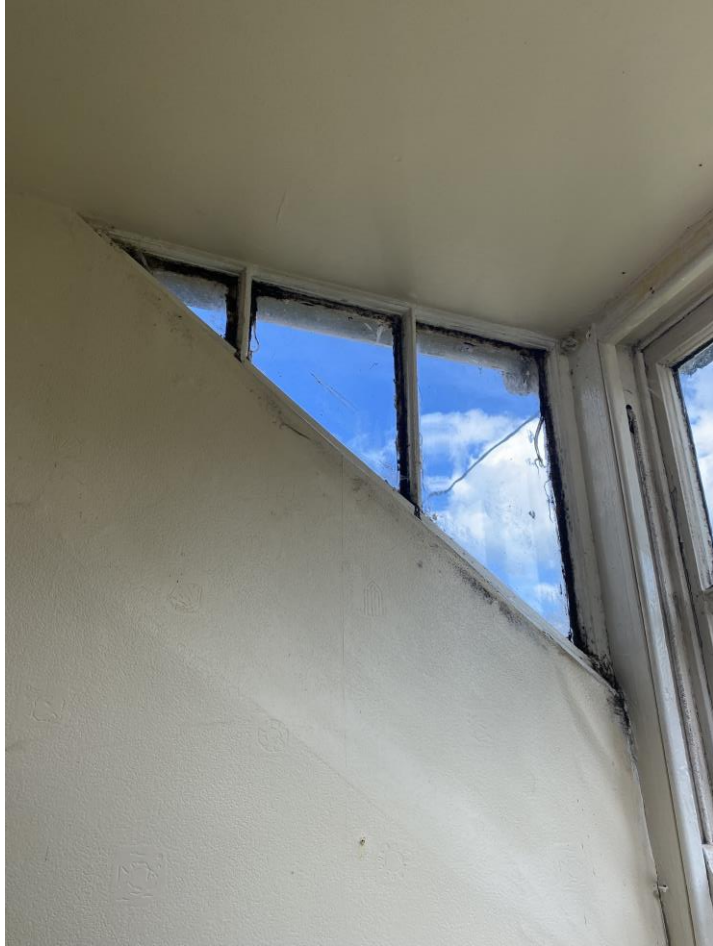
Mould to internal walls as a result of water penetration through cracked / broken glass

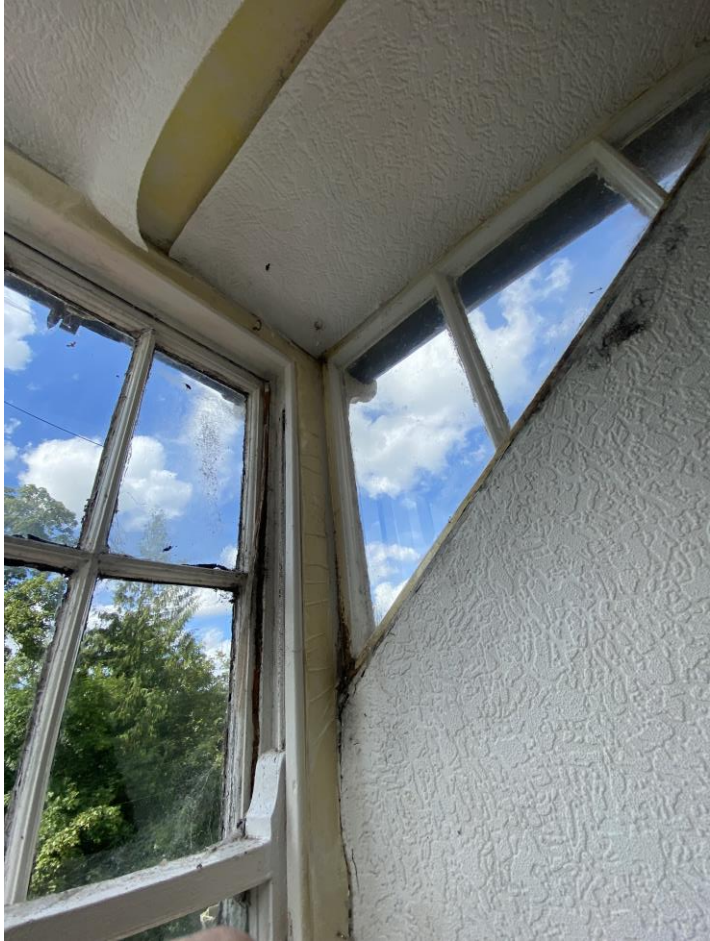
Mould to internal walls as a result of water penetration through corner post / frame junction with roof
