REPORT on VISUAL STRUCTURAL INSPECTION

NORTH BARN

MANOR FARM

REF 22-407-RE-02

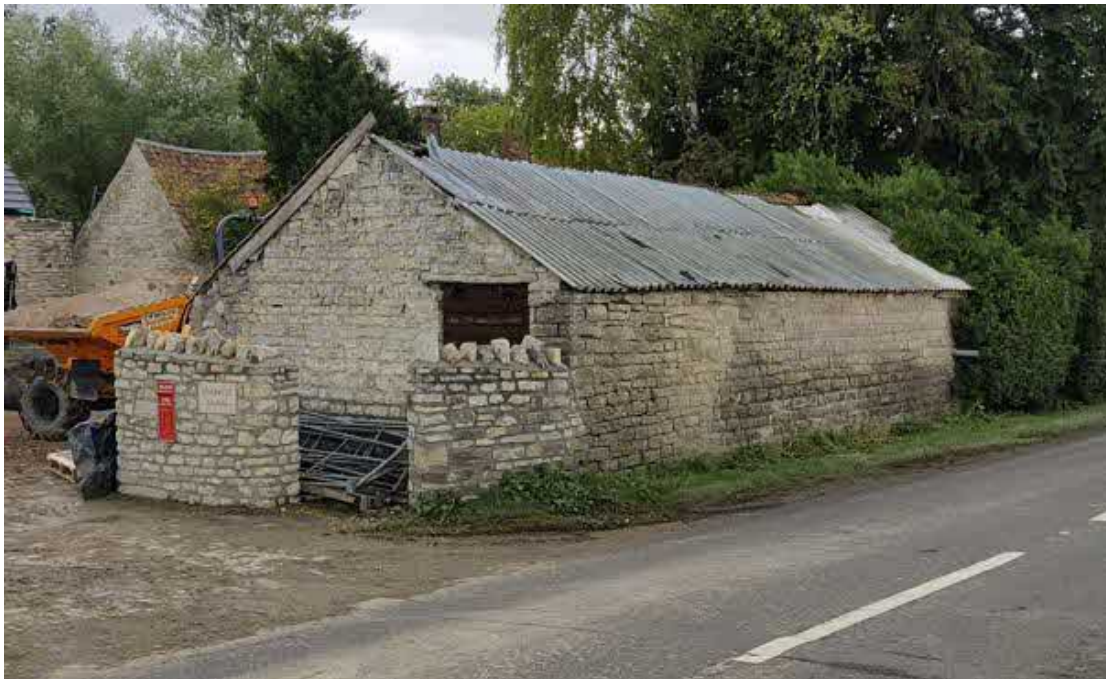
Figure 4 – View from NE

- 4.1 The structural fabric of the building i.e. stone and block appeared to be in good condition generally.
- 4.2 There are no visible significant (category 4 to 5) cracks to walls, suggesting no significant foundation or ground movement has occurred.
- 4.3 There is a moderate (Category 3) vertical crack to the stonework in the NW corner.
- 4.4 The floor slabs are in good condition with no sign of significant movement.
- 4.5 The building appears to have been well ventilated and generally the visible timber appeared to be in good condition. There are signs of water ingress and associated wet rot to some of the roof timbers.
- 4.6 The roof cladding is largely un-distorted, suggesting that excessive deflection of the timbers or steel has not occurred. However, some of the roof finishes are missing, most likely caused by to wind-uplift due to the dominant opening to the south elevation.
