REPORT on VISUAL STRUCTURAL INSPECTION

SOUTH BARN

MANOR FARM

REF 22-407-RE-01

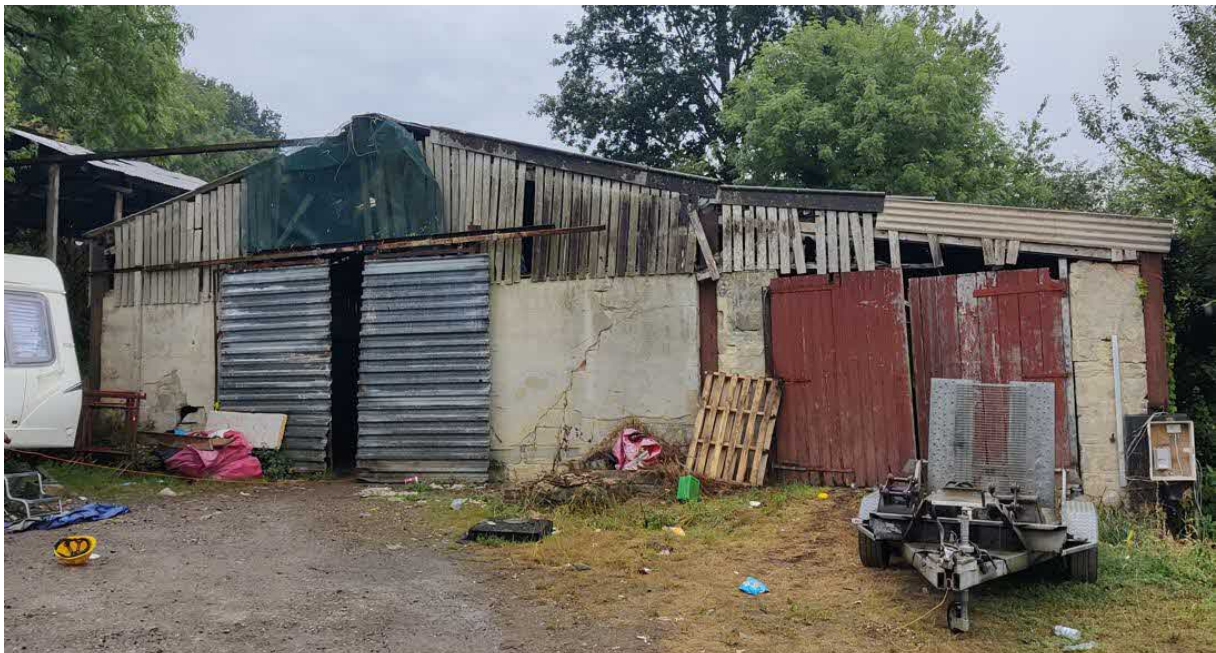
Figure 2 - View from East towards the front of the barn

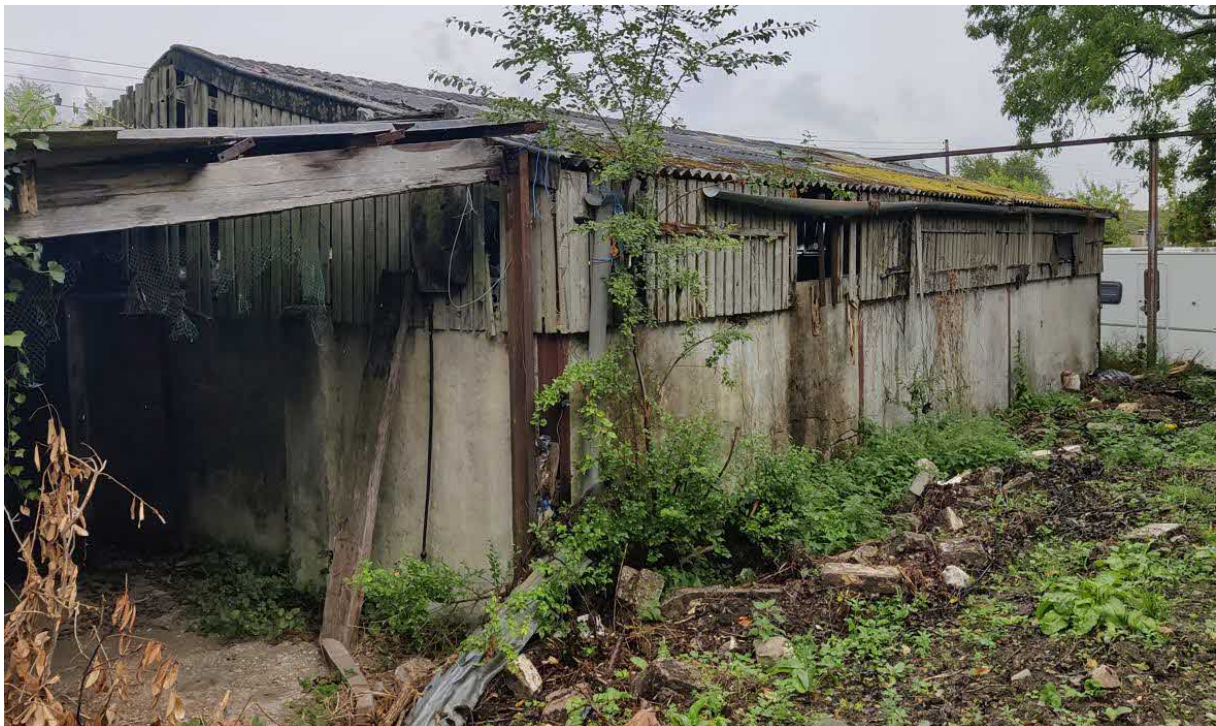
Figure 3 – View from the SW

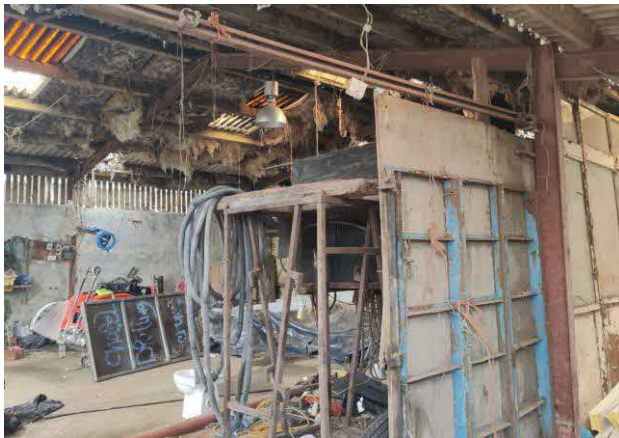
Figure 4 - Internal view of main portal

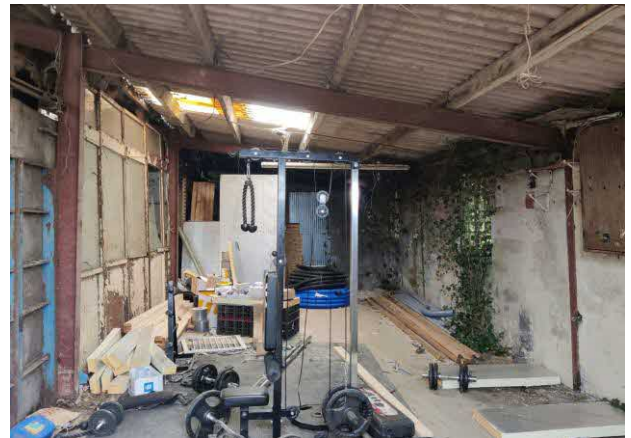
Figure 5 - Internal view of lean-to

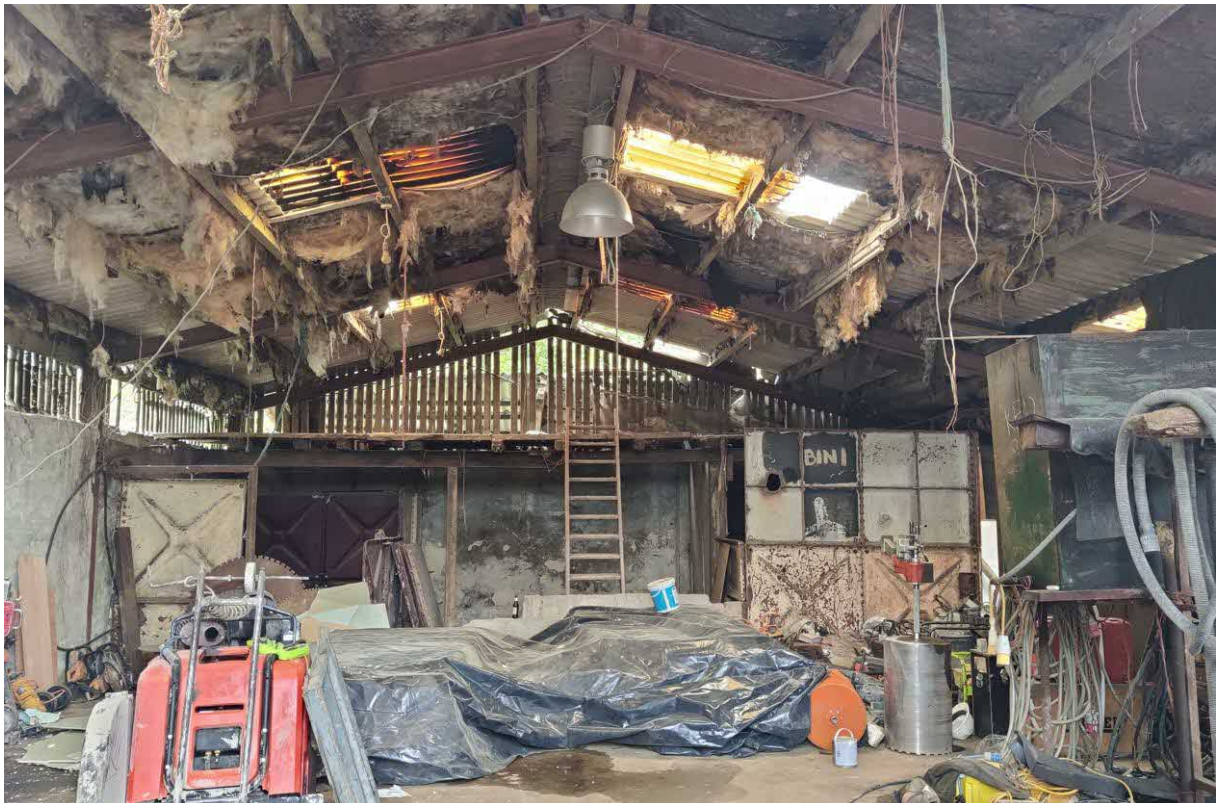
Figure 6 – Internal view from the East
