STRUCTURAL ENGINEERS

L-22035.001

25th August 2022

Re: The Manor House, Polebrook

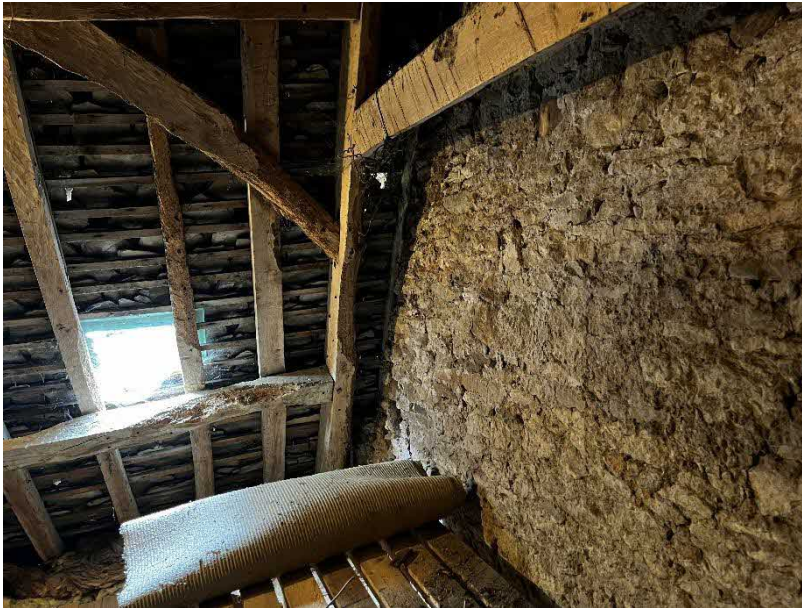
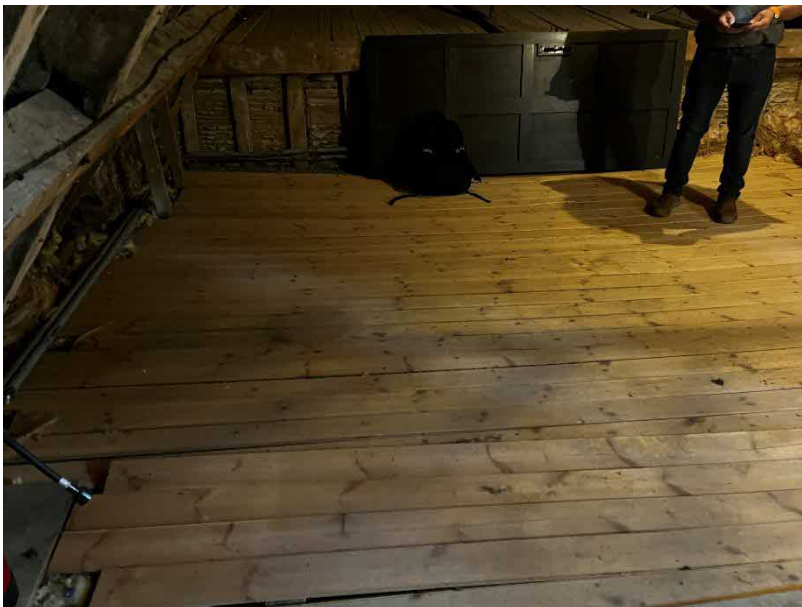
As can be seen from the adjacent images and those in the photographic index the cut roof is in a poor state of repair. The purlins are undersized and angled to the roof pitch promoting significant levels of deflection and roof thrust at eaves level

There is significant rot and infestation in the timber members. The bottom image also indicates the ceiling joists are overstressed and the deflection in the tonged and grooved boarding is visually evident.

Some new timbers have been introduced to the southern end of the roof void where the ceiling level is raised. Steel "L" straps have also been installed to tie the southern gable to the cut roof members.

We understand that as part of proposed refurbishment works that the Collyweston slate is scheduled for removal to facilitate repairs, introduction of breathable membrane and insulation prior to re-slatting with reclaimed Collyweston slate. As this is the case, we recommend that new timber purlins be installed alongside the existing and located vertically about their stronger axis. New trusses can be formed either side of the existing to support the new purlins and additional rafters can be installed between the existing to close centres.

New ceiling joists or proprietary Posi Joists or similar can be designed and installed to span from flank wall to flank wall to form the new floor deck suitable to support loads associated with habitable space. These can be installed alongside the existing ceiling joists if required.

There are new stud walls proposed as part of the remodel for habitable space within the roof void. These can be locally strengthened together with the new floor joists under to offer intermediate support to the new purlins and reduce the applied loads onto the new trusses.

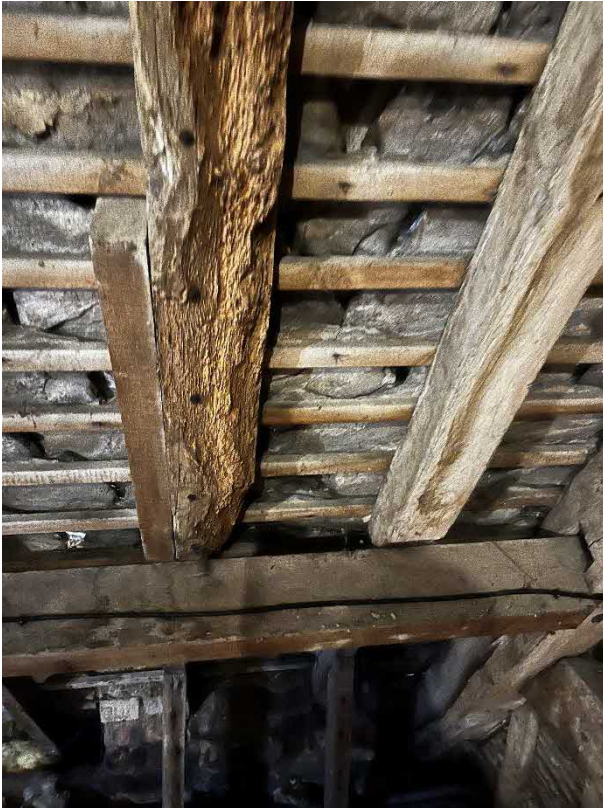
As noted, it is our opinion the timbers within the section of roof inspected have suffered loss of section through rot and infestation. The purlins are angled to the slope of the rafters, as such they are working about their weaker axis and have suffered significant levels of deflection causing thrust and wall rotation at eaves level.

1. Significant loss of section.

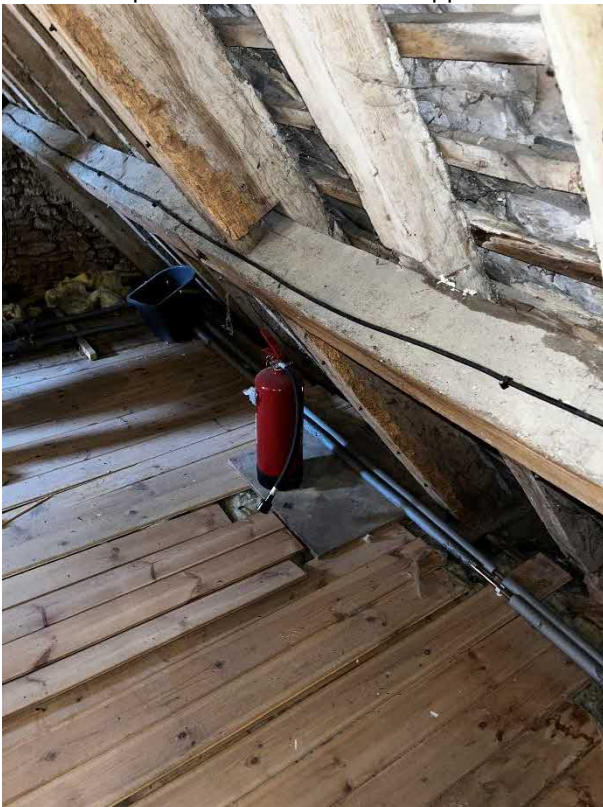
2. Undersized purlins deflected under applied loads.

- Install new timber purlins about their vertical axis built into the gable walls and supported from new strengthened truss members that flank the existing.
- Provide timber wedges from the purlin to the existing rafters to offer full support.
- Provide new timber rafters along side the existing, where the existing have been subject to loss of section due to rot and infestation, birdsmouth new rafters on to purlins and wallplates.
- Have a specialist inspect and treat the timbers as required to ensure new timbers are not affected.
- Install new floor joists/ Posi joists to span from flank wall to flank wall to provide new floor deck suitable for habitable loading.
- Utilise the new stud walls and floor joists to split the span of the purlins and reduce loads onto the new truss members.

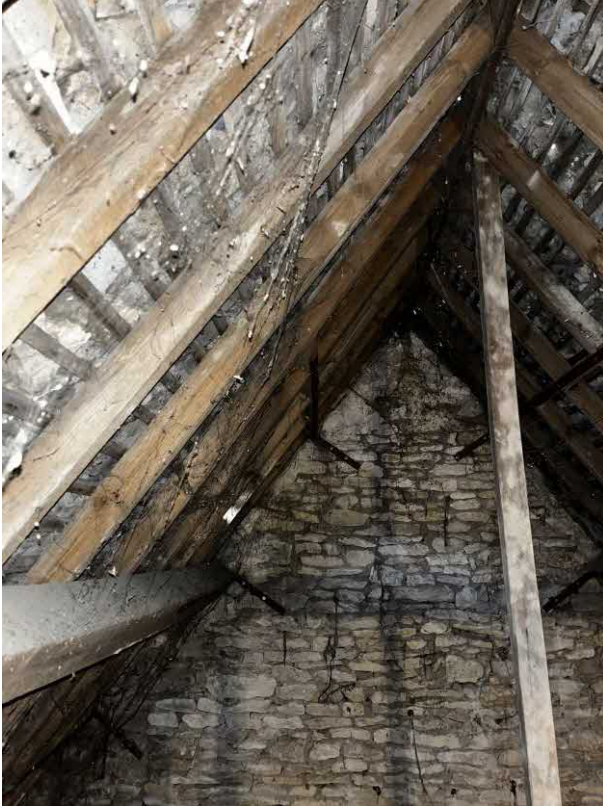
3. Purlins and rafters to southern end in better condition with L straps to gable

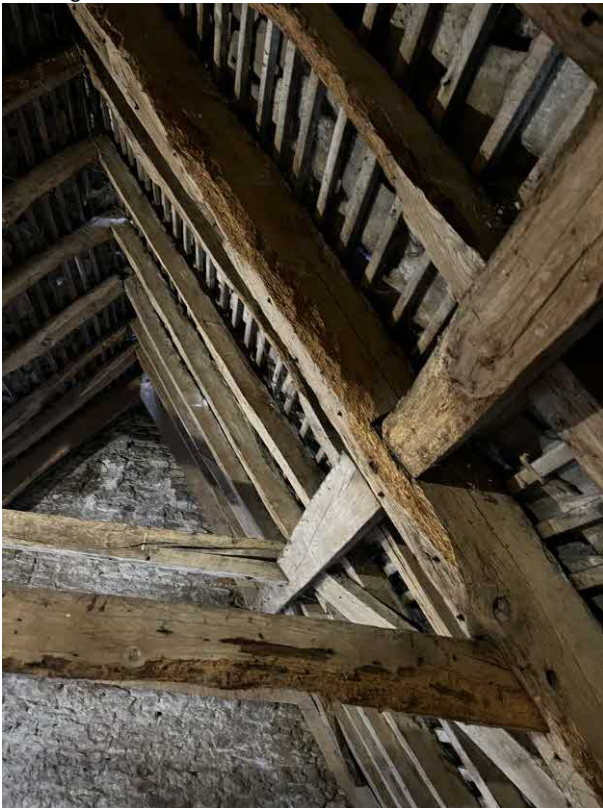
4. Existing trusses with rot and infestation.
