Historic
Building
Recording

FORMER AGRICULTURAL BUILDING NORTHWEST OF FIELD HEAD

Newbiggin
County Durham

Project 416-22-HBR | April 2022

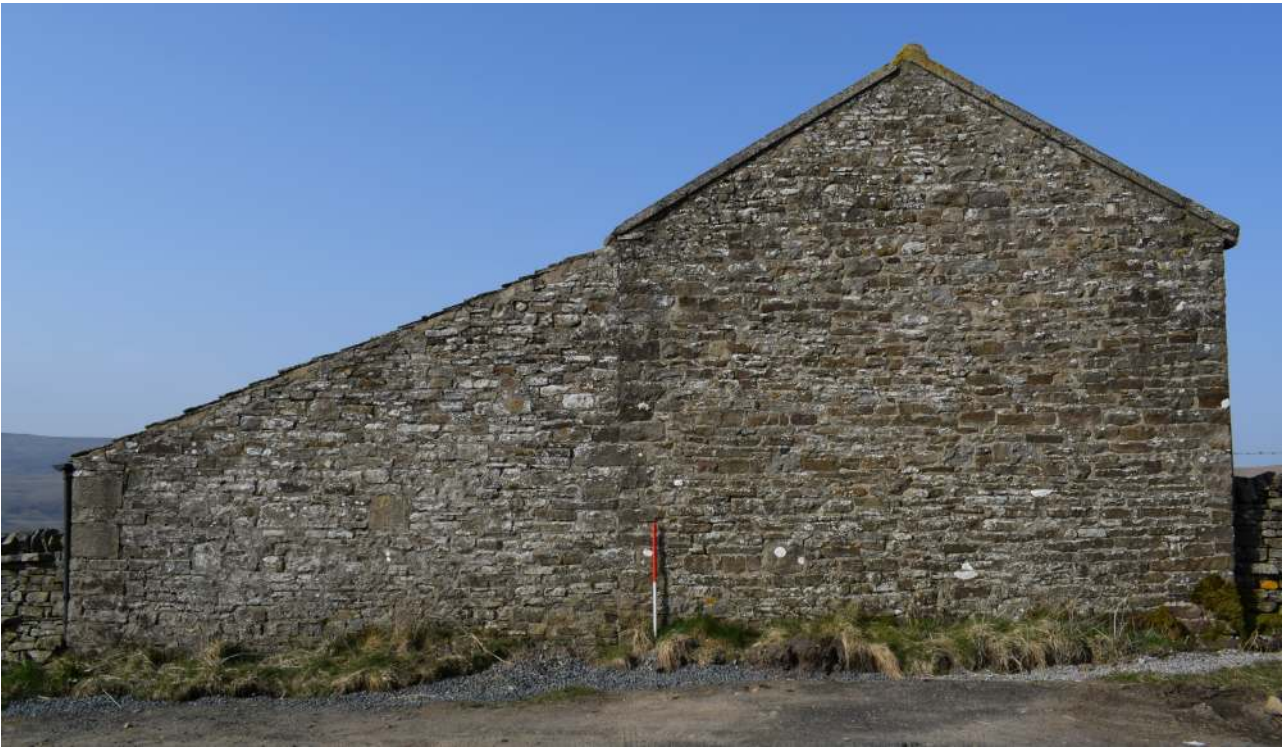
Plate 7. The east-facing elevation as seen from the road

- 3.4.1 The east-facing elevation is the direct view of the building from the road. The relationship of the original northern (taller) build against the lean-to can be seen in detail in *Plate 7*, with the lean-to having only been partially tied into the older structure: only three tie stones are visible within the

elevation, with the rest of the wall structure built butting against the older wall. The original wall also retains its quoined corner, still visible in the elevation. The quoins on the lean-to are a mix of stones similar to that of the original build, mixed with larger blocks. The elevation does not contain any blocked features: near the apex of the original build appeared to be the potential of a blocked small opening, but inspection of the photographs against the internal wall structure in the same area suggest that this ‘opening’ scar is merely a trick of the stone colouration.

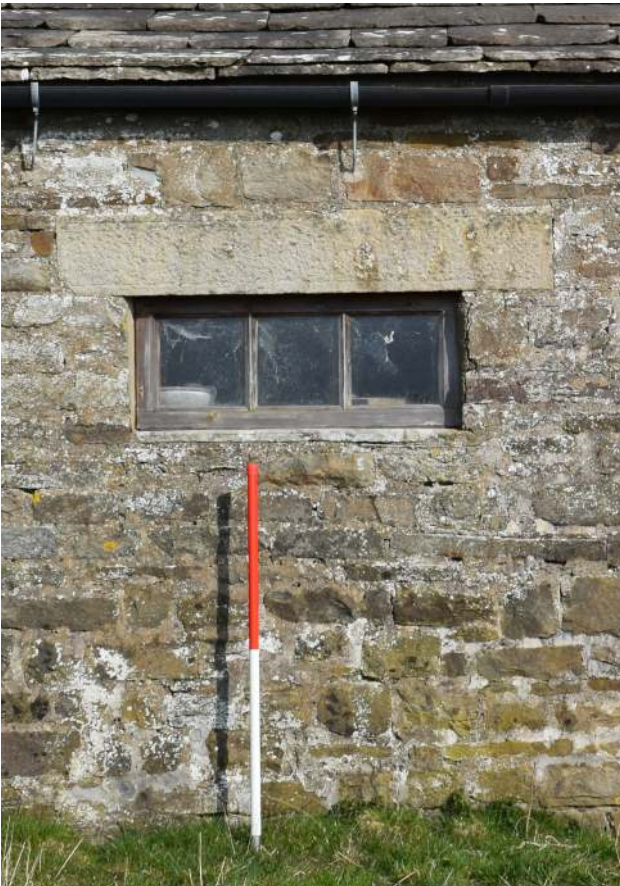
Plate 12. Western elevation, W3 (blocked)

- 3.6.2 Set in the southern extent of the lean-to wall is a blocked window, W₃, which can be seen on Plate 12. The window has a stone lintel and a haphazard thin stone sill.

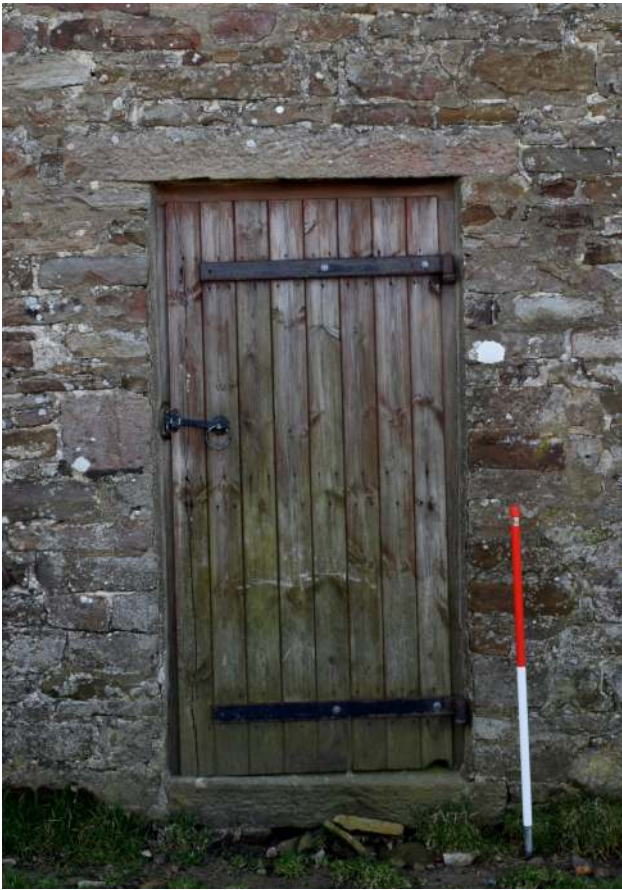
Plate 15. Northern elevation, D2

- 3.7.2 The door, D₂, is set on a large stone sill with a substantial stone lintel over (see Plate 15 for details). The doorway potentially originally sported quoins up the door jambs, but repair work surrounding the opening means this is uncertain. The timber slatted door itself is of relatively new construction.

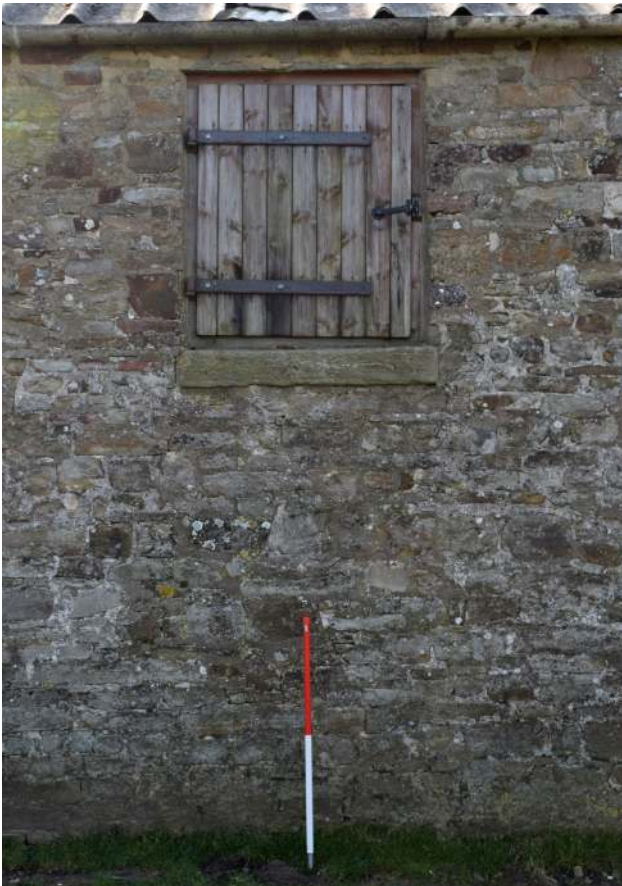
Plate 18. Northern elevation, blocked window, W6

- 3.7.3 The windows, W4 and W5 are both set on stone sills, which are level with the central door lintel. Each window opening is set with a timber frame, inserted at the same time as the window shutters were installed. These shutters are modern and date to the same installation as the door. See *Plates 16* and *17* for window detail.
- 3.7.4 Over the central door is a barely perceivable blocking that would originally have been a small opening. The location of this is highlighted in yellow on *Plate 18*.

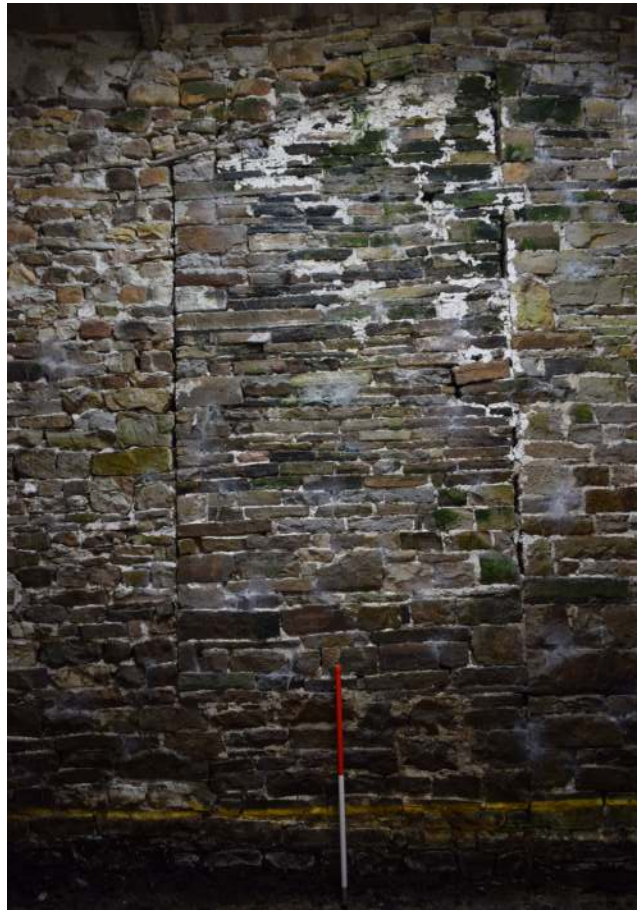
Plate 26. Blocked opening W9, looking south

4.2.6 To the east of the original elevation segment is a further blocked opening W9 (see *Plate 26*). This feature runs from foundation level to the height of the W8 window lintel and measures 1.7m wide. The head of this blocked feature lies at a 20° angle, suggesting a further roof line, the base of which can be traced running through the elevation to the eastern extent of the wall, with further stonework set above it.

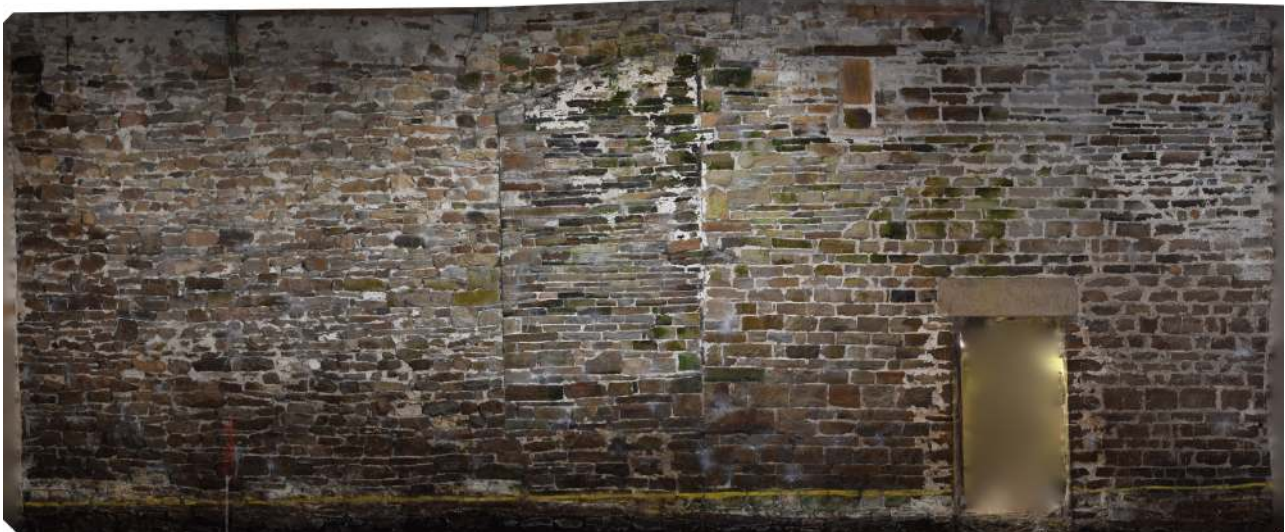
Plate 27. Photogrammetric reconstruction of the internal north-facing wall showing multiple phases of construction

4.2.4 The southern internal wall was a later insertion for the most part. *Plate 27* shows a photogrammetric scaled orthogonal view of the wall. The western end of the structure can be seen to have potentially the remains of the original wing ‘fossilised’ in the stonework, which headed south off the main building, noted on the 1897 Ordnance Survey mapping (see *Section 2.3*). *Plate 27* clearly shows the roofline of the structure, which also ties in with a change of external build as noted in *Section 3.6.1*.

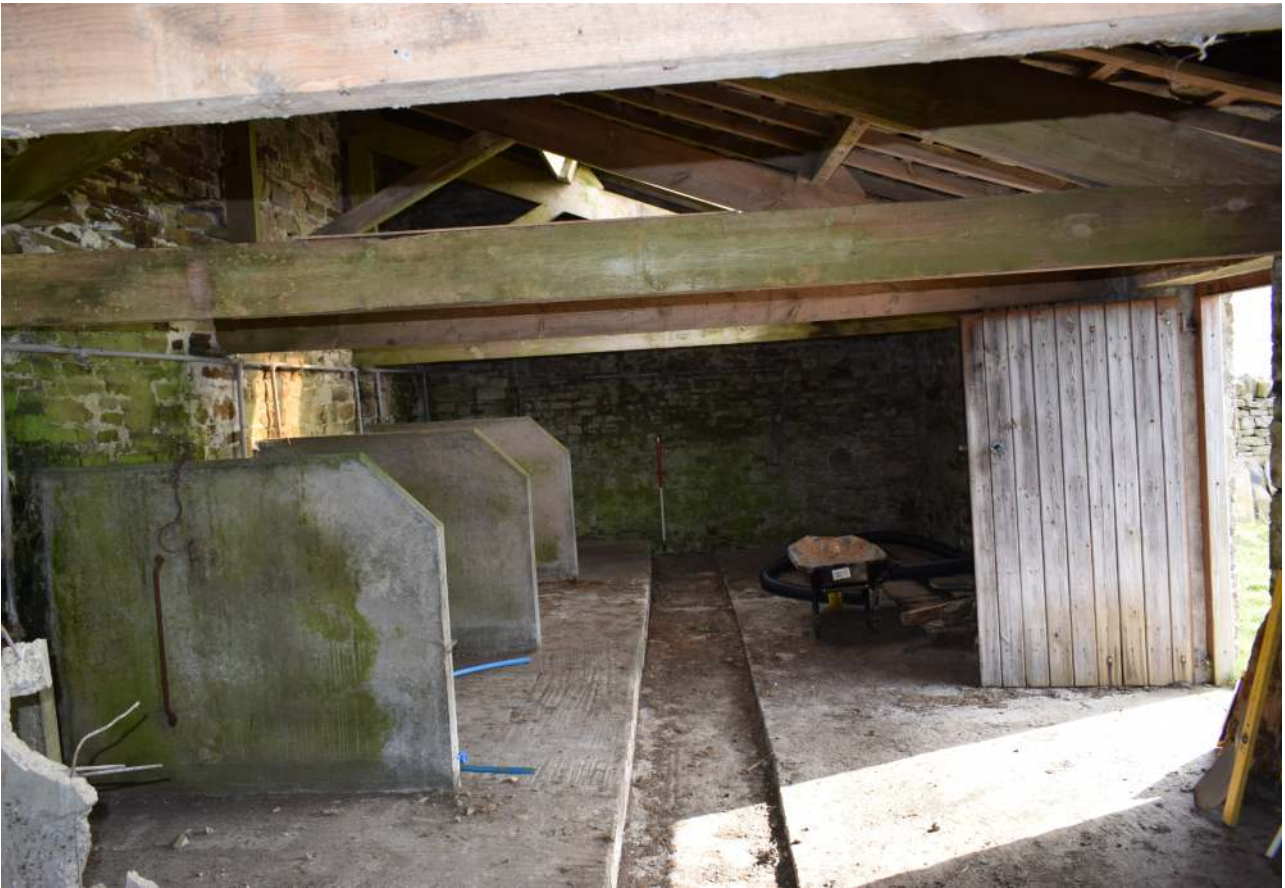
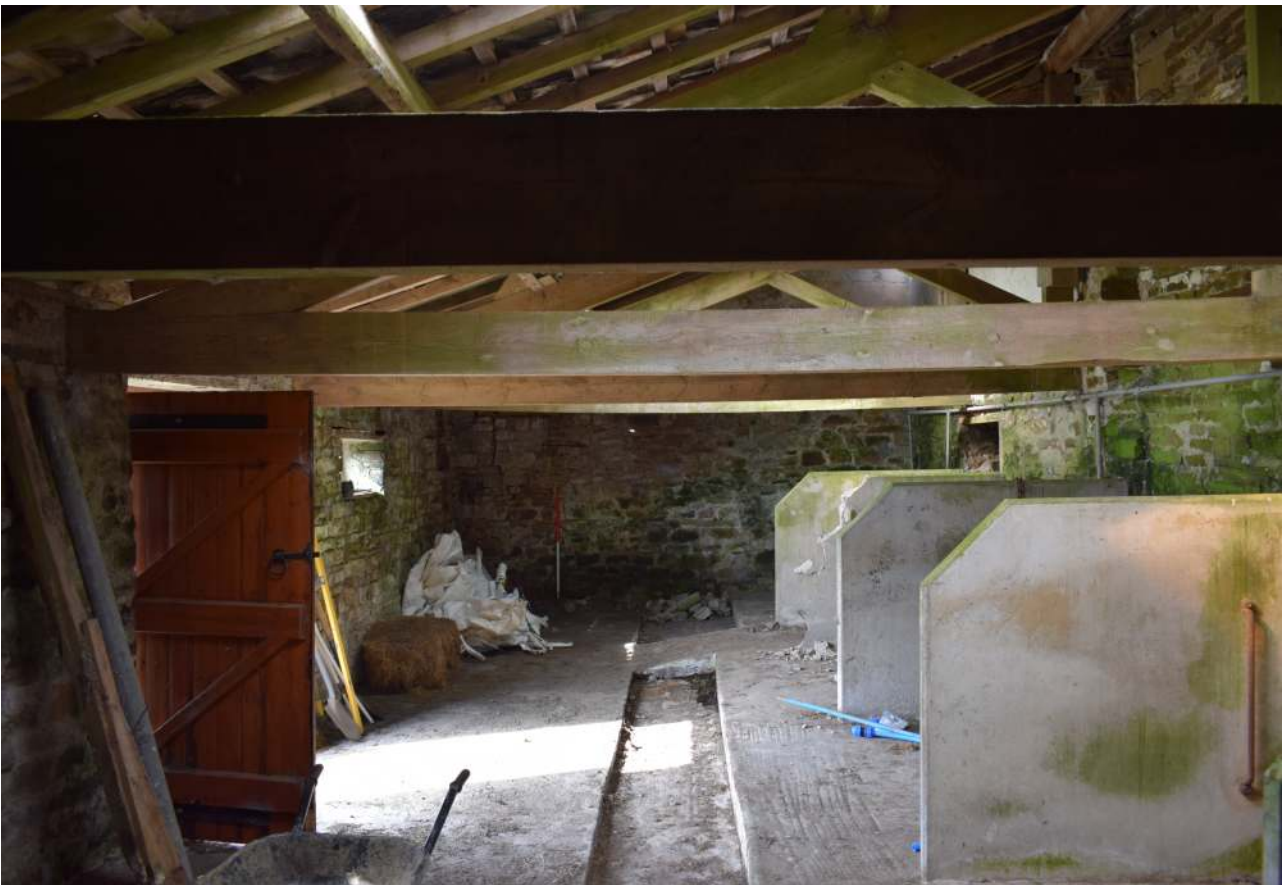
4.3.2 Internally, the roofing structure appears to be relatively modern, likely replaced within the last couple of decades (see *Plates 29-30*). The walls are constructed of similar materials to the older northern house, suggesting that the byre likely re-uses materials originally from the southwestern wing of the building. There are patchy areas of internal render visible on the western wall.

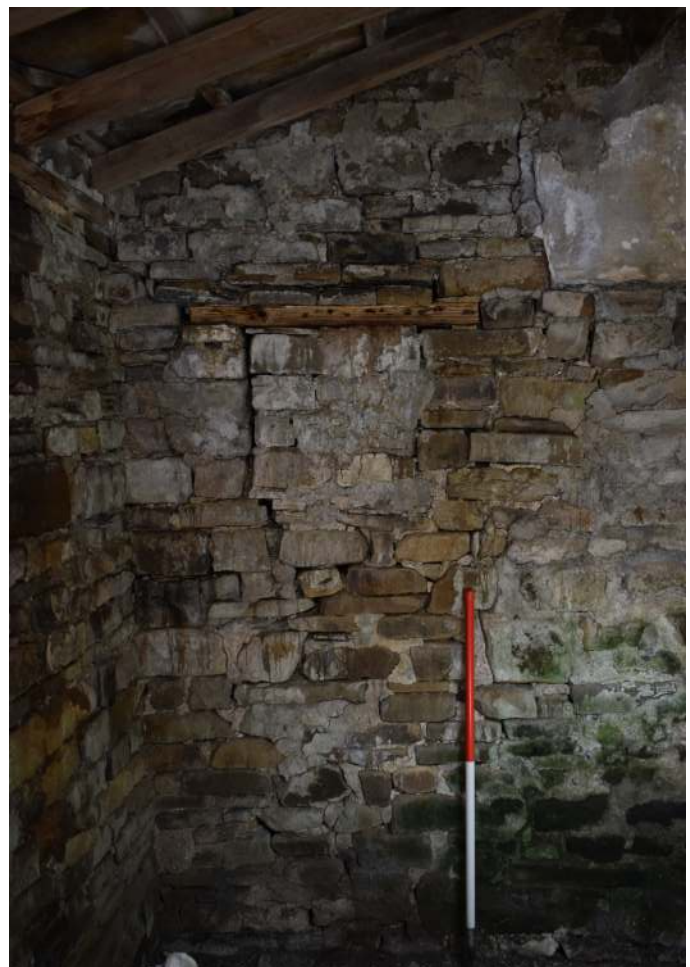
Plate 32. Blocked window W3

4.3.3 Set into the western wall is blocked window W3. This structure has a timber replacement lintel but the sill has gone, replaced by blocking. The window can be seen on *Plate 32*.

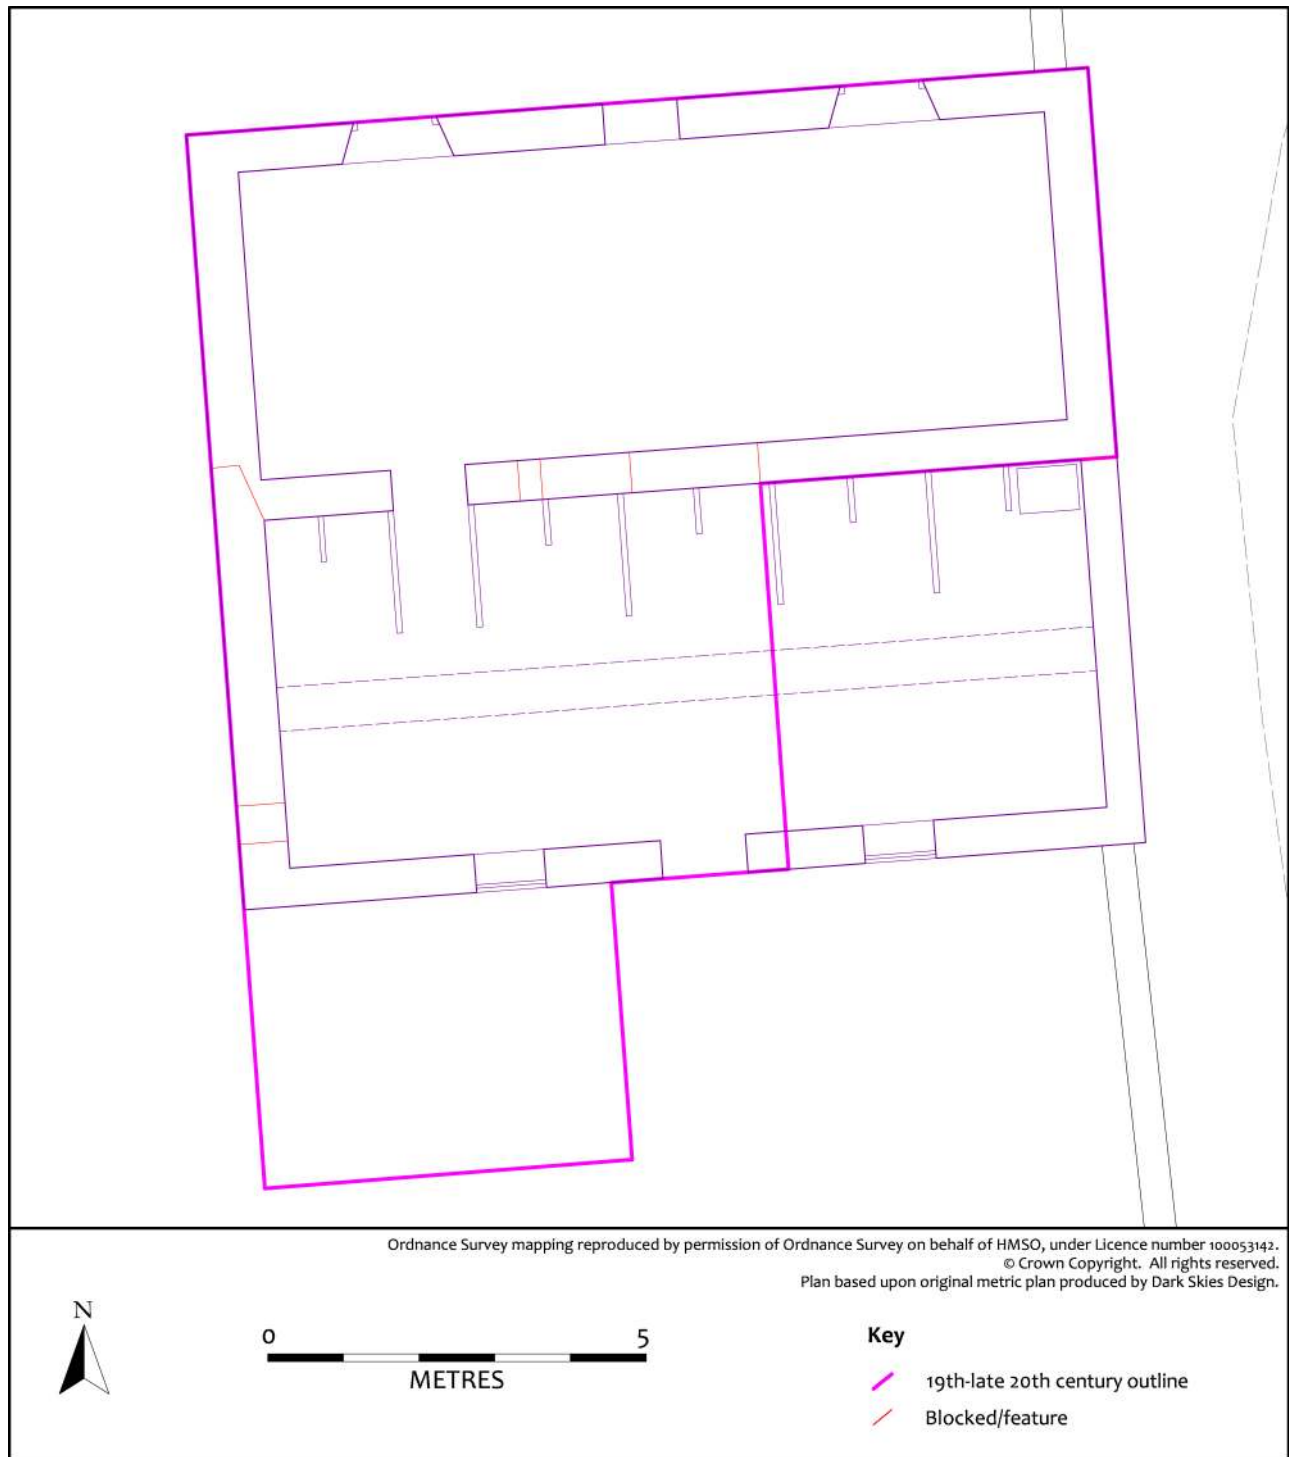
Figure 11. The 19th and 20th century plan superimposed on the current layout

- 5.1.1 Figure 11 shows the outline of the building as depicted on the Ordnance Survey maps from 1897 through to the late 20th century, superimposed on the building as it now stands. While the 1859 map does show a building present at the site, it does not provide enough detail to allow for definitive phasing of the structure.

- 5.1.5 According to *Figure 11*, the mid-extension's eastern wall marries with the eastern extent of blocked area W9. The structural evidence suggests that this block was likely in two parts, with a low-roofed structure running north-south to the western extent (evidenced by the roof-line noted in the western extent of the original build's southern wall) and an interconnected structure marked with the blocked area of wall. This may suggest the presence again of a fireplace that was modified to provide heat to the mid-extension.
- 5.1.6 As to the purpose of the now gone southern extension, with what appears to have been a rebuild of the southern wall of the mid extension for the construction of the present-day lean-to/byre, no evidence remains as to the nature or form of this build.

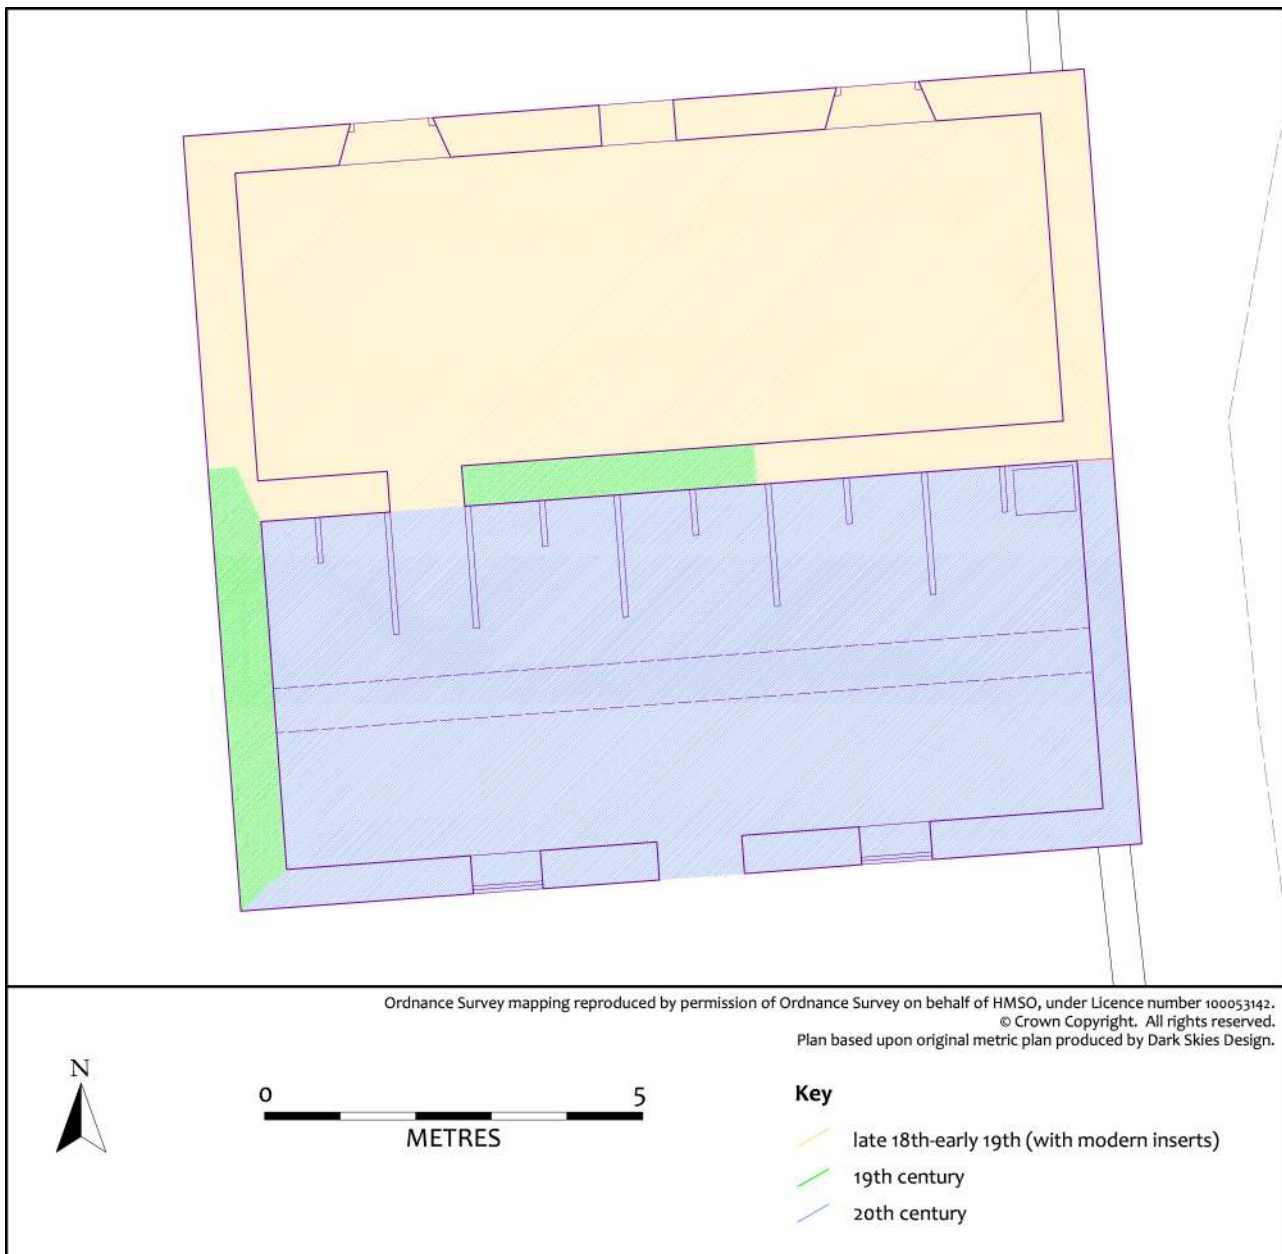
Figure 12. Suggested phasing of the present structure

- 5.1.2 The construction of the byre/lean-to saw the demolition of the southern extent of the building, with the new southern elevation being building along the same foundation line as existing at the western extent of the structure and extended east. Examination of the elevation suggests a complete rebuild, as there is no discernable difference between where the wall would likely have pre-existed and the new construction. There is also no scarring or staining in the stonework where the demolished southern extension was removed.
