Arboricultural Hazard Assessment

5 High Street, Scalby

Site Address:	5 High St Scalby, Scarborough, YO13 0PT	Client:	Mr & Mrs Dennis
Report Ref:	HSSS01-22	Report Date:	1st August 2022
Author:	Laurence Smith BSc (Hons) Arb, M Arbor A	Signed:

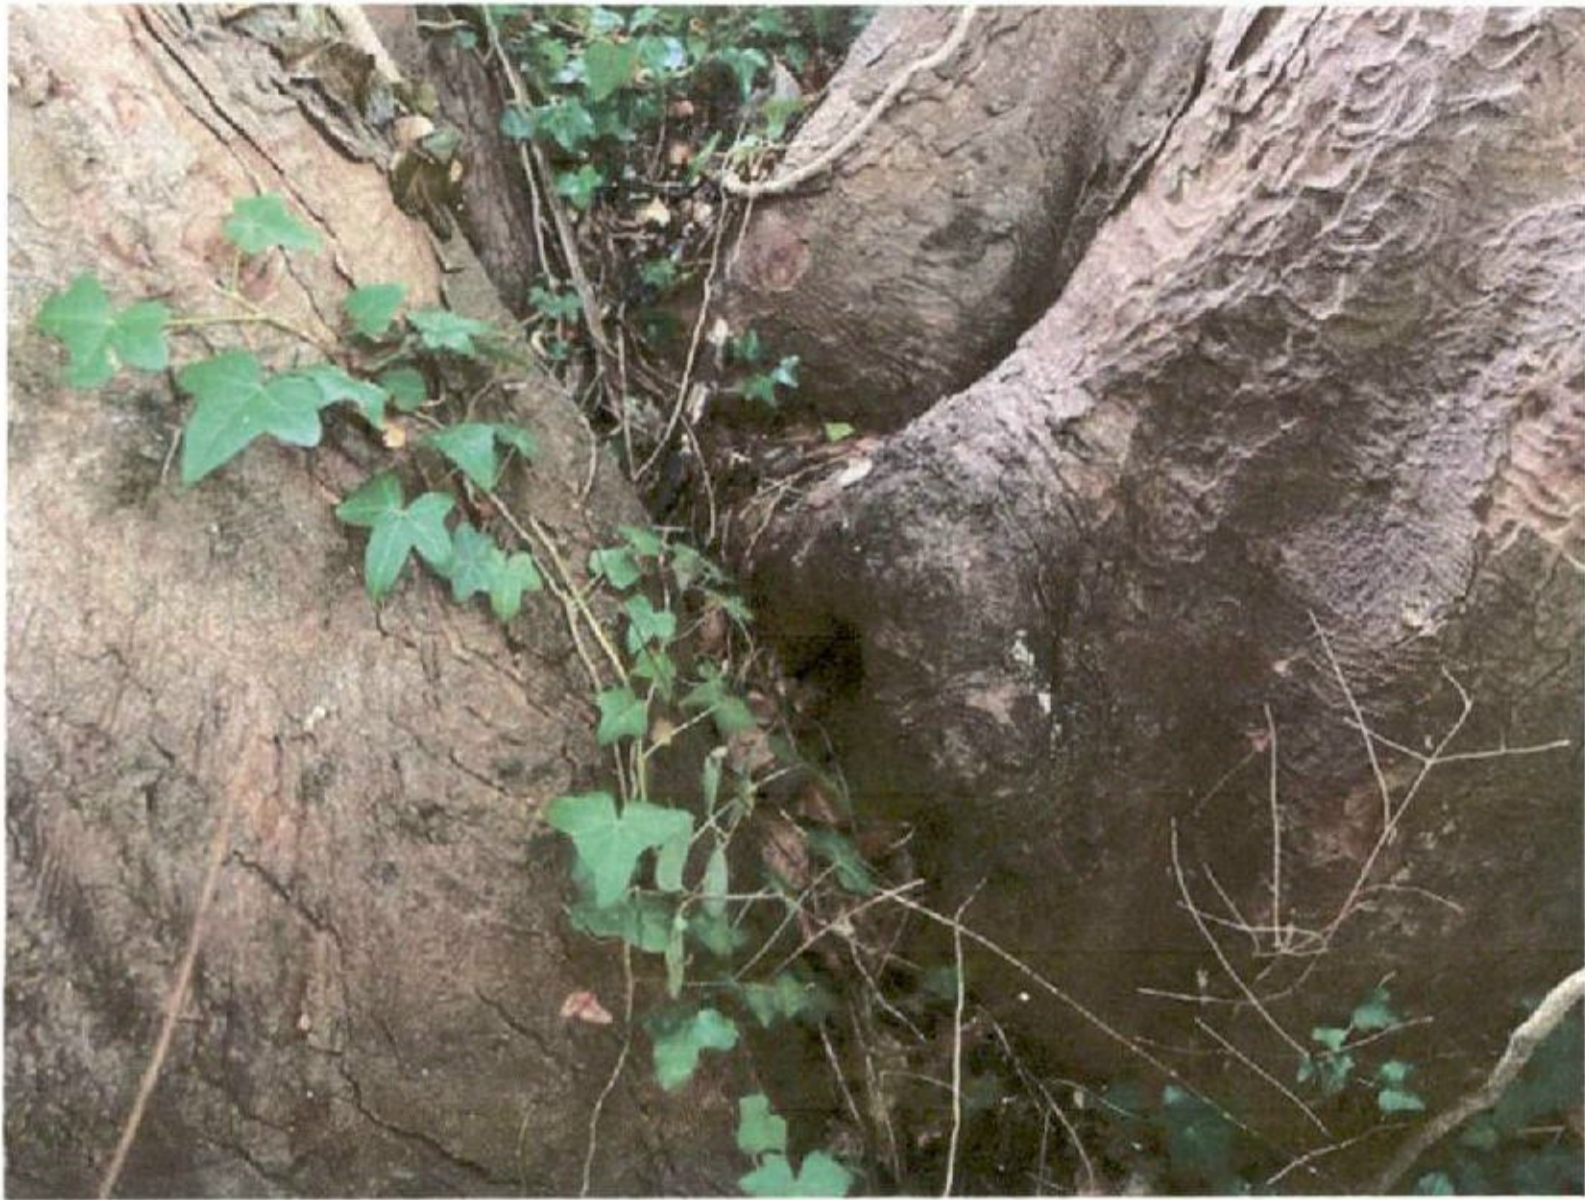
The most significant finding was at the union between the two adjoining stems. This union appears to be partially bark included, which can form a weaker union due to the lack of connective tissue. However, Sycamore trees are (anecdotally) typically more resistant to this type of failure. In addition, no swelling was observed around the base of this union which would suggest the tree has not had justification for spending resources to add strength to this region.

Despite the lack of evidence to suggest that the tree is at risk of failing at this point, if a failure should occur, it is likely the impact would be significant given the high frequency of road users. Furthermore, changes in climate has led to the increase in frequency of storms and high wind events which can cause failures in healthy trees. Given these factors, it would be advisable to install a soft tree brace which triangulates between the three stems.

Figure 1. A partially bark included union on T1.

T1 should be crown cleaned, removing deadwood, minor rubbing branches and poorly attached limbs. While carrying out these works, a visual inspection of the tree should be undertaken by the contractor with any significant findings reported back to Key Tree Solutions. A soft cable brace (Cobra Brace) should be installed to triangulate between the three upright stems. This

should be installed at approximately 2/3 the height of the tree and with enough slack to still allow for natural movement between the three stems. Although not significant, consideration should also be given to removing or severing the Ivy to allow for better ongoing monitoring of the stems.

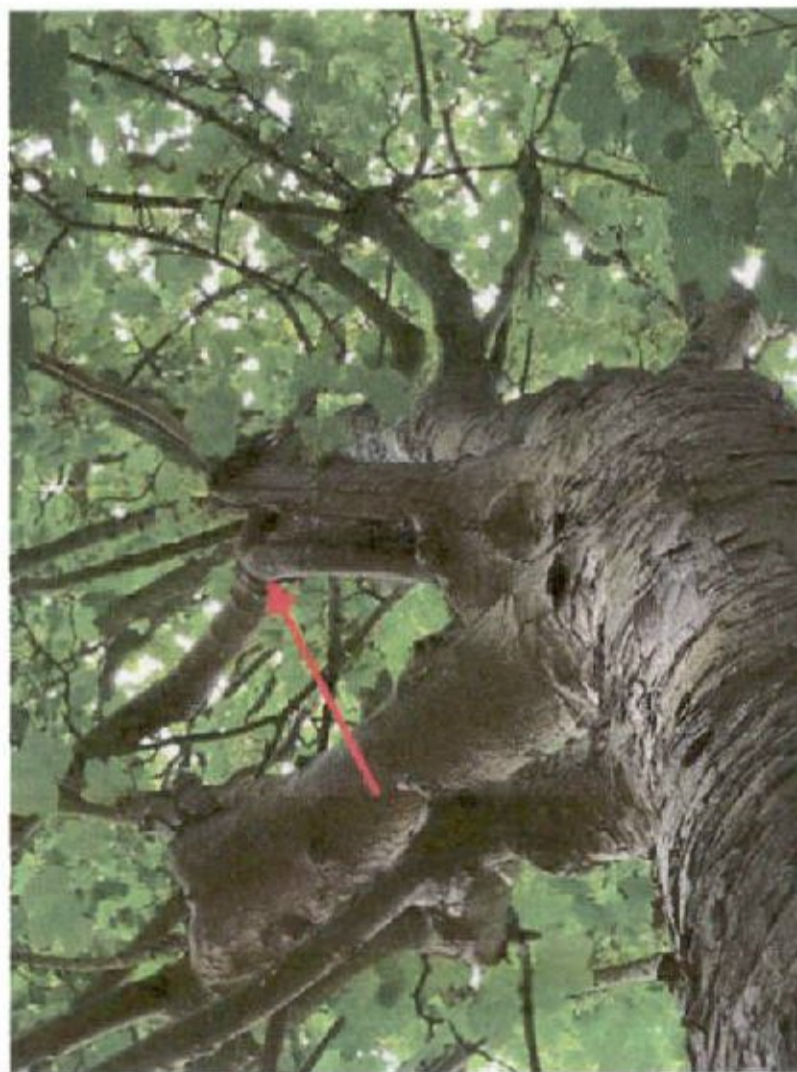
Figure 2. A poorly attached limb on T1.

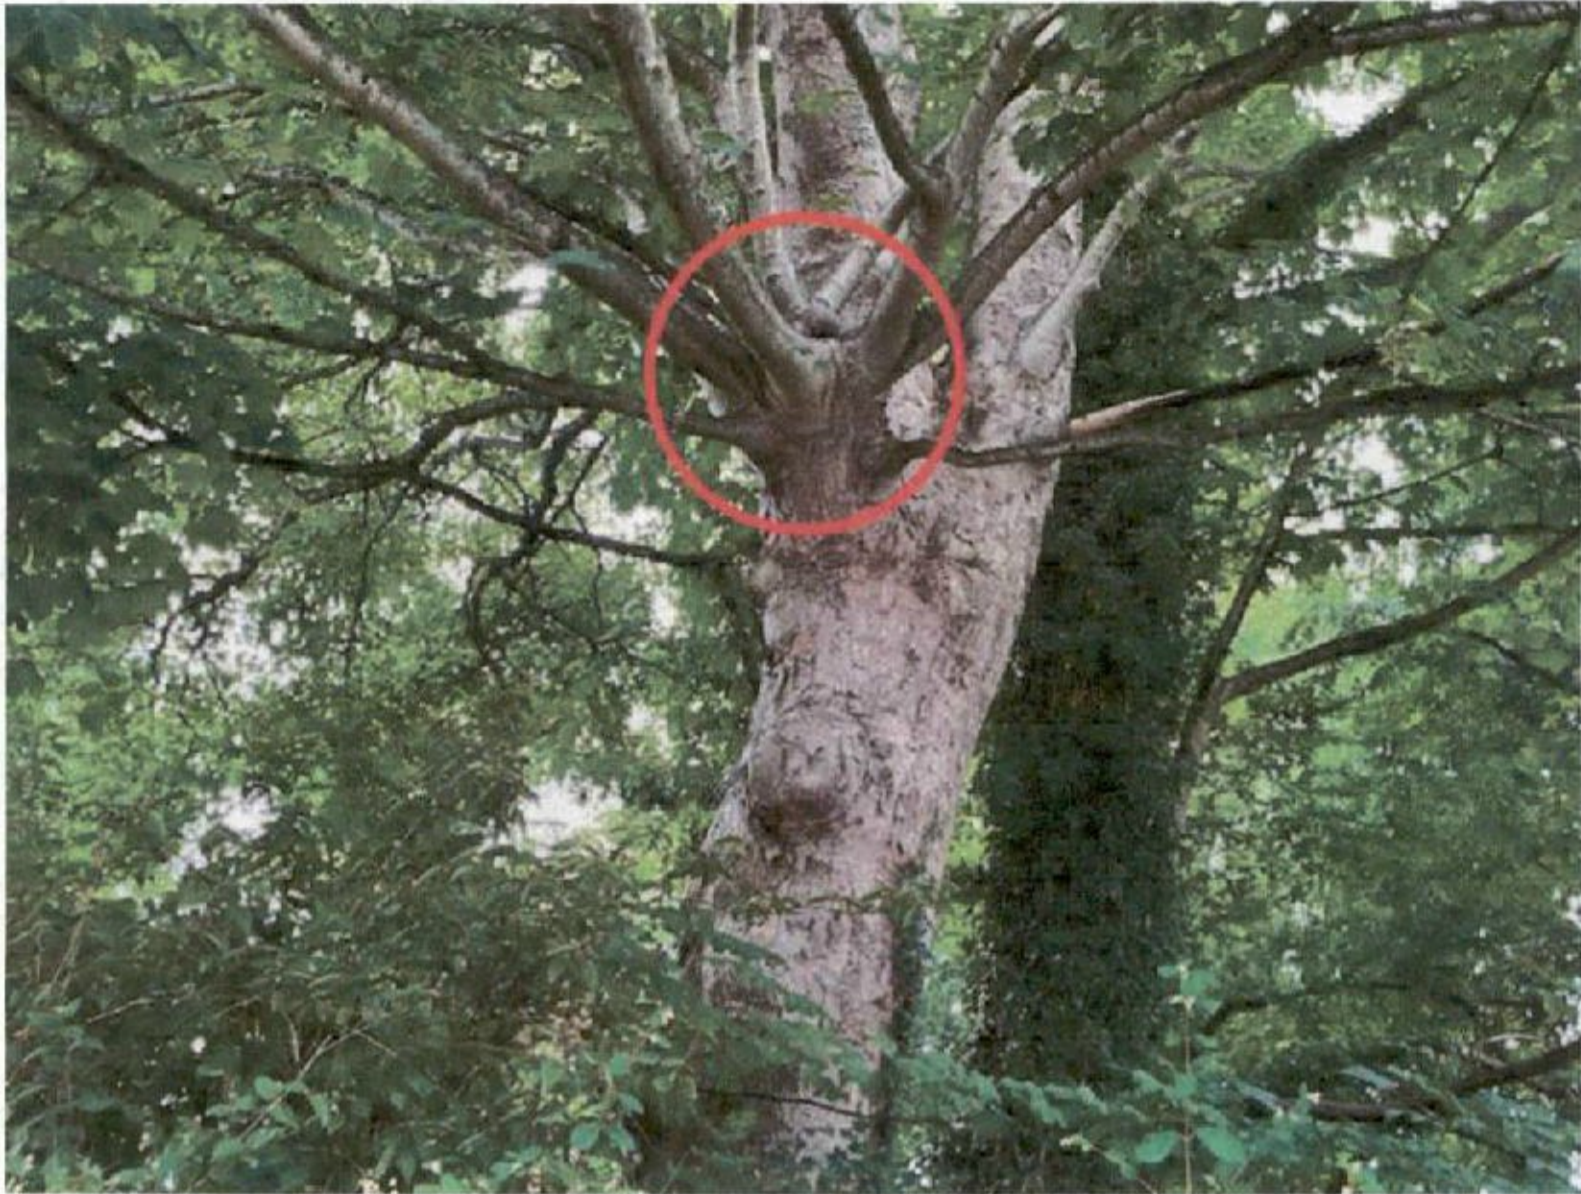
Figure 3. Prolific growth from an old pruning point on T1, possible minor decay cavity not visible from the ground.

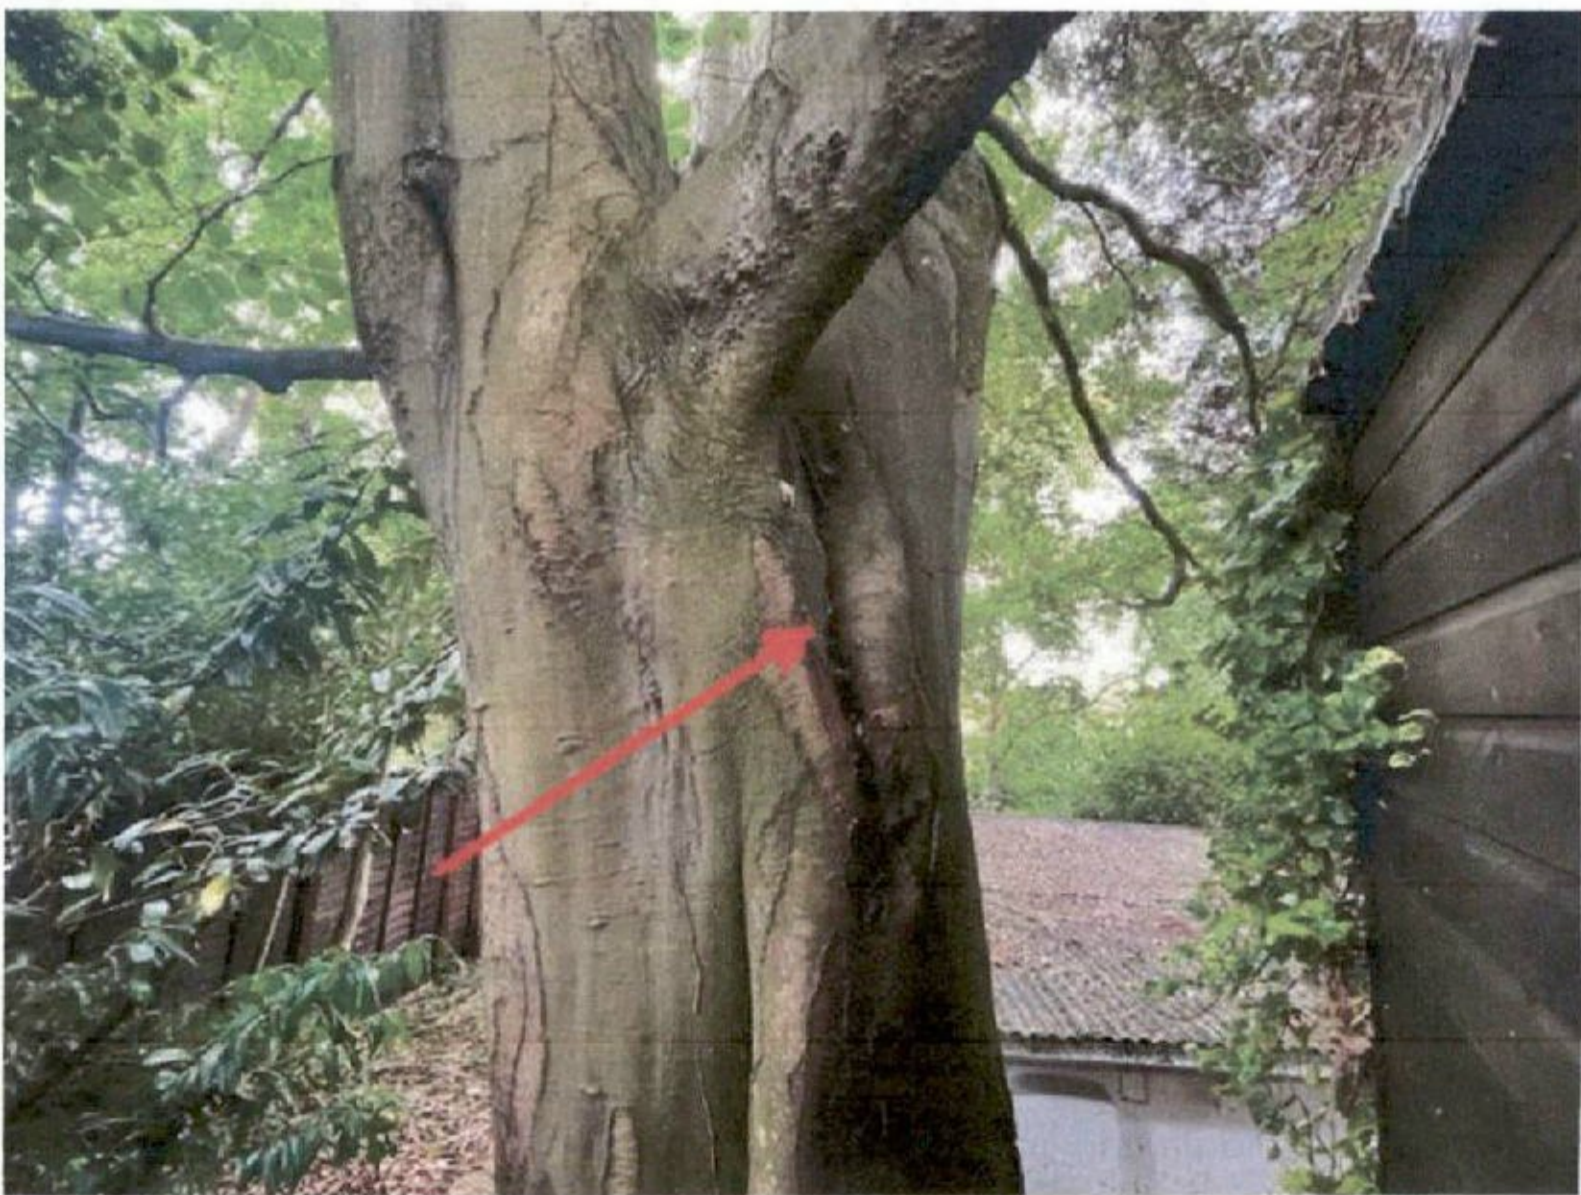
T3 also has three bark included unions, however unlike T1, these inclusions are considerably larger and all three have large swellings with expansion cracking below the unions. This development of growth is in reaction to significant strain at the union as the tree attempts to add strength to the region. These growths are sometimes termed as 'Elephant ears' and considered strong visual warnings of a potential failure point. In addition, Beech is possibly one of the trees most likely to suffer failures of this type.

Figure 4. Side 1 of T3's lowest bark included union.

Given the defects and high targets associated with the large Beech (T3), it is recommended that this tree is removed to prevent failure.

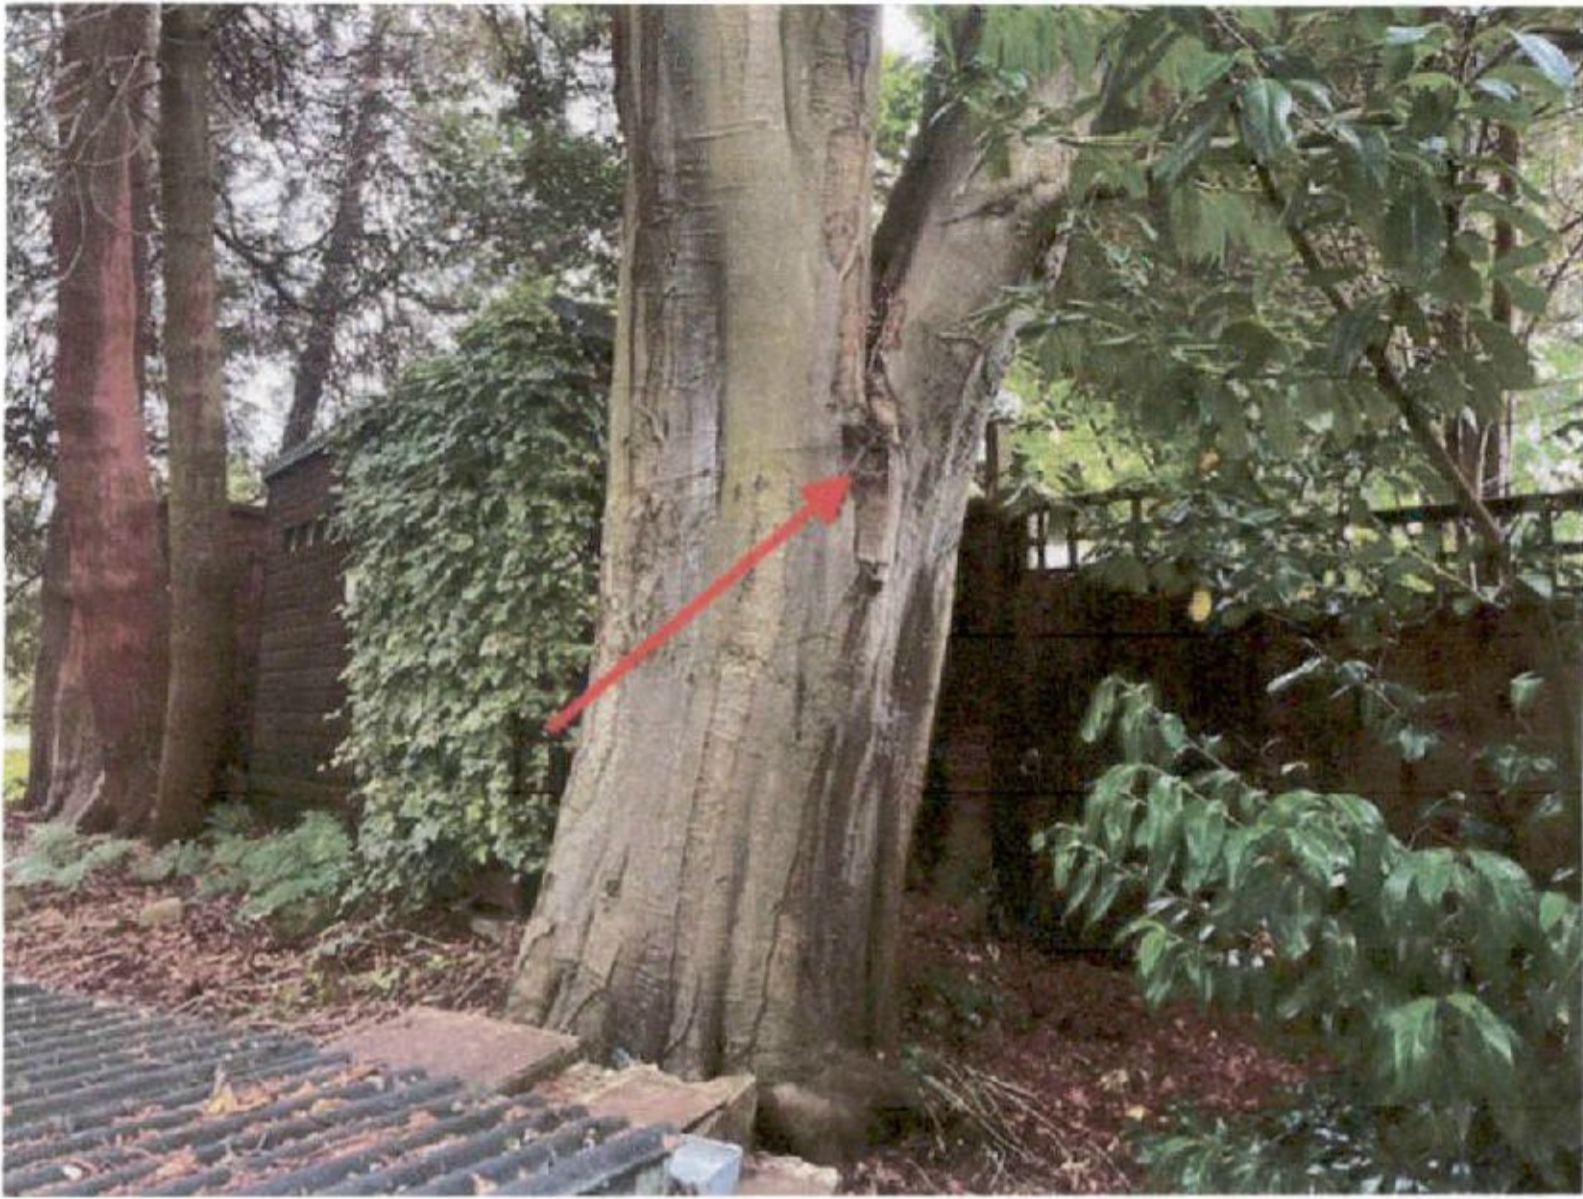
Figure 5. Side 2 of T3's lowest bark included union.

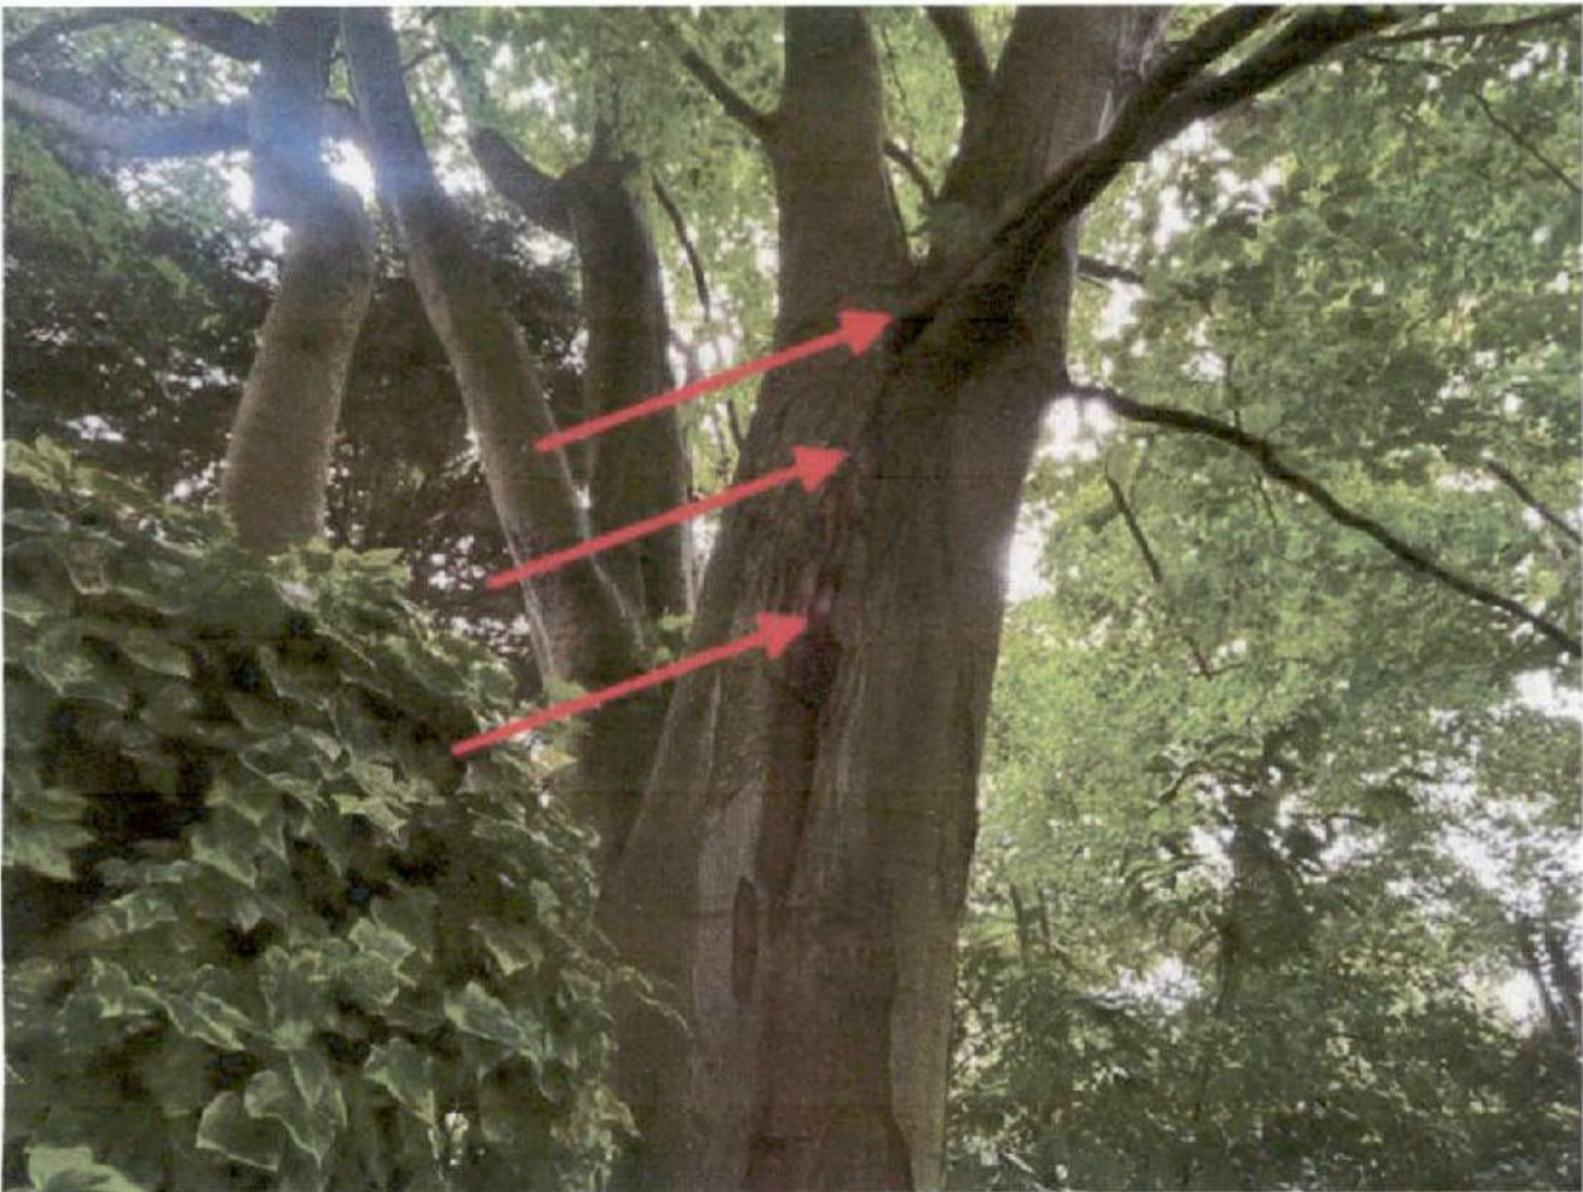
Figure 6. T3's middle bark included union.

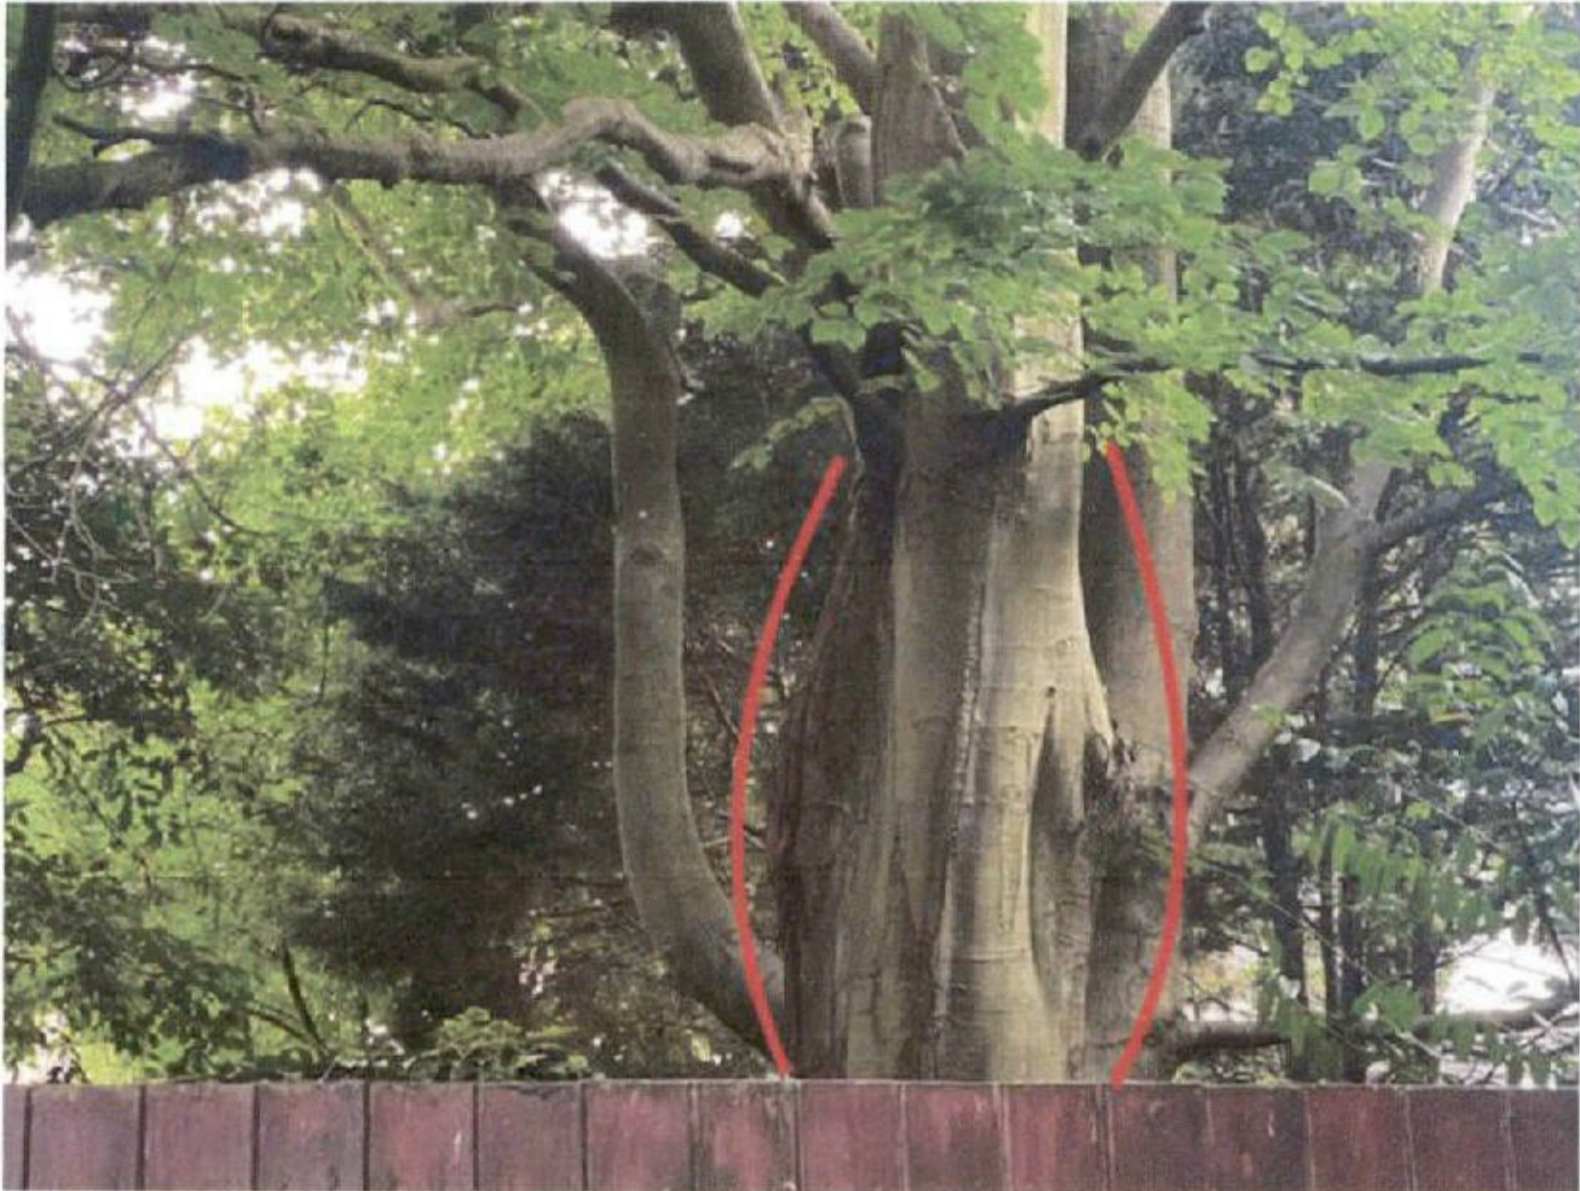
Figure 7. Large swelling (Elephants ears) around the middle bark included union on T3.

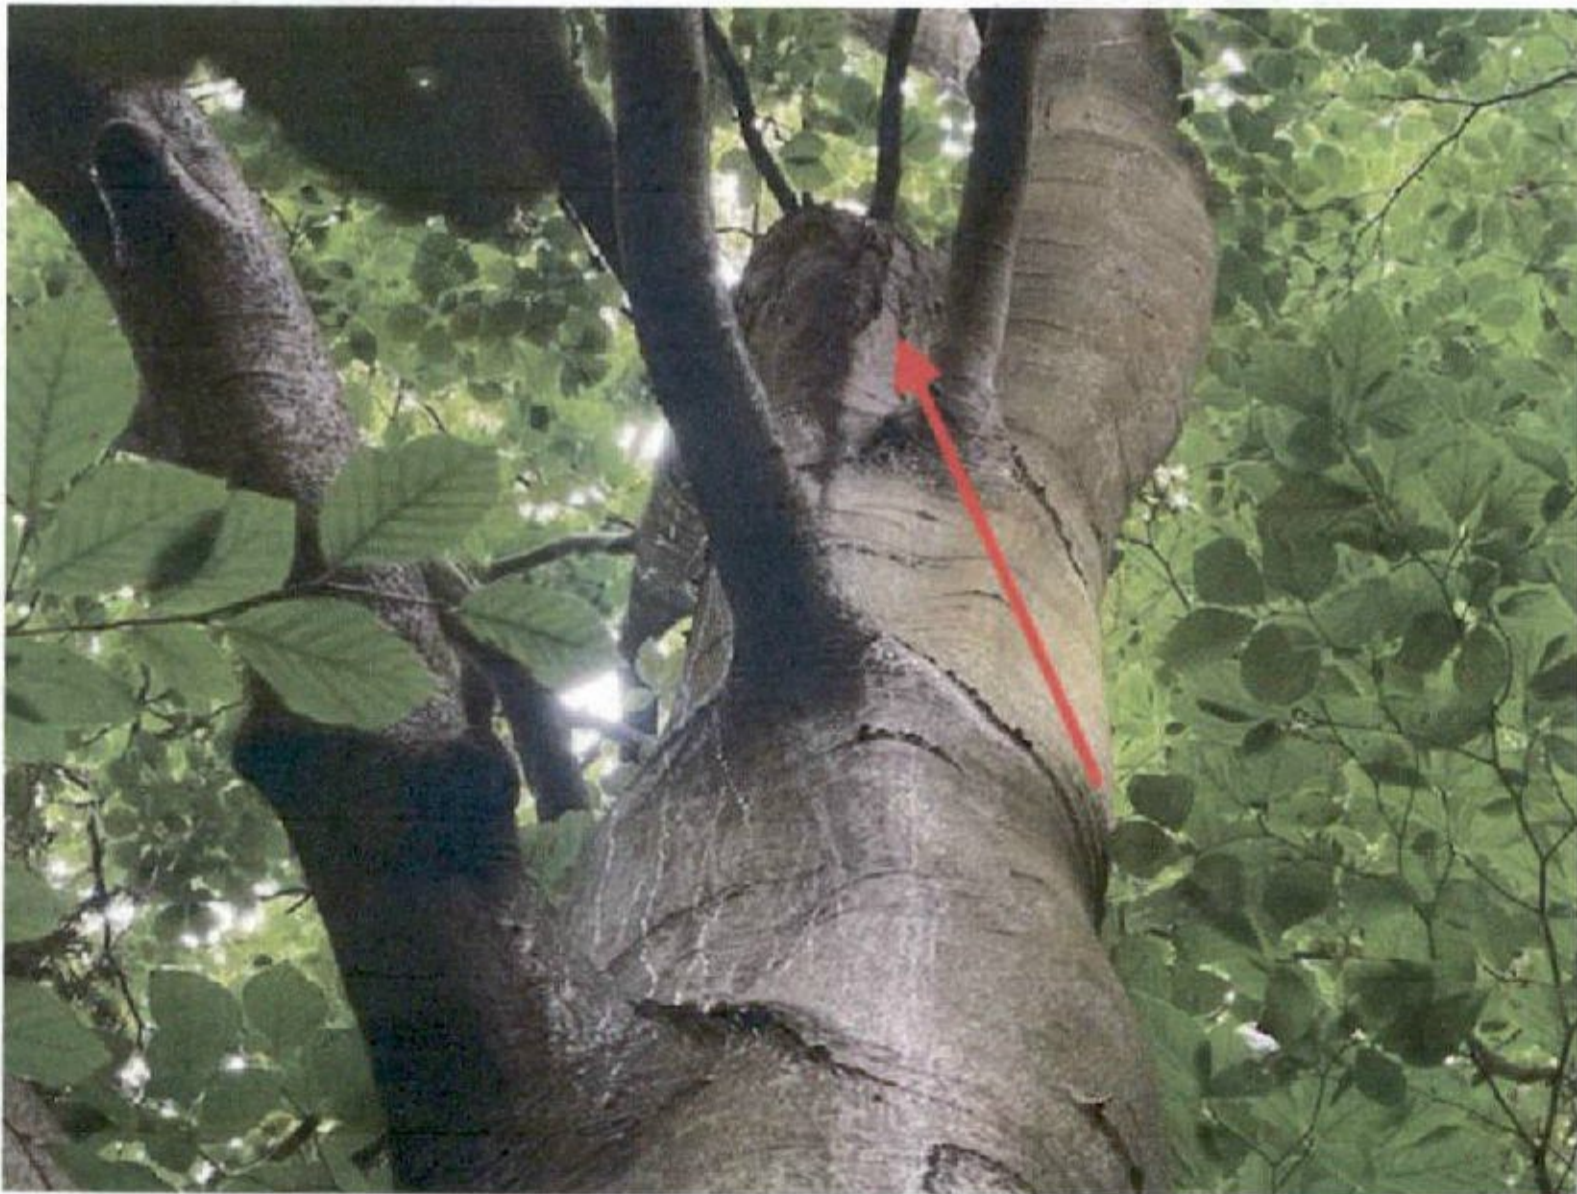
Figure 8. Swelling below the highest bark included union on T3.
