BUCKS PLANT CARE LTD

Arboricultural Risk
Assessment for
The Old Plough,
Peggs Lane, Buckland,
HP22 5HX

2022

BPC Ref: 20789

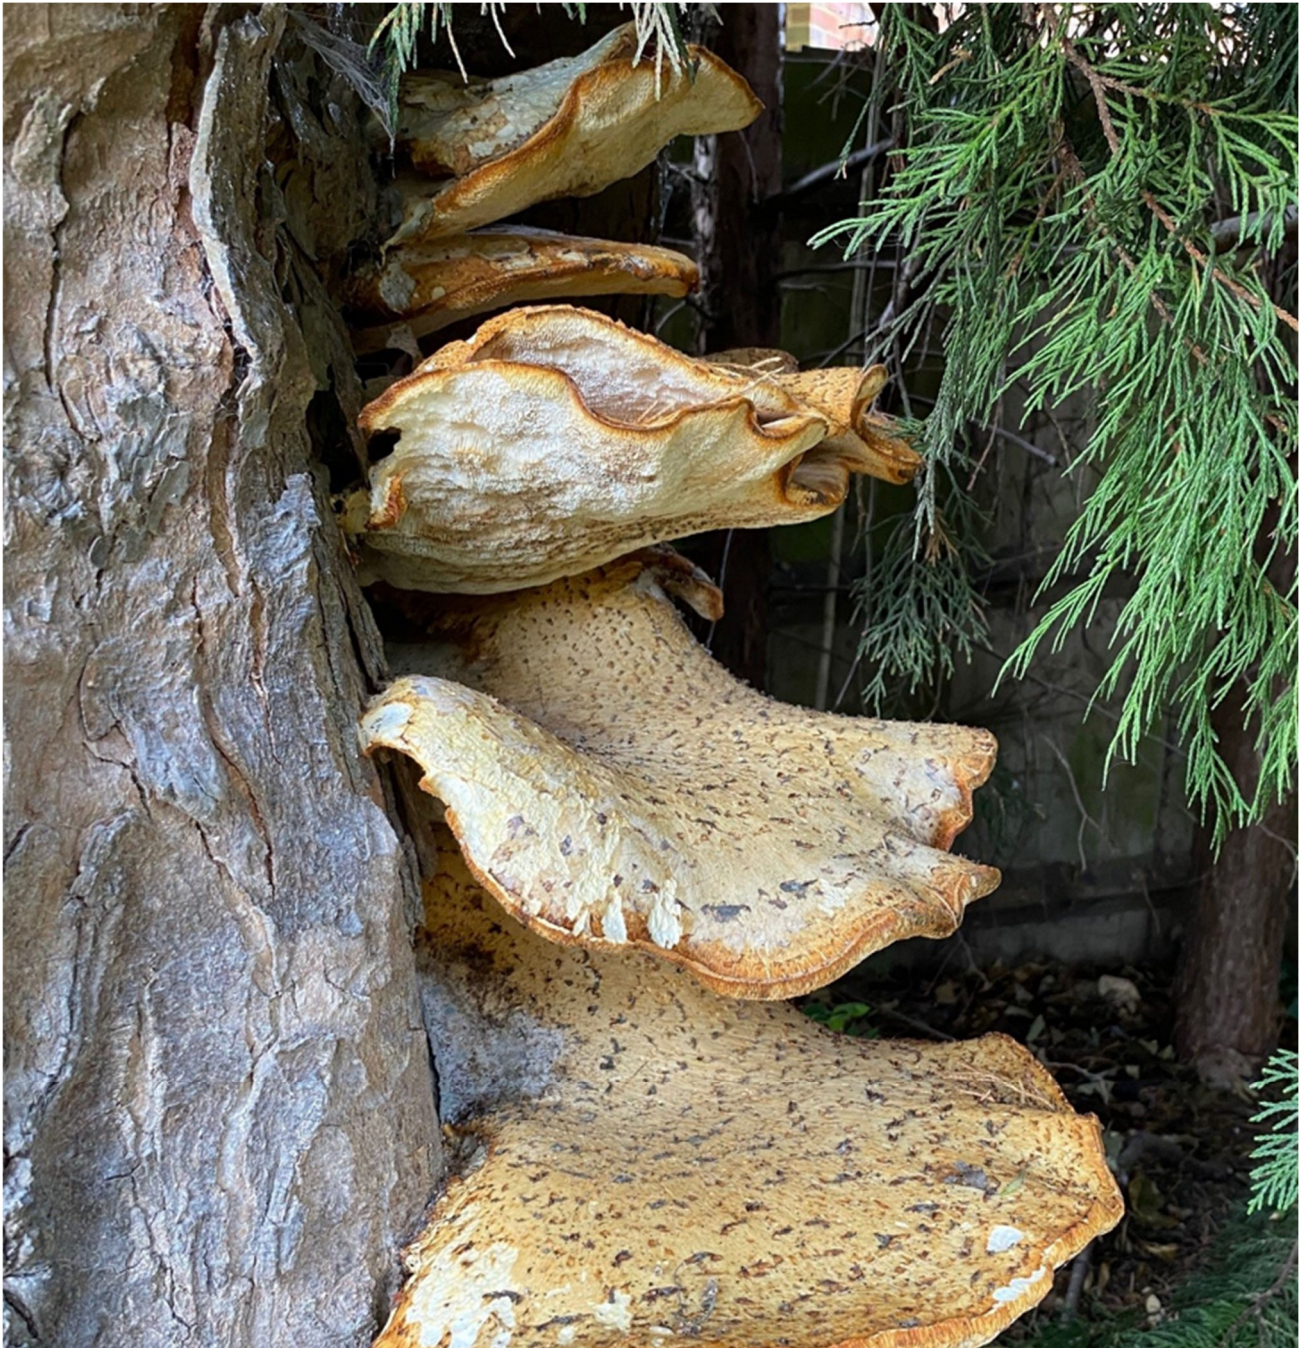
5.3. The owners are concerned about the safety of the tree due to the presence of fungal brackets. This photo was taken by Peter Elwin on the 31st August 2022.

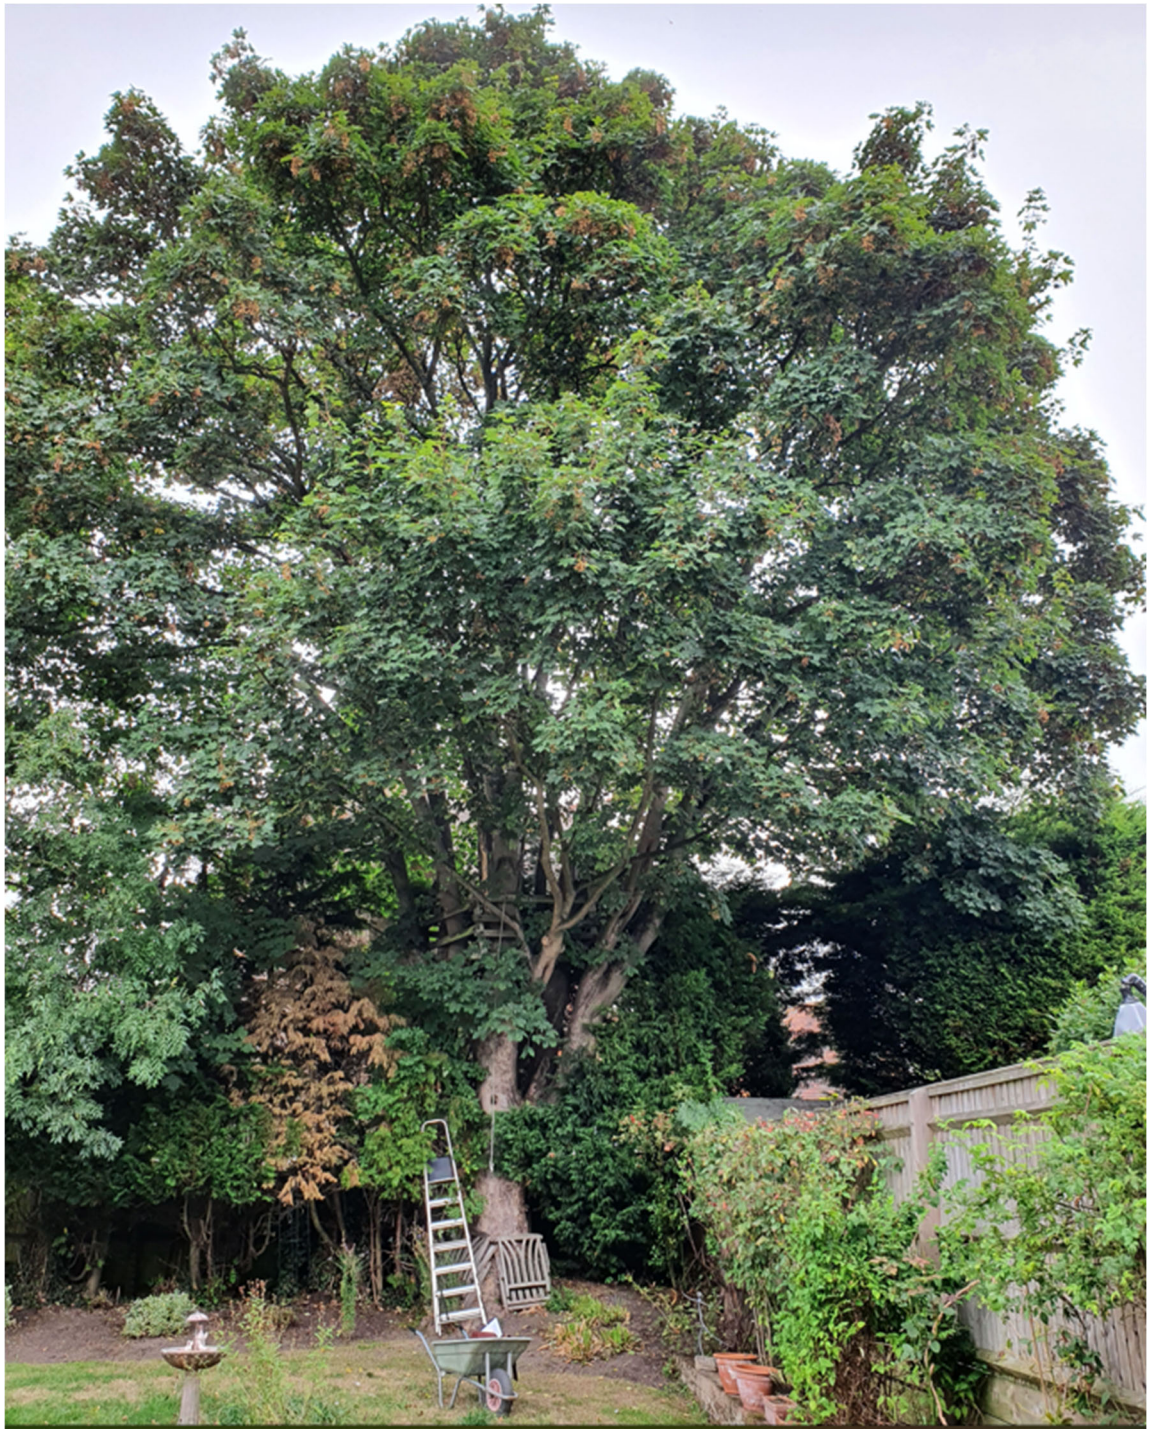
5.4. The tree in question is a mature sycamore.

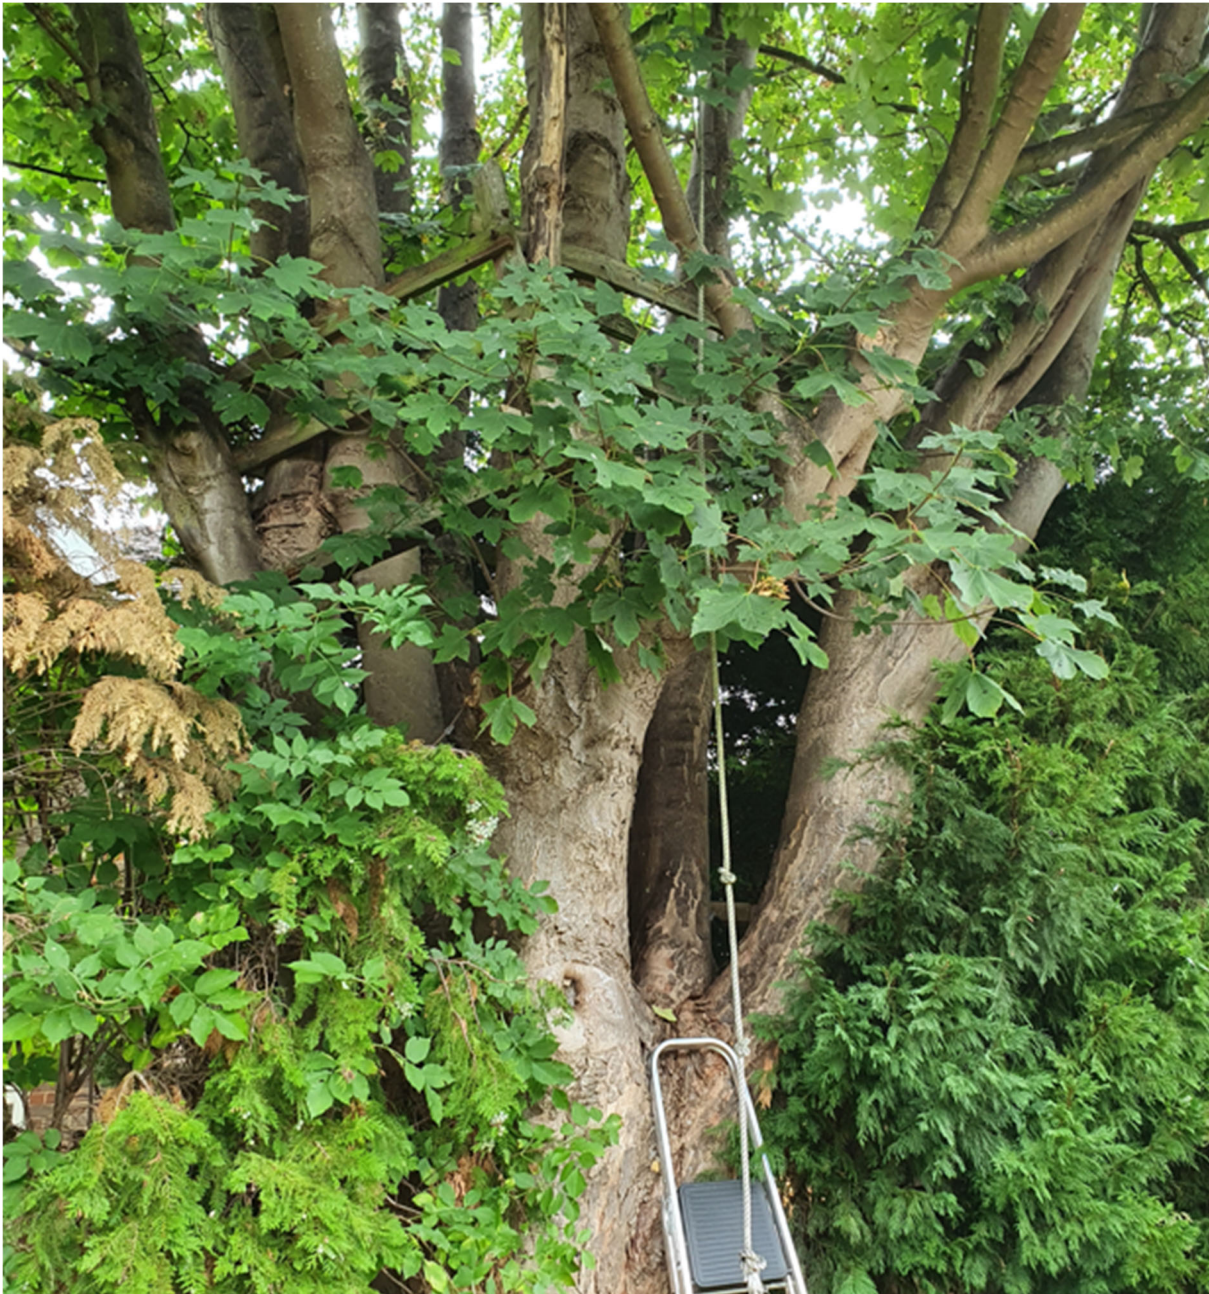
5.5. It is 20 meters tall with a crown spread of 12 meters. It has a single stem for 2 meters and then breaks into 5 stems, one of which breaks into 3 more stems.

The upper crown from the multiple stems up appears in good health with some deadwood present.

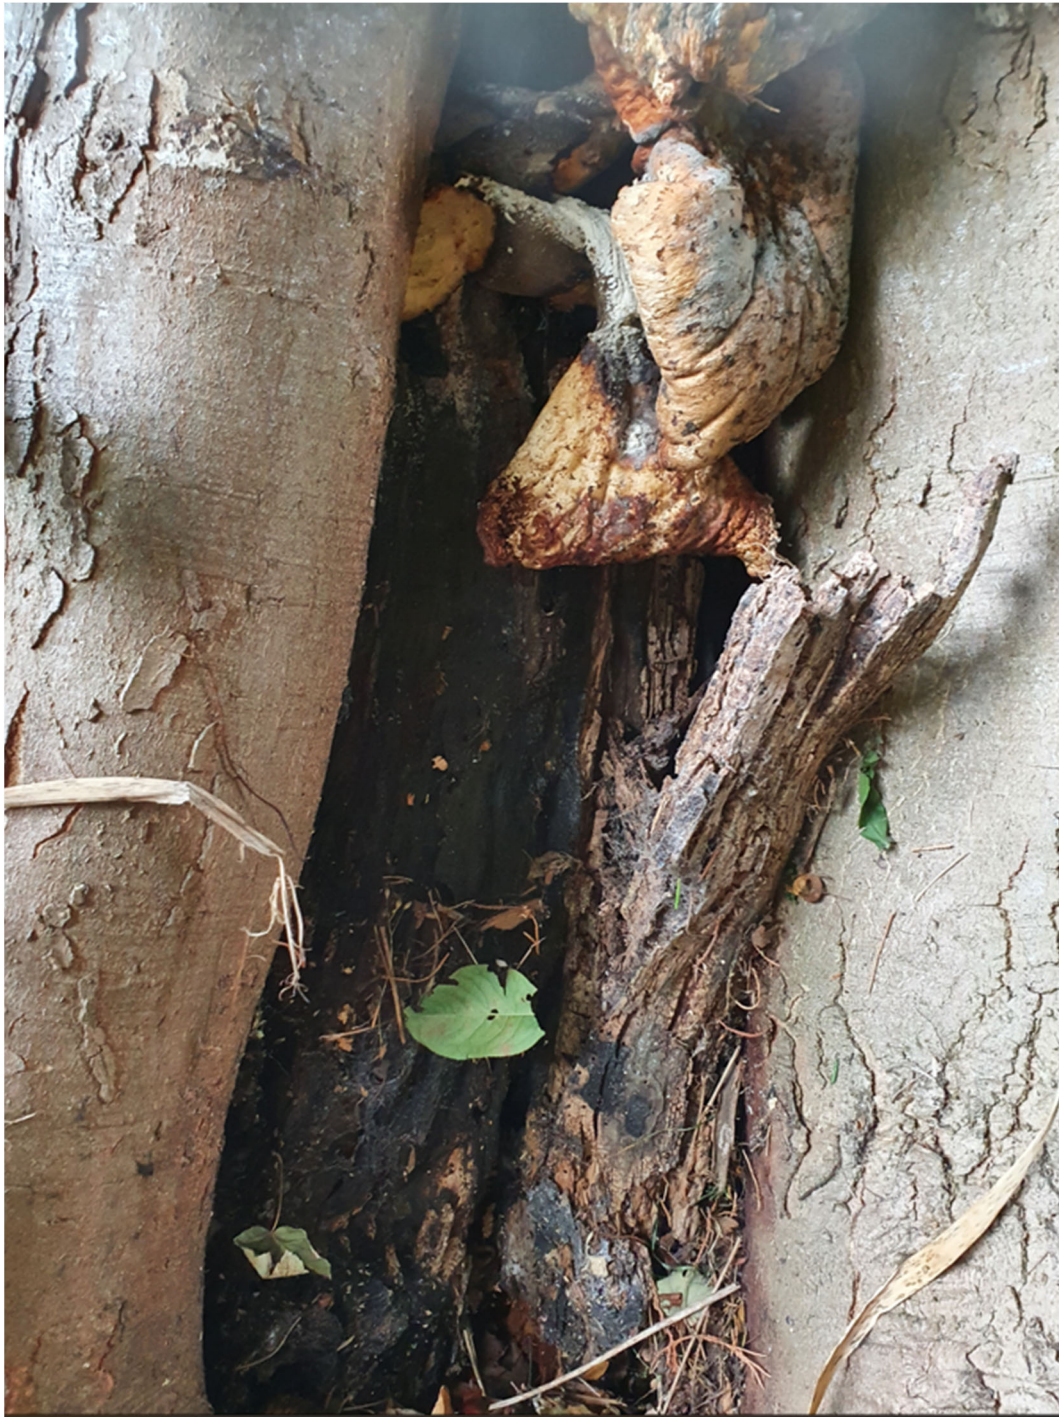
- 5.6. On the east side of the main stem there is a large cavity. On the day of the inspection the fungal brackets had mainly fallen off or shrivelled.

5.7. The fungi has been identified as Dryad's saddle (*Cerioporus squamosus*)

6.3 There are 2 options available for this tree:

1. Fell to ground level , which removed all risk.
2. Reduce it by 10 meters to reduce the stress to the base of the tree and the union of stems further up. This would require regular management every 3 years to pollard back any new growth. This will help to maintain the tree as a screen and for ecological purposes. This will also enable the tree to be veterinised and become a habitat for many flora and fauna.

6.4 Regular inspections every 3 years will be required to monitor its condition.

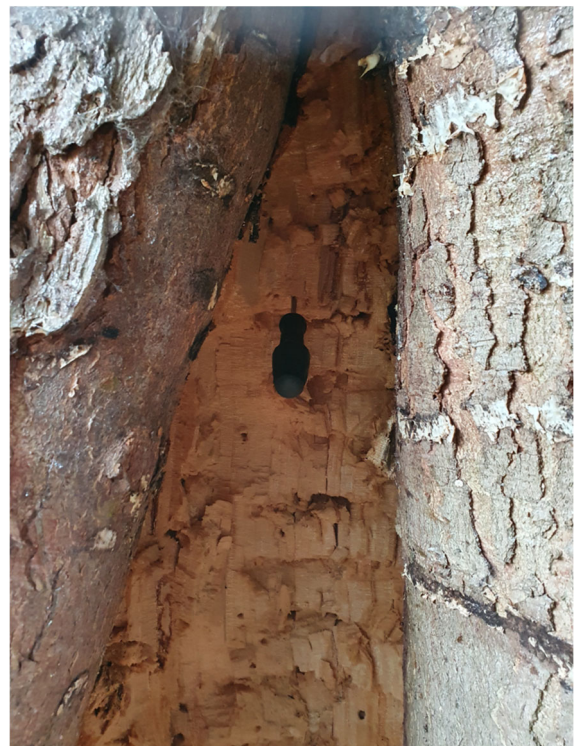
5.8. An investigation was carried out to determine the extent of the decay. After removing the soft decayed wood a large cavity was revealed.

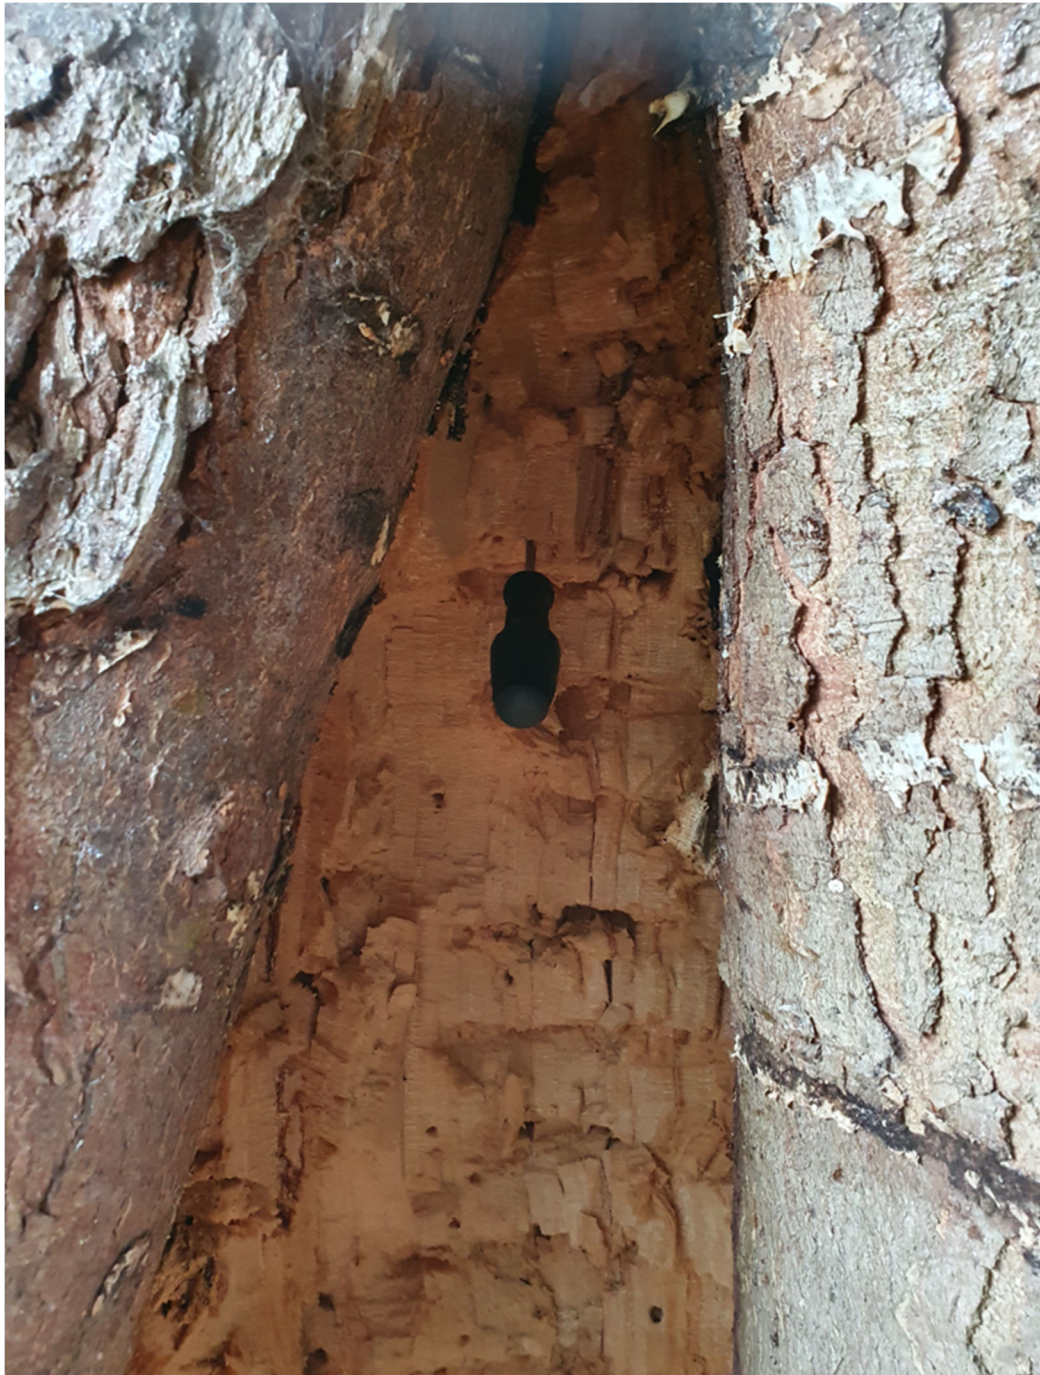
- 5.9. Using a 24cm screwdriver it was demonstrated that the decay continues up inside the trunk.

5.10. Although a large proportion of the central heartwood has been colonised by the fungus and made dysfunctional the outer supporting structure is in good health with many cambium channels supporting the crown.
