CRACK MONITORING

for Subsidence Management Services

Greenfields, Vale Lane, Kersey, Ipswich, IP7 6EH

Client:	Subsidence Management Services
Client Contact:	Simon Davy
Claim Number:	10237146
Client Reference:	IFS-AVI-SUB-19-0083874
Policy Holder:	Mr Kenneth Gleed
Report Date:	30 September 2022
Our Ref:	M14544

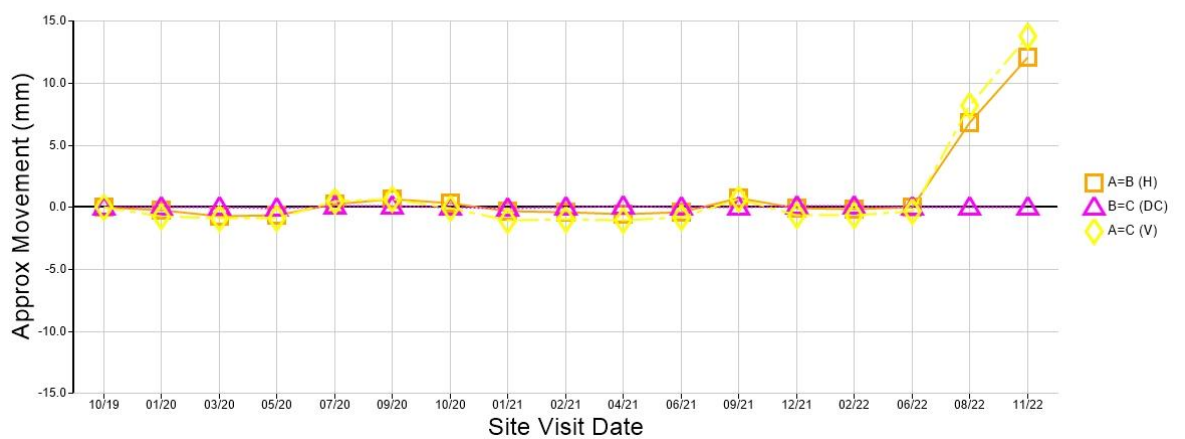
C5 - EXT Stepped crack to LH gable - low level (Front)

8 June 2022	67.09	97.00	73.51	1.20
8 August 2022	73.92	96.98	82.06	6.80 - 9.20
29 November 2022	79.24	96.98	87.64	11.20 - 12.10
