# **TREE DECAY DETECTION REPORT**

CLIENTMr M Burroughs<br/>18 All Saints Road<br/>Poringland<br/>Norwich<br/>NR14 7TASITE/TREE INSPECTEDAs above<br/>Oak located in front gardenINSPECTED BYColin McDonald Tech Cert (ArborA)<br/>Arboricultural Consultant<br/>Treecare Consultants LtdDATE OF INSPECTION11 October 2022

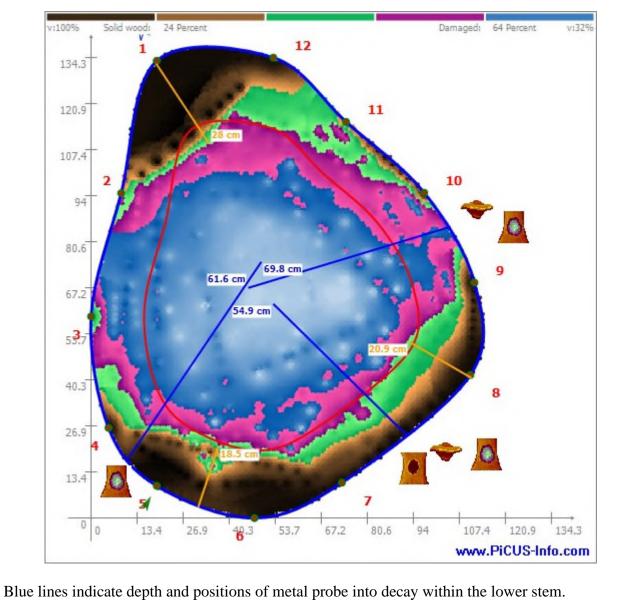
Orange lines indicate depth and positions of metal probe into decay within the lowe

In order to fully establish the extent of decay a Picus Tomograph decay scan was carried out at just above ground level. The resulting tomogram identified an extensive area of decay within the stem base and root crown. The tomogram estimates 64% damaged wood shown by the blue and violet colouring with only 24% of solid wood remaining shown as brown. The green colouring is intact wood with less density than the solid wood but most likely contains insipient decay which makes up the remaining 12% of the cross section tissue.

The decay pattern is shown to be breaking through to the outer shell wall of the stem on the east and west side with minimal solid wood connection to the northern and southern outer shell walls. There is a large solid root buttress to the north but the solid wood residual wall to the south is notably thin with less than 20cm depth.

It is recommended that the tree is felled as soon as practically possible but within six months.

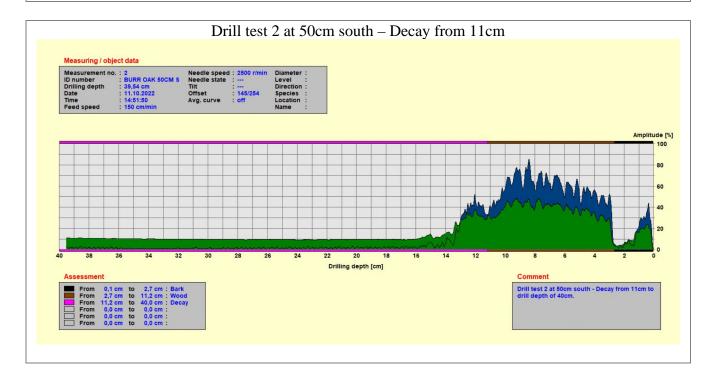
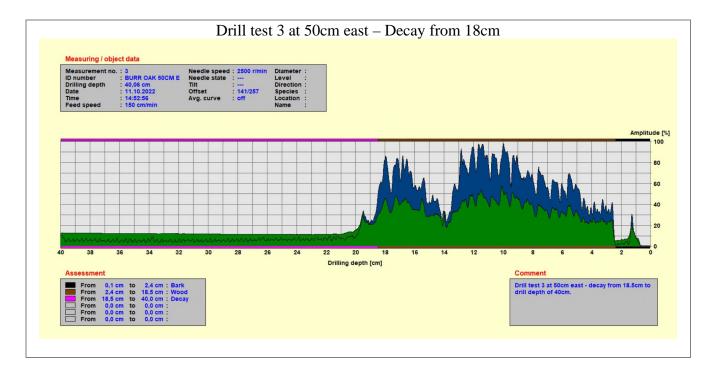
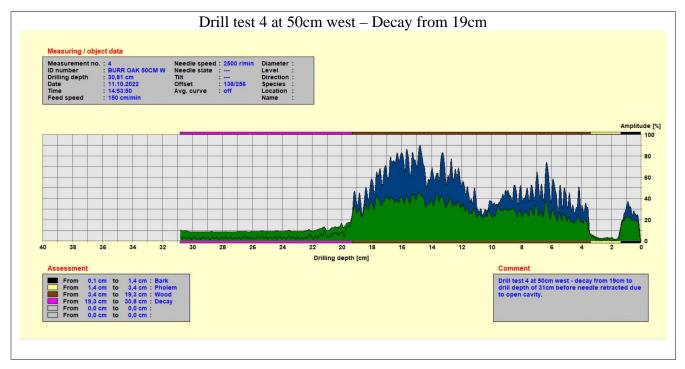
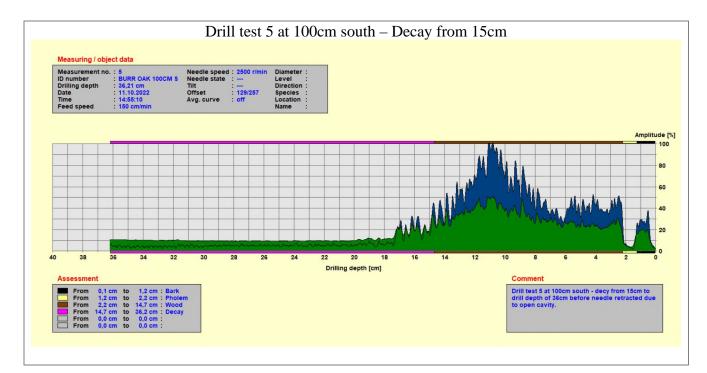
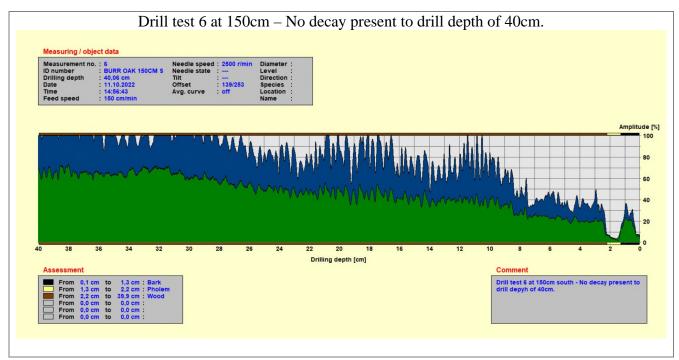
In order to establish how high the decay extends up the stem, resistance drill tests were carried out at 50cm above ground on the main compass aspects. The results of these tests are shown in section 6 of this report. The drill tests identified an extensive decay cavity at a depth of between 11cm and 24cm. A drill test was taken on the southern side of the stem at 100cm which identified decay at 15cm depth and a further drill test taken at 150cm on the same side identified no decay. The internal decay cavity therefore extends up the stem to a height of approximately 125cm.

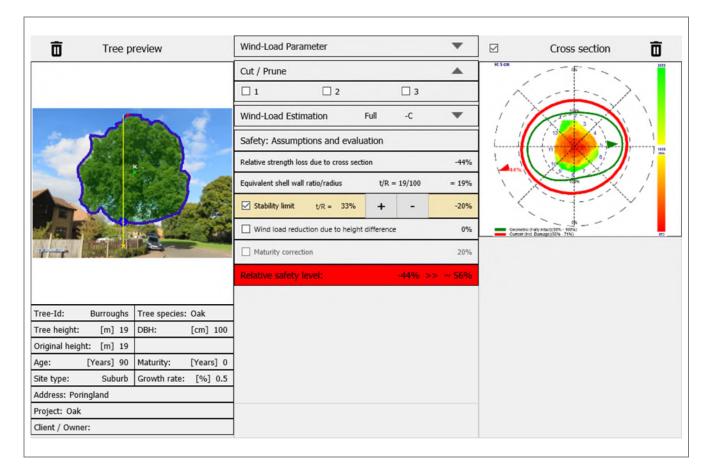
Results as the tree stands at present in relation to the relative strength loss due to decay – Relative Safety Level = 56%. The minimum acceptable level would be 100%.

A biomechanics Rinntech software analysis estimates a stem cross sectional strength loss in relation to the decay as -44% (see section 7). The relative safety level of the stem cross section at present is therefore calculated as 56%. The minimum acceptable level would be 100% without having to mitigate with intervention and therefore the tree has an unacceptable level of safety at present. The decay within the lower stem is excessive and is breaking through the outer residual stem wall on two sides. The risk is therefore that the lower stem will collapse through torsional loading from wind forces exerted on the crown lever arm causing twisting of the stem base. The decay will continue to progress increasing the risk and it is therefore recommended that this tree is removed at this stage in order to prevent the risk of harm or damage occurring as a result of structural failure of the tree
