Report on Structural Inspection

Barn, Abbey Fields Farm, Newstead Abbey Park, NG15 8GE

April 2022

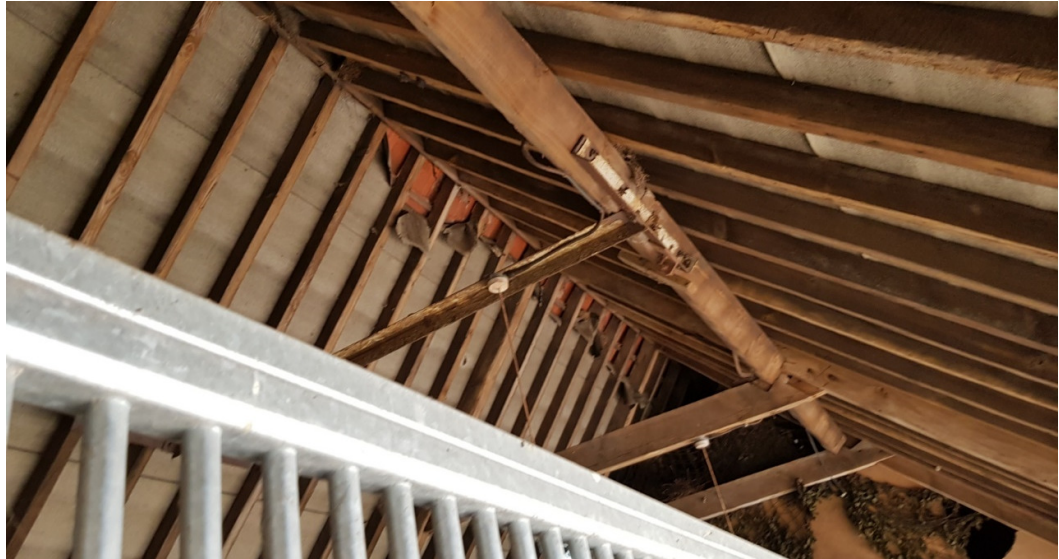
Figure 1 Rafters, purlins, trusses and splice

Internally the structure is exposed. The timber rafters are supported on a single row of inclined timber purlins on each pitch. The purlins are supported on two raised chord A frame timber trusses, one above the timber partition and one a third way into the open central space. The purlins are supported on the internal brick wall. A steel splice and tie connect the

purlins in the central space where there is a butt joint where we assume there used to be a wall or truss. There was no diagonal bracing or sheathing in the roof.

- The truss joints have become dislodged indicating outward spread of the truss;
- The purlin splices are inadequate;
- The purlin bearings on the internal brick wall are inadequate;

- The roof has racked over;
- There is some weathering of the stone on the East gable where the wall has been pointed with sand/cement mortar;
- There are voids in the stone walls;

- The existing roof structure has a missing truss or support wall and has spread. We recommend that the roof structure is replaced. If the new roof is to be vaulted then a ridge beam could be used, with sheathing or bracing to the roof plane;

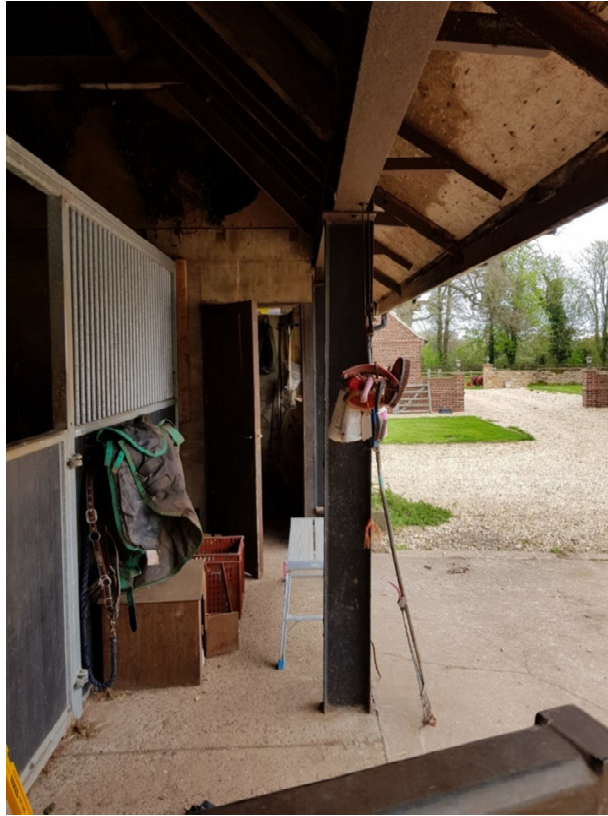
Figure 2 Steel arrangement in front (South) wall

The front elevation is mainly open, with return walls each end to enclose the partitioned rooms. The roof is supported over the opening by a steel beam on posts at each end of the opening and an intermediate post where the beam is interrupted.

- There are cracks of around 10mm width in the North wall, seen from the Garage;
- Steel beams and columns supporting the front elevation are unpainted and have surface corrosion;

- Remove the steel beam and posts in the South elevation and infill with masonry built on a new footing;
- Replace timber lintels and embedded timber in walls, if found;

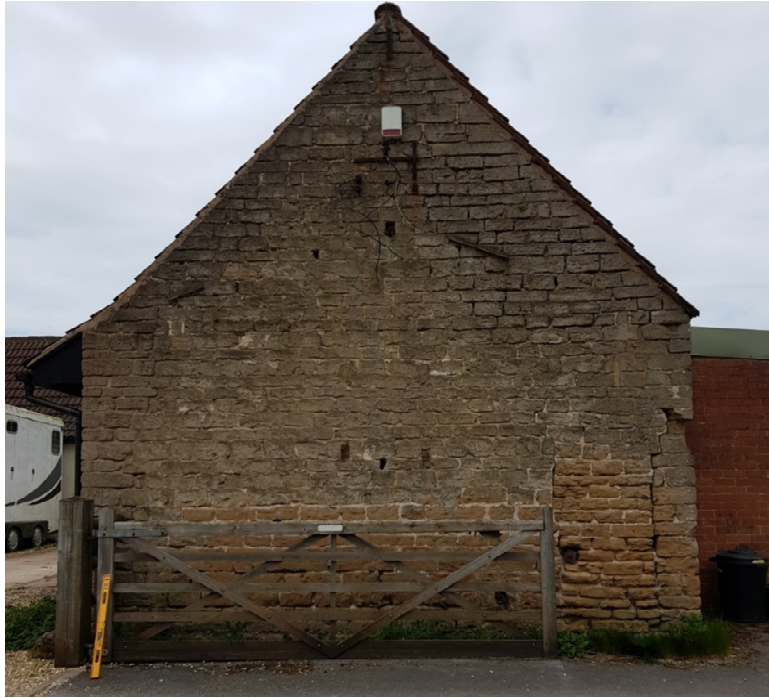
Figure 3 East Gable

There appears to be an infilled doorway in the East gable where the sides have not been bonded in. There are scars of an old roof verge on the external face of the east gable.

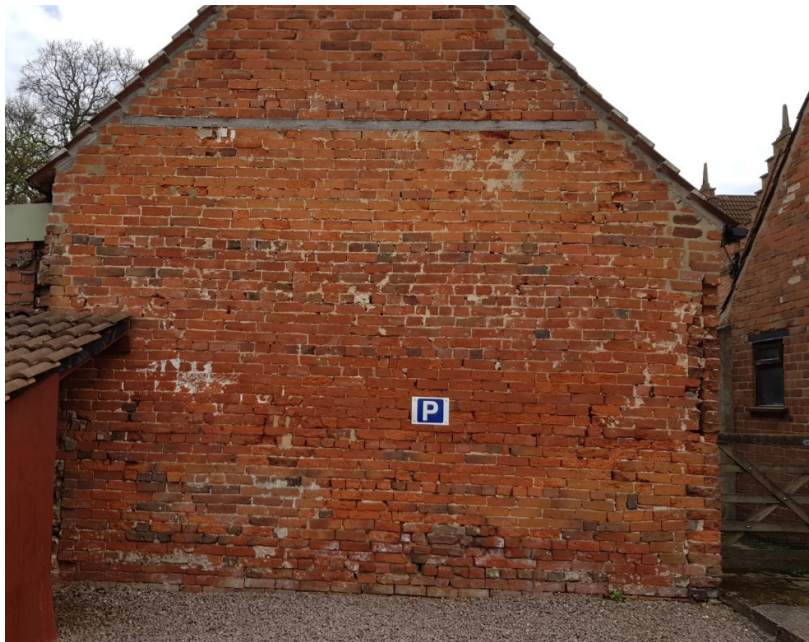
Figure 4 West Gable

The West gable, front return and internal wall are constructed in solid 230mm thick brick. The gable adjoins a neighbouring farm yard but we were permitted access to inspect it. There is a timber plate buried in the gable above eaves level.

- The West gable does not look well built and has a timber plate built in it which is exposed externally;
- The existing footings are at least 1.15m deep onto natural sand strata, and therefore the ground floor formation could be lowered to accommodate a new slab, insulation and screed/finishes;

- Tie internal brick wall to walls each end and bond corners with insitu concrete corner bonders;
- Rebuild the West gable wall – in stone as proposed;
- Remove the cement based mortar pointing in the stone walls and replace with lime mortar. Fill voids in the wall where they are found;

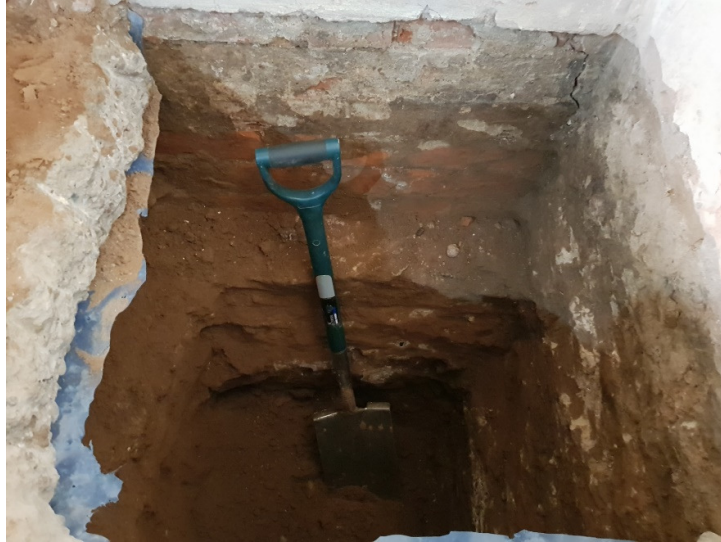
Figure 5 Trial Hole

A trial hole was dug inside the central open space, against the rear stone wall and internal brick wall. The hole was excavated to a depth of 1.15m and the base of the wall footing was not found. The brick wall was built off a stone wall, changing from brick to stone 450mm below floor level, which projected 130mm from the face of the brick. The ground floor slab is 120mm thick mass concrete cast on sandy made ground which appears to become natural sand at approximately 0.8m deep.

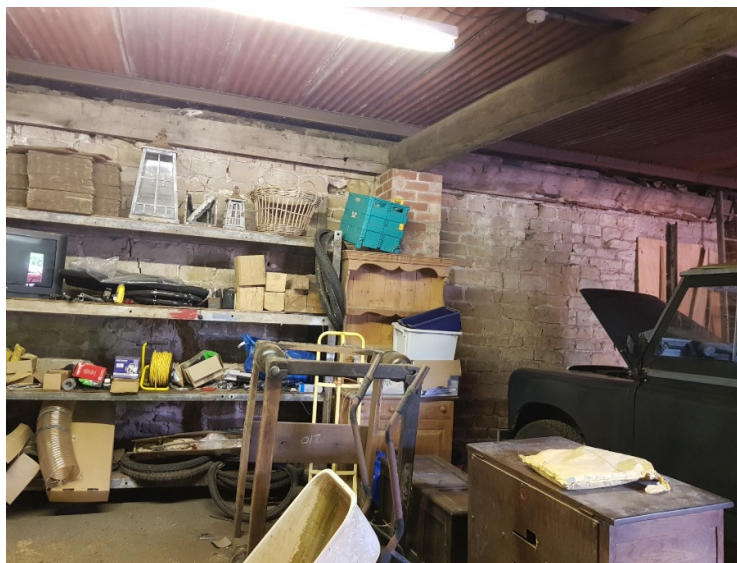
Figure 6 North wall seen from the garage

The North wall is generally rendered/plastered internally but its construction can be seen from the garage extension side. There is a recess formed in the wall behind the shelving.

- Tie across cracks in the external walls with Helifix crack repair system;
- Reinststate the stone in the recessed area in the North wall;
- Introduce independent lintels over windows;
