**Visual Structural Survey
21-2123**

**Part demolition, alterations, extensions and
conversion of barns to form 3 dwellings**

**Laddus Farm
March River Side
Upwell
Cambridgeshire
PE14 9AT**

4th October 2022

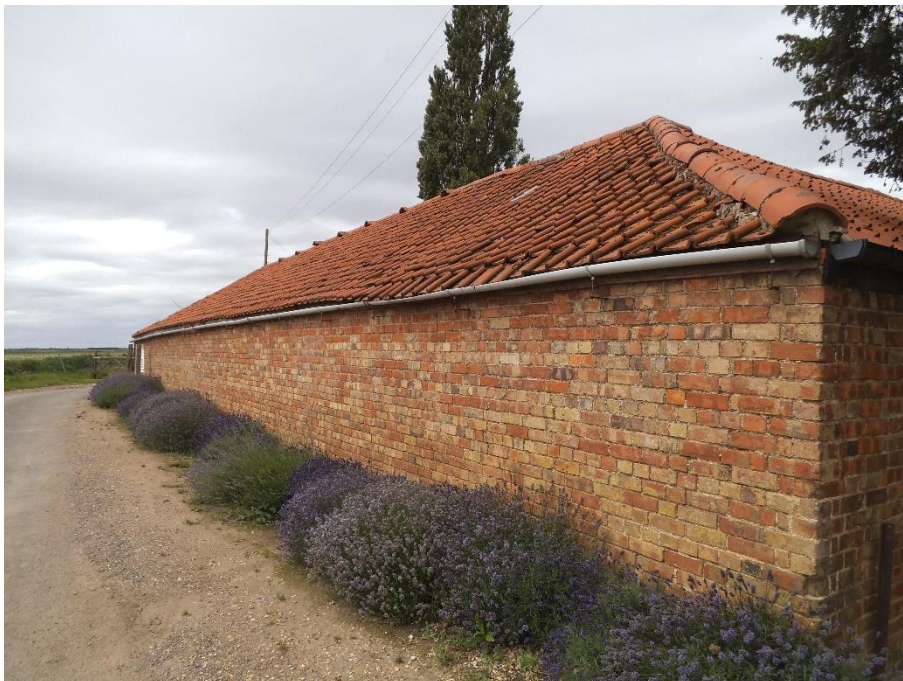
Barn 1 as seen from the road

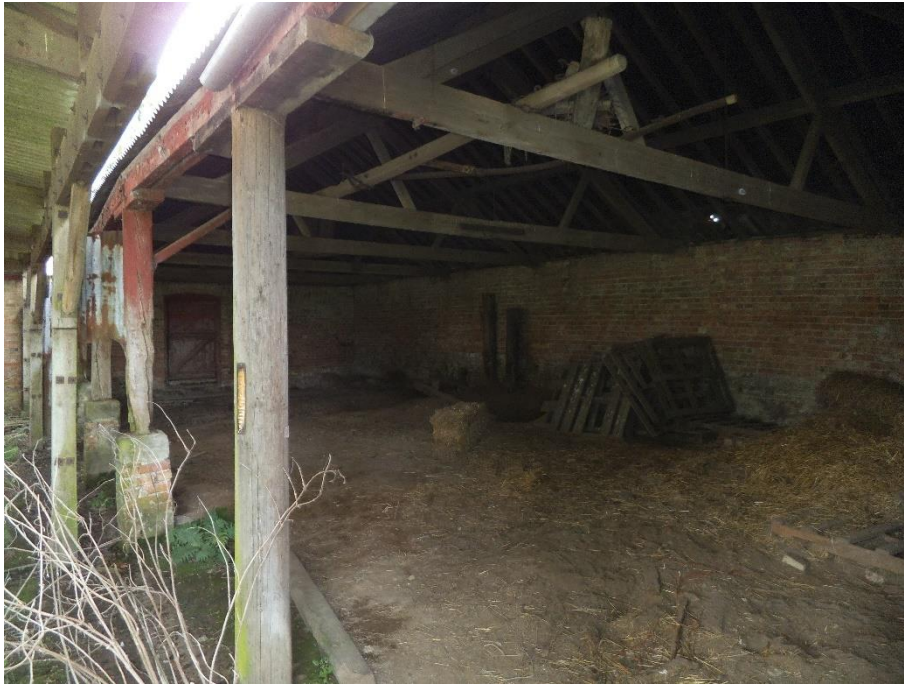
Barn 1 as seen from the rear

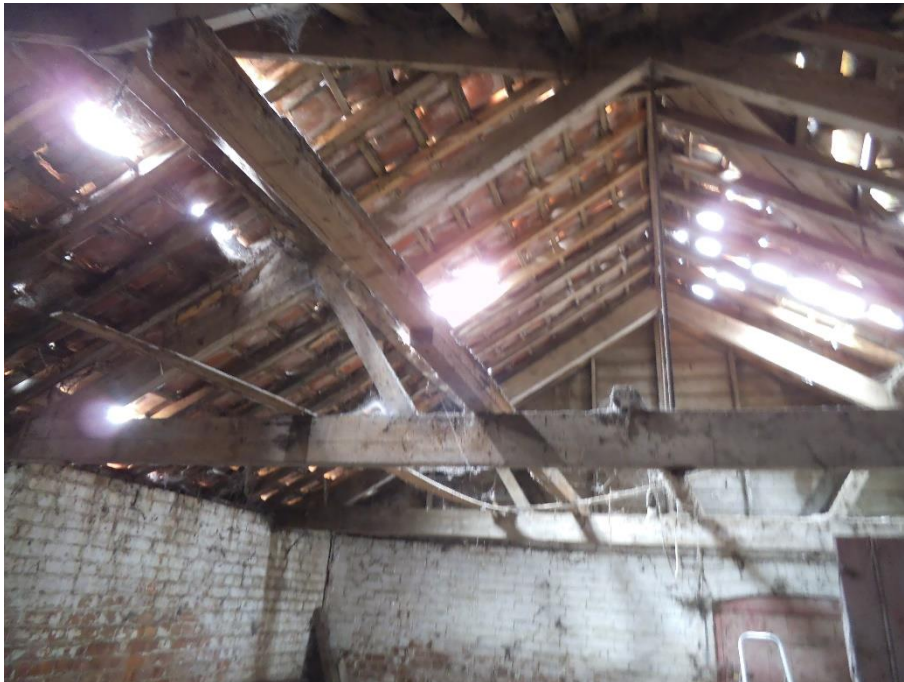
The front wall of the barn is leaning out slightly with a crack evident where the wall separating the storage area from the cart shed abuts, as shown below, otherwise there was no evidence of distinct structural distress.

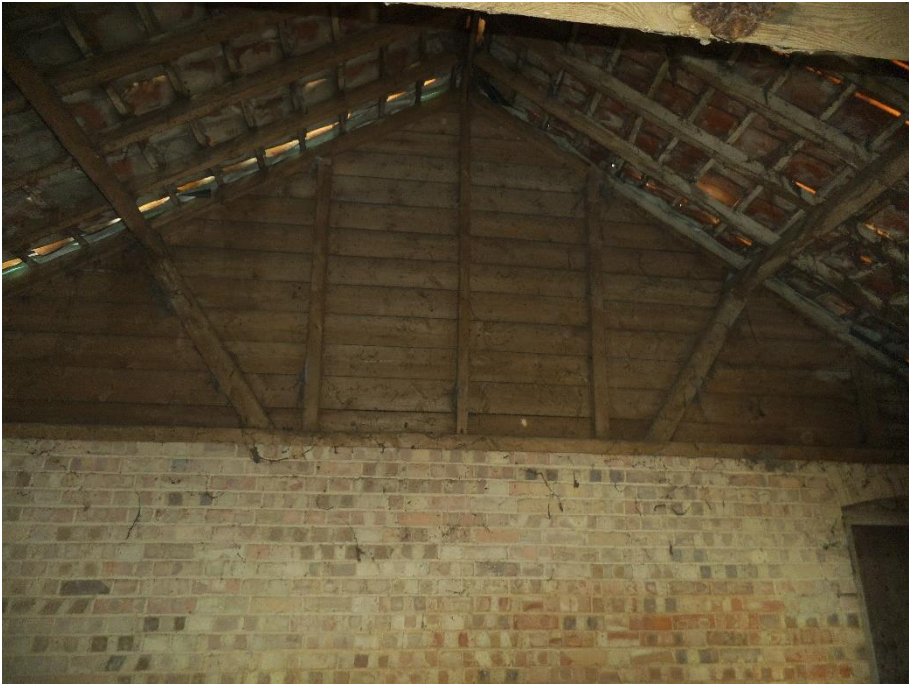
Walls at roof level separating sections of the barn are formed of timber studwork and boarding, as shown below. These will require removing and re-building to provide suitable fire separation.

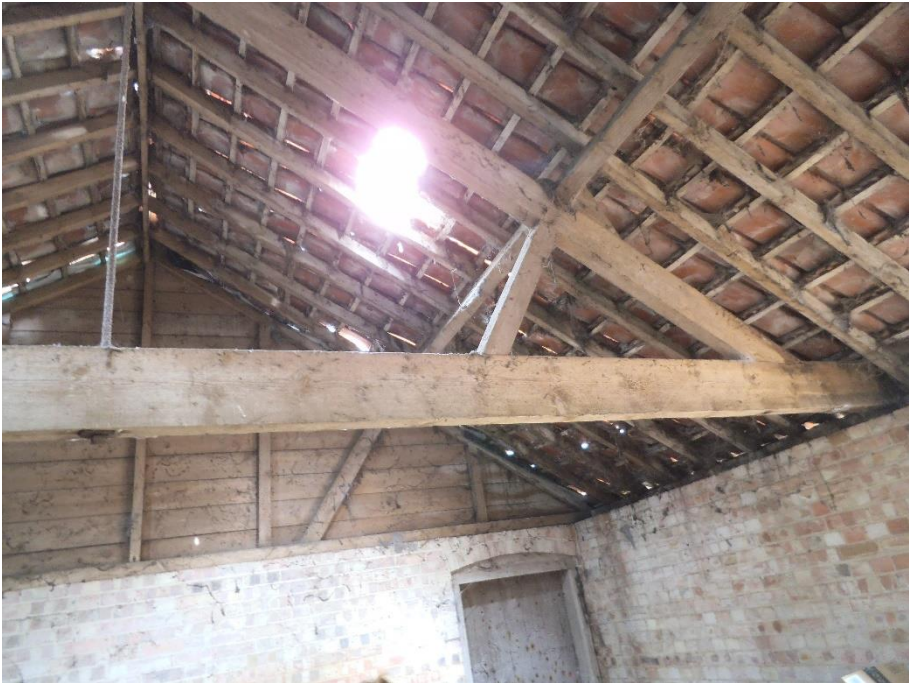
The roof of the barn is hipped and formed of a cut roof. The roof is covered with clay tiles.

The existing walls will need raising and the roof will need to be replaced in order to accommodate the requirements of the flood risk assessment.

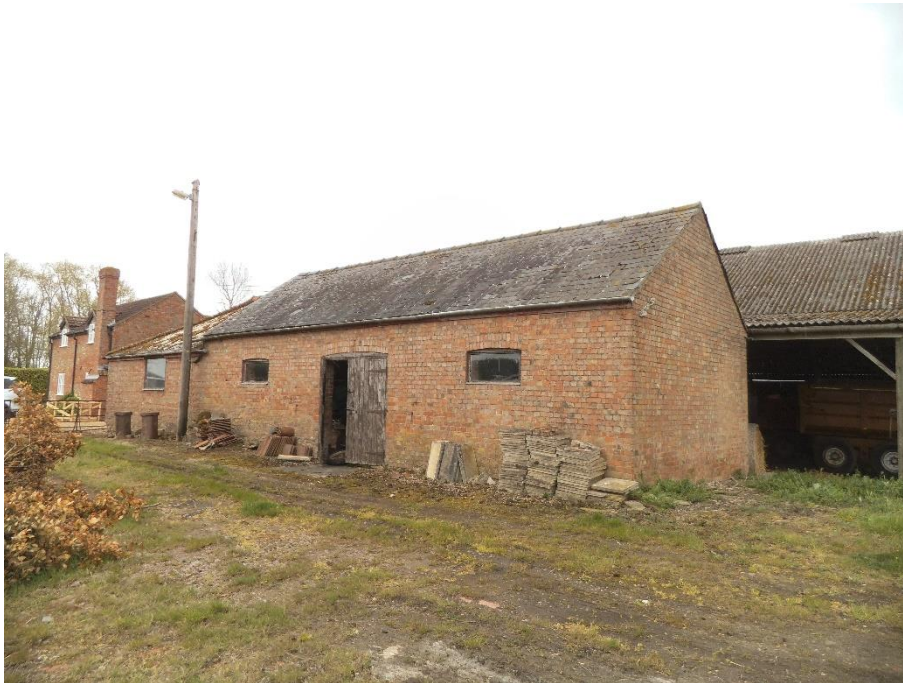
Barn 2 as seen from the rear.

The barn is constructed with solid brick walls. There was no evidence of distinct structural distress, with external walls being reasonably aligned in their horizontal and vertical axis and distinct lines of structural cracking were not noted.

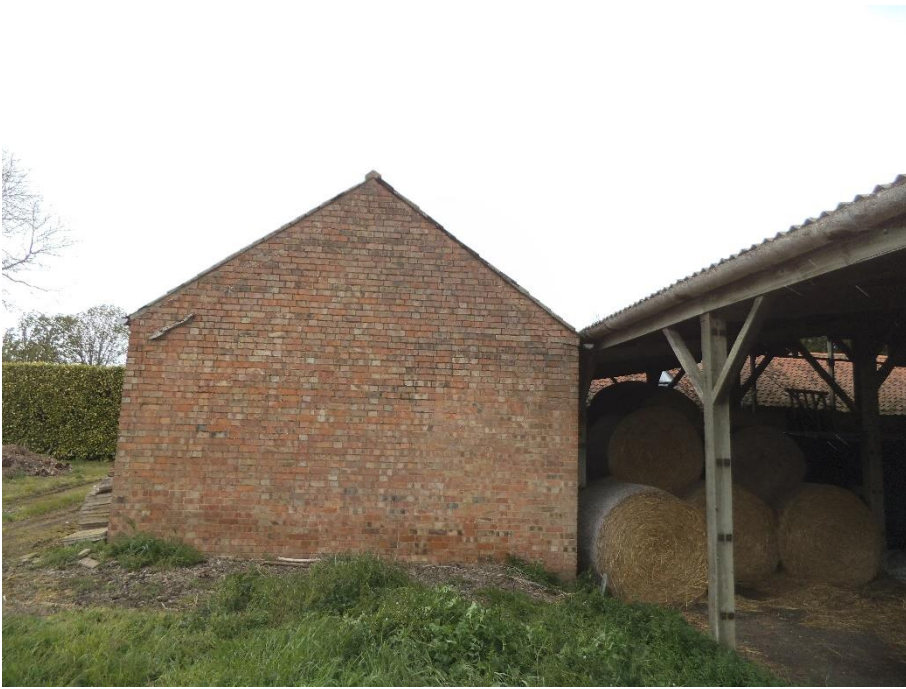
Barn 2 from side

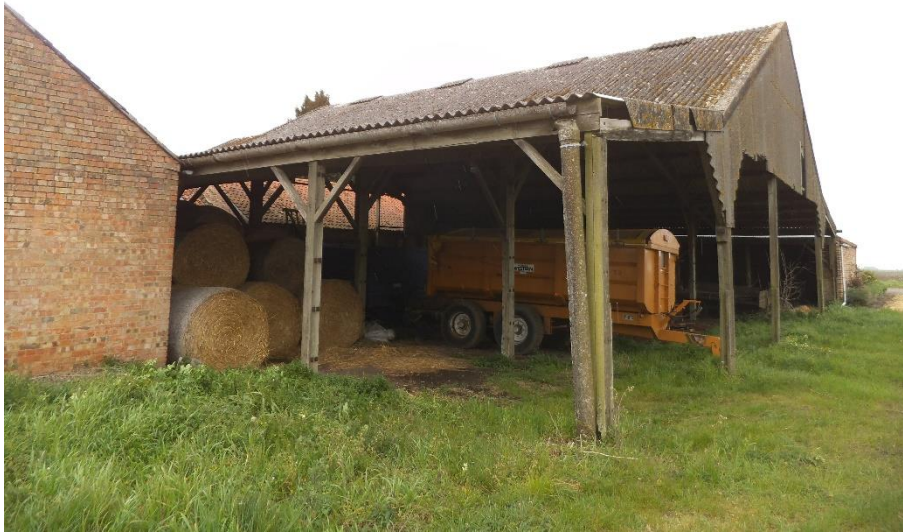
Timber frames, and asbestos clad section of barn to be removed.
