## The Old Rectory

Project Address: The Old Rectory, Clyst St Lawrence

Service: Timber & Render Condition Assessment

Our Reference: 212238/The Old Rectory/Report

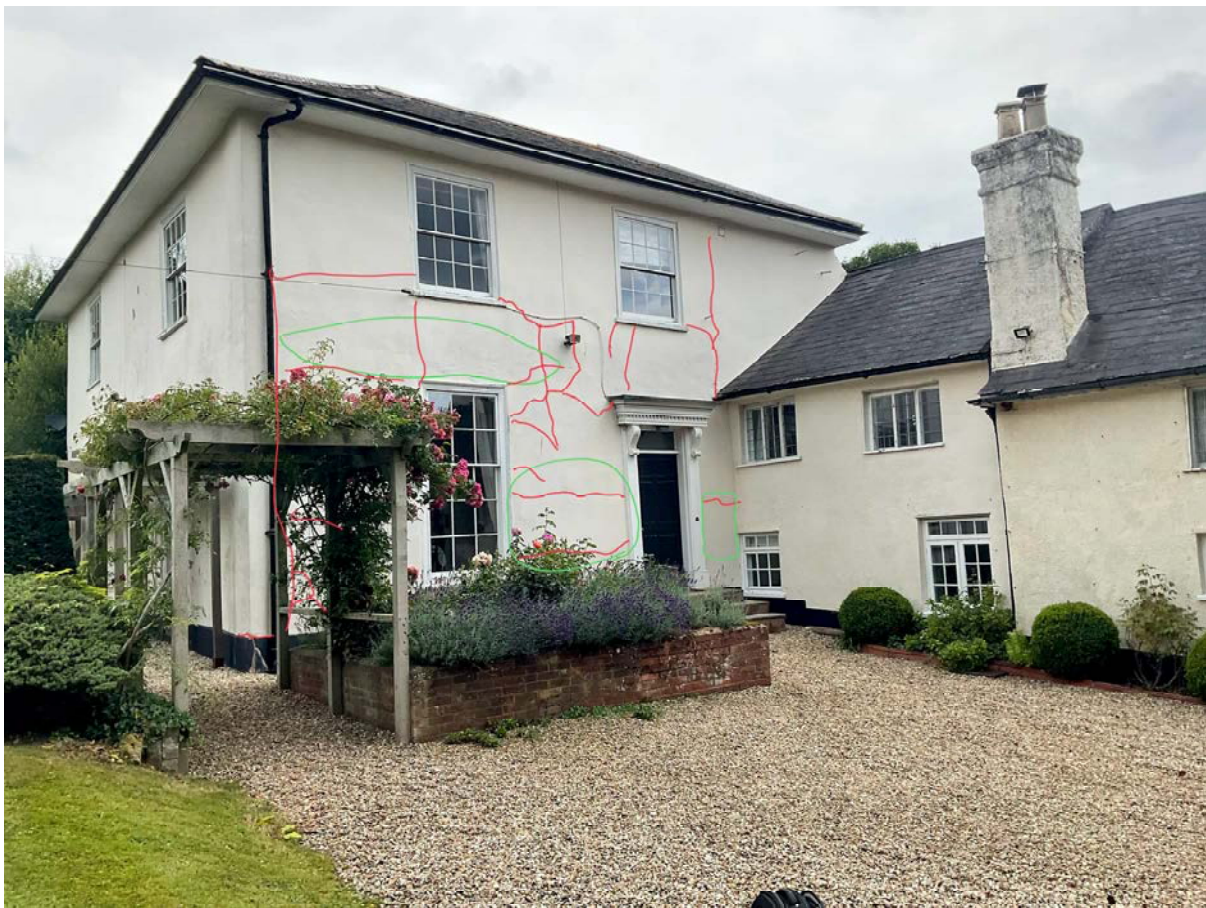
**Figure 1: Easterly Elevation**

The external render is severely defective, with extensive cracking evident to all elevations, and with large sections of render presenting a safety concern as it detaches further from the walls.

Cracks thought to be significant are identified in red, typically these fractures are 2-7mm wide, with areas of previous repairs highlighted green (these repairs often featuring hard cement-based mortars)

Unfortunately I do not believe that the render can be conserved, and will require replacement in its entirety. Although I fully support the principle of like-for-like repairs, I would recommend consideration is given to opportunities to improve thermal performance, with the potential to use breathable insulated lime-render for replacement, while also considering sensitive thermal improvements around windows and doors.

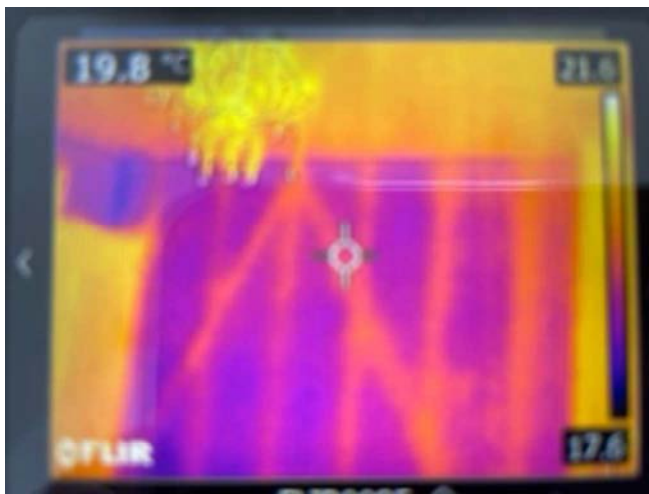
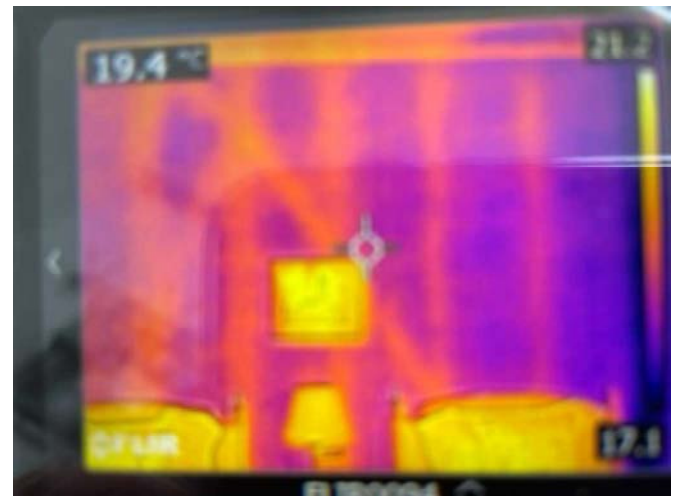
I noted considerable variations in the thickness of external walls, both at, and between, ground floor and first floor levels, and was suspicious that the construction method was not all that it seemed; I used a Flir E8 thermal imaging camera in the hope it could provide an insight into what lay beneath the rendered covering, and was able to confirm that the Georgian range had been built utilising a lightweight trussed-timber frame method rather than being of solid wall construction (see Fig.5&6).

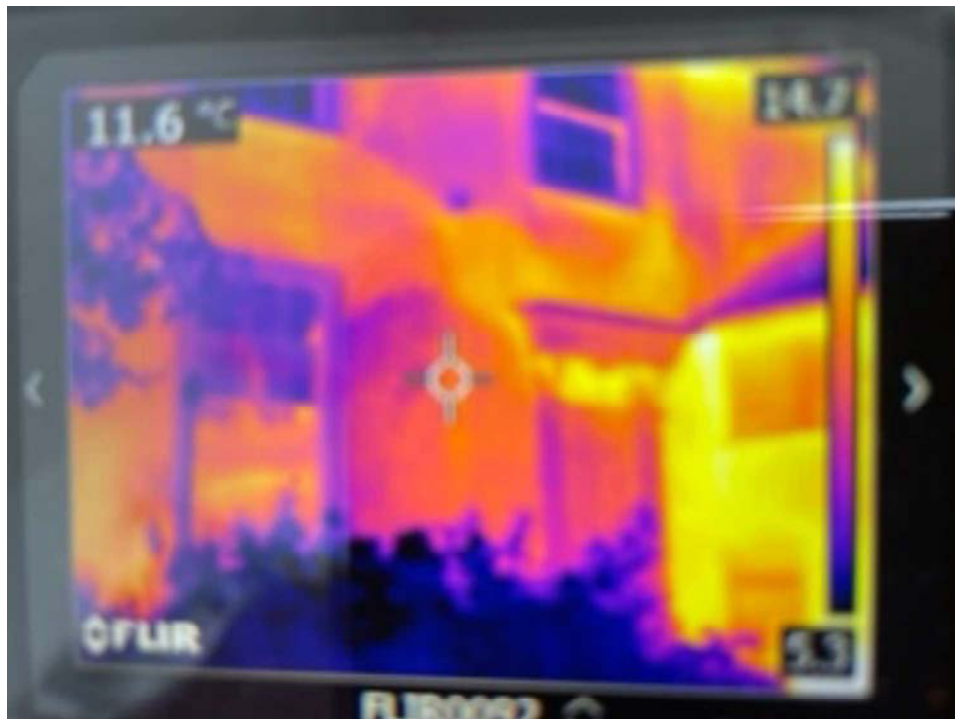
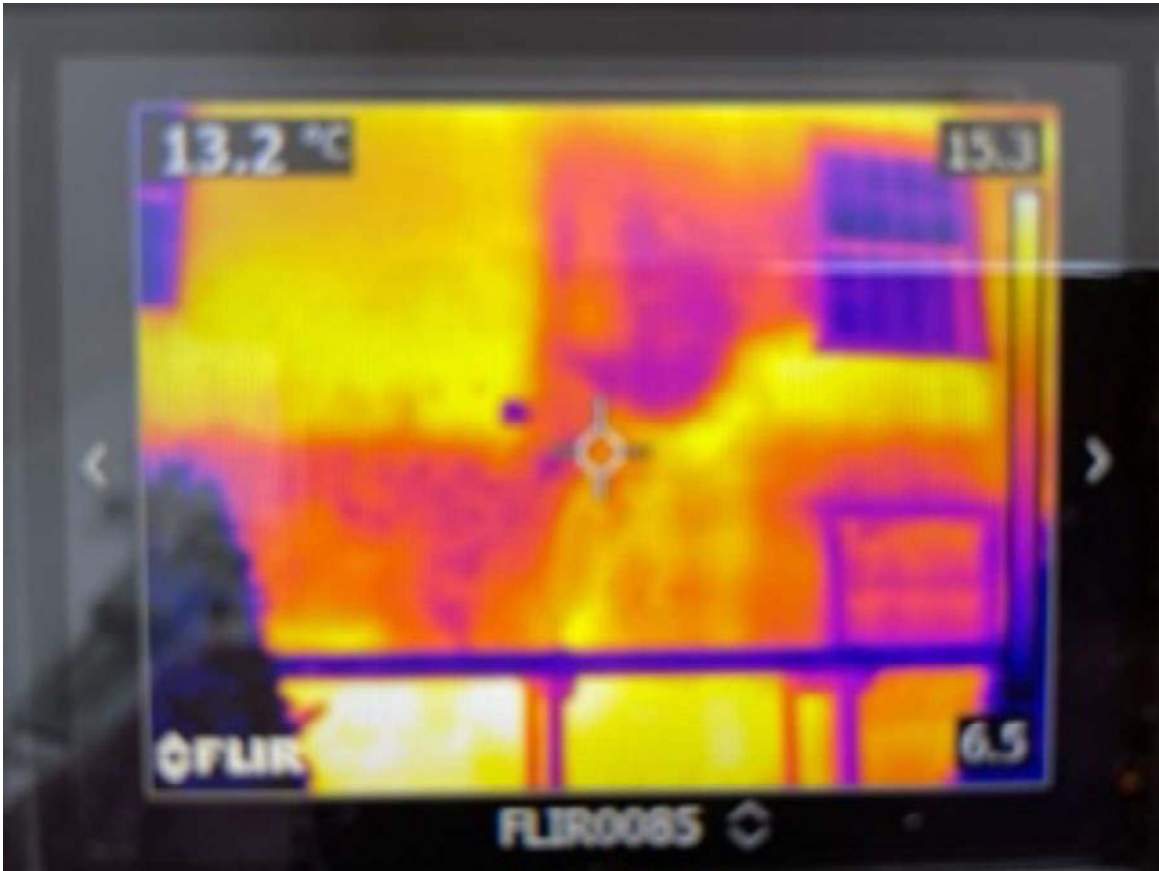
preferable to assess heat loss), I requested that the central heating was left on during the day in order to better assess thermal performance and condition. As could be expected for such a period property, significant heat loss was identified around fenestration (see Fig.7-9). Furthermore, thermal anomalies associated with moisture ingress were noted behind many sections of render, particularly evident around the extensive cracking that features on all elevations (see Fig.9).

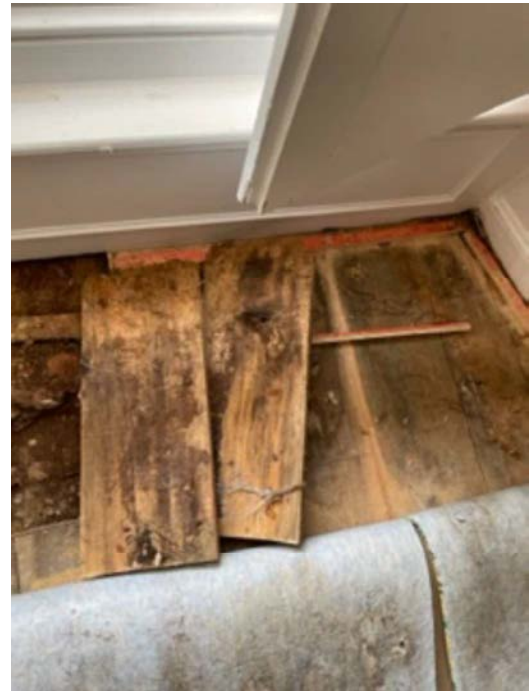
FIGURE 12

Wood decaying fungal mycelium (*Coniophora puteana*) was noted on the underside of the underlay (see Fig.12).

SHOWING FUNGAL MATERIAL ON UNDERLAY AND FLOORBOARDS.

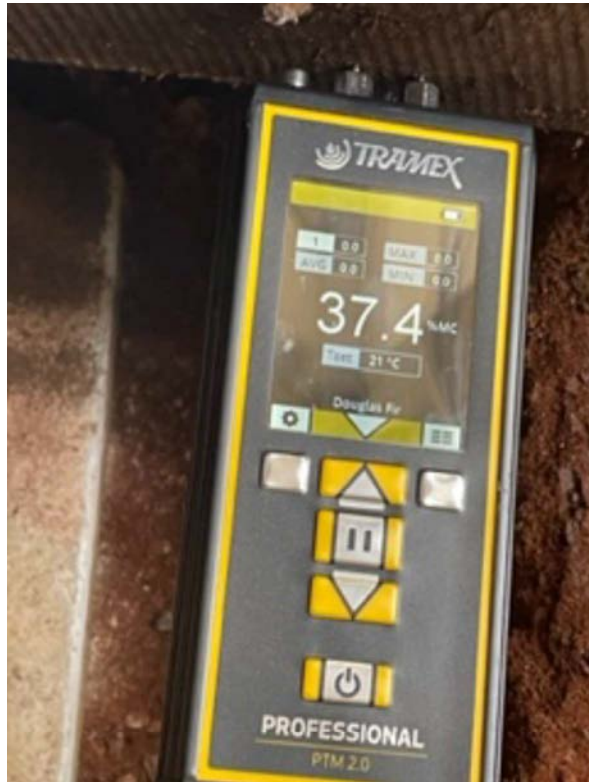
FIGURE 13

Softwood timber floorboards were suffering fungal damage, with oak joists showing both fungal and beetle damage, being worst affected close to the bearing-ends. I used a Tramex moisture meter and recorded high moisture levels (above 20%) throughout the exposed area (see Fig.13), reaching moisture fibre saturation in locations close to the westerly wall; providing the optimal conditions required for fungal initiation.

SHOWING HIGH MOISTURE READINGS.

The existing configuration of the joist bearing-ends means that they will always absorb moisture, accelerating deterioration, therefore I recommended that the joists-ends are isolated from masonry, and consideration is given to providing support from a sleeper wall.

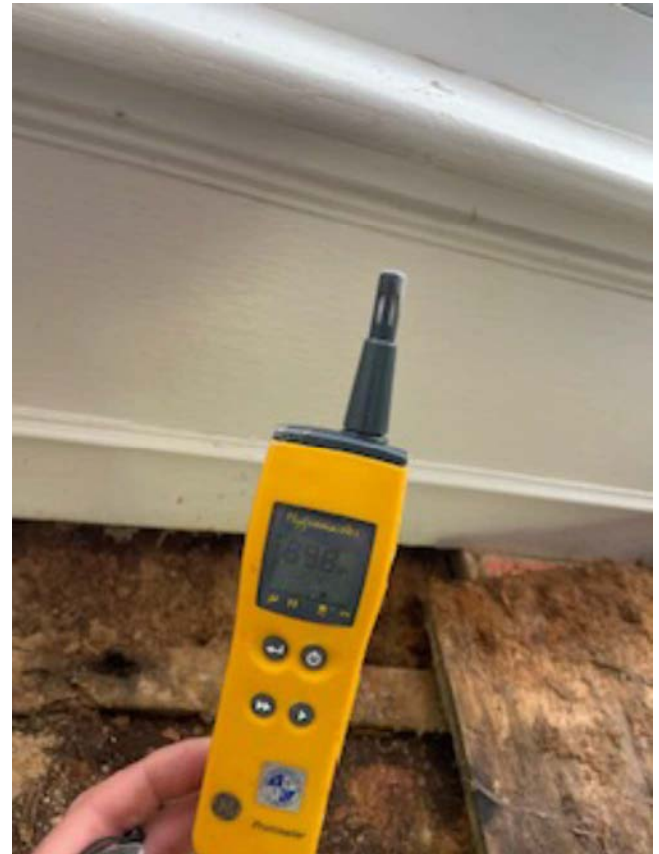
FIGURE 14

In common with all other areas assessed, I used a hygrometer to measure humidity within the subfloor void. Figure 14 shows readings of 89.8%rh (relative humidity), with the moisture content of joists reflecting the high humidity levels within the sub-floor void. As a consequence of lifting floorboards and creating improved air circulation, I would expect the real sub-floor humidity levels to have been significantly higher. Of note, 90%rh is equivalent to 20%WMC, the *at risk* threshold that supports fungal development.

HYGROMETER SHOWING SUB-FLOOR HUMIDITY

Additional to repairing the defective floor joists, and in order to provide a long term solution to the dampness that has facilitated the decay, I recommend the causes of subfloor dampness are further investigated. This investigation could include an assessment into the condition of nearby drainage and consideration how ground levels and surface water can be better managed around this area in particular, and the property in general.

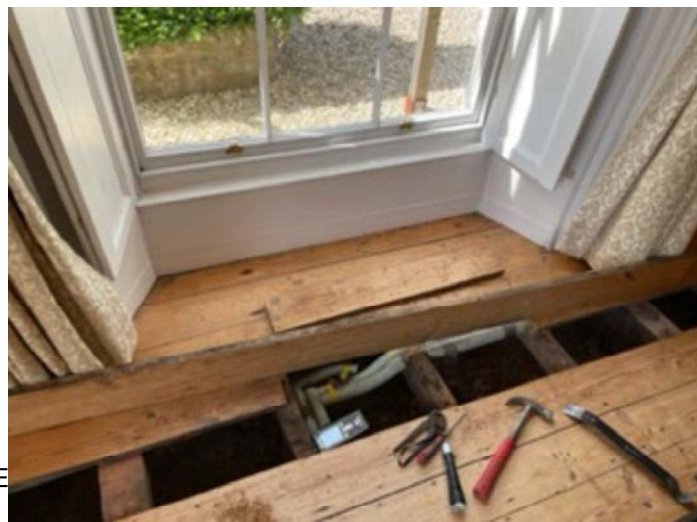
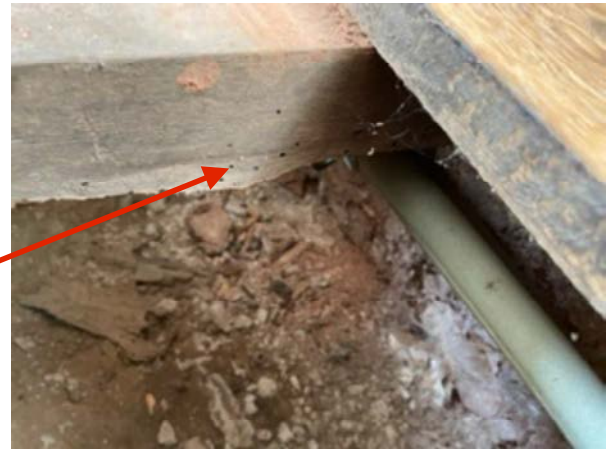
A section of the perimeter floorboard was lifted in front of the Southerly elevation. Again the joist-ends bear onto masonry, which has led to the timbers absorbing moisture and facilitating decay. Deathwatch beetle damage (DWB) was noted to the sapwood portion of several joists, with some of the tunnelling presenting as recent activity (see Fig.16-19).

Three joist-ends in front of the southerly window were identified as requiring repair, however considering the recent/ongoing DWB activity mentioned, there is a risk that other timbers have also been affected. It is advised that further floorboards are lifted to provide a better understanding into the extent of decay-related issues.

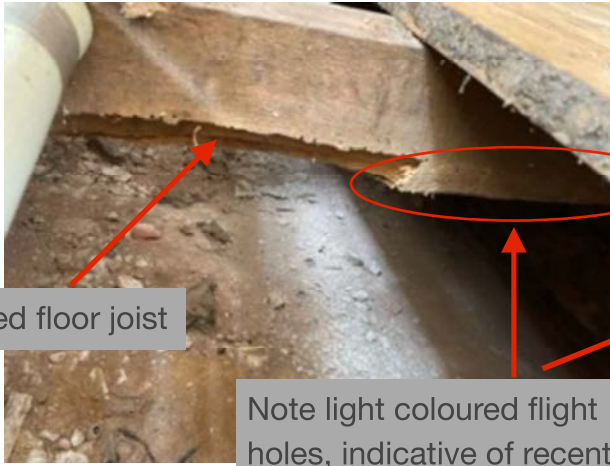
Figure 17

DWB Damaged floor joist

Note light coloured flight holes, indicative of recent DWB activity

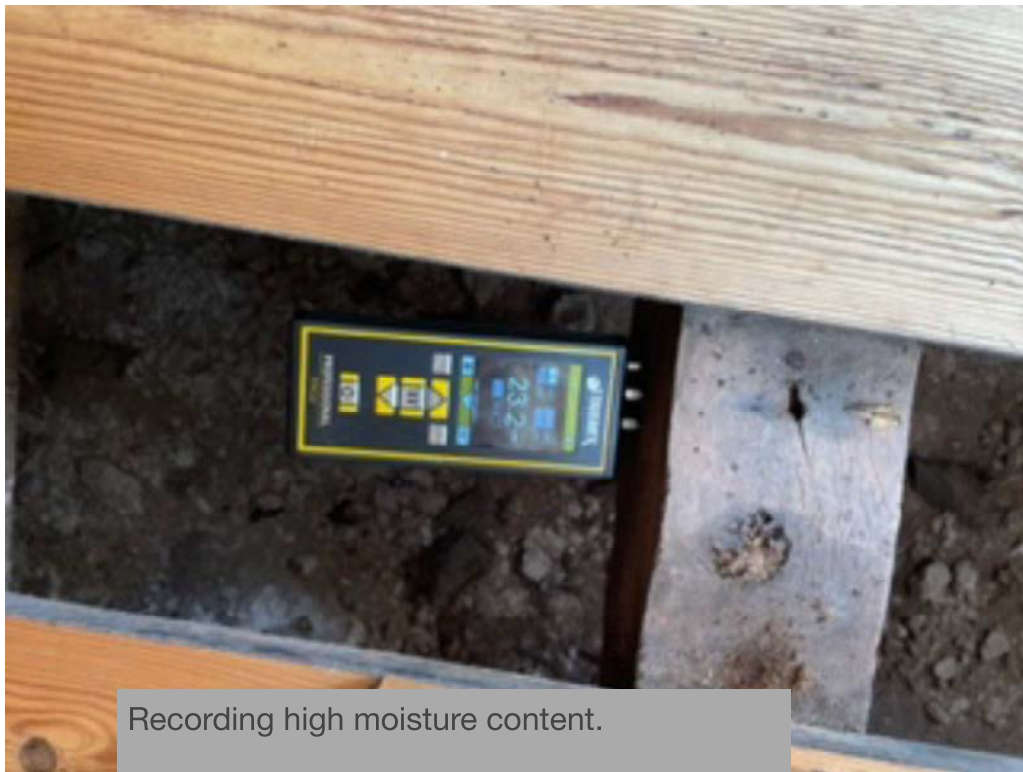
Figure 19

Recording high moisture content.

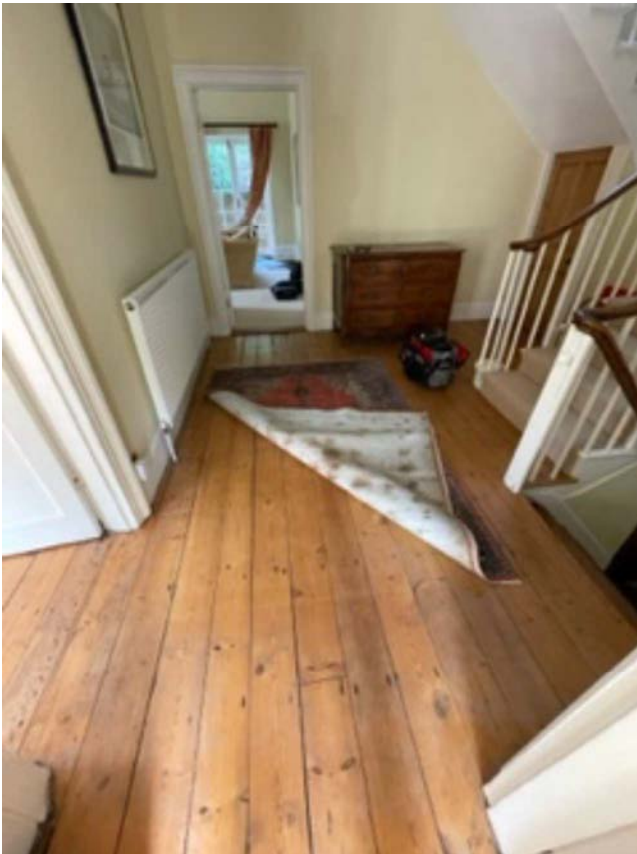
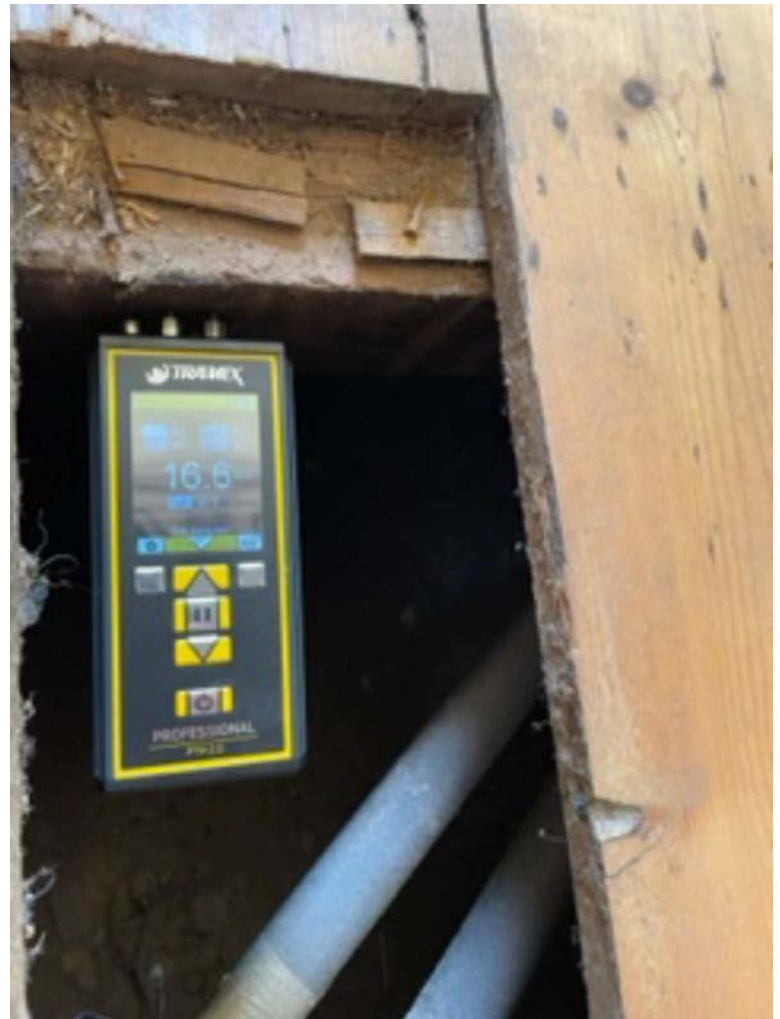
A floorboard was lifted within the hall. Immediately noticeable was the greater depth to the sub-floor void, with humidity levels and associated wood moisture content recording lower in this area (see Fig.20&21).

**Figure 21: Showing low moisture content**

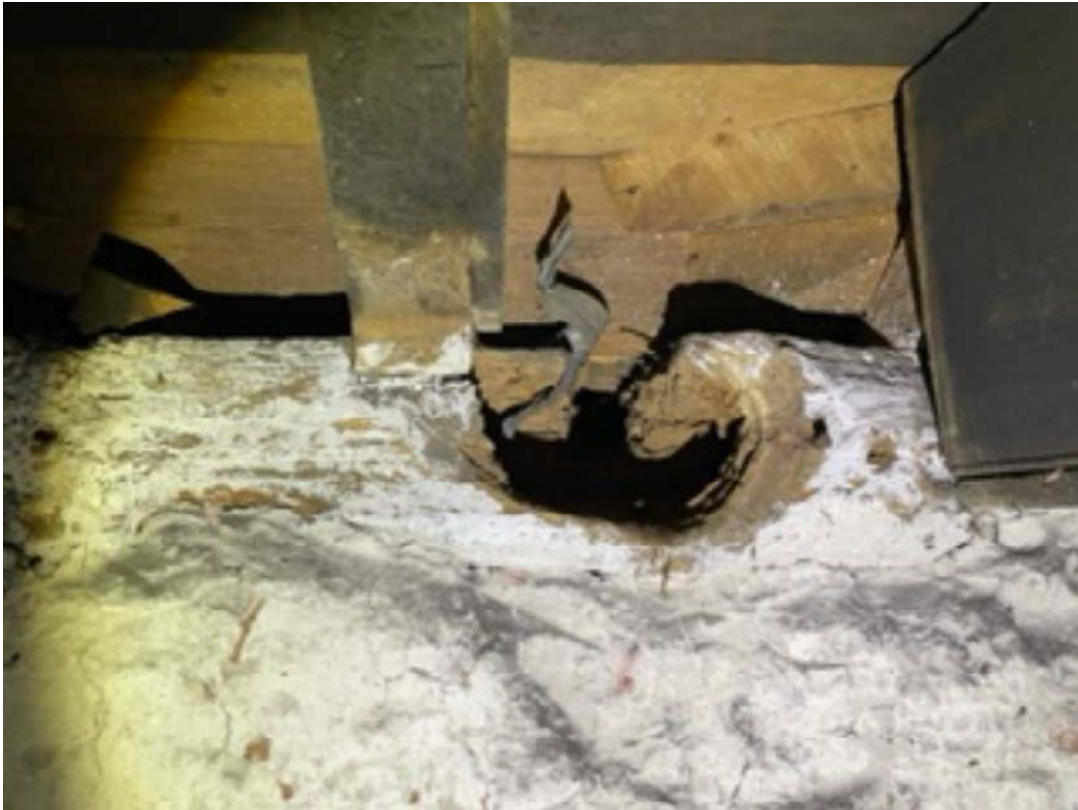
Figure 22

Recent DWB activity was noted in the under-stair cupboard, with the oak wall plate severely defective and requiring replacement to prevent consequential movement of the bearing joists and stairs (see Fig.22).

This space is likely to suffer poor air circulation, therefore it is advised the timbers are periodically monitored and that I am contacted should concerns arise.

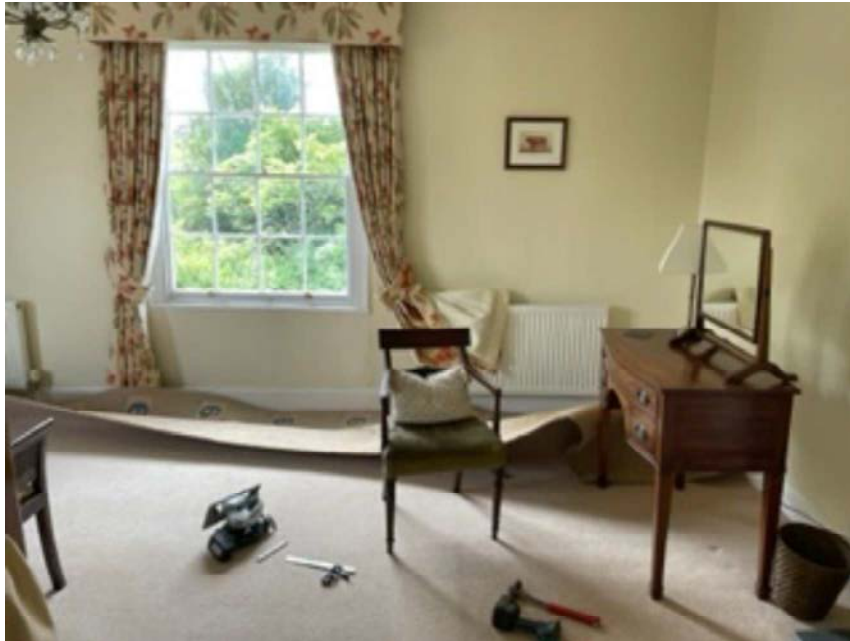
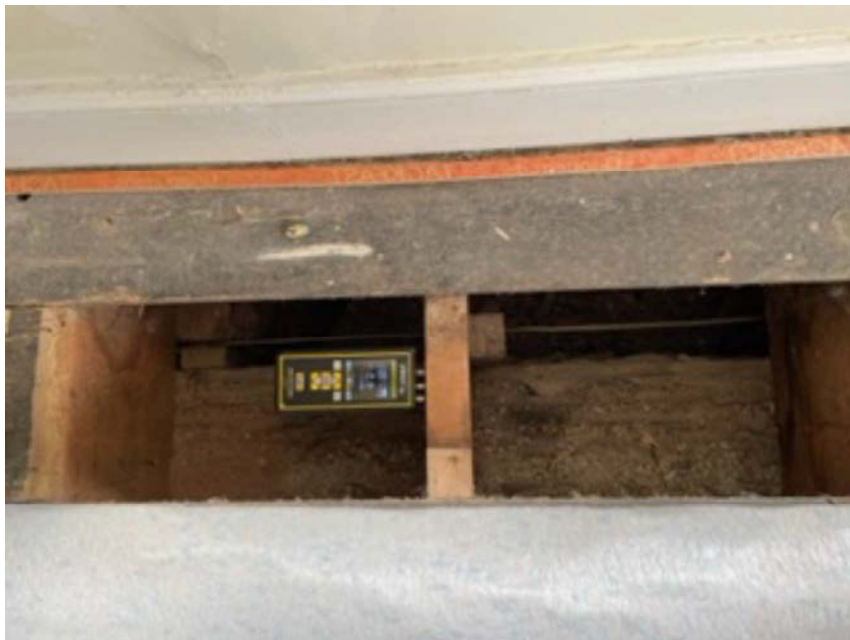
A section of floorboard was lifted from in front of the southerly window. Although water staining was noted towards the bearing-ends of several joists, moisture levels were low and no decay was observed in this albeit limited inspection (see Fig.24&25).

Recording low moisture content (9.6%WMC)

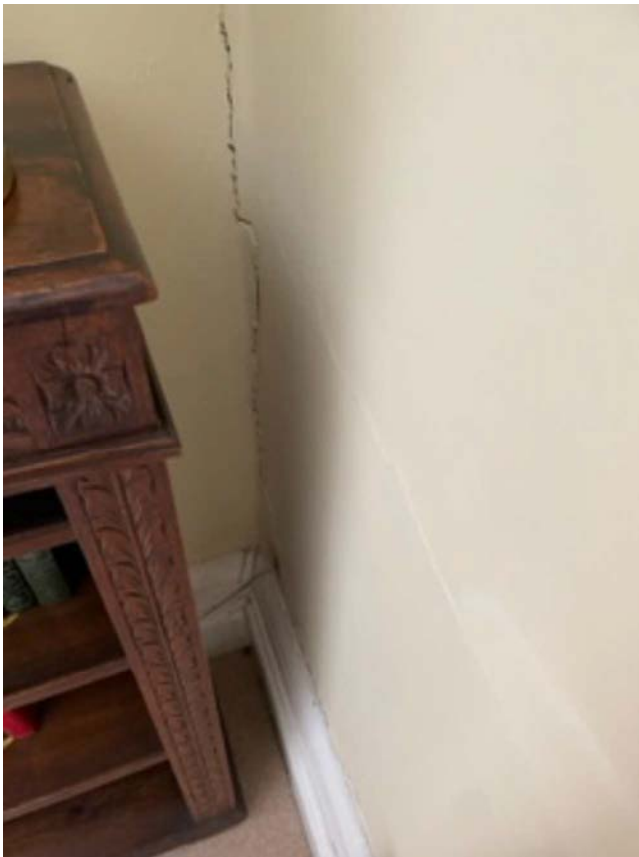
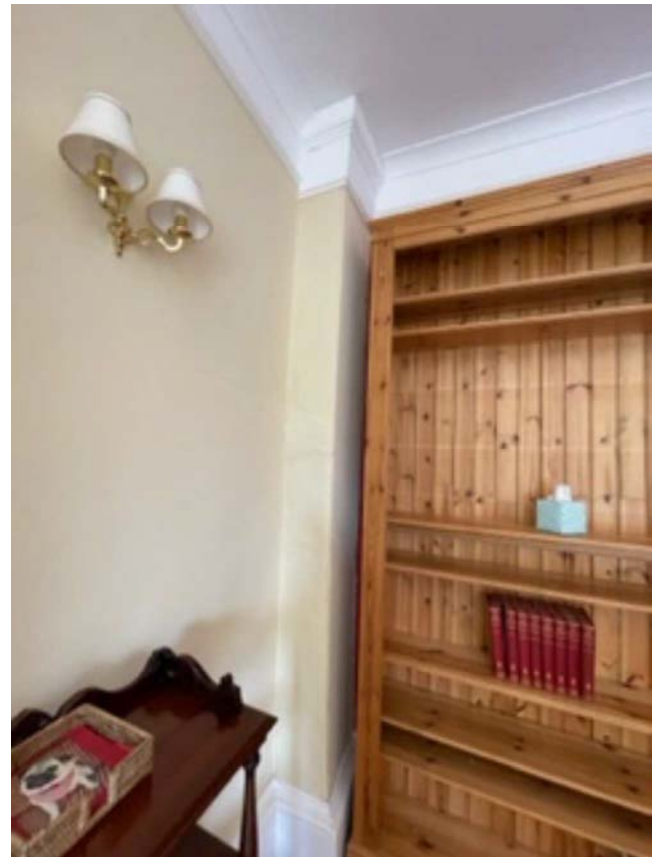
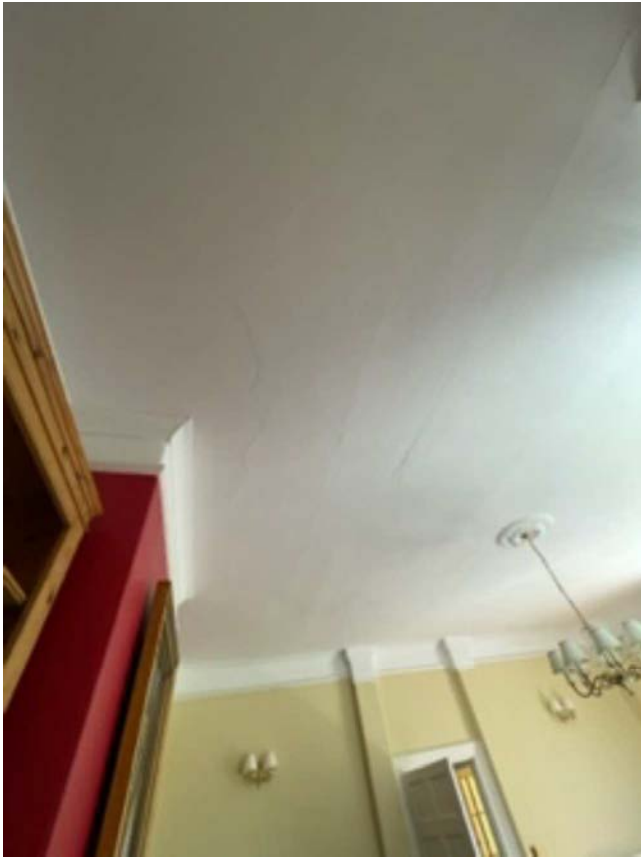
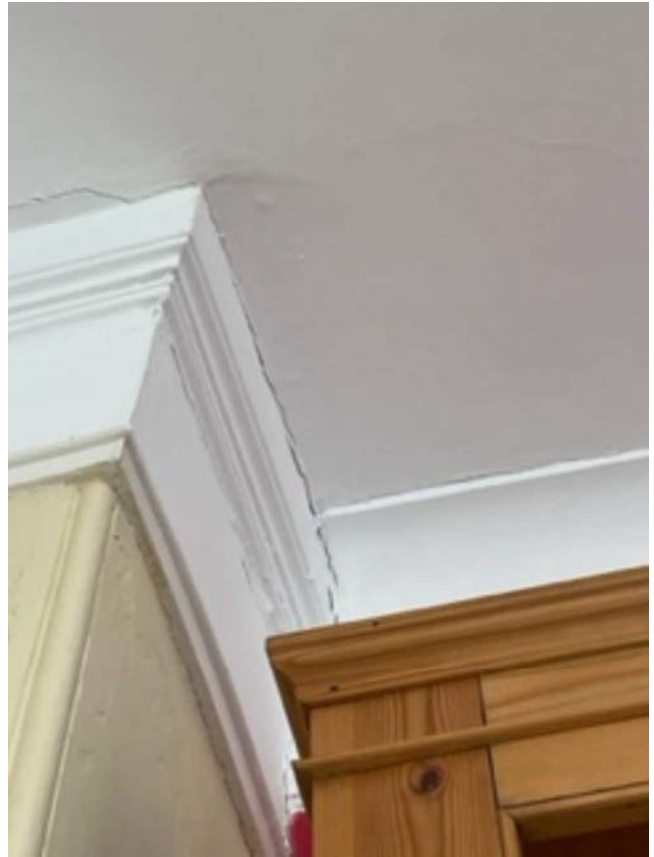
cracking to wall and ceiling plaster was common in all rooms within the Georgian range of The Old Rectory, thought highly likely to be a consequence of movement and deterioration of the timber-framed construction (see Fig.26-29).

As there is potential for further cracking to manifest during the remedial works, it is recommended that any repair of plaster is undertaken after the timber-framed elevations have been assessed and repaired as appropriate, and after the external rendering has been completed.

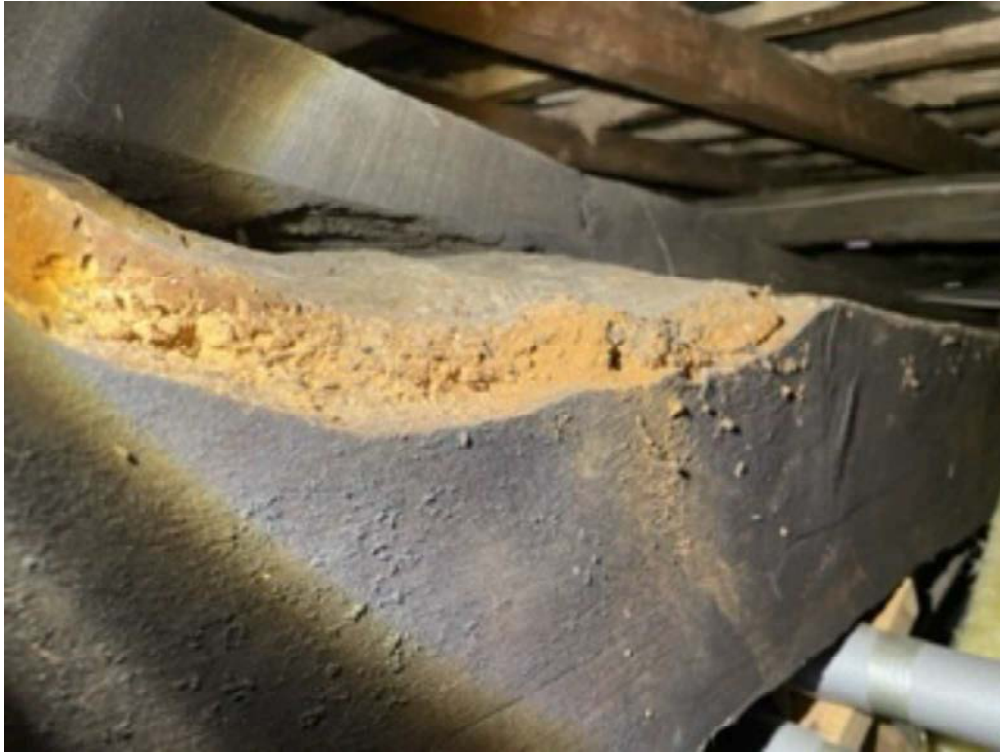
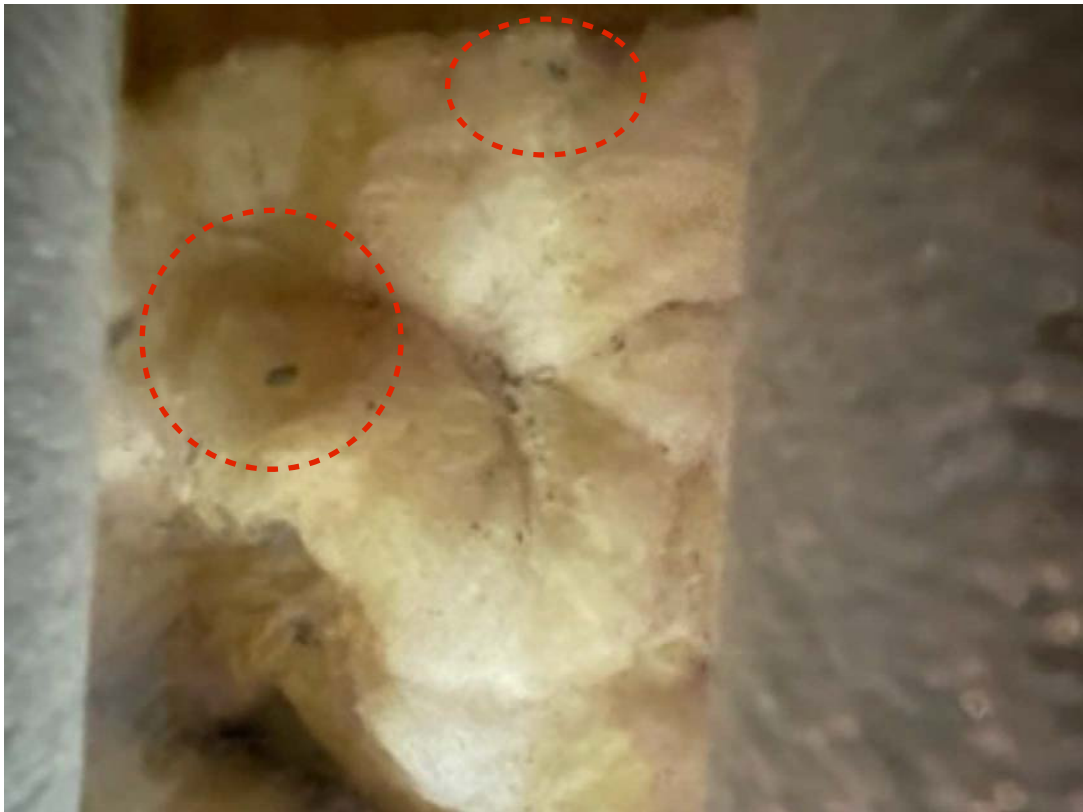
Although I attempted to inspect the roof spaces, access was very limited. That said, of those timbers closely inspected, I did not encounter significant defects. However, I did note several adult DWB scattered around and small areas of DWB damage (see Fig.30&31). Considering the low numbers of DWB and associated damage appears contained within the sapwood, and that the property is adequately heated and ventilated, I do not believe this to be significant. It is advised that the roof space is periodically inspected and I am contacted should you have any concern that the beetle population is growing.
