Proposed Ground Floor Layout (Wall Repairs) 1:100

Project
Refurbishment Works at The Old Rectory
Clyst St Lawrence, CULLOMPTON, EX15 2NW
for Drs Dixon

Dwg title
Proposed Works
Proposed Ground Floor Layout
03_01-02 Wall Repairs

dwg no	MD22_0411 - 33	Initial
scale	1:100	date
		drawn
		chkd.
		AJPaton
		AJP

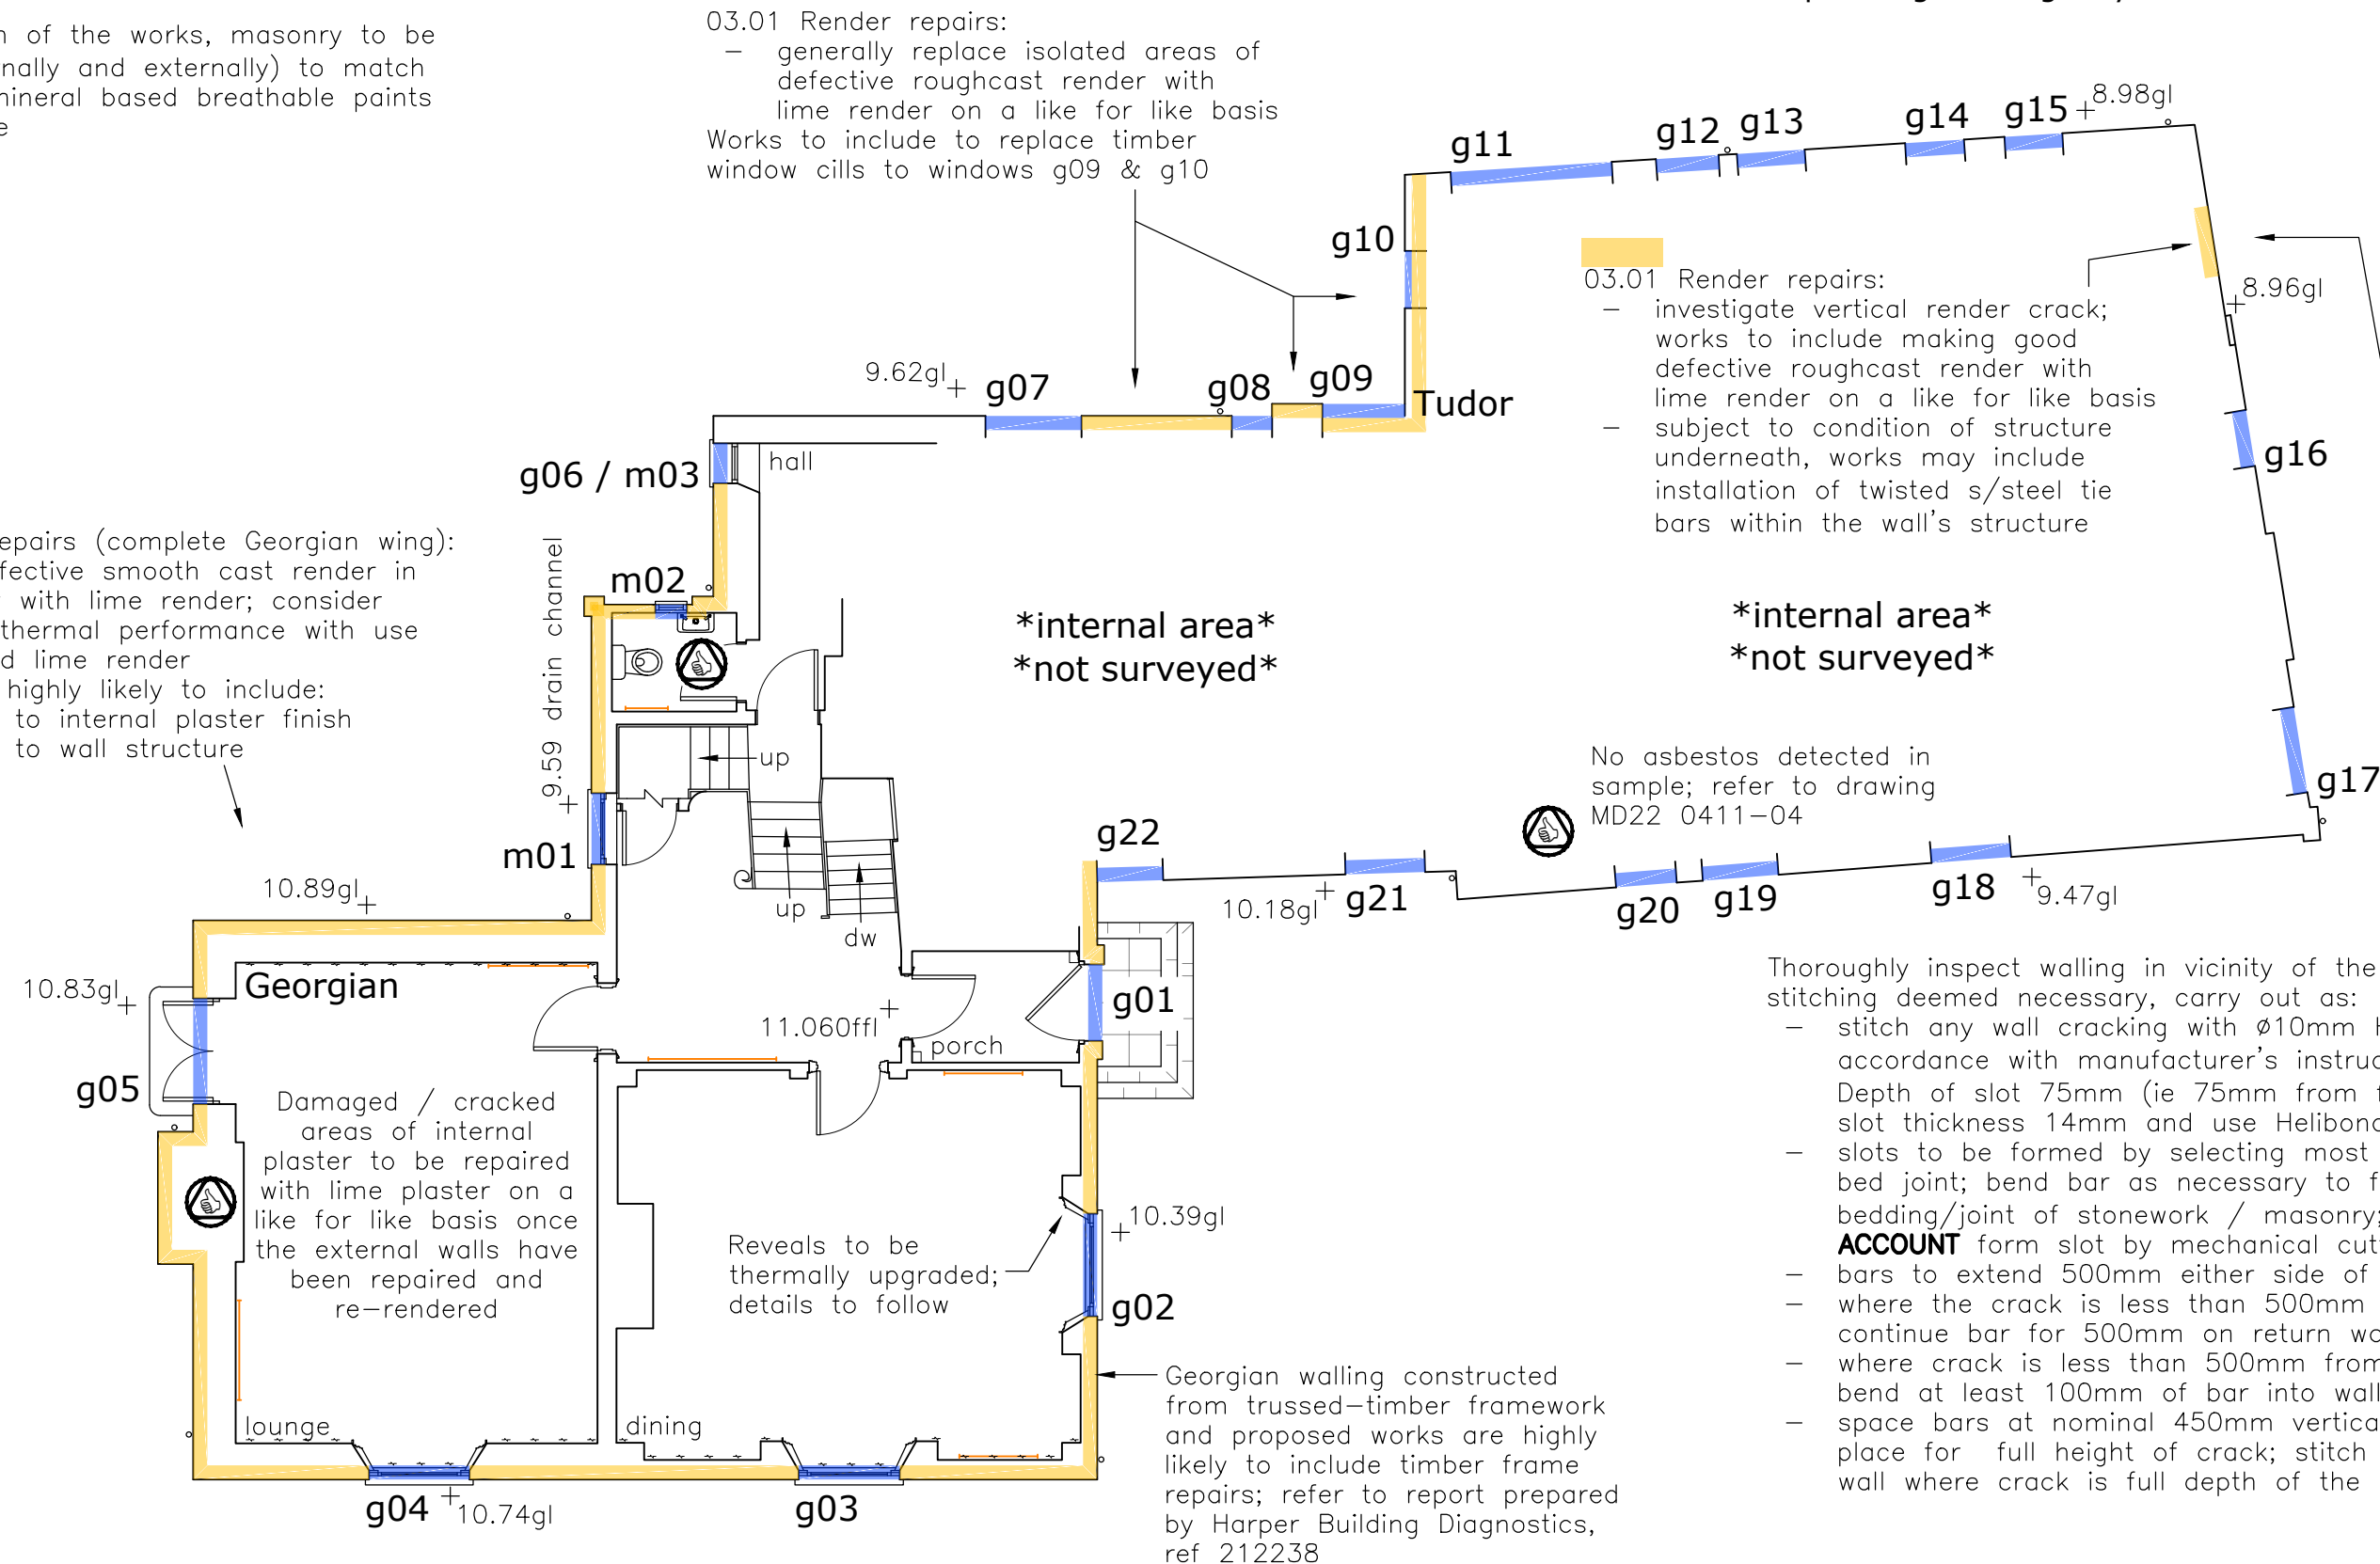
03.01 Render repairs:
- generally replace isolated areas of defective roughcast render with lime render on a like for like basis
Works to include to replace timber window cills to windows g09 & g10

03.02 Render repairs (complete Georgian wing):
- replace defective smooth cast render in its entirety with lime render; consider improving thermal performance with use of insulated lime render
- works are highly likely to include:
-- repairs to internal plaster finish
-- repairs to wall structure

03.01 Render repairs:
- investigate vertical render crack; works to include making good defective roughcast render with lime render on a like for like basis
- subject to condition of structure underneath, works may include installation of twisted s/steel tie bars within the wall's structure

internal area
not surveyed

No asbestos detected in sample; refer to drawing MD22_0411-04

Georgian walling constructed from trussed-timber framework and proposed works are highly likely to include timber frame repairs; refer to report prepared by Harper Building Diagnostics, ref 212238

Upon completion of the works, masonry to be decorated (internally and externally) to match existing using mineral based breathable paints suitable for lime

Thoroughly inspect walling in vicinity of the crack if stitching deemed necessary, carry out as:
- stitch any wall cracking with Ø10mm Helibars in full accordance with manufacturer's instructions. NOTE: Depth of slot 75mm (ie 75mm from face of wall), slot thickness 14mm and use Helibond GROUT
- slots to be formed by selecting most appropriate bed joint; bend bar as necessary to follow natural bedding/joint of stonework / masonry; on **NO ACCOUNT** form slot by mechanical cutting
- bars to extend 500mm either side of crack
- where the crack is less than 500mm from corner, continue bar for 500mm on return wall
- where crack is less than 500mm from an opening bend at least 100mm of bar into wall
- space bars at nominal 450mm vertical centres and place for full height of crack; stitch both sides of wall where crack is full depth of the wall

Reveals to be thermally upgraded; details to follow

Damaged / cracked areas of internal plaster to be repaired with lime plaster on a like for like basis once the external walls have been repaired and re-rendered
