Filename md22_0411

Proposed Works:

Summary of Works:

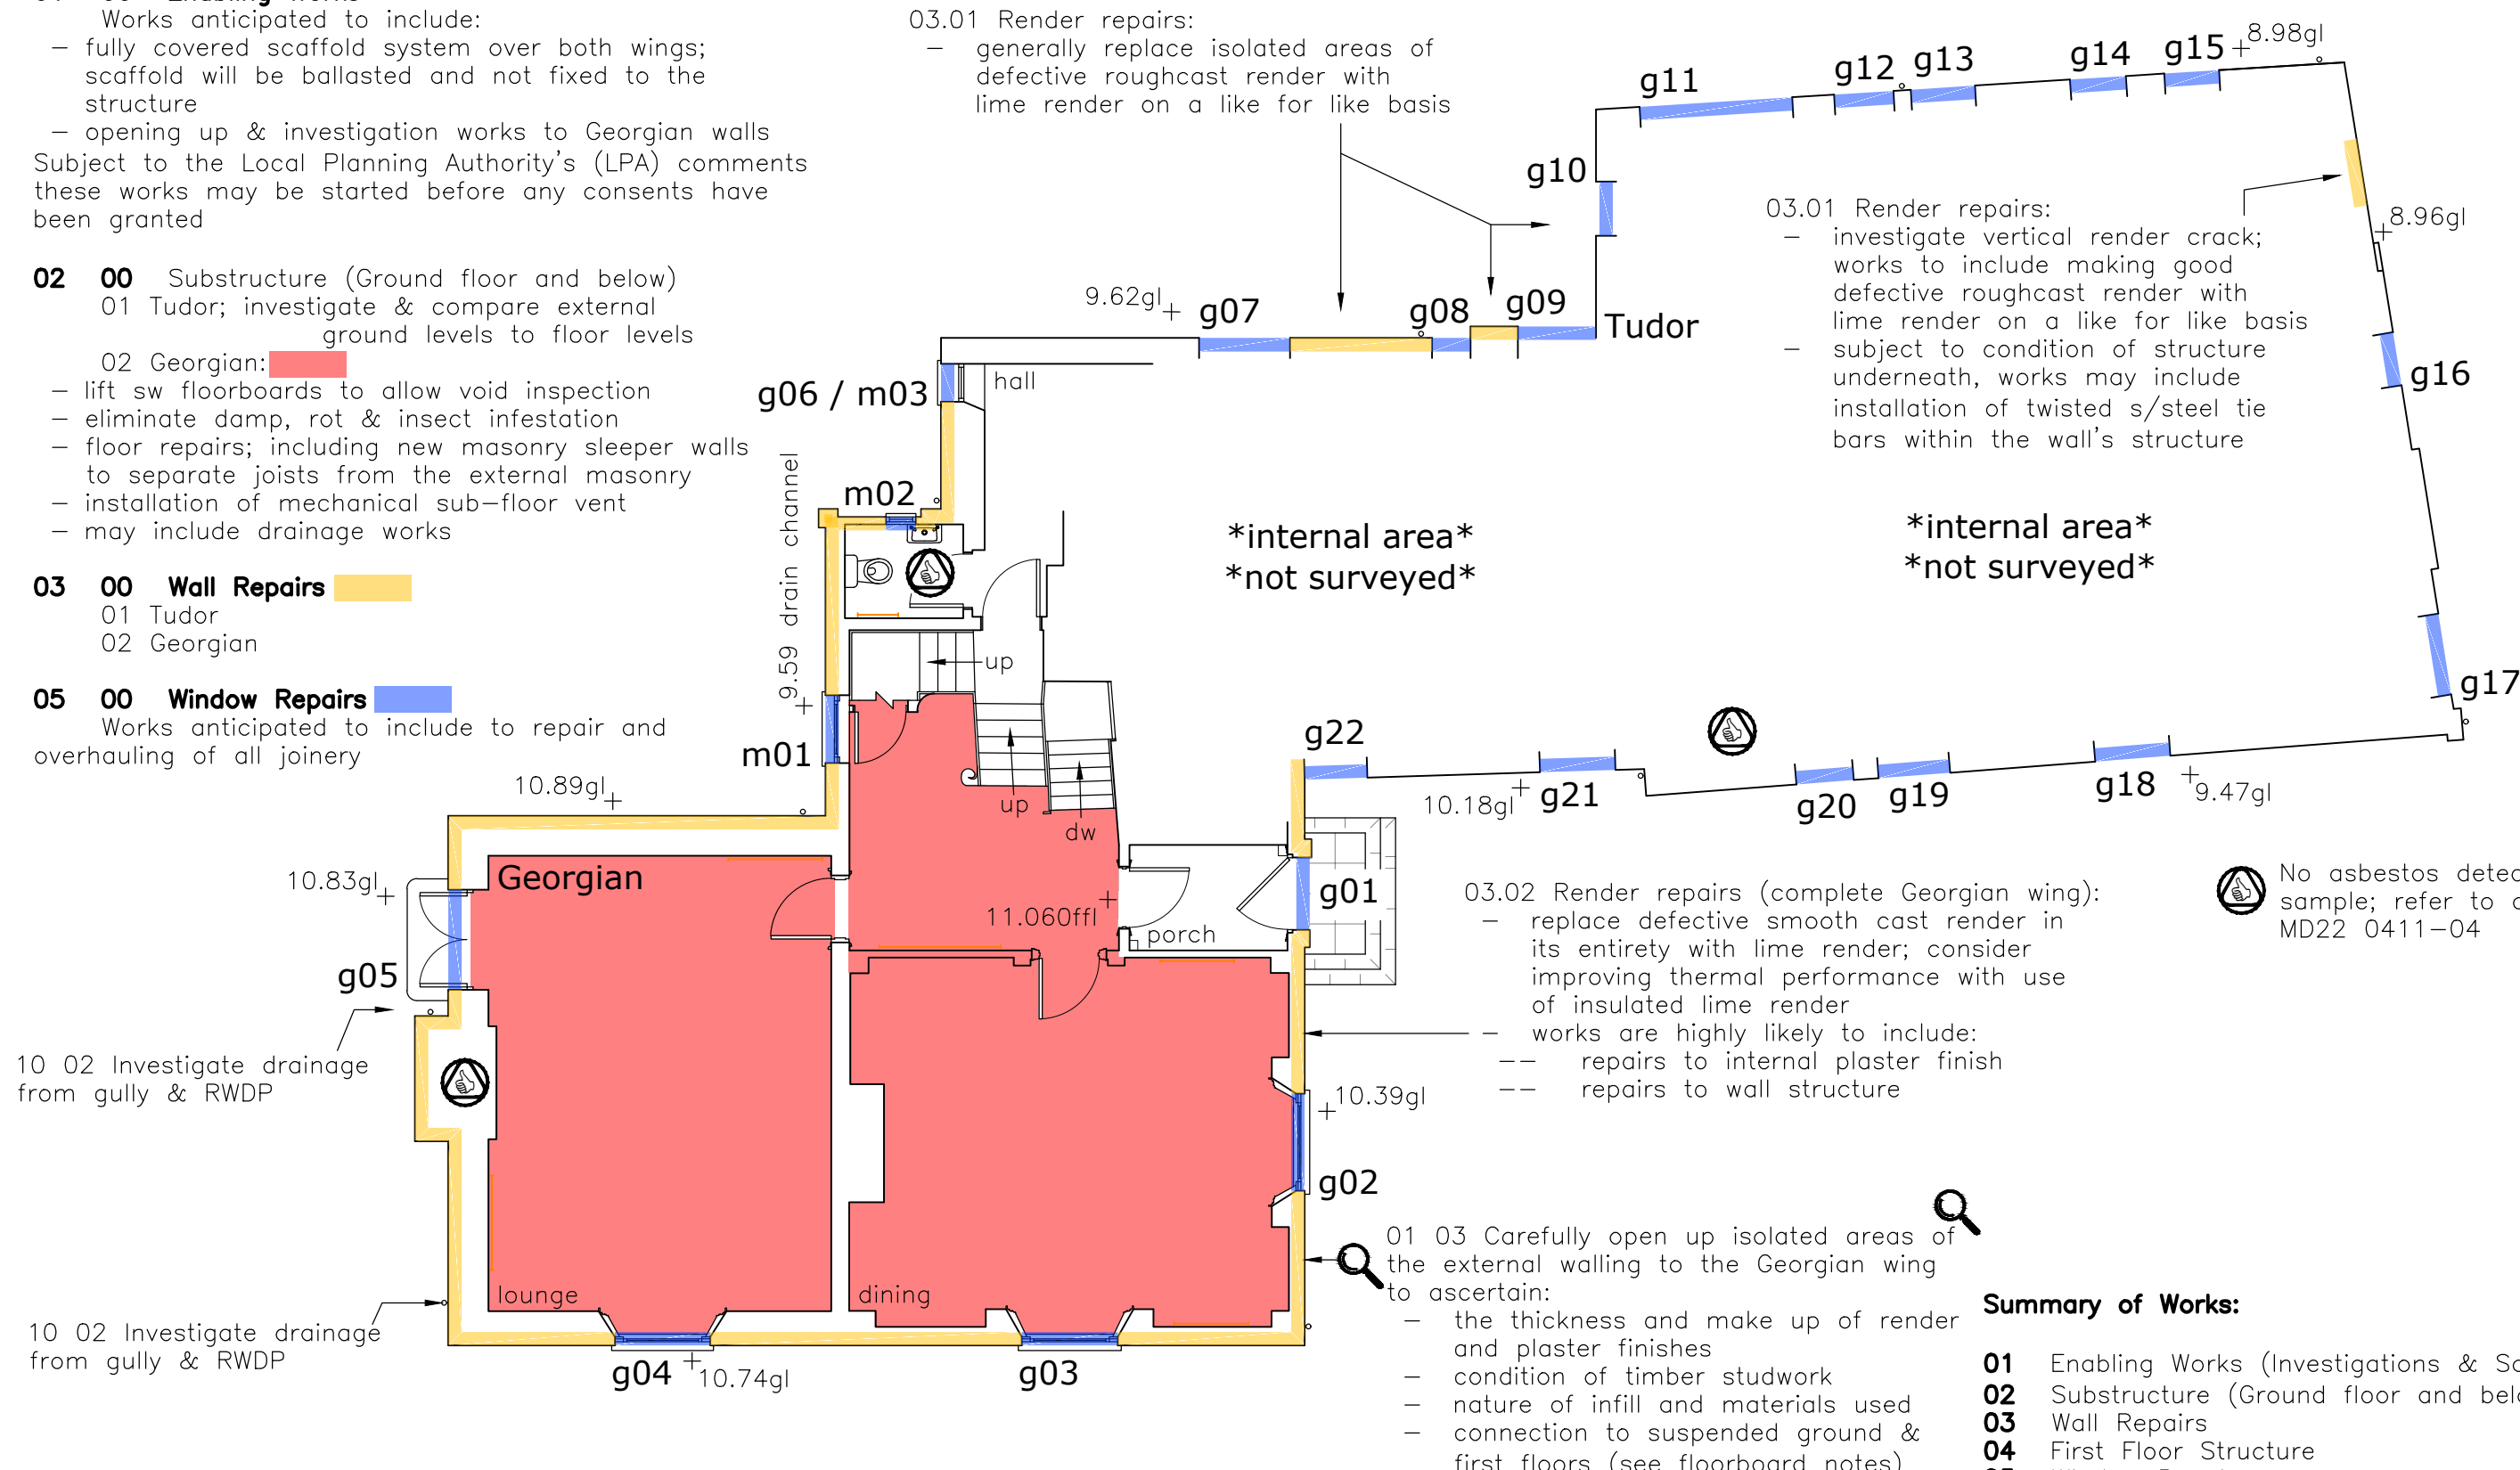
Existing Ground Floor Layout 1:100

01 Tudor; investigate & compare external
 ground levels to floor levels
 02 Georgian:
 - lift sw floorboards to allow void inspection
 - eliminate damp, rot & insect infestation
 - floor repairs; including new masonry sleeper walls
 to separate joists from the external masonry
 - installation of mechanical sub-floor vent
 - may include drainage works

03.01 Render repairs:
 - investigate vertical render crack;
 works to include making good
 defective roughcast render with
 lime render on a like for like basis
 - subject to condition of structure
 underneath, works may include
 installation of twisted s/steel tie
 bars within the wall's structure

01 03 Carefully open up isolated areas of
 the external walling to the Georgian wing
 to ascertain:
 - the thickness and make up of render
 and plaster finishes
 - condition of timber studwork
 - nature of infill and materials used
 - connection to suspended ground &
 first floors (see floorboard notes)
 Subject to findings during enabling works,
 the new render is highly likely to include
 the introduction of suitable insulation
 materials

10 02 Investigate drainage
 from gully & RWDP

03.01 Render repairs:
 - generally replace isolated areas of
 defective roughcast render with
 lime render on a like for like basis

03.02 Render repairs (complete Georgian wing):
 - replace defective smooth cast render in
 its entirety with lime render; consider
 improving thermal performance with use
 of insulated lime render
 - works are highly likely to include:
 -- repairs to internal plaster finish
 -- repairs to wall structure
