Proposed First Floor Layout (Wall Repairs)

Filename md22 0411

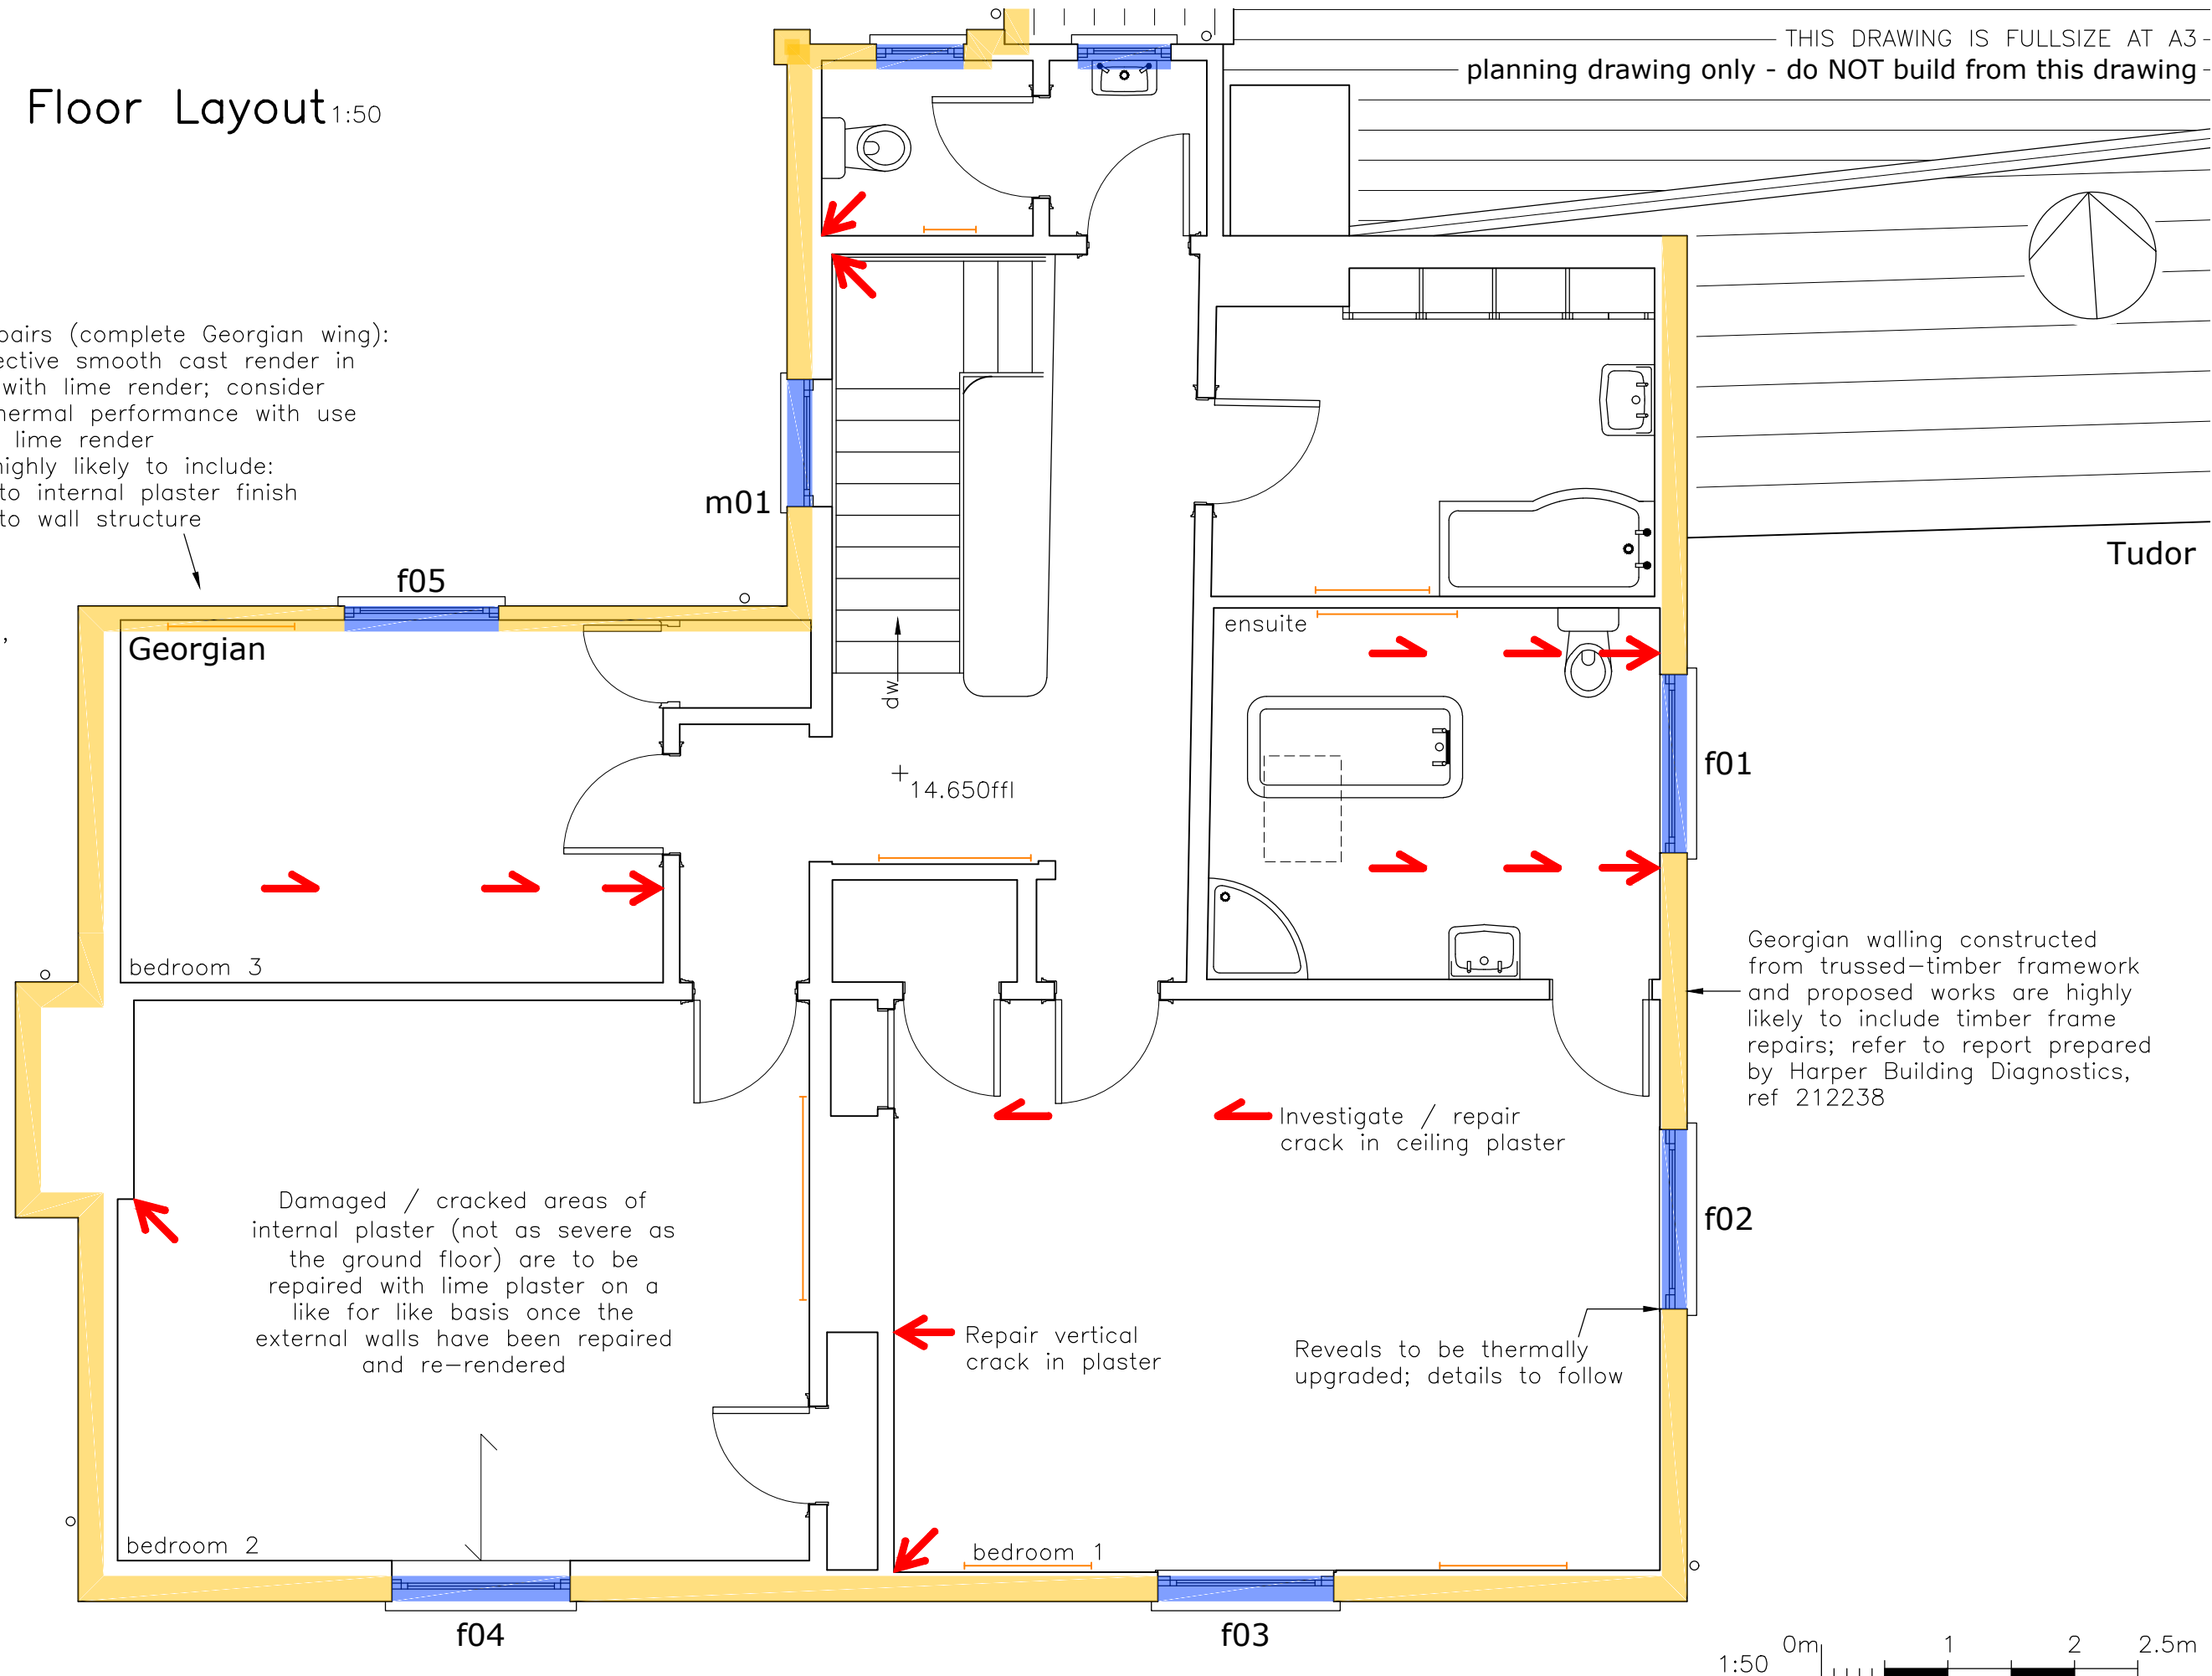
Georgian walling constructed from trussed-timber framework and proposed works are highly likely to include timber frame repairs; refer to report prepared by Harper Building Diagnostics, ref 212238

Damaged / cracked areas of internal plaster (not as severe as the ground floor) are to be repaired with lime plaster on a like for like basis once the external walls have been repaired and re-rendered

Investigate / repair crack in ceiling plaster

Repair vertical crack in plaster

- 03.02 Render repairs (complete Georgian wing):
- replace defective smooth cast render in its entirety with lime render; consider improving thermal performance with use of insulated lime render
 - works are highly likely to include:
 - repairs to internal plaster finish
 - repairs to wall structure

Upon completion of the works, masonry to be decorated (internally and externally) to match existing using mineral based breathable paints suitable for lime

Reveals to be thermally upgraded; details to follow
