**Condition Report for**  
Refurbishment Works at  
The Old Rectory, Clyst St Lawrence, CULLOMPTON,  
Devon, EX15 2NW

**ref: md22 0411rev Initial**

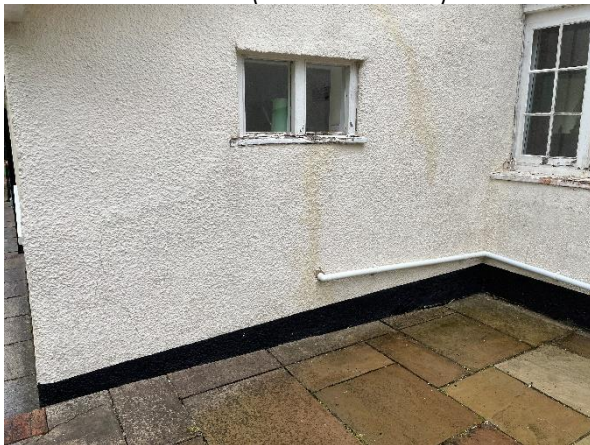
g10

Although the render is on the 'hard side', overall it appears in sound condition. There are some areas of isolated damp to the rear (North) elevation and these are attributed to the failed rotten window cills.

Areas of concern (rear elevation):

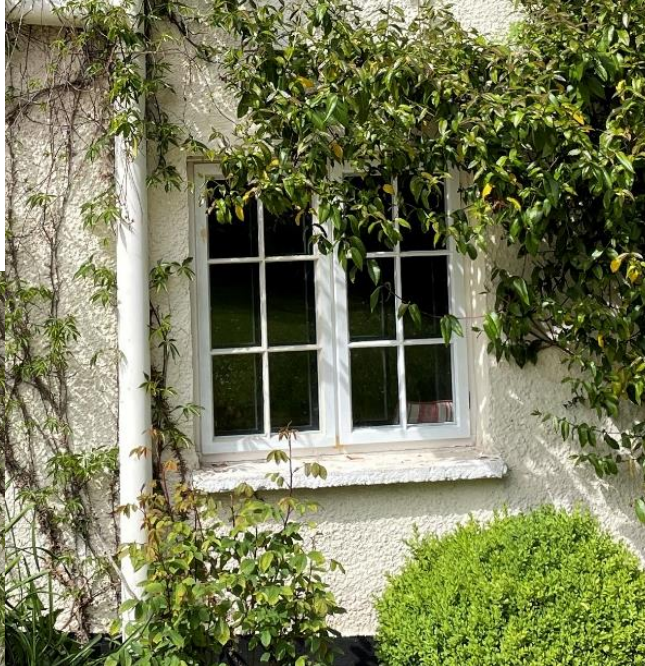
g18 – Tudor Wing (right photo)

Timber side-hung storm casements  
White gloss  
Internal slimline secondary glazing  
Condition sound but needs redecoration

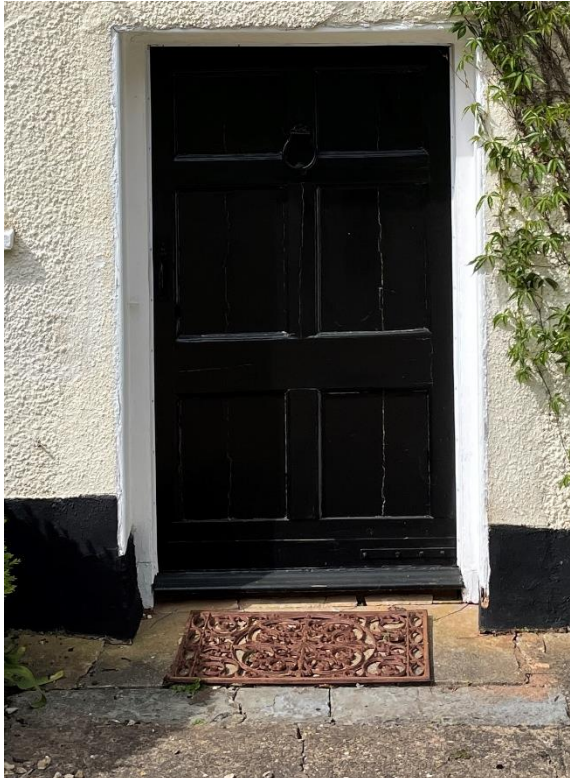
g19 – Tudor Wing (left photo)

Timber panel door  
Black satin  
Condition:  
- r-hnd timber reveal liner rotten at base  
- rest sound but needs redecoration

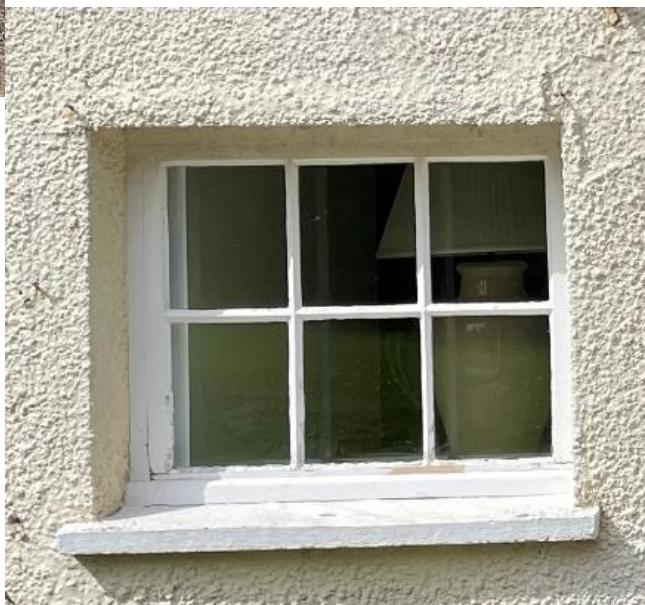
g20 – Tudor Wing (right photo)

Timber fixed flush casement  
White gloss  
Internal slimline secondary glazing  
Condition sound but needs redecoration

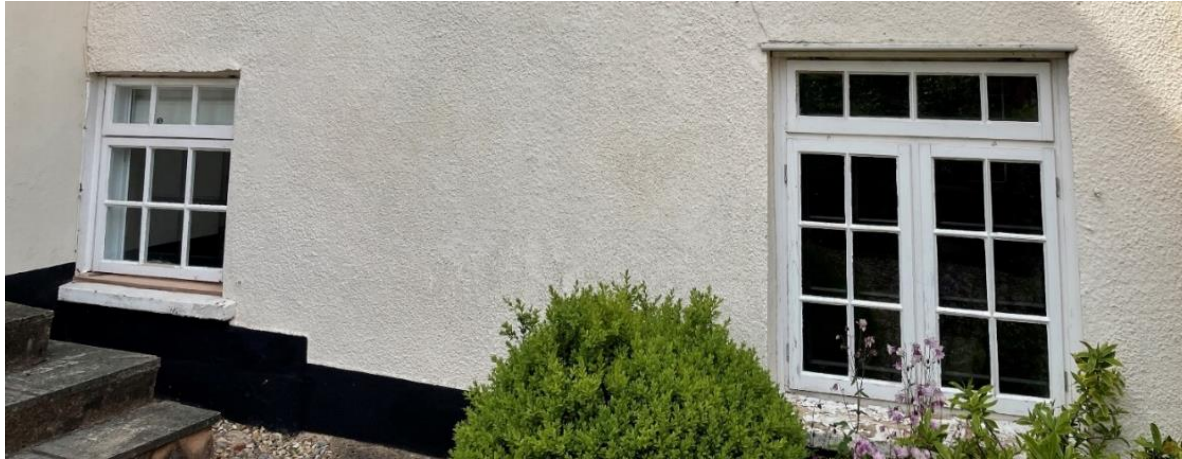
g21 & g22 – Tudor Wing (photo below)

Timber storm casements finished in white gloss. Both have Internal slimline secondary glazing  
Condition sound but needs redecoration

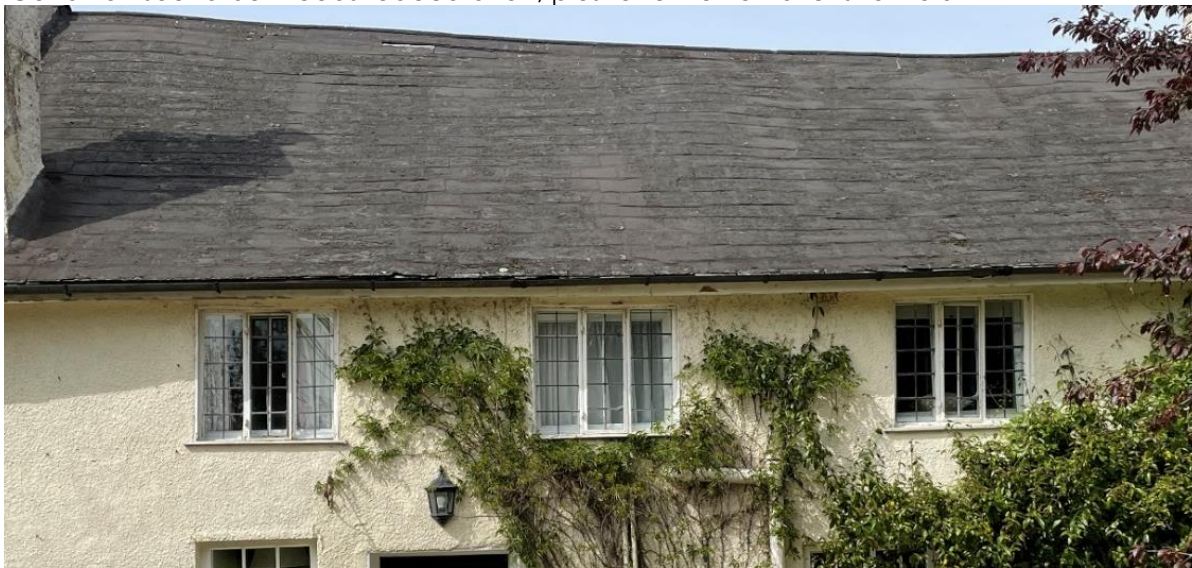
f12, f13 & f14 – Tudor Wing (photo below)

Timber with steel casements and timber reveal liners; all finished in white gloss.  
All have leaded lights and Internal slimline secondary glazing  
Condition sound but needs redecoration; plus renew external cills to f13 & f14

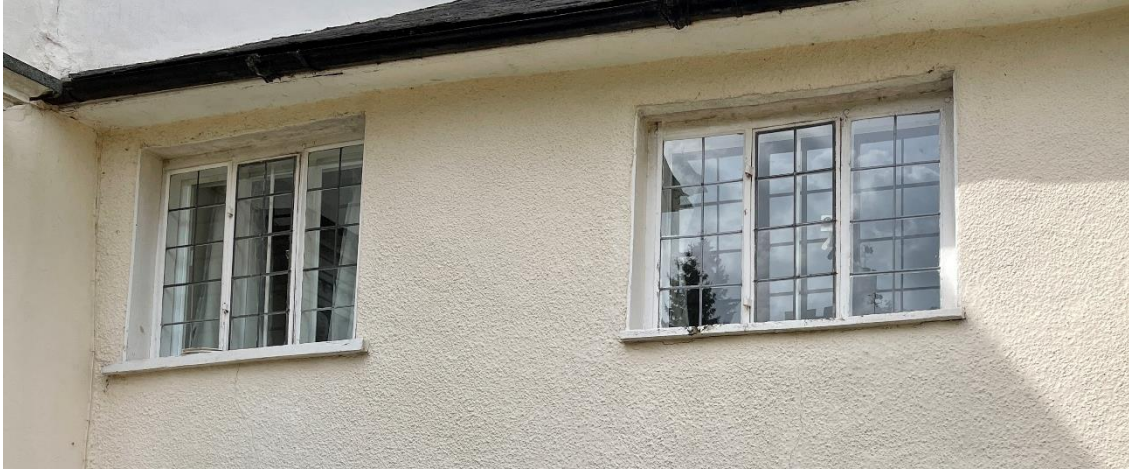
f15 & f16 – Tudor Wing (photo below)

Timber with steel casements and timber reveal liners; all finished in white gloss.  
All have leaded lights and Internal slimline secondary glazing  
Condition sound but needs redecoration; plus renew both external cills

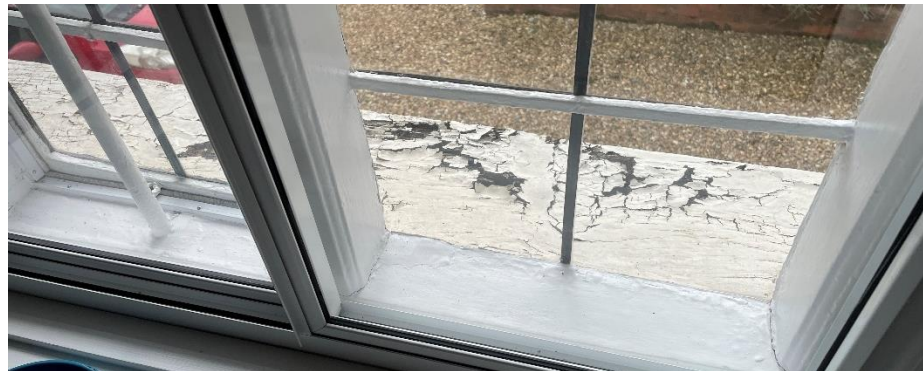
m03 – Tudor Wing

Timber frame with steel casement finished in white gloss  
Internal slimline secondary glazing  
Condition sound but needs isolated frame repairs and redecoration

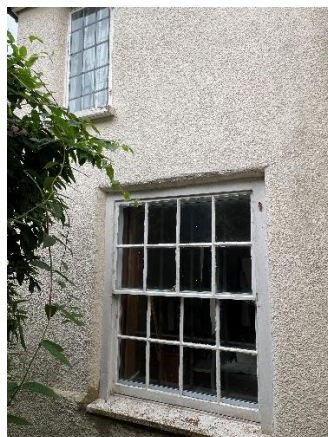
g06 – Tudor Wing

Timber double hung sash windows finished in white gloss  
No sash horns, very thin window bars and historic glass suggest these are historical

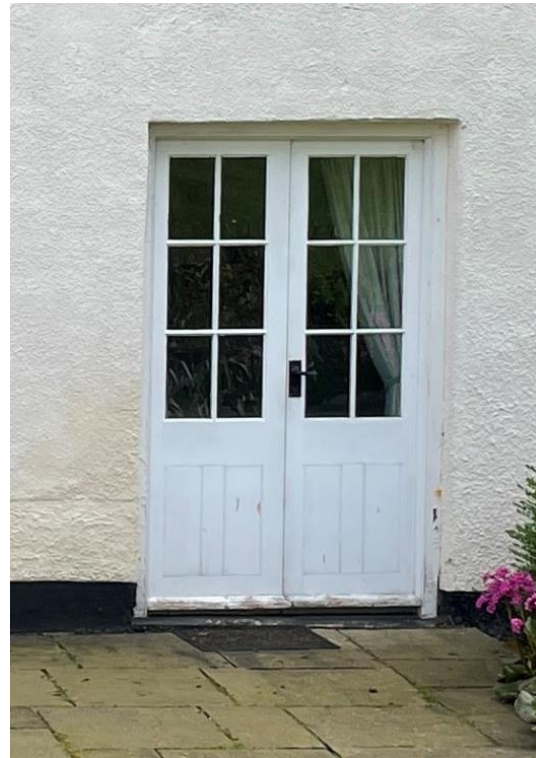
g07 – Tudor Wing (right photo)

Timber French (inward opening) doors finished in white gloss  
Relatively modern  
Condition sound but needs redecoration

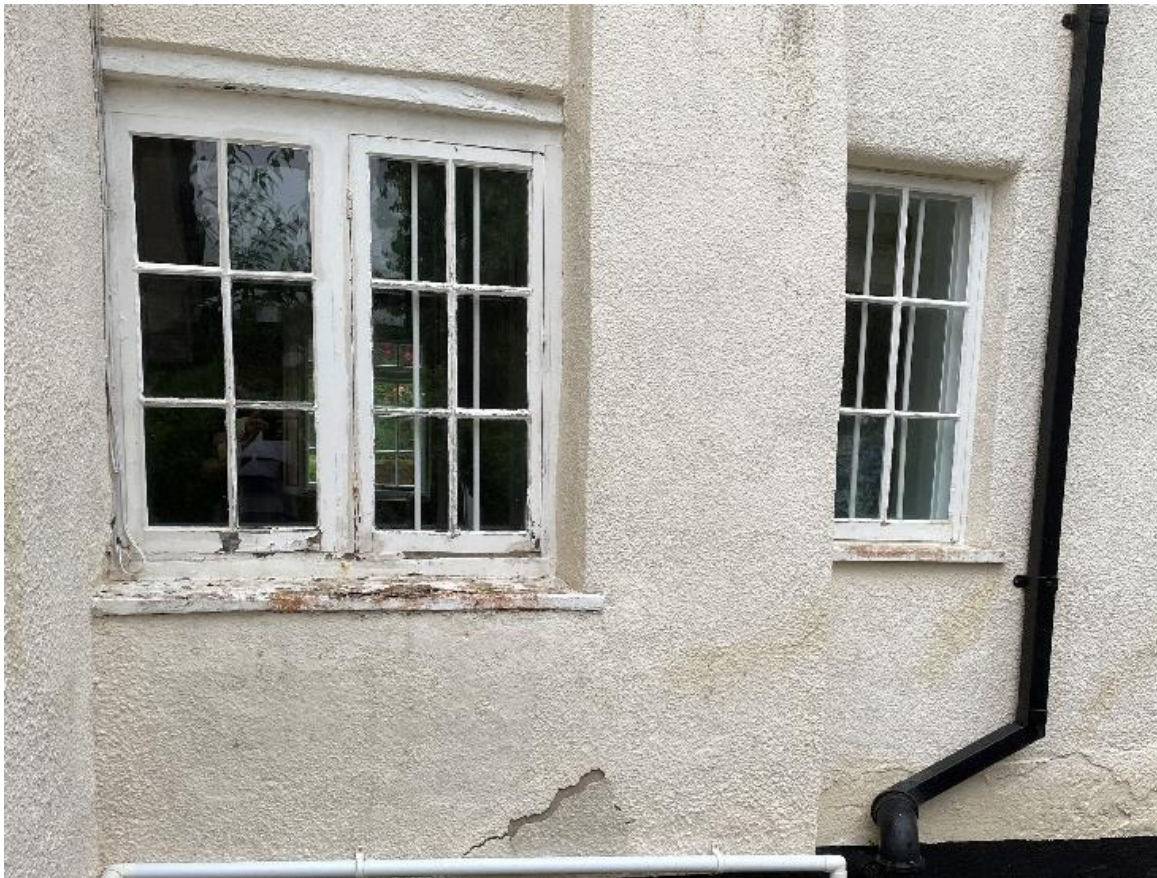
g08 and g09 – Tudor Wing (photo below)

Timber flush casement finished in white gloss  
Condition:

- g08 (right window) sound but needs redecoration
- g09 (left window) poor and needs casement lower rail replacement, cill replacement and redecoration

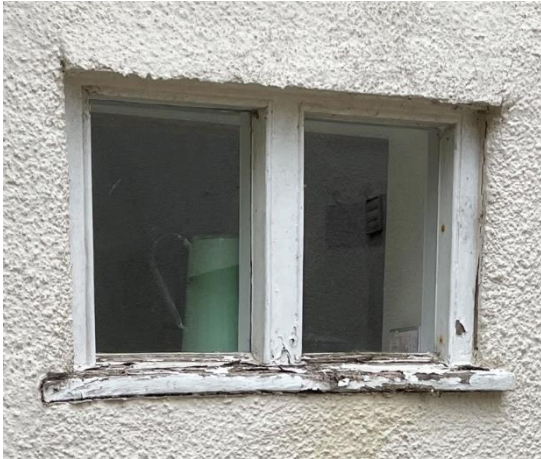
g10 – Tudor Wing (left photo)

Timber fixed casement finished in white gloss finish  
Condition poor and needs replacement lower rails & cill and redecoration

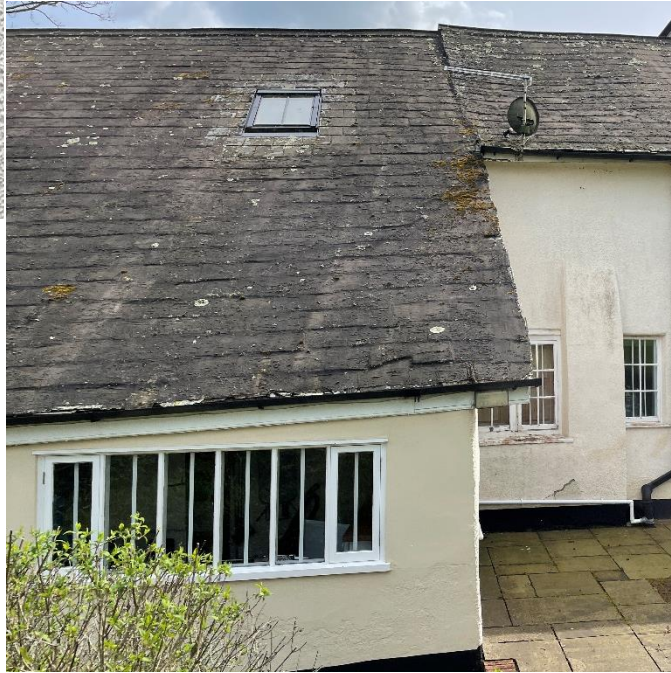
f08 – Tudor Wing (photo left)

Velux conservation style rooflight  
Condition fair

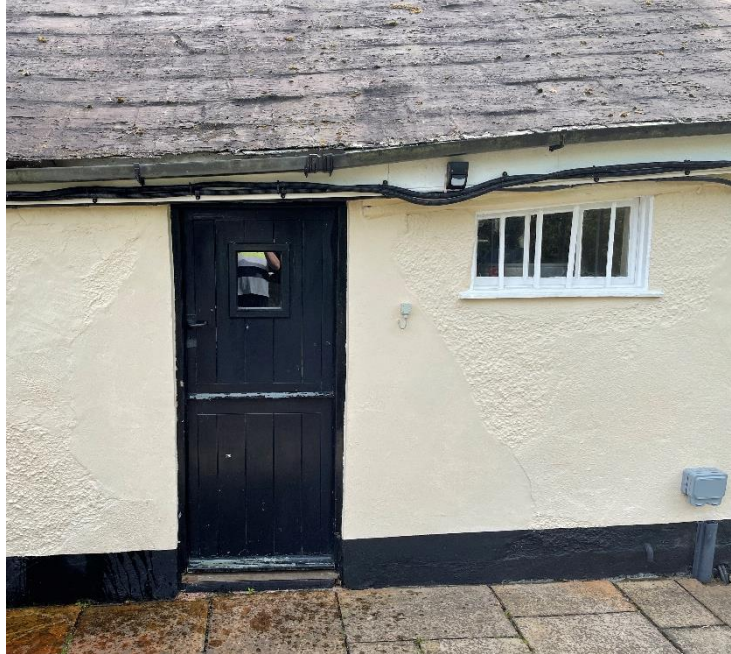
g15 – Tudor Wing (lefthand door)

Timber stable door (modern) finished in black satin  
Condition sound

g14 – Tudor Wing (righthand window)

Timber flush fixed casement finished in white gloss;  
thin window bars  
Condition sound

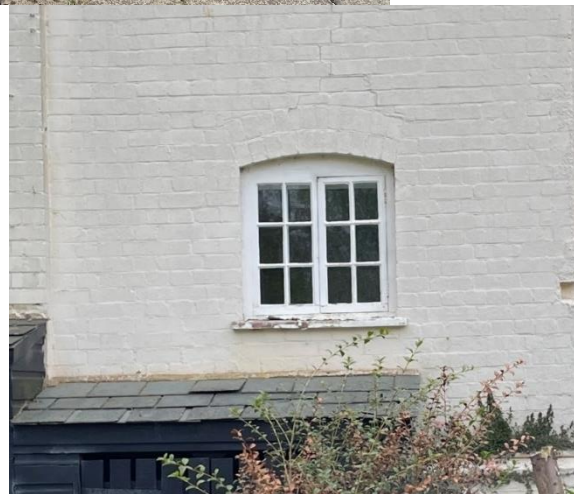
g17 – Tudor Wing (left photo)

Timber storm casement finished in white gloss  
Internal slimline secondary glazing  
Condition sound but needs redecoration

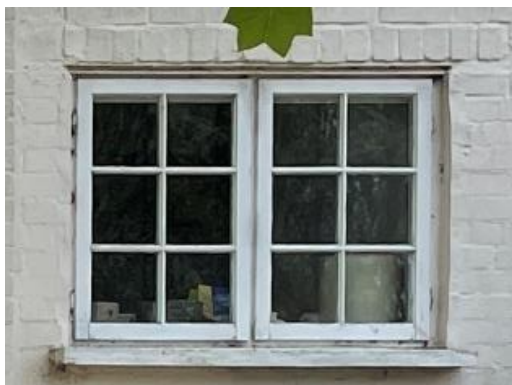
f09 – Tudor Wing (right photo)

Timber storm casement finished in white gloss  
Condition sound but needs redecoration

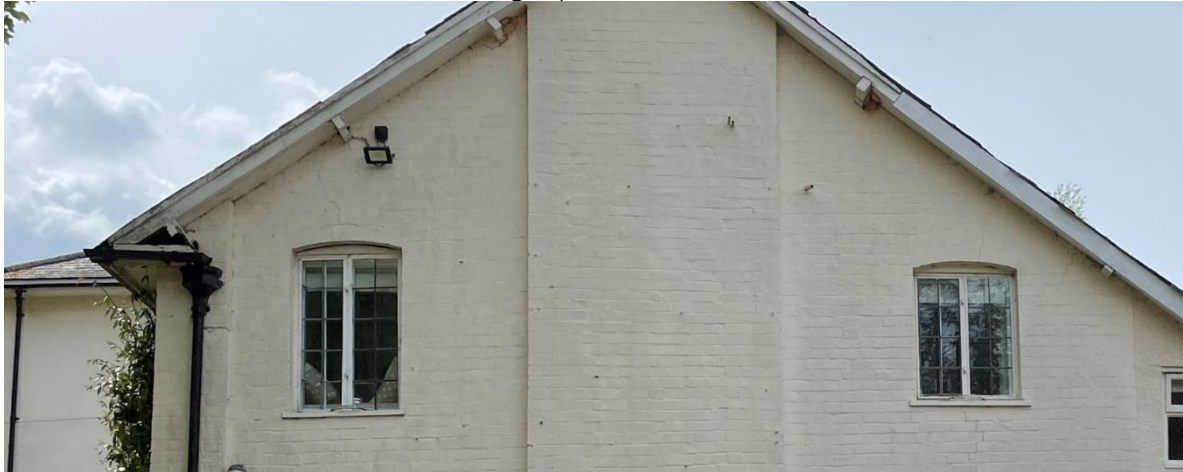
5.01 Tudor Wing Cont'd...  
f10 & f11 – Tudor Wing (photo below)

Timber with steel casements with leaded lights finished in white gloss

Internal slimline secondary glazing

Condition sound but needs redecoration and:

- f10 repair / renew external cill
- f11 external cill has had its nosing replaced

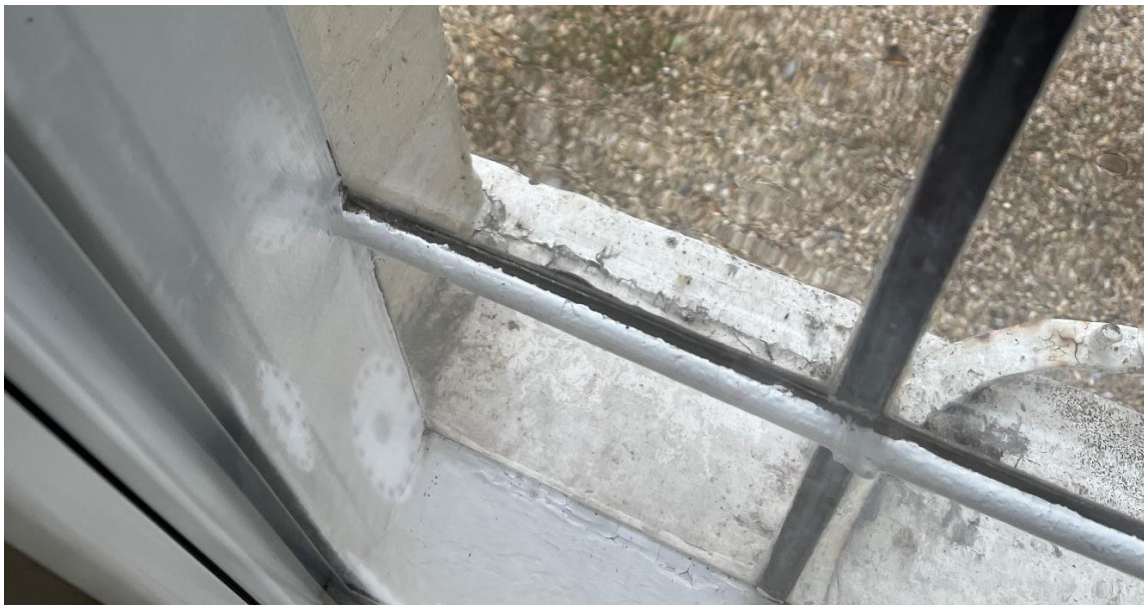
f11: previous nosing repair to external cill:

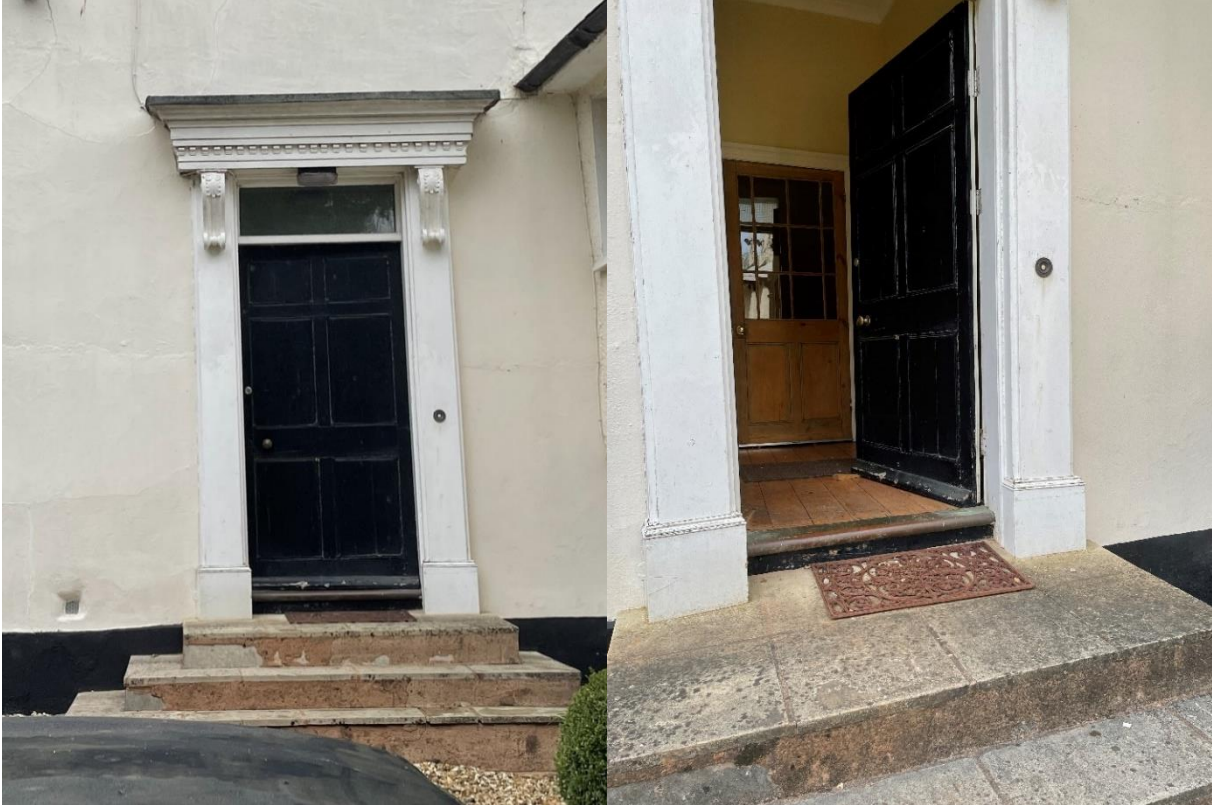
g01 – front door Georgian Wing (photos below)

Timber panel door finished in black satin with white timber portico surround  
Believed to be original  
Condition sound but needs redecoration

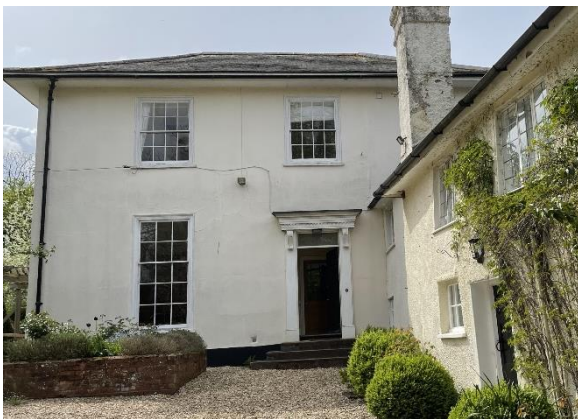
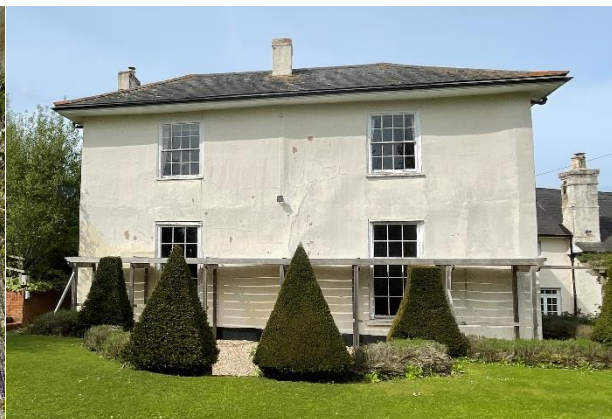
g02, f01 & f02 & g03, g04, f03 & f04– Georgian Wing (photos below)

Timber double hung sash finished in white gloss  
Lack of sash horns, very thin window bars and historic glass (except g03) suggest these are original units  
All have timber cills, except g03 & g04, which have masonry cills  
g02, g03 & g04 have working internal timber shutters  
Condition sound but require redecoration

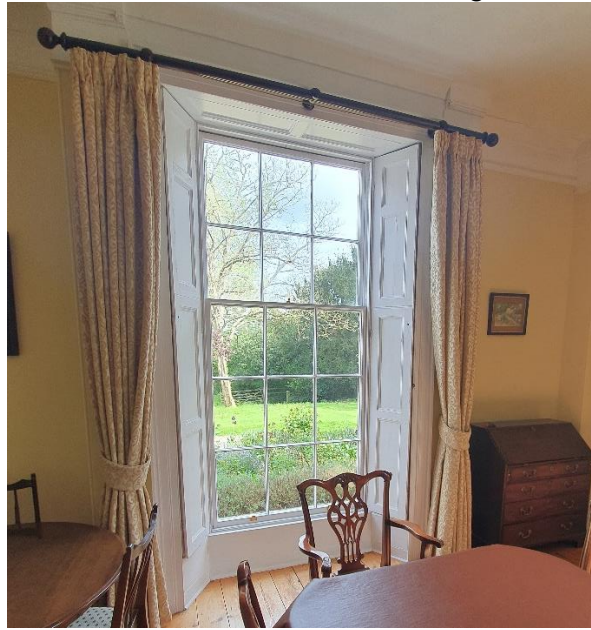
g03 – internal view (photo below)  
showing shutters

Note; this casement does not have historic glass

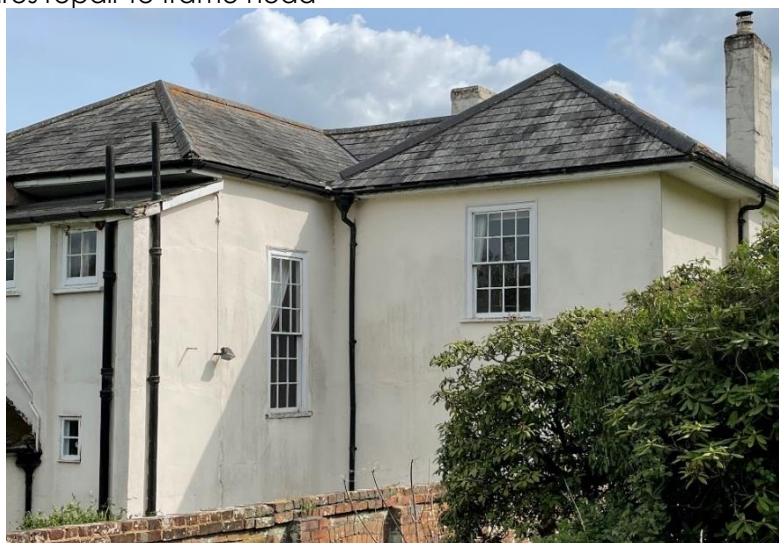
m01 & f05 – Georgian Wing (photo below)

Timber double hung sash finished in white gloss  
Lack of sash horns, very thin window bars and historic glass suggest these are original units  
Condition sound but require redecoration, plus:  
- m01 requires repair to frame head

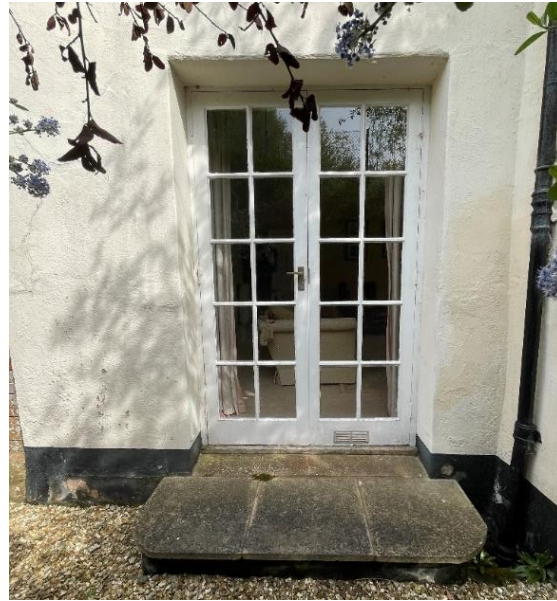
5.02 Georgian Wing Cont'd...  
g05 – French Doors  
Georgian Wing (right  
photo)

Timber French (outward opening) modern doors finished in white gloss  
Condition sound but require redecoration

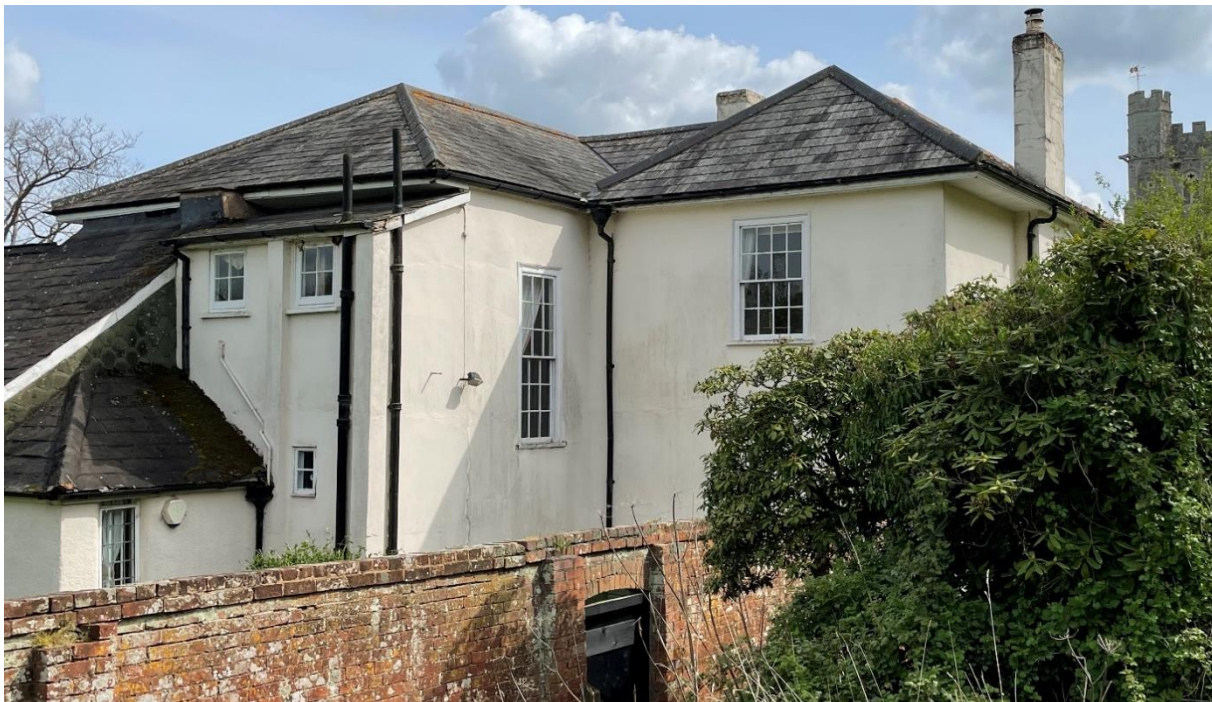
m02, f06 & f07 – Georgian  
Wing (photo below)

Timber flush casement finished in white gloss  
Condition sound but needs redecoration

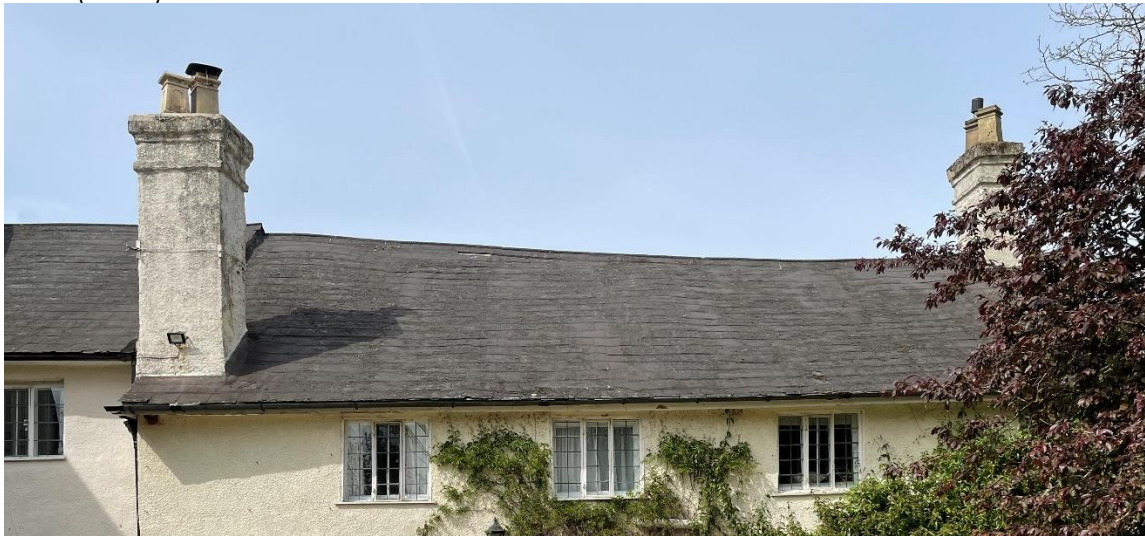
Front (south) elevation

The slate roof covering (both slopes) over the Tudor Wing has been turnerised and is therefore deemed to be in a poor condition.

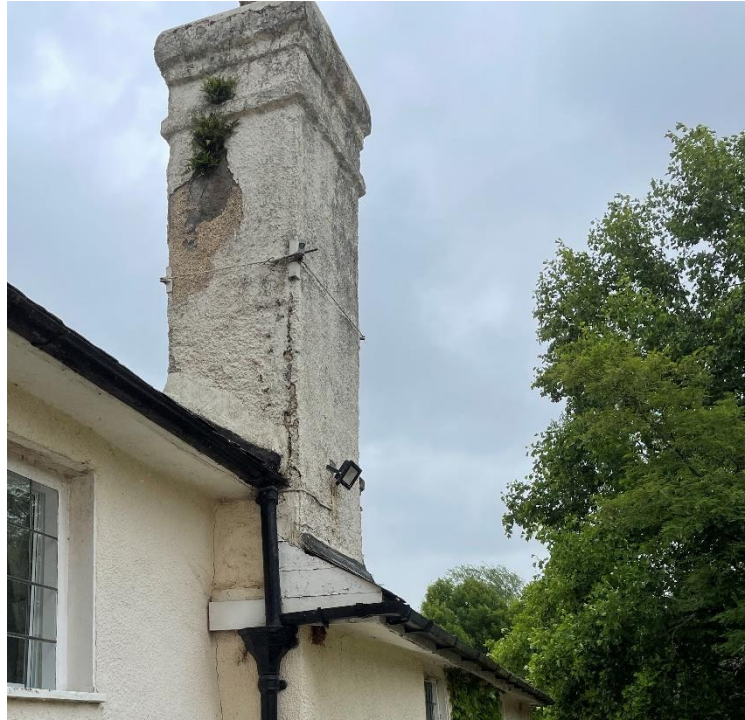
- two flue masonry stack
- appears to have lead flashings (have been turnerised)

Blown render to front stack:

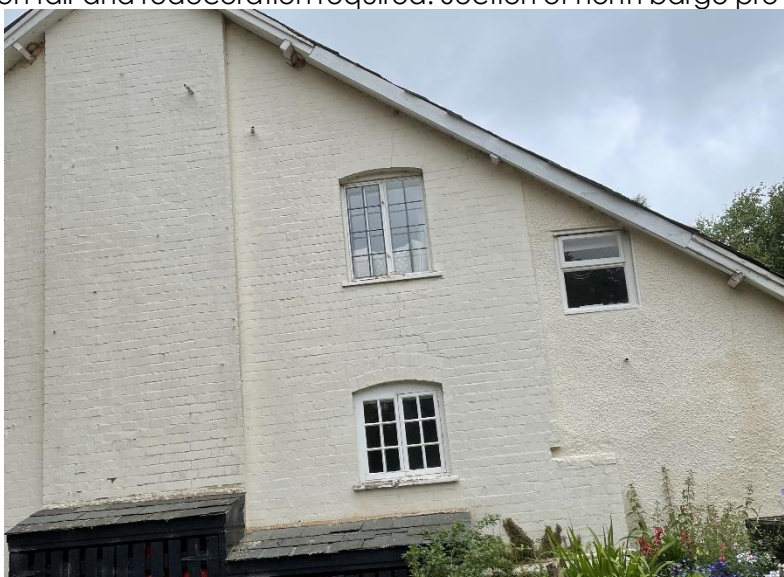
Timber fascias to both slopes and timber barge boards to gable; all finished in white gloss. Overall condition fair and redecoration required. Section of north barge previously repaired.

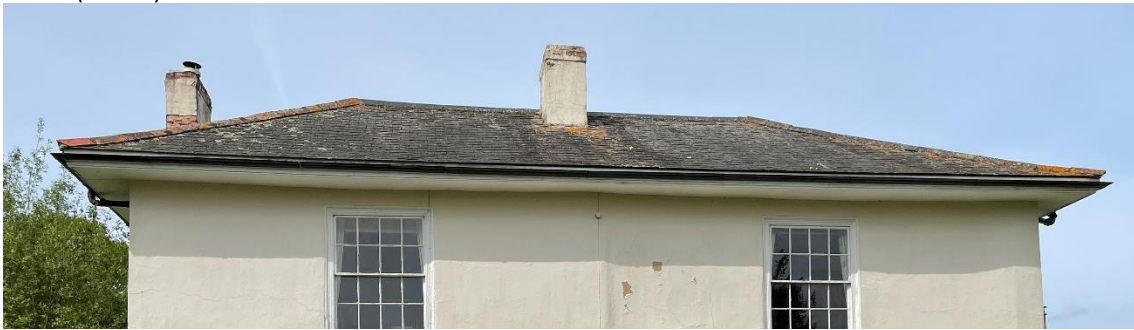
Front (south) elevation

Multi-hip natural slate roof covering. Although the roof would appear in sound condition there are frequent slipped slates and the whole roof covering is deemed to be 'nail sick'.

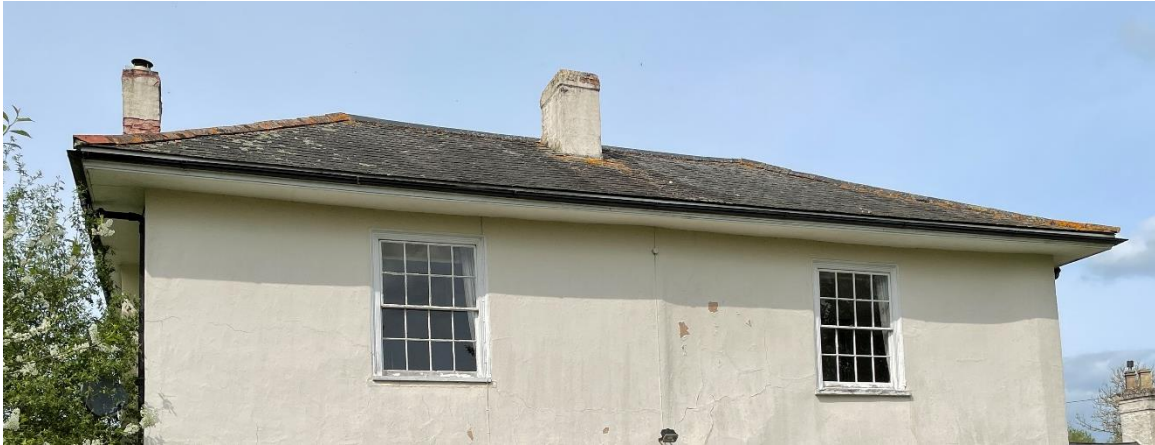
Front and side stacks:

Both full chimneys from masonry and neither appear to have any visible leadwork. Render finish to both in poor condition, with some blown render to side chimney, which appears to be constructed from brick.

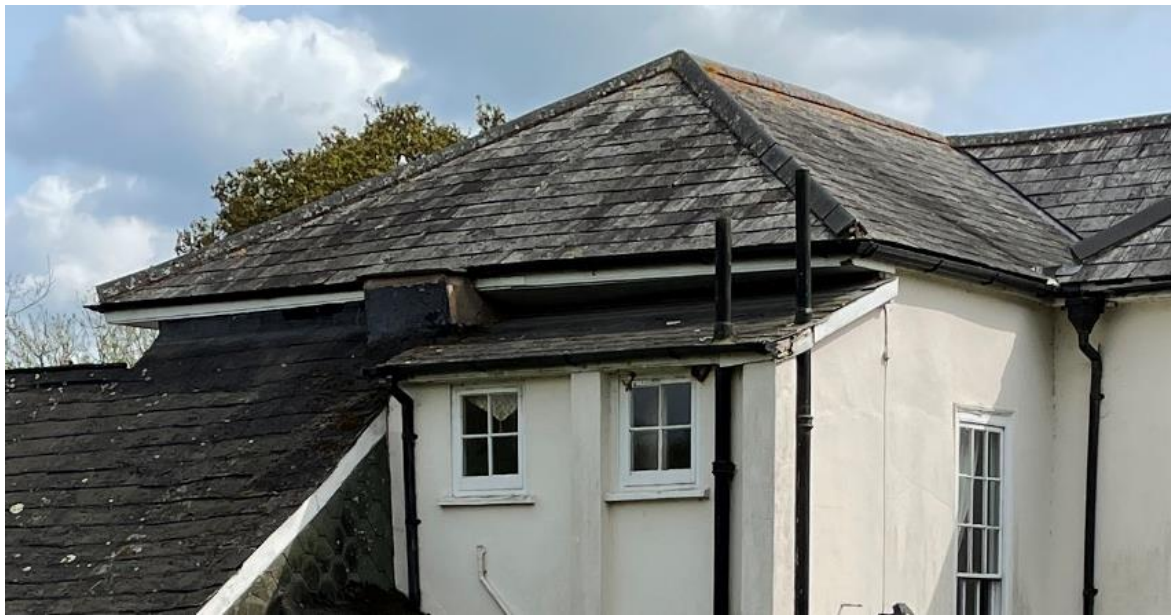
Rear (capped) stack:

Part chimney on north elevation capped at eaves level.

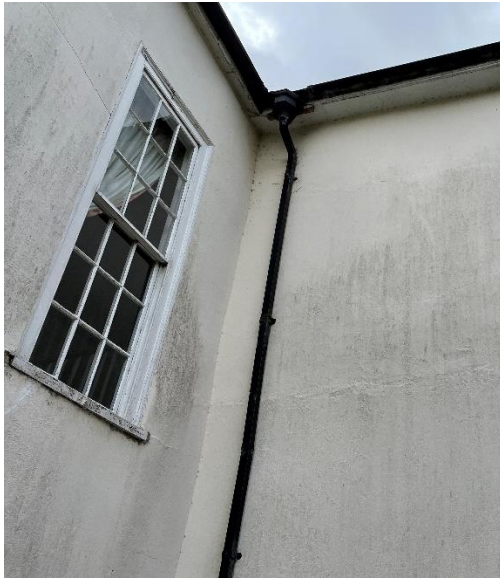
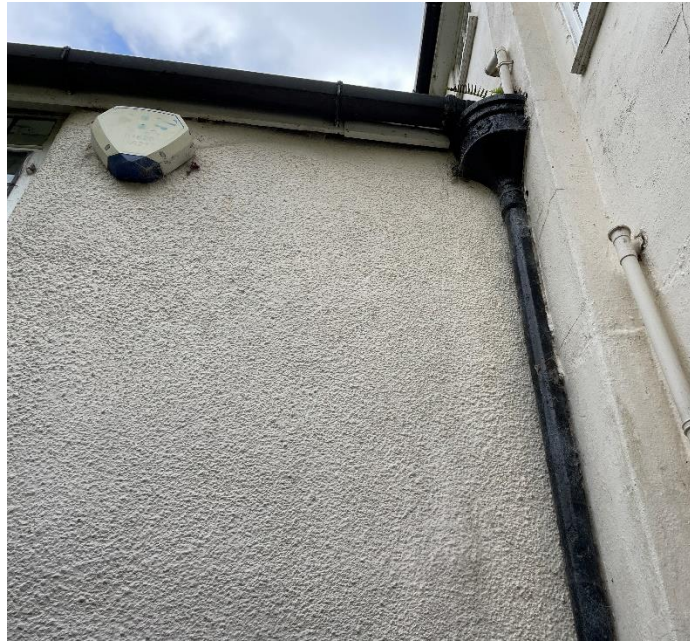
Cast iron ogee gutters and downpipes finished in black enamel; all require overhaul and checking to ascertain whether sufficient drainage capacity.

Rear downpipe, serving rear roof, black, square section uPVC. Rear downpipes, serving rear projections, black, square section uPVC. Cast iron hopper to rear projection.
