TREE SAFETY AND MAINTENANCE REPORT, LAND AT 3 BEEHCROFT, DUNDRY, NORTH SOMERSET BS41 8LE

Client: Mr A Gregory

Date 15 April 2022

AJE/AF/29211

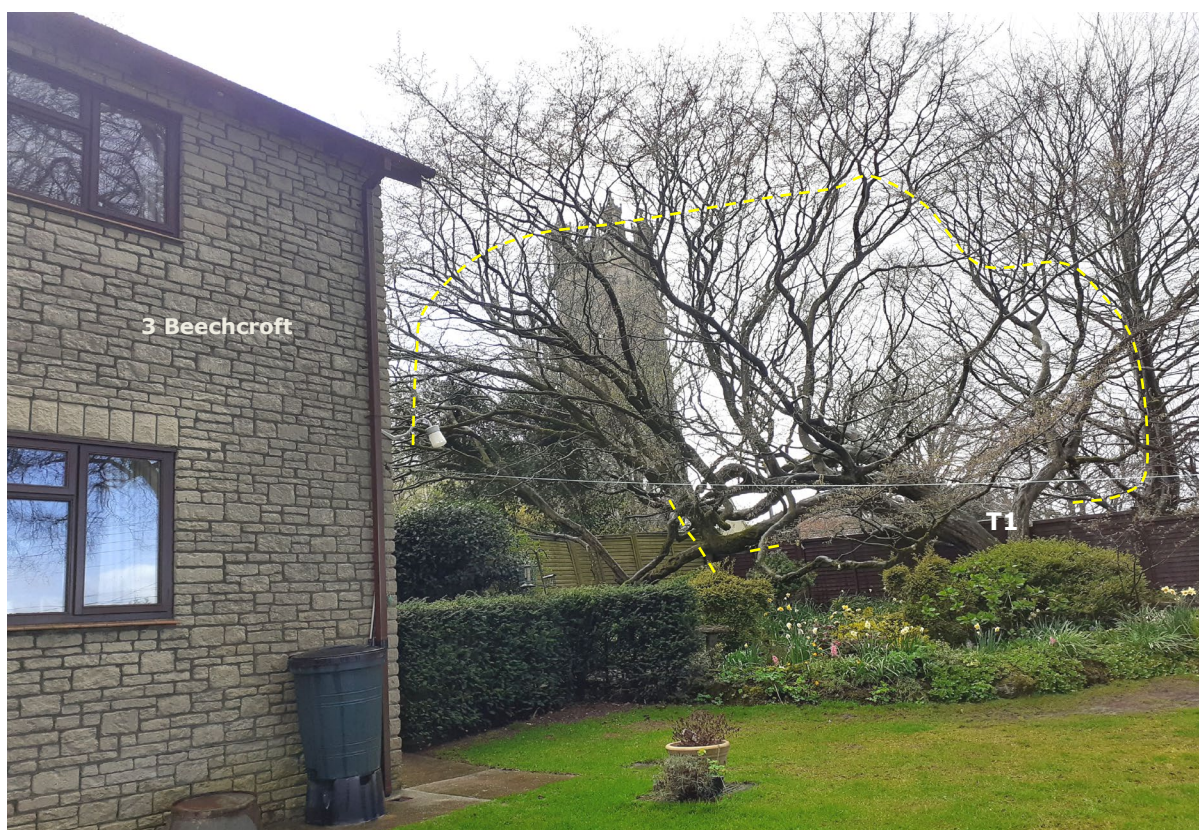
Viewed facing west with the rear elevation of No 3 to the left of the camera, note the large, characterful T1 has a pronounced southerly trunk lean, presumably a result of historical storm damage, the wide crown windsail area has mature regrowth returned towards the upright; the lowest limbs have damaged the southerly and westerly fence panels and grow across St Michael's churchyard towards a Copper Beech. The proposals are to shorten the lowest heavy laterals (Yellow dash lines) and reshape the upper canopy, needed to clear and repair the fence, reduce the risk of limb and trunk failures and allow better access to the patio and shrub bed beneath.

- 1.4 T1 (**Page one picture**) is a substantial one sided Hornbeam; it has heavy limbs damaging wooden fencing, it overhangs the garden shrubbery and St Michael's Churchyard. Recommendations made are to clear the fence panels to allow repairs, reduce its wide crown windsail area and future risk of limb or trunk, failures.

Tree Ref No. 'T'	Species	Hgt (m)	Crown Radial Spread	TD (mm)	AGE	CON	TGTS	Priority Category	Structural condition and observations	Recommendations
T1	Hornbeam (<i>Carpinus betulus</i>)	12	N -5m E -10m W - 9m S - 12m	600	OM	G	GY GRNDS BLD	M — 3	DI, the trunk is 40cm from the wooden fence panel and 9.6m from the westerly flank wall of the house; it has a 45 degree southerly lean. The first fork arises at 1.5m above GL supporting limbs spreading across the fence and graveyard, up to the outer foliage of a maturing Copper Beech growing within the graveyard. There is a south westerly facing lateral and numerous southerly facing horizontal, becoming down swept outer limbs, one of which has a 'hazard beam' split just beyond a fork with the parent stem.	<ul style="list-style-type: none"> •CR- Cut south westerly facing lateral, closest to fence, back to 1.4m from the parent stem; cut to a minor cavity, retaining the near upright branch. • Shorten the westerly facing sub-leader by 3m, back to appropriate side growths, cuts 15cm diameters. • Shorten southerly facing heavy down swept branches by 3m (Page one yellow dash line) to clear fence height, cuts 15cm diameters • Shorten the above down swept damaged branch, cut back to the hazard beam split, retain split (bat wildlife habitat?), cut at 35cm diameter • Crown lift lowest lawn facing, 7m long, down swept curving branch, cut back to parent stem, cut diameter at 15cm. • Inspect for and carry out CDW
