Preliminary Bat Roost Assessment	
For:	Mr David Dickson
Site	Low Farm, Moor Lane, Syerston, Newark, NG23 5NA
Report Date:	24 th October 2022
Report Reference:	SQ-809

Client:	Mr David Dickson
Site Name:	Low Farm, Moor Lane, Syerston, Newark, NG23 5NA
Grid Reference:	SK 74955 47295
Report:	Preliminary Bat Roost Assessment
Date of survey:	20 th October 2022
Surveyed by:	Sam Toon BSc (hons) GradCIEEM Natural England Bat Licence: 2018-35446-CLS-CLS

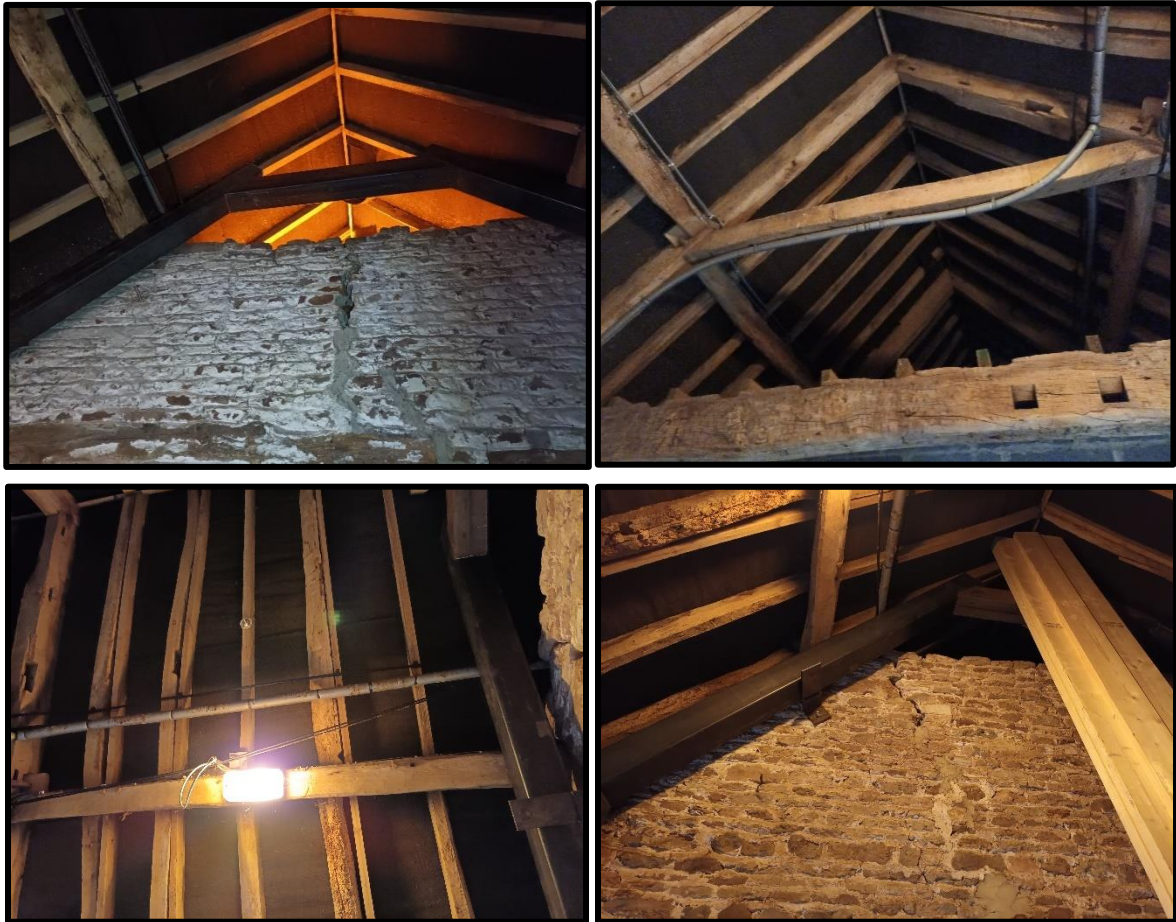
Figure 2: Barn Internals

- 3.3.3 The internals of the barn were recorded as being well maintained throughout in relation to the ceiling and the walls. Two cracks within the walls were recorded during the survey, however, both were heavily cobwebbed, suggesting lack of disturbance. All remaining walls were recorded as being in good condition, with no further cracks or fissures present.

- 3.3.4 The ceiling was recorded as being in a good condition, with the felt lining showing no signs of damage or tearing in which bats could potentially utilise or access.

- 3.3.5 It was deemed that due to the condition of the internals of the barn showing no potential roosting features and the frequent use with high levels of artificial lighting, any features in which bats could utilise would most likely be present externally.

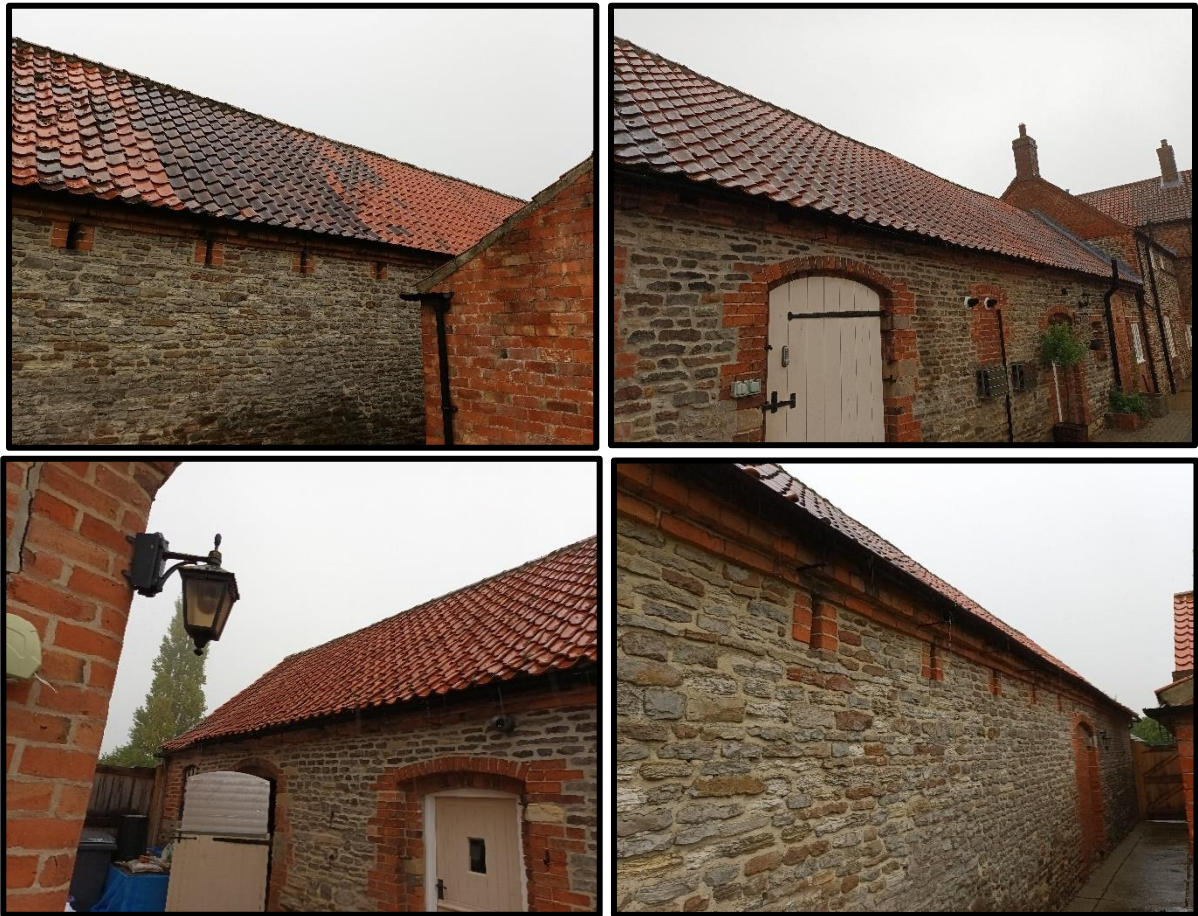
Figure 3: Barn Externals

- 3.3.6 The externals of the barn comprised of brick walls with clay pantiles along the roof. The brick work was recorded as being in good condition with no evidence of damage or cracks. All mortar was present and intact with no gaps recorded which bats could potentially utilise.

- 3.3.7 The eastern elevation recorded multiple gaps along the upper sections of the wall, however, these were deemed to be architectural detailing, providing shallow recesses which did not allow access within the barn and were recorded to be more of an aesthetic feature.

3.3.8 The roof appeared to be in a good condition and well maintained on all inspected elevations. The clay pantiles were all recorded as present and intact, with no evidence of damage or lifted tiles recorded. The main ridge was also recorded in good condition, with all tiles present, and the mortar was also recorded as being intact.

3.3.15 For the purpose of this report, in relation to roosting bats when assessed by a licenced ecologist (2018-35446-CLS-CLS), the barn was assessed as containing negligible potential for supporting roosting or sheltering bats. No further survey effort is recommended at this juncture.

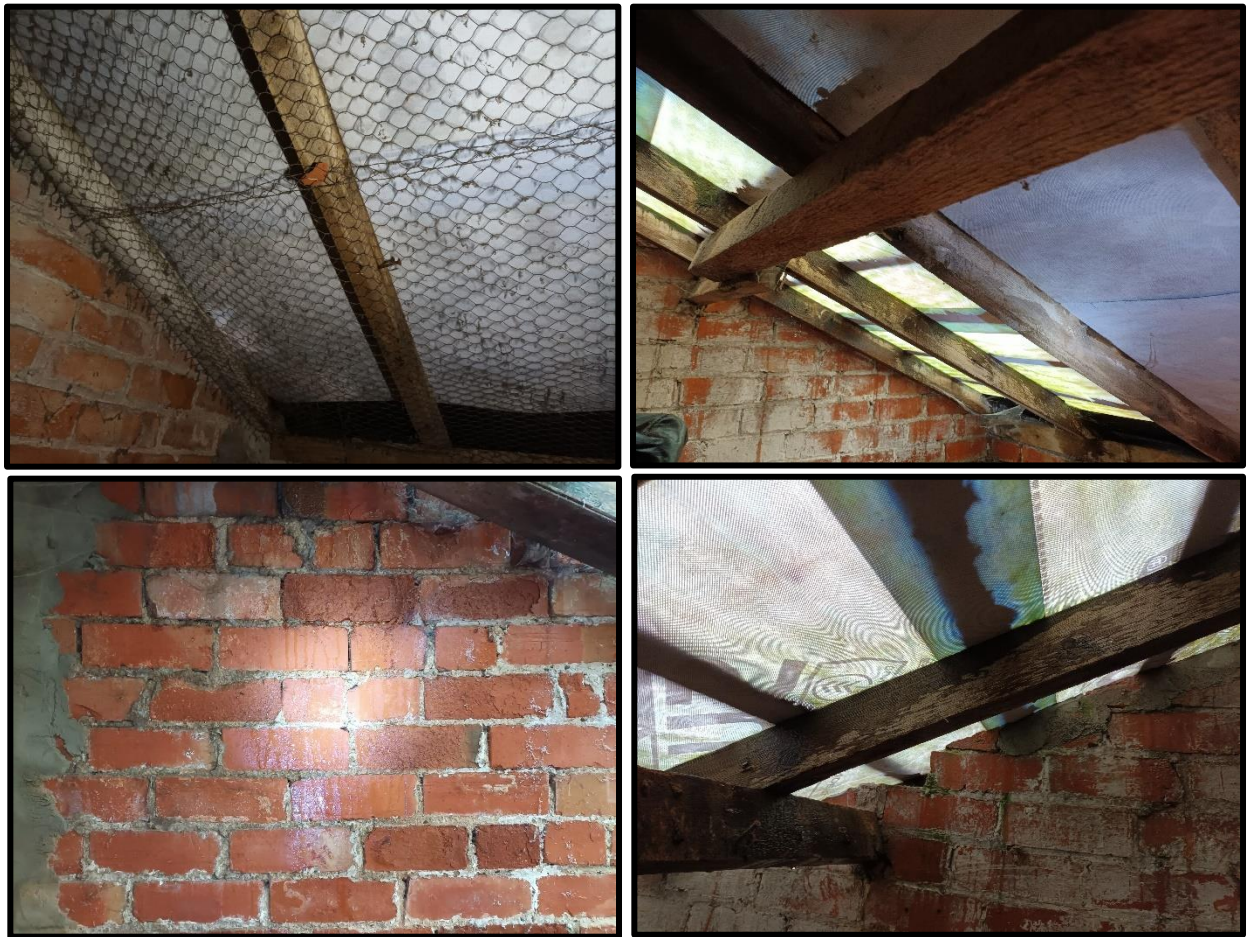
Figure 4: Kennel Internals

3.3.10 The internals of the kennels recorded no field sign evidence relating to bats. The walls were recorded as being in a good condition structurally, with no features present.

3.3.11 The roof was recorded to leak with running water recorded internally. This was considered to have been occurring for a prolonged length of time, as silica crystals were starting to protrude through the brickwork, demonstrating a high moisture content. One of the compartments to the kennels recorded chicken wire along the roof, potentially to deter nesting birds from utilising the structure.

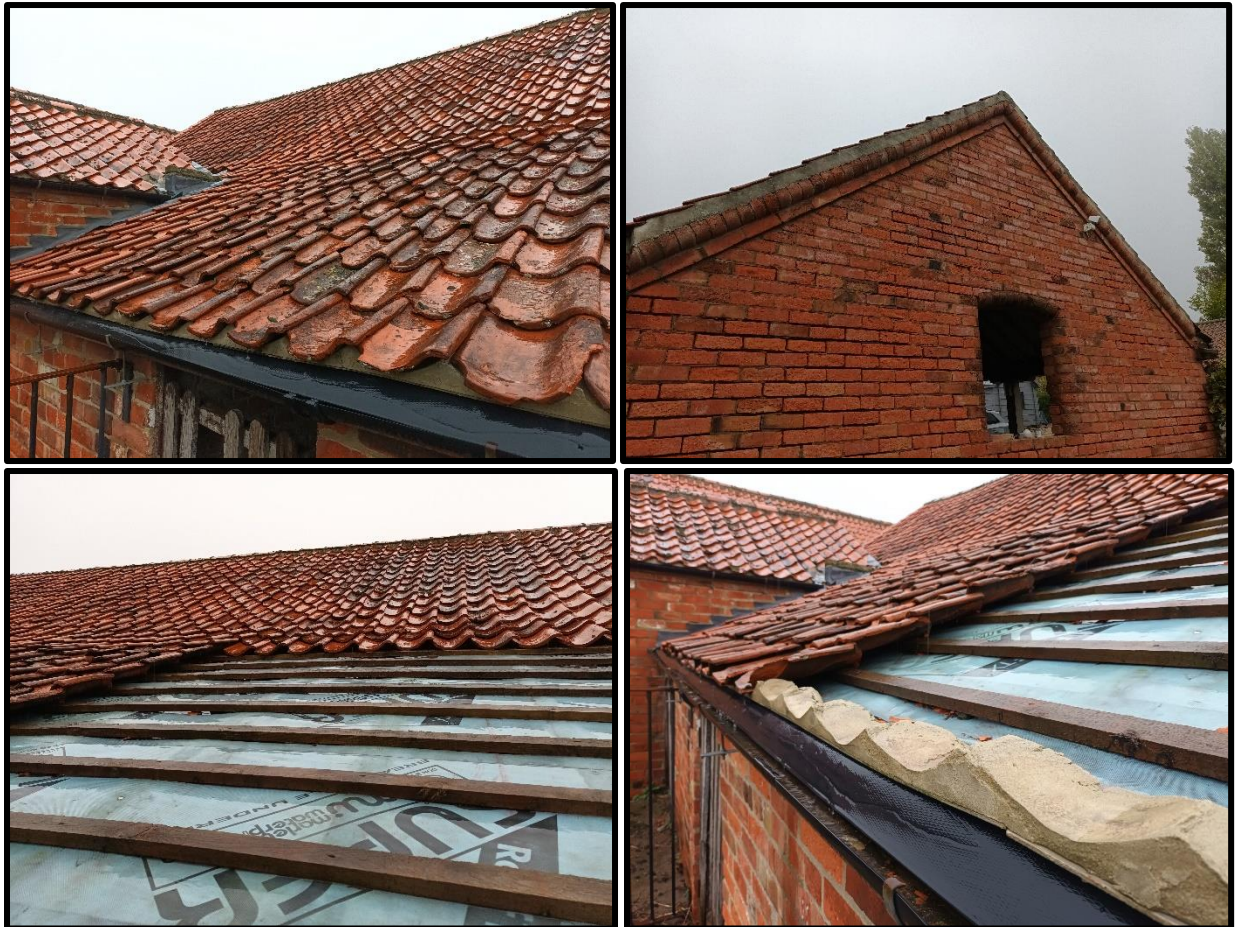
Figure 5: Kennel Externals

3.3.12 The externals of the kennels were recorded as being in a moderate condition, with the brickwork showing no signs of damage or cracks/fissures which bats could potentially utilise. No signs of damage to the mortar was recorded between the brickwork.

3.3.13 The tiles were recorded as being in good condition, with no signs of damaged or lifted tiles present along the profile. The ridge was also recorded as being in a good condition, with all tiles and mortar recorded as present and intact.

3.3.14 A small section on the lower level of the kennel roof recorded minor works had commenced with a number of tiles being stripped from the roof, exposing the wooden timbers and plastic membrane sheeting. The removal of these tiles provided a suitable gap between the tiles and membrane which bats could utilise. However, due to the plastic membrane present

being a suboptimal material for supporting bats and the time of year in which the works had been undertaken, it is considered unlikely bats would utilise this section.

3.3.16 For the purpose of this report, in relation to roosting bats when assessed by a licenced ecologist (2018-35446-CLS-CLS), the kennel was assessed as containing negligible potential for supporting roosting or sheltering bats. No further survey effort is recommended at this juncture; however, a precautionary roof strip/inspection is deemed necessary to ensure bats have

not utilised the section of roof that has had tiles stripped between the survey and the onset of works.

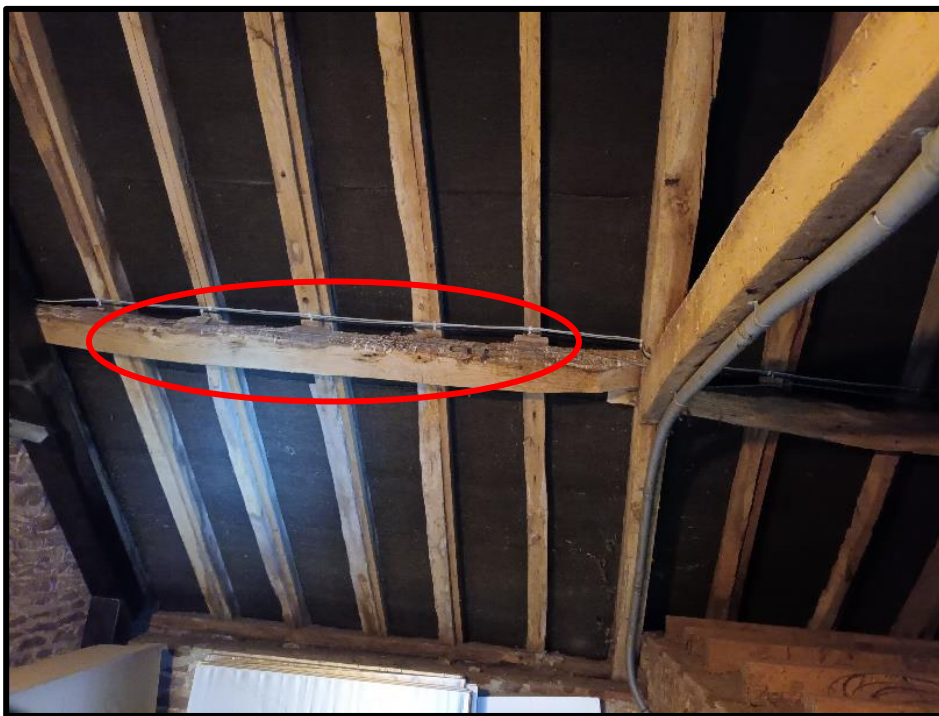
Figure 6: Bird Droppings

3.3.17 The internals of the barn recorded historical evidence of bird presence along a wooden roof beam, with multiple droppings recorded. It was discussed on site that doors to the barn were kept shut, preventing access to the internals which birds could utilise. Furthermore, no accessible points within the roof which birds could utilise were noted. No impacts are predicted at this juncture within the barn.
