TOPPING ENGINEERS

STRUCTURAL INSPECTION REPORT

The Yews, Dunnington

19035-SIR-001

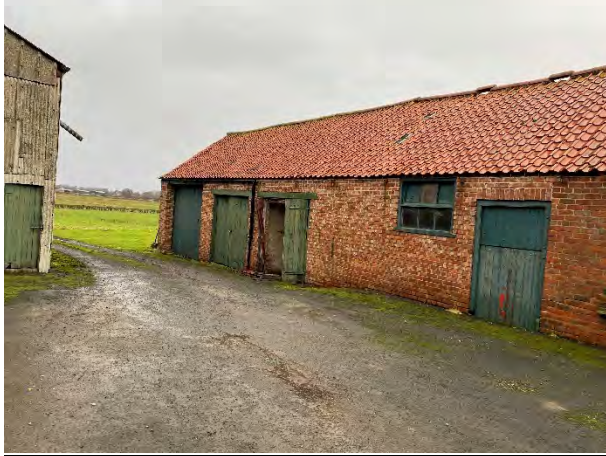
When viewed externally, the roof line is undulating and internally there are numerous holes visible in the pantile covering and consequential decay in some of the structural timbers.

Courtyard view (West) shows undulating roof line

To achieve the conversion, structural repairs would be required to the walls, in particular, the west elevation. A full rake out and re-pointing of the walls would be needed with isolated repairs to lintels. The timber roof clearly requires some repair along with a full strip and re-cover.

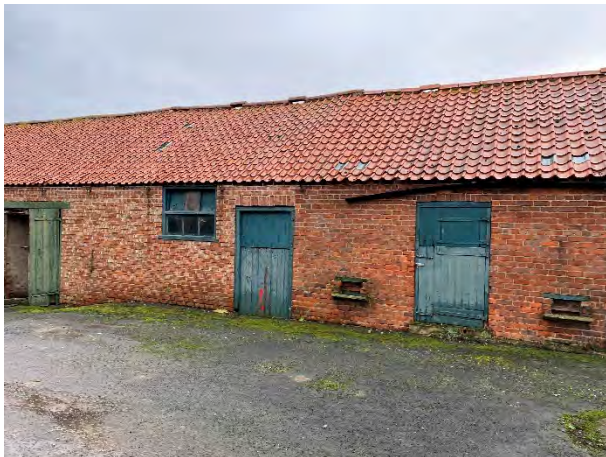
The condition of the brickwork was observed to be aged and weathered in the most exposed areas, with partially open joints where pointing has eroded. Rainwater goods were observed to be partially missing and in poor order.

Dilapidated Rainwater goods

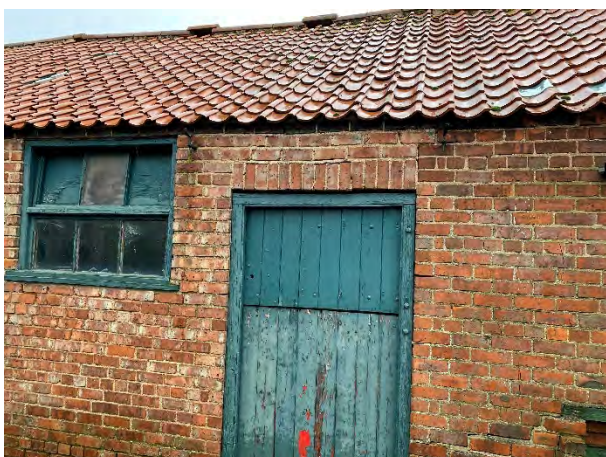
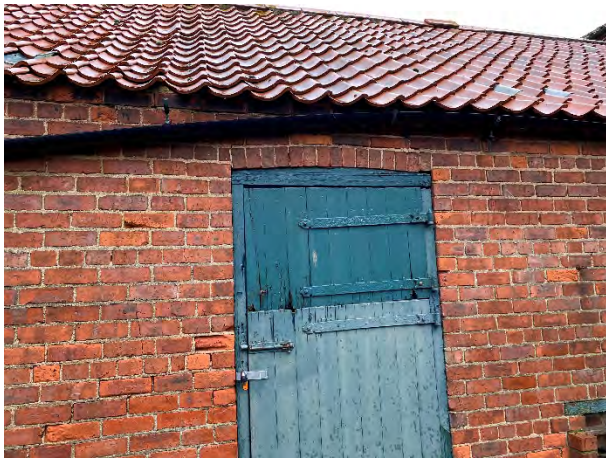
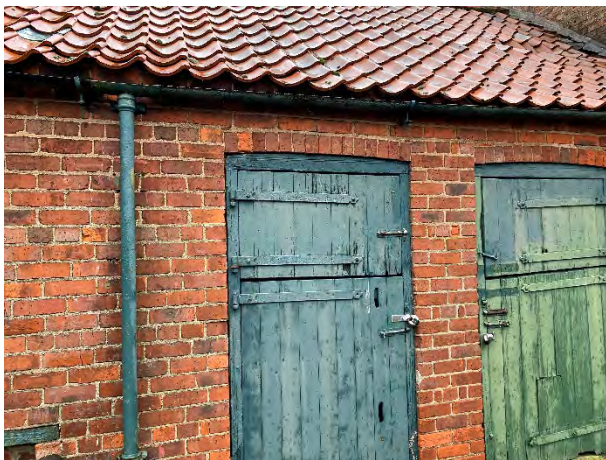
Stepped diagonal cracking is visible in the cross walls to the northern end of the building, an indication of structural movement at the northern end of the west elevation. Lintels to the west elevation are a mixture of timber and brick arches. The timber lintels were observed to be in a relatively satisfactory condition. The brick arches were observed in a moderate condition such that limited movement was observed and as a minimum the arches would require slate packing using conventional masonry repair techniques.

Movement over Door

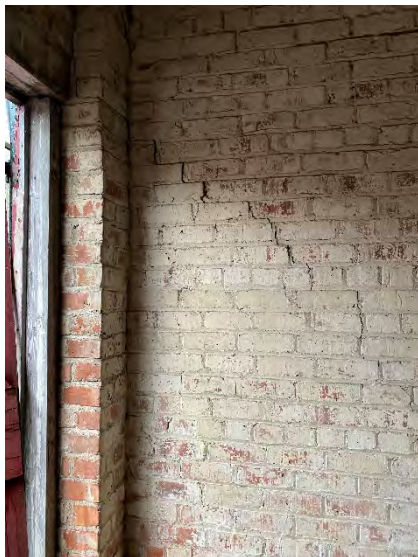
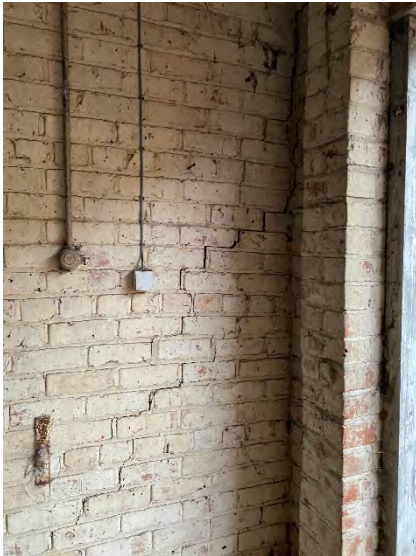
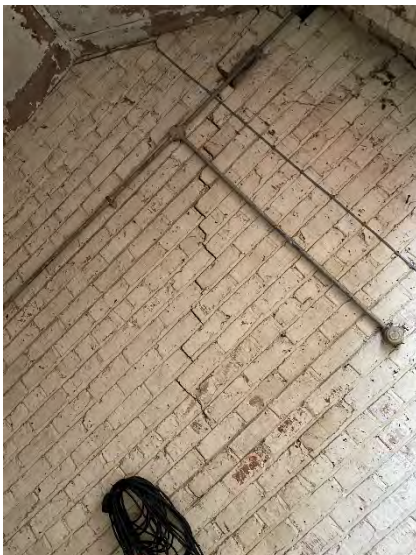
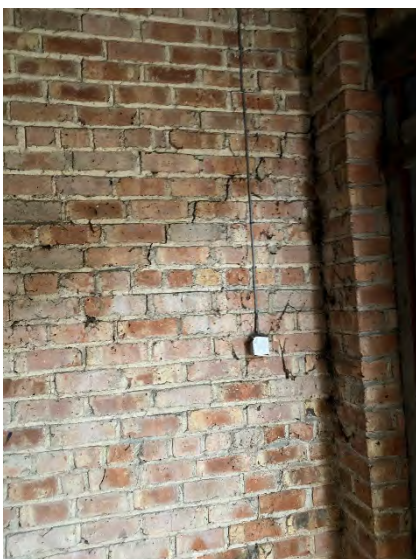
The masonry walls are generally plumb and in line but there is an area of lateral movement on the west elevation. The area is c2-3m wide and affects four courses of masonry (0.9m²).

Movement towards West Elevation

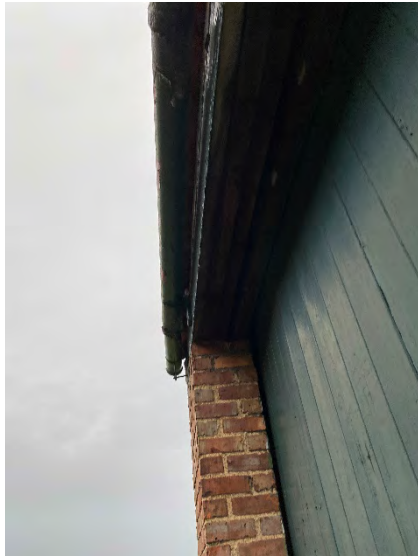
Weathering to Gable Wall

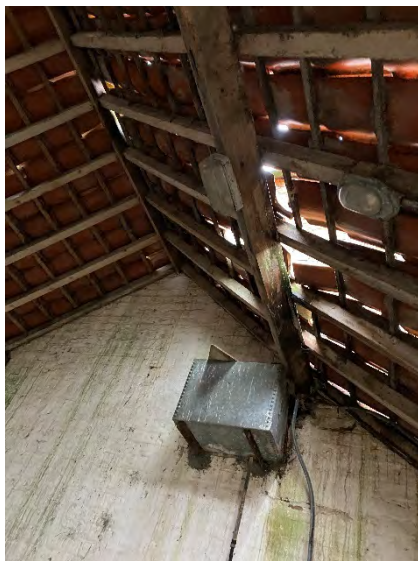
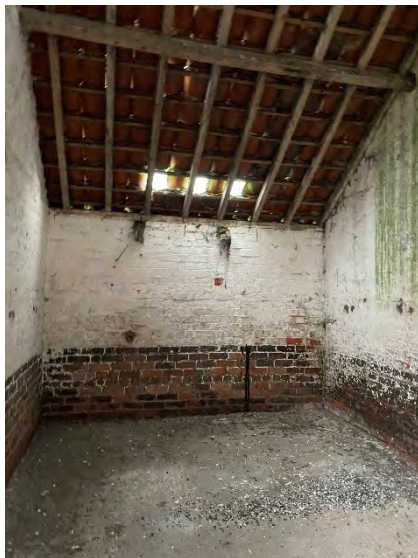
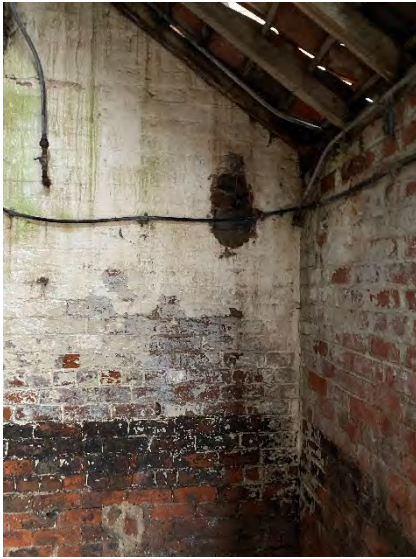
Dilapidations of Roof

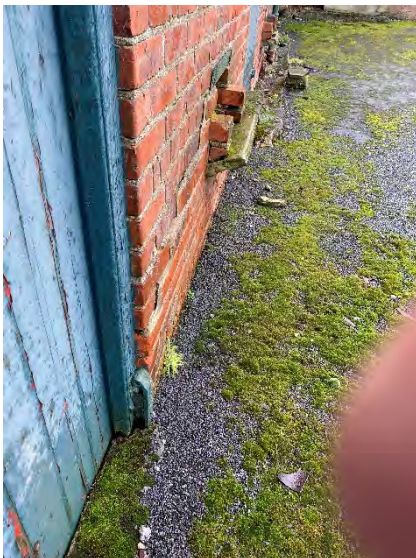
Lateral movement/damage to West Elevation

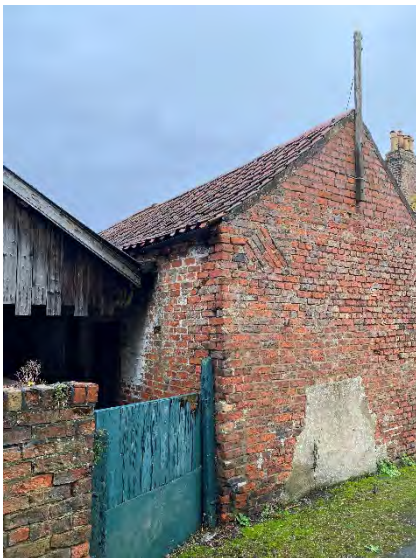
Masonry to the building is extensively weathered with large areas of eroded pointing with open joints.

General Weathering

Structural repairs to the masonry would be required along with a full strip and re-cover of the roof, repairs to any defective structural timber and a full re-pointing of the external envelope.

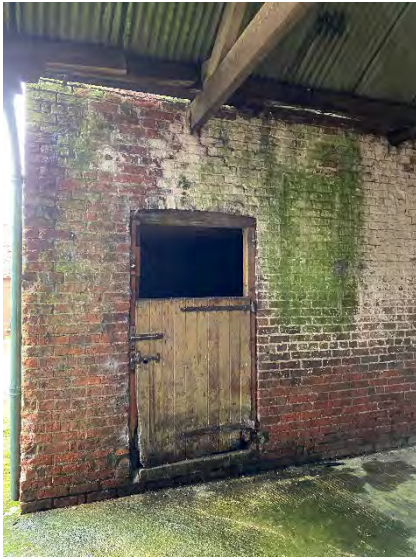
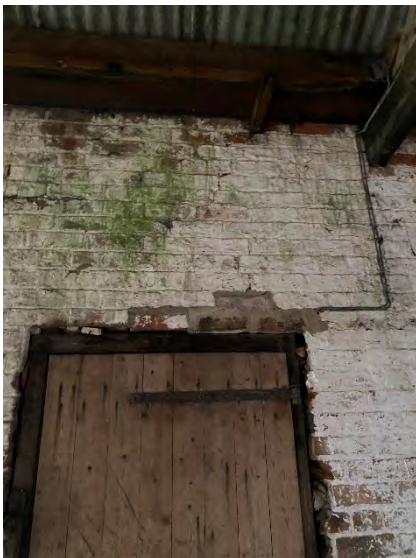
On the west elevation movement was noted above the masonry arched lintels along with a small area of missing brickwork and exceptionally high erosion/weathering. The area is limited to say 5m² and requires repair using conventional techniques.

Covered yard Elevation with movement over lintel

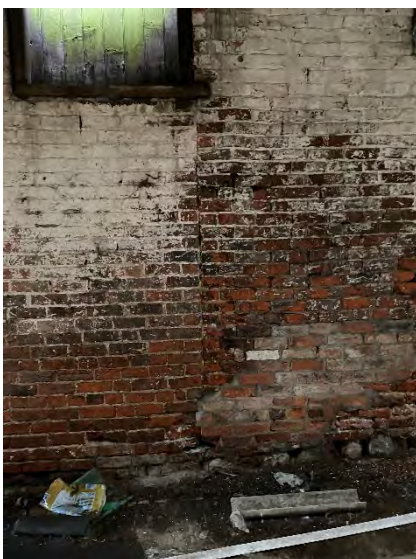
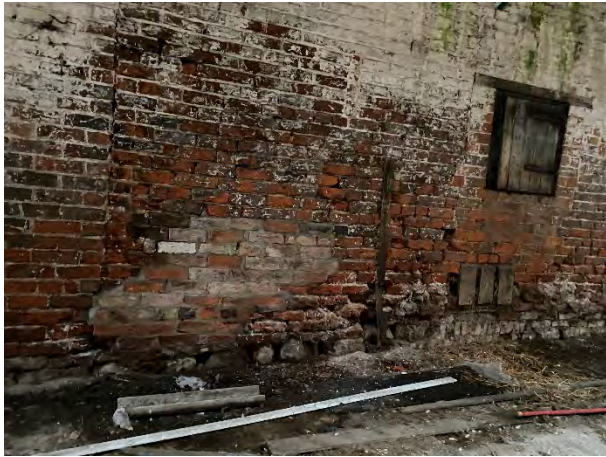
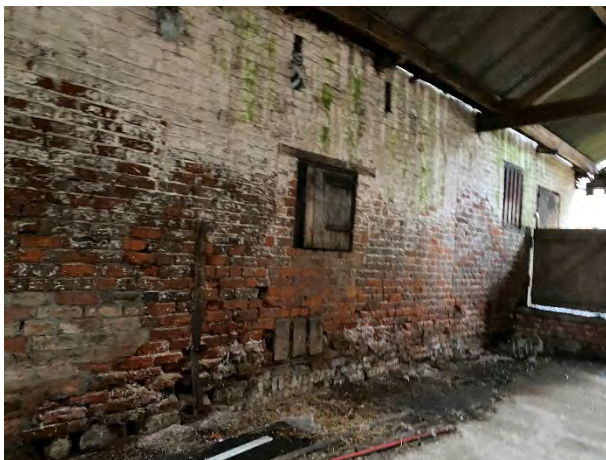
Heavily eroded brickwork

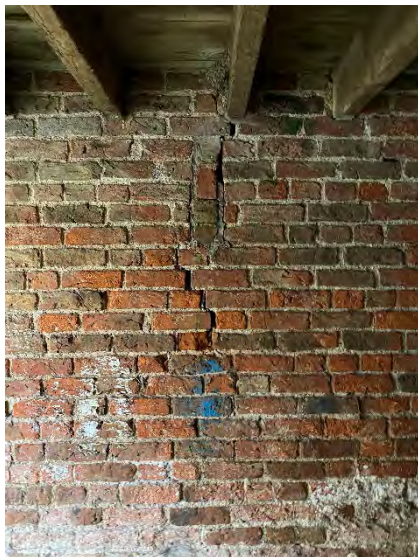
Vertical crack

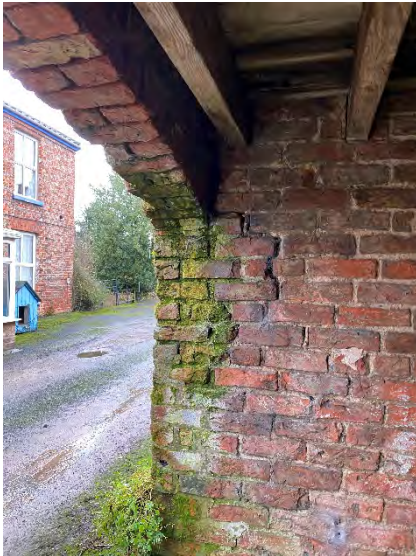
Cracking to the spandrel at the change in level between roofs on the east elevation was noted along with displacement of the masonry to the left-hand side of the eastern arch.

Movement around arch

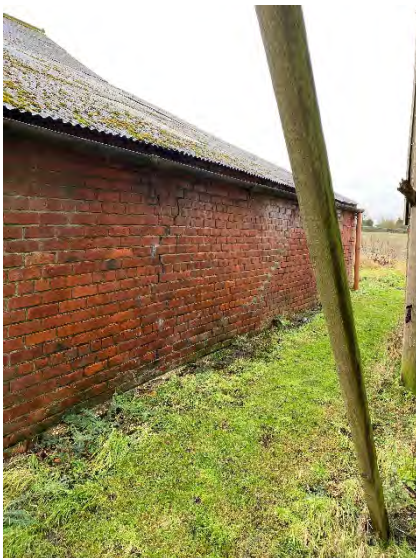
The lean-to extension has suffered structural movement on the north elevation, visible through previous re-pointing of cracked masonry. No evidence of recent movement was observed.

Movement in North Elevation

The form of Building C is suitable for residential conversion. Repairs to address the isolated age-related defects in the original section of the building, would be required along with structural repairs to the north elevation of the historic extension and internal repairs to address any defective structural timber. We have reviewed the proposals shown on Charlotte Kitchen Architects drawings, which retain the form of the building and confirm these proposals are achievable.

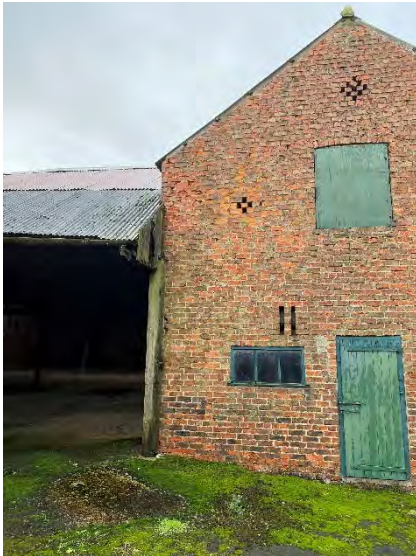
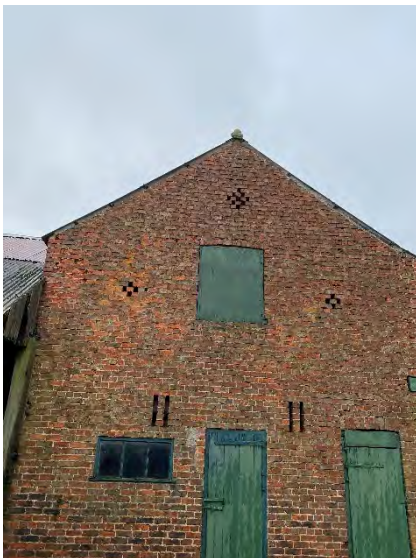
Generally, the walls to the original building are plumb and in line. The original southern section of the building is aged and weathered with isolated masonry issues limited to deterioration of cruciform ventilation holes and minor movements around windows.

View on gable with defects around cruciform ventilation holes

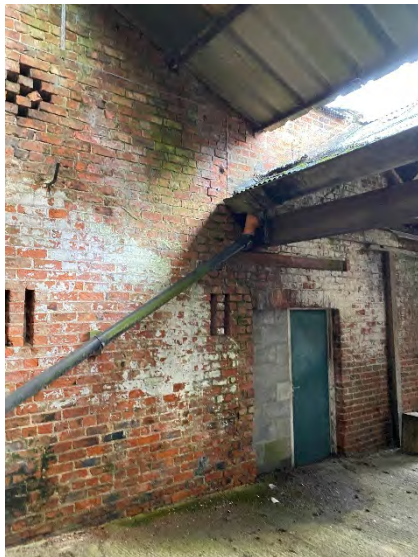
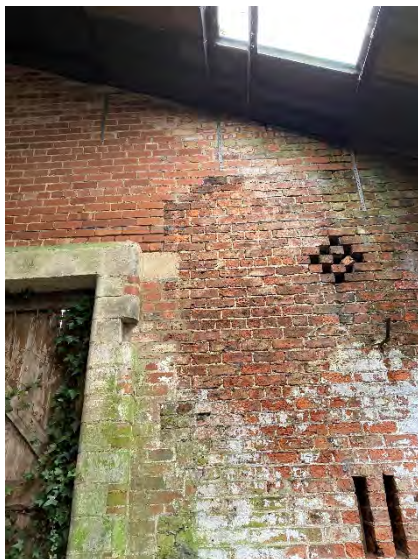
Defects around ventilation holes

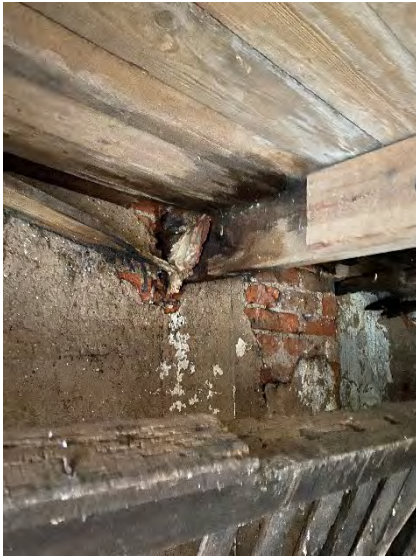
Internally the first floor has previously been repaired but there is evidence of rot and decay in the original structural timbers. A low steel rail is used to support the floor timbers and the rail is not a conventional structural section.

Defects in timber partially rectified

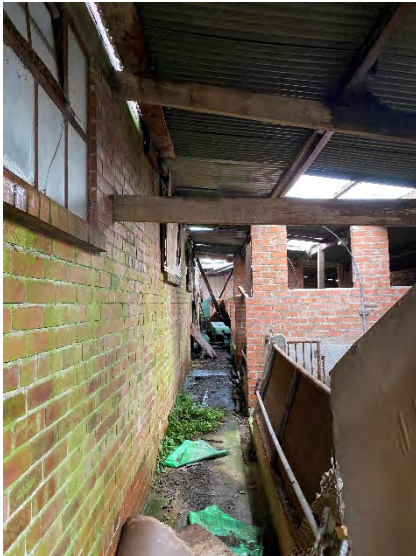
Poor roof construction

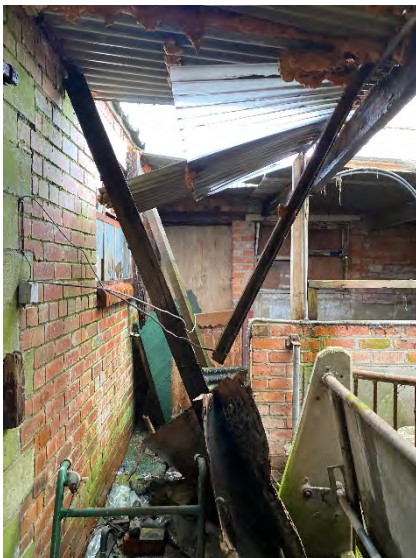
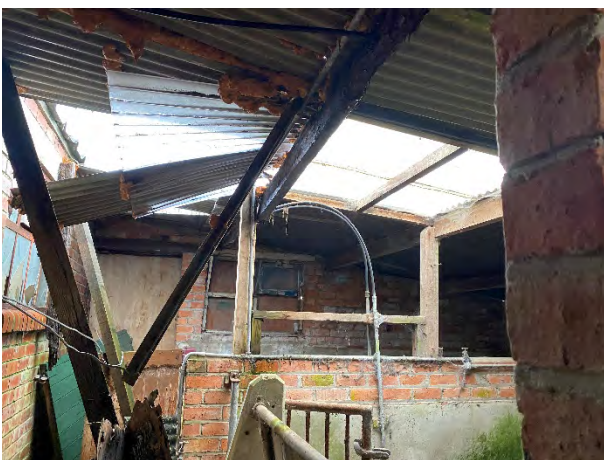
With the exception of the roof to building H, the remainder of these buildings are in reasonable structural condition where visible. The west elevation of building H is observed by vegetation at the southern end. The timber roof trusses to building H have deteriorated and failed where the roof covering is missing.

Roof missing/failed

As previously stated, the buildings are in reasonable structural repair, with the exception of the roof to Building H which would require replacement, irrespective of a conversion to residential accommodation.
