Hill House, Top Green, Denston, Suffolk CB8 8PW.
Historic building recording and analysis of the House. Recorded 27 05 2022.

Site name/Address: Hill House, Top Green, Denston, Suffolk CB8 8PW.	
Parish: Denston	West Suffolk
NGR: TL7613252879.	Site Code: N/A
Type of Work: Historic Building Recording	Site Director/Team: Barry Hillman-Crouch
Date of Work: 27 05 2022	Size of Area Investigated: 20x40m
Location of Finds/Curating Museum: N/A	Funding source: Owner
Further Seasons Anticipated?: No	Related EHER Nos:
Final Report: Hill House, Top Green, Denston, Suffolk CB8 8PW. Historic building recording and analysis of the House. Recorded 27 05 2022. Barry J Hillman-Crouch MStPA DipFA BSc HND.	
Periods Represented: C15th - C20th	
<p>SUMMARY OF FIELDWORK RESULTS:</p> <p>Hill House is a typical Georgian country house of the MC18th that has built on an earlier cross-wing frame from a C15th open hall house. The western bays on the ground and first floor are framed for a cross-wing with heavy 8in wide axe finished oak studs, cambered top-plates and trenched down braces from swept jowl storey posts. On the ground floor, the few remaining studs in the eastern frame have fixture holes suitable for

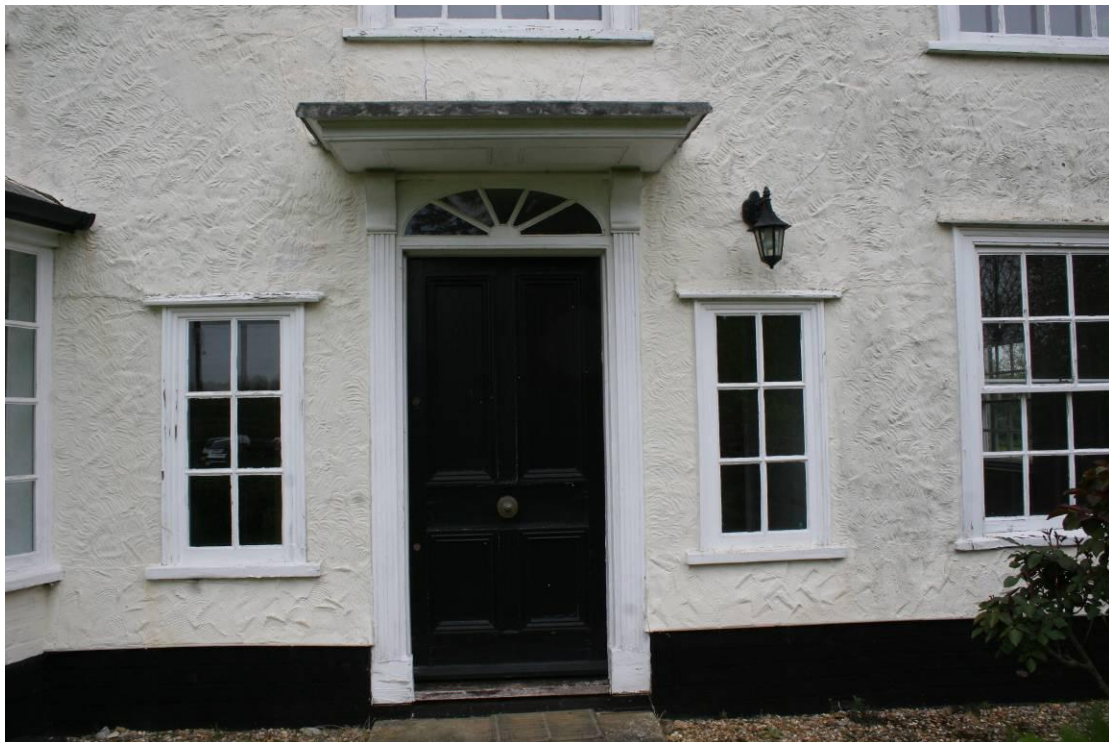
The off-centre doorcase.

The window frames and doorcase appear original and well kept with let in repair sections and recently replaced leadwork. The walls are clad with hard cement finished with a broom swept pattern on EML (Expanded Metal Lath) and with galvanised drips. C20th casements have been inserted on either side of the doorcase to light the entrance hall.

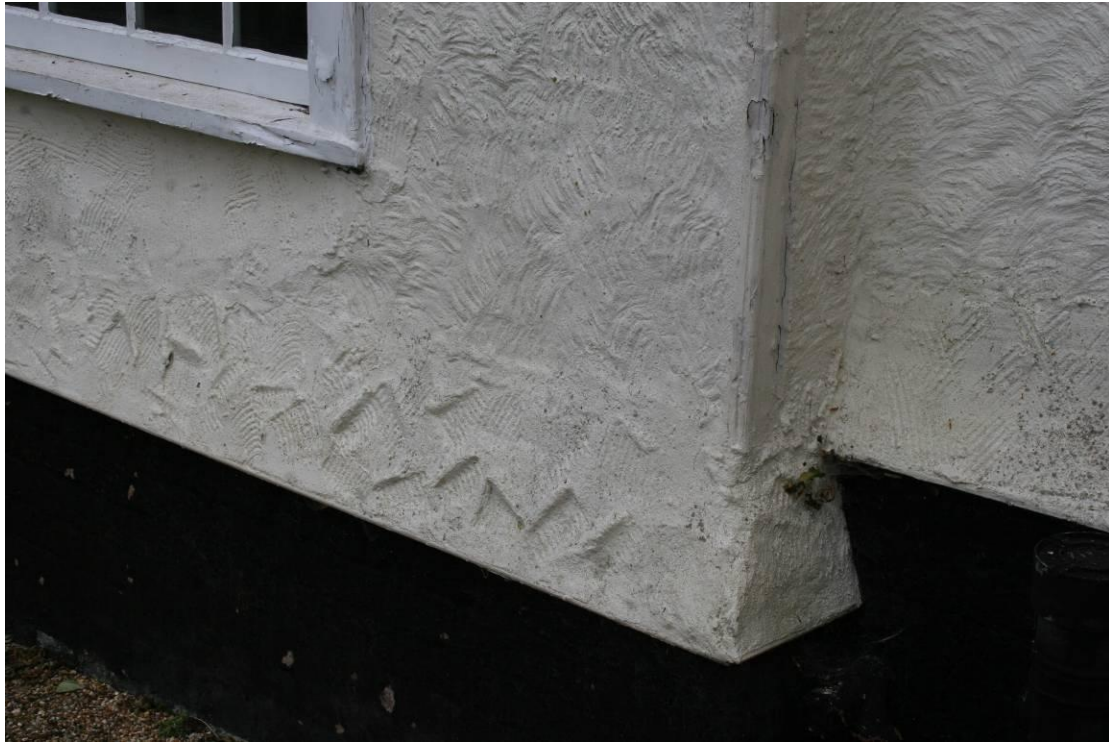
Detail of the modern render and galvanised drip detail on the NE corner.

The render has a broomed finish with repair sections over the galvanised drips. The rear extension has a single high level casement window with portrait panes in an opening metal frame but a LC20th machine made fixed light.

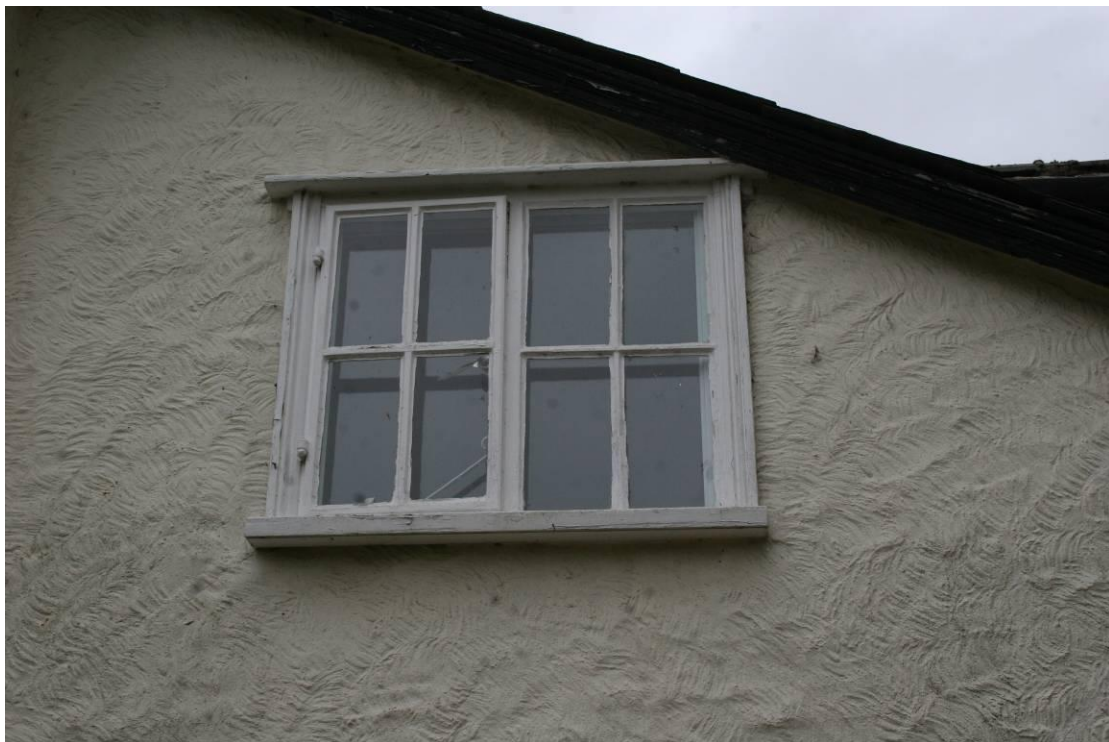
Upper floor window with metal frame.

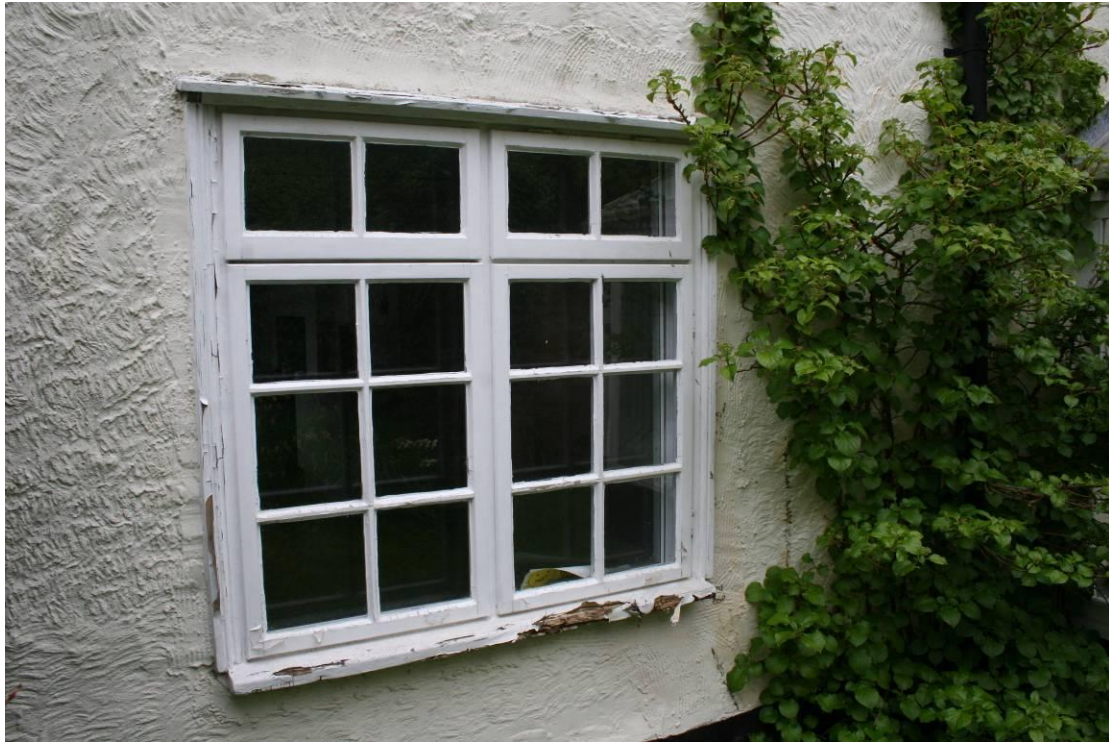
LC20th casement window in the west elevation.

The ground floor has a poor quality LC20th timber casement at the end of its serviceable life. The render shows several attempts to repair failing sections under the window.

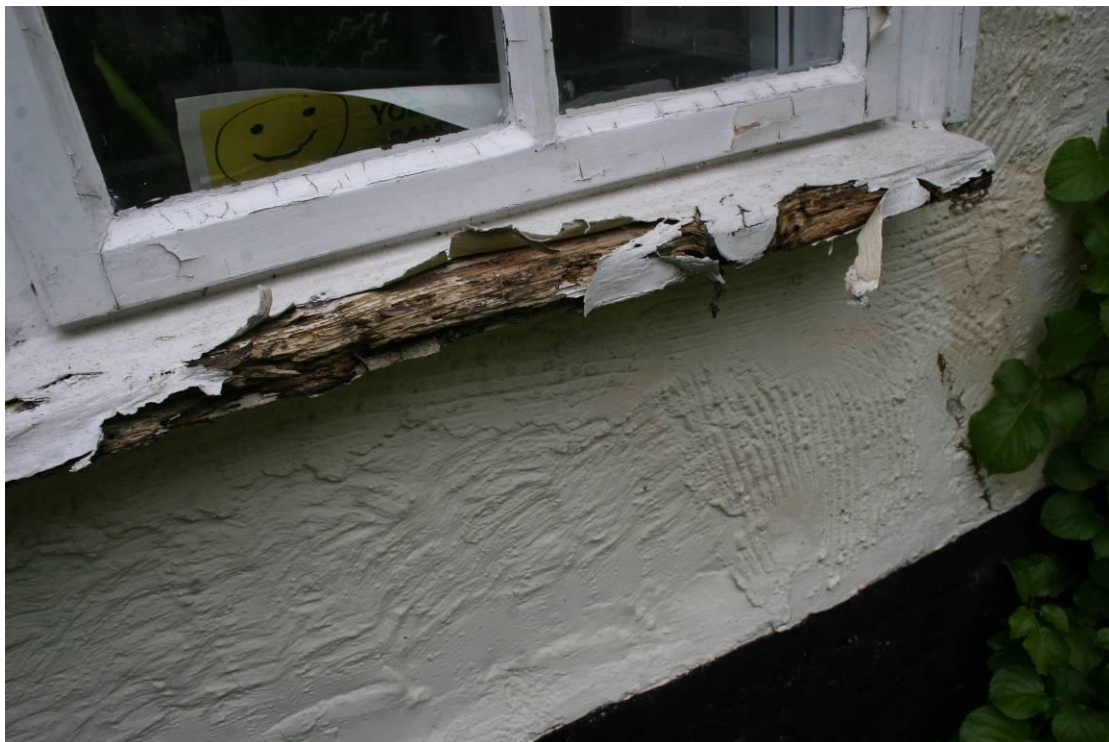
Low quality timber was used in the LC20th casements.

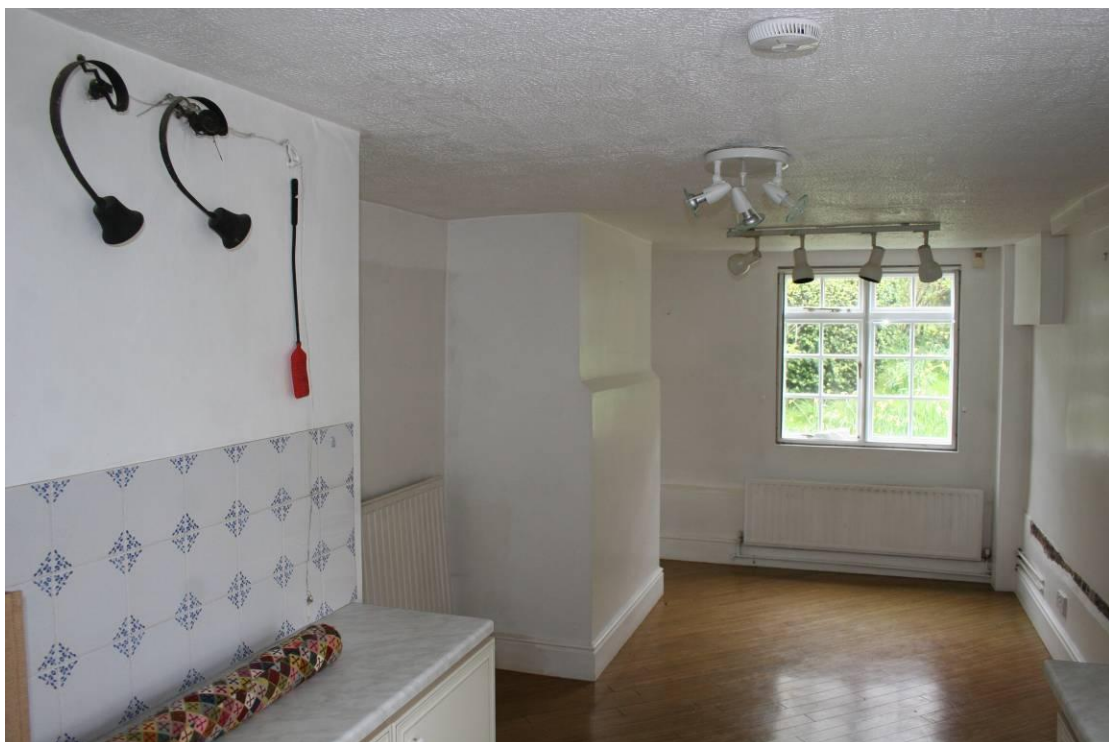
Looking W in the Kitchen. A fireplaces has been bricked up.

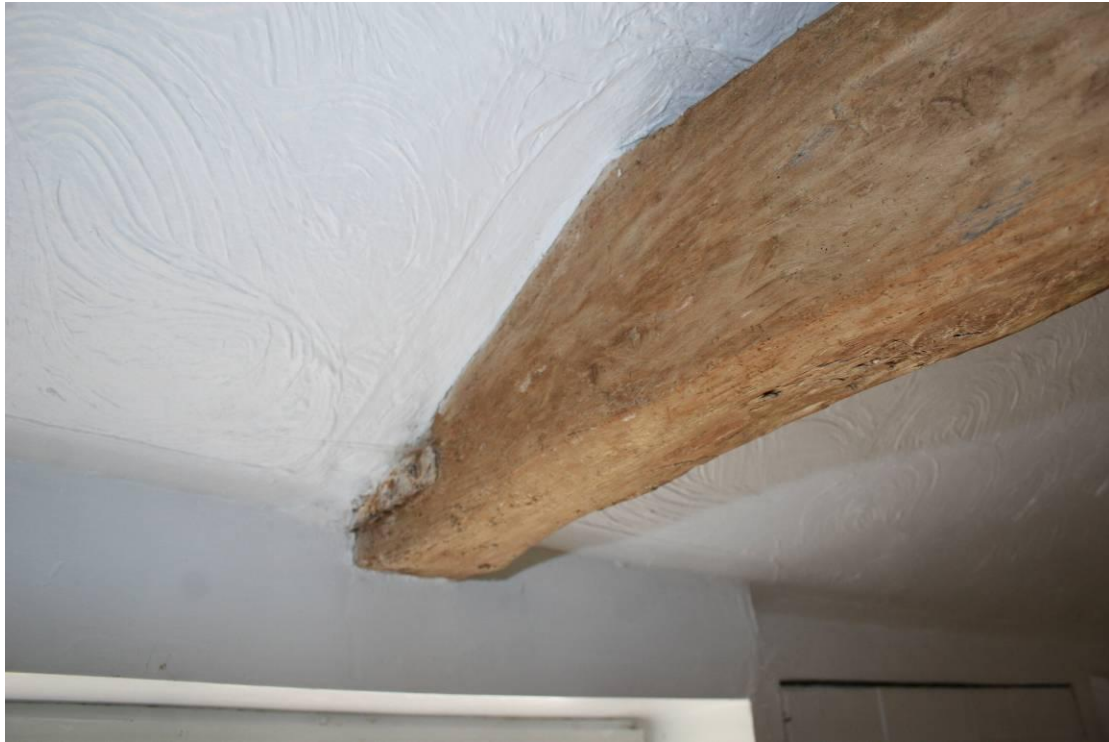
The eastern end of the tie-beam with short iron tie.

There an exposed deep section timber tie-beam fixed with hand wrought short iron ties and with one sharp carcase hook. The timber appears sandblasted and has lost its patina. All the wall finishes are recent and the ceilings are plaster boarded.

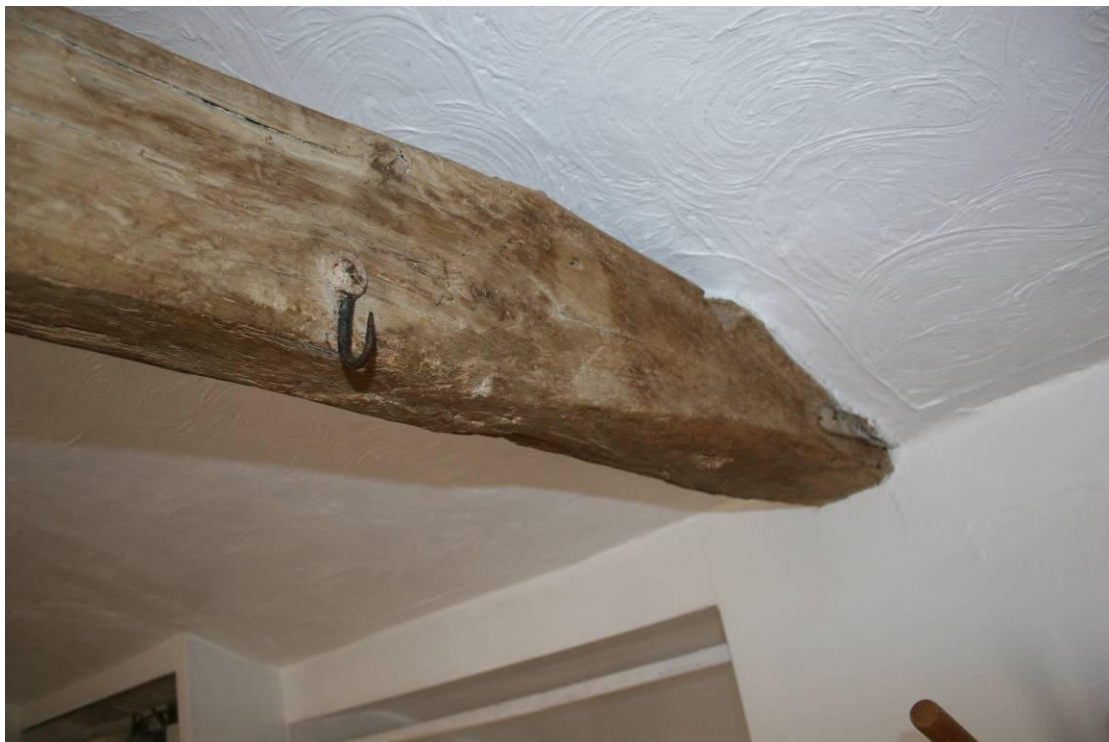
The western end of the tie-beam with short iron tie and carcase hook.

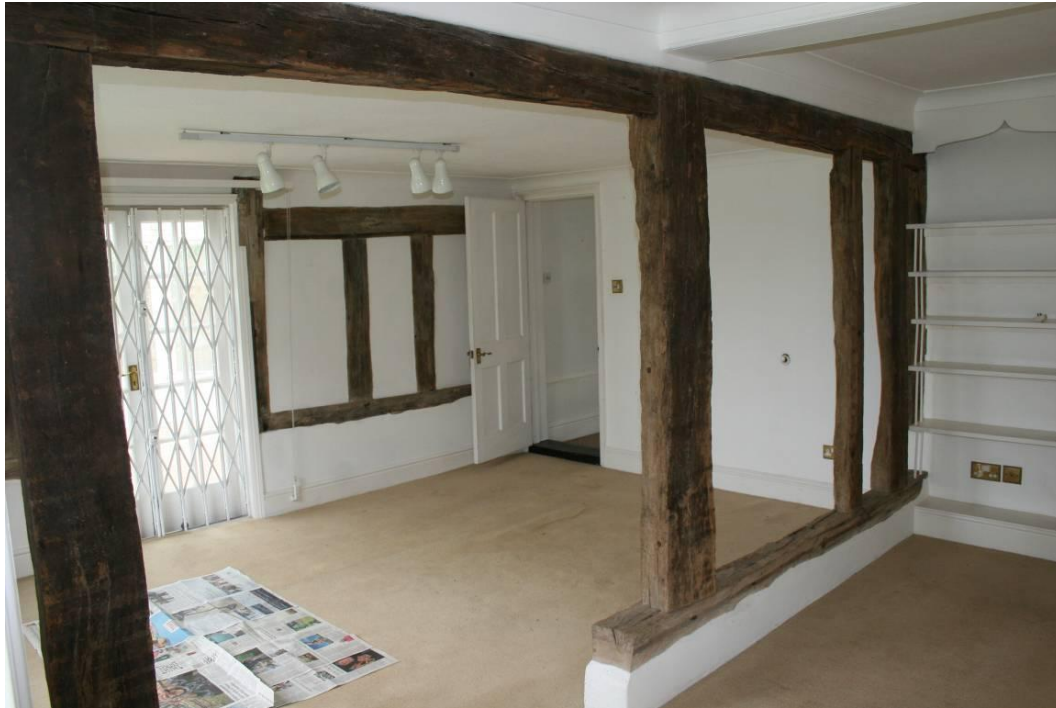
The dividing wall has been largely removed.

The dividing wall has the original storey post that carries up into the room above and three original studs with darts and mortices for ledgers for wattled panels. The faces have stripes from being lime plastered and each has a few fixture holes. The 6in wide studs are morticed into the midrails and the sole plate which is a later replacement.

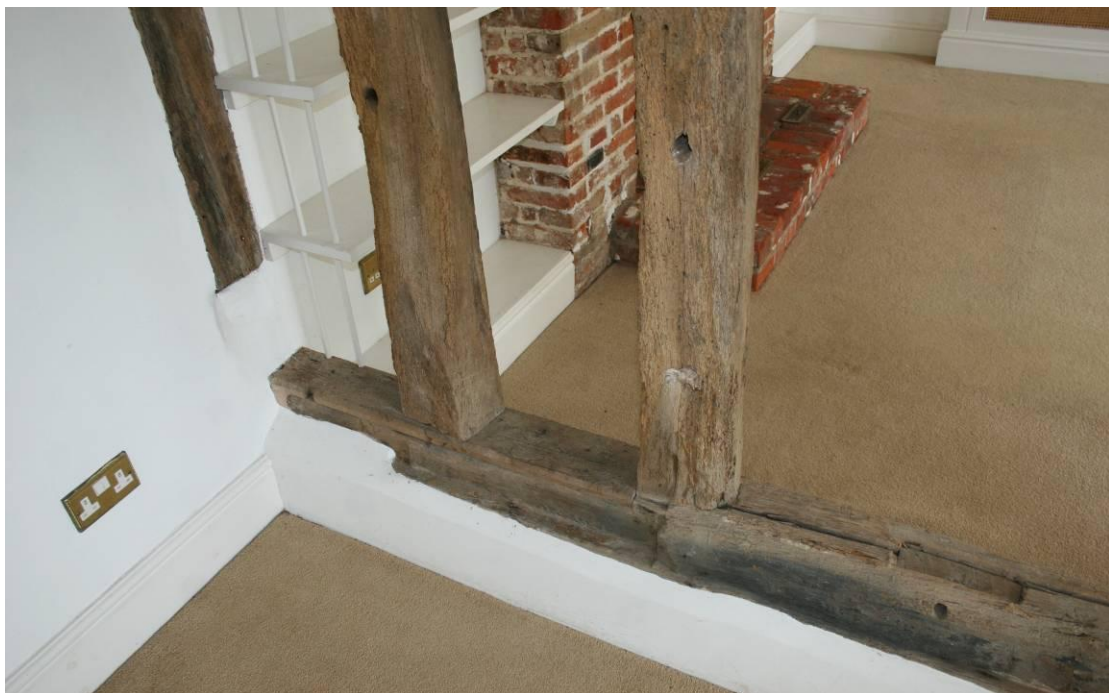
The soleplate is rebated for a doorway.

The soleplate has a rebate for a doorway which was subsequently blocked with an inserted stud. The storey post has a slip tenon which is numbered to match the sole plate but also has an earlier number. The wall was remodelled in the Georgian era when the house was given its current form.

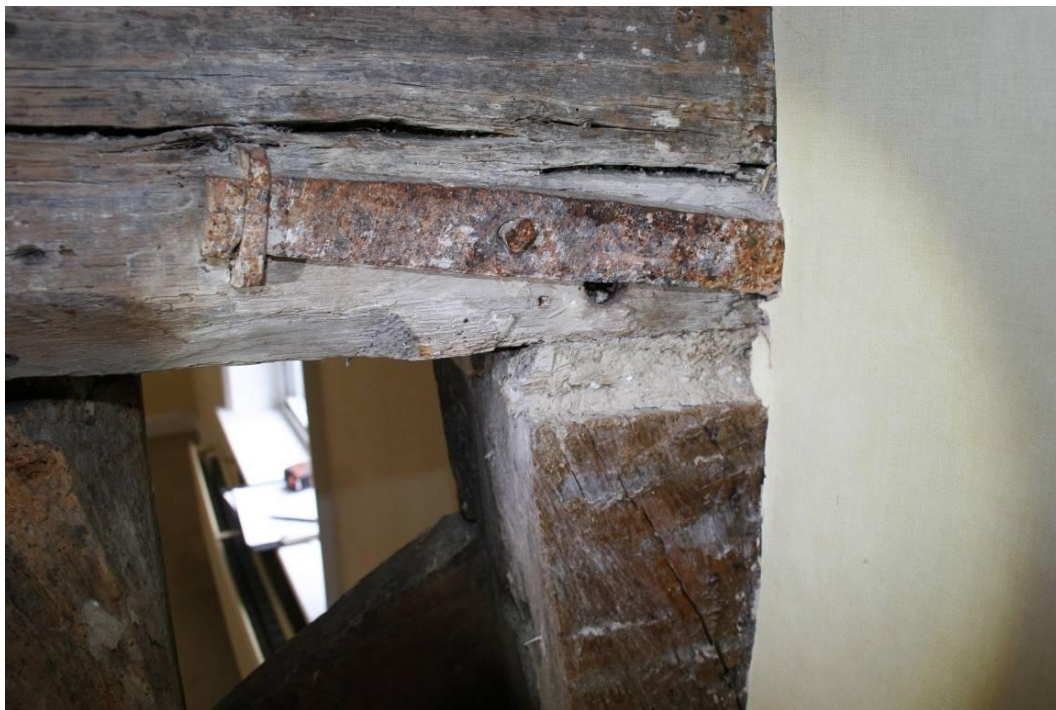
C18th wrought iron tie used to repair the failed joint in the top-plate. Looking E.

The frame has braces from the jowled storey posts that are trenched across the studs on the eastern side (where the timbers are blackened). The joints with the top-plate and storey posts have been reinforced with C18th style hand-wrought iron ties fixed with staples and nails. One of the studs is an obvious insertion and this would have been where the hatch door into the upper room would have been.

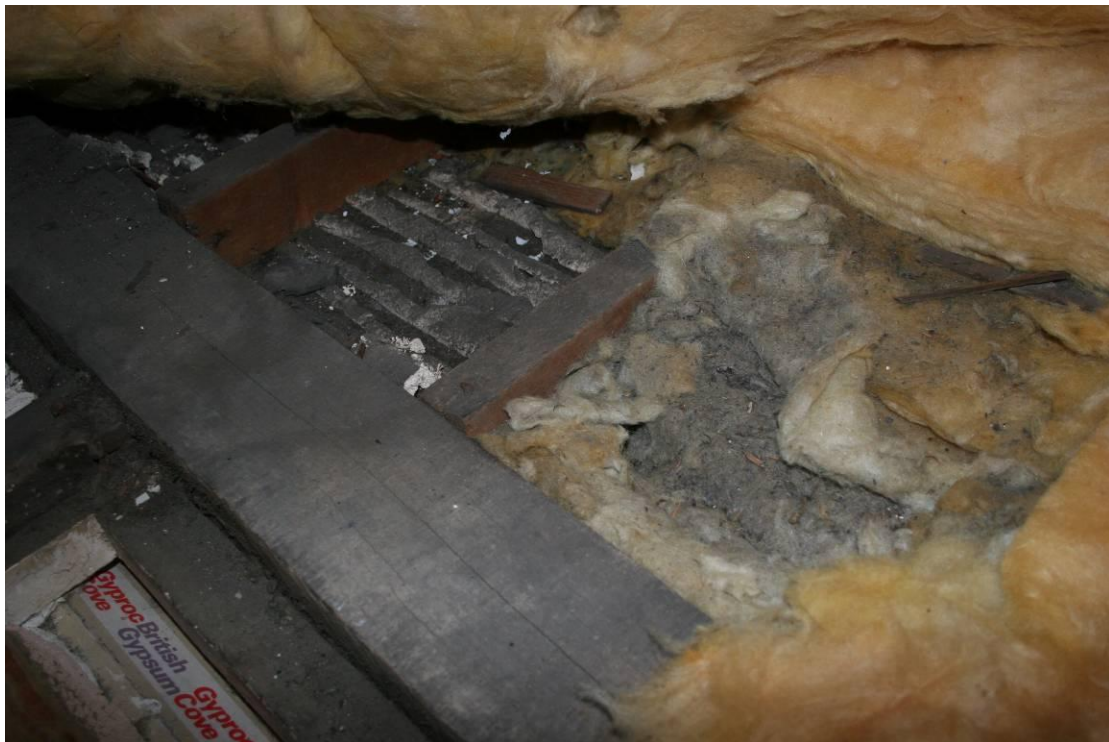
Earlier softwood main ceiling joist with skew nailed common joists. Note plasterboard.

The ceilings have machine cut softwood main joists which appear older and greyer than the bright red softwood common joists which are skew nailed in place. The ceilings have cedar laths and bright white plaster used in the MC20th before plasterboard made it obsolete in the 1960's. Sheets of British Gypsum Gyproc have been used to overboard all the ceilings.
