STRUCTURAL ENGINEERS REPORT

Norwood Farm Cow Barn

For Dyson Farming

3416 – Norwood Farm Cow Barn
27th September 2022

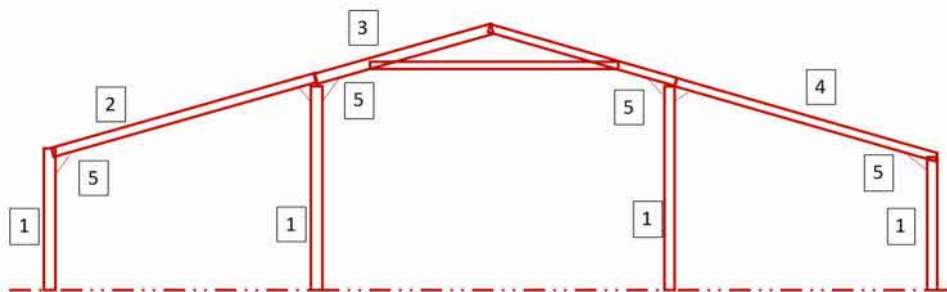
The building is a single storey structure consisting of a three bay portal frame with precast concrete columns and timber/steel rafters and timber purlins/plan bracing. The building is open at either end.

- 1 Precast Concrete Columns
- 2 Timber rafter
- 3 Timber tied truss
- 4 Steel beam
- 5 Steel Haunches

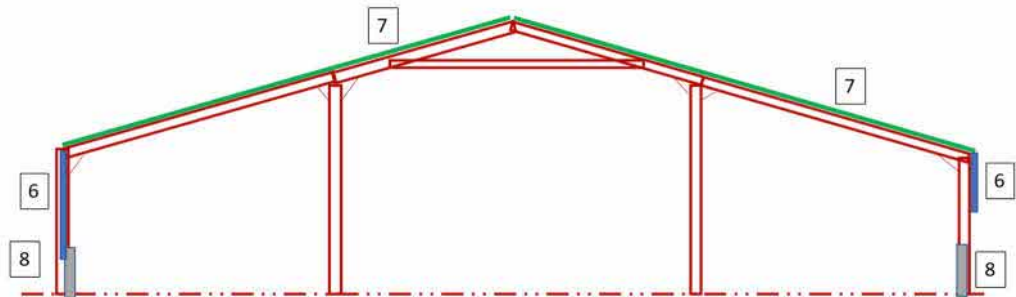
The longitudinal elevations have a low precast concrete/blockwork load at ground level and timber boarding, full height on one side and part height on the other, with cement particle boarding roofing. (This should be checked by a specialist to confirm whether any asbestos is present)

- 6 Timber boarding
- 7 Cement board roofing
- 8 Concrete/Blockwork wall

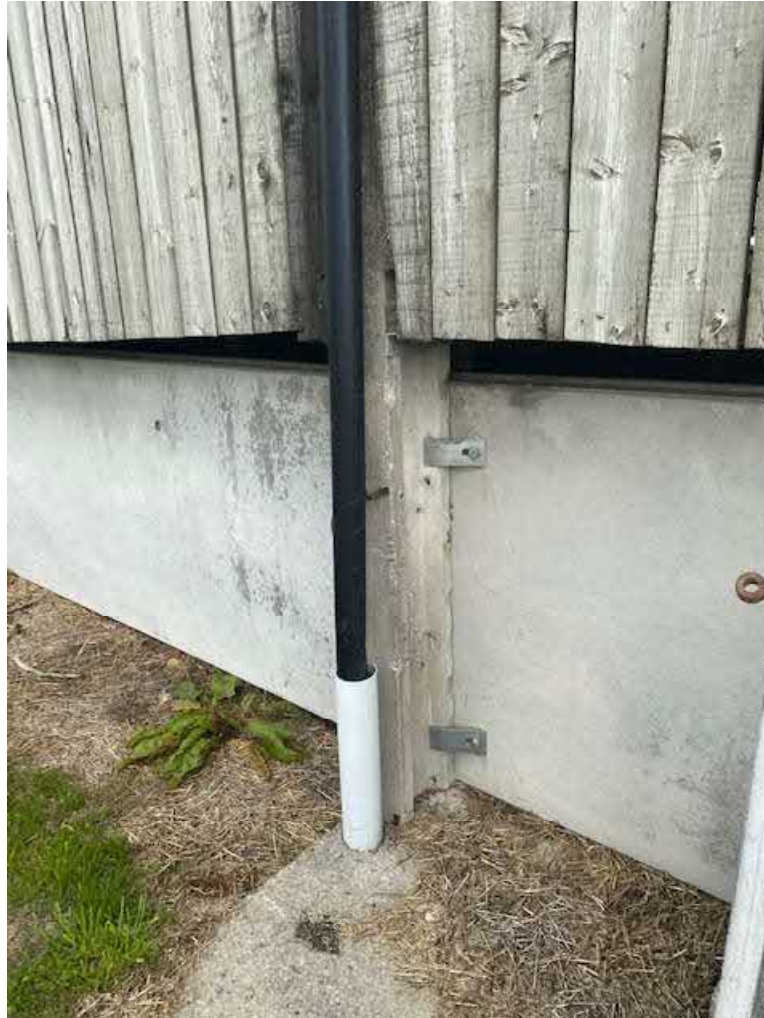
Although there is some chipping to the flanges of the precast concrete columns, there are no signs of rusting or spalling of concrete

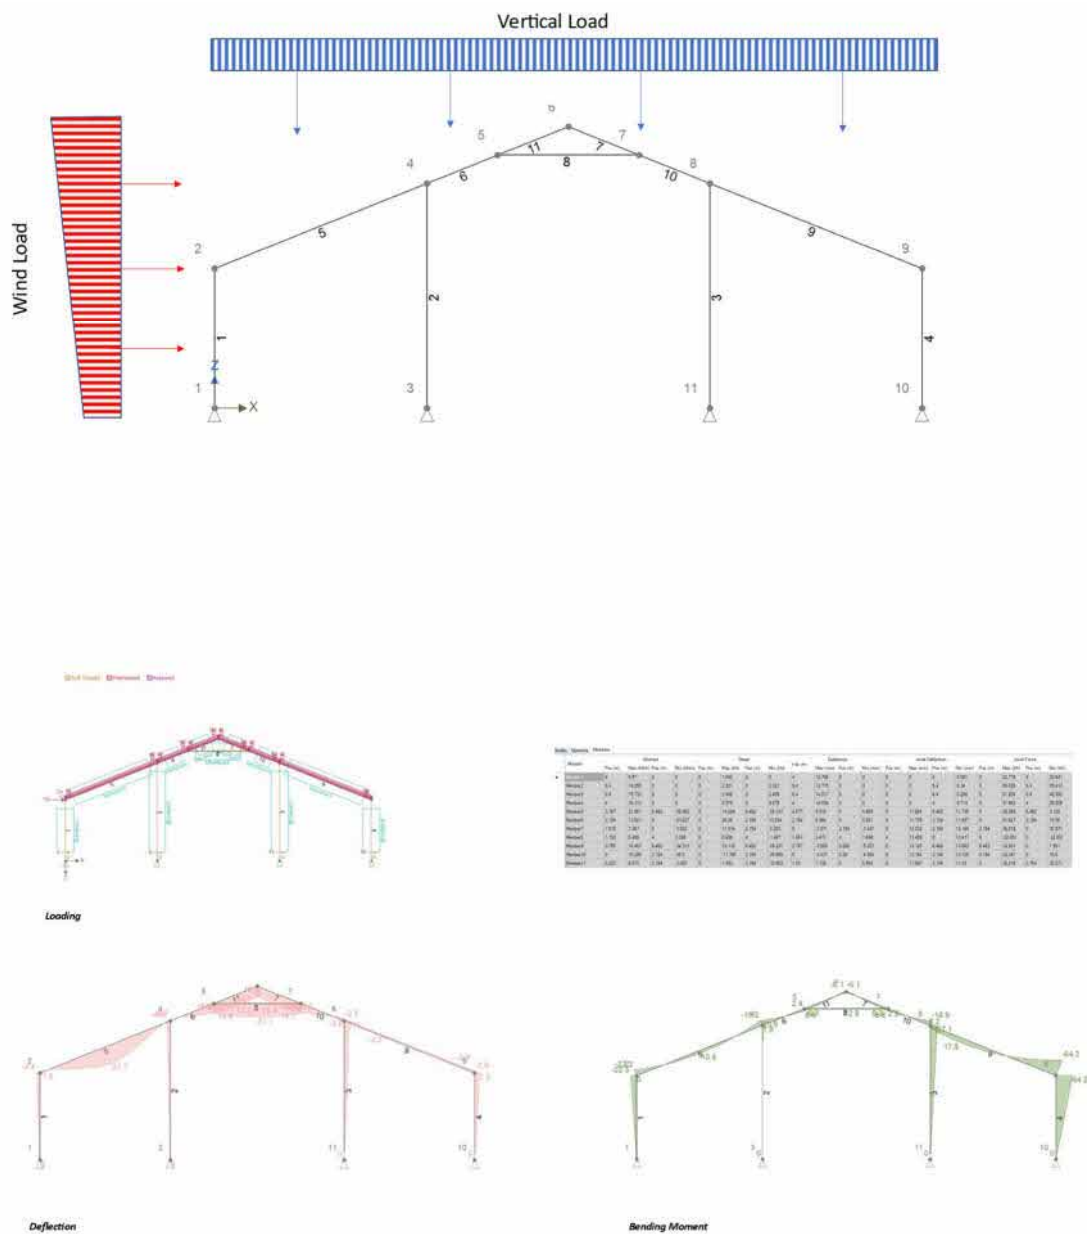
The building acts as a portal frame relying on the stiffness of the connections to the columns to the main rafters to provide lateral stability. The concrete columns have steel haunches connecting the rafters to provide the necessary stiffness. The relative stiffness of the steel rafters compared with the timber rafters/truss means that this bay is providing the majority of the lateral stability.

An initial analysis has been carried out under vertical and lateral load for comparative stiffnesses shows the greater forces in the steel rafter bay and greater deflections in the timber rafter bays. Although a full rigorous analysis will be required under the detailed design, the moments and deflections appear to be acceptable.

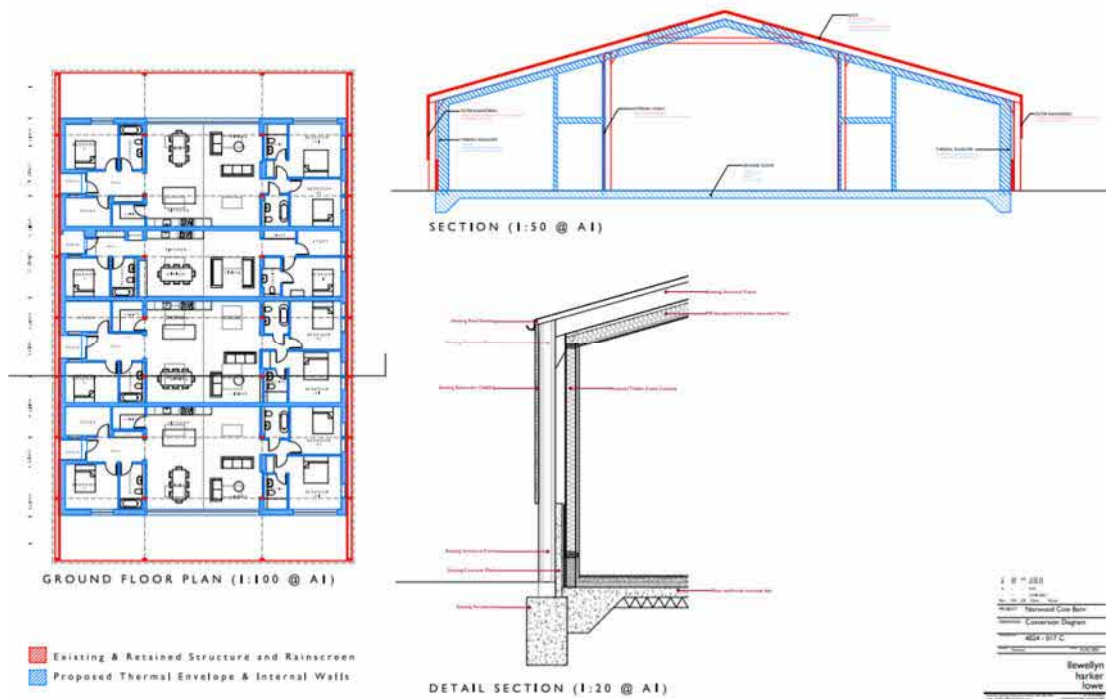
As the barn is currently partially open, the uplift on the roof from wind loads will actually reduce when the façade is fully enclosed. As present the open façades mean that the roof acts like a “wing” so the governing design case is uplift rather gravity loading.
