**Farm Buildings  
at  
Mill Farm, Worlingworth IP13 7HT  
for Pre-Application Enquiry DC/21/05763**

**Heritage Report**

**John Walker  
Vernacular Building Historian  
September 2022**

## Description of Farm Buildings at Mill Farm, Worlingworth for Pre-Application Enquiry DC/21/05763

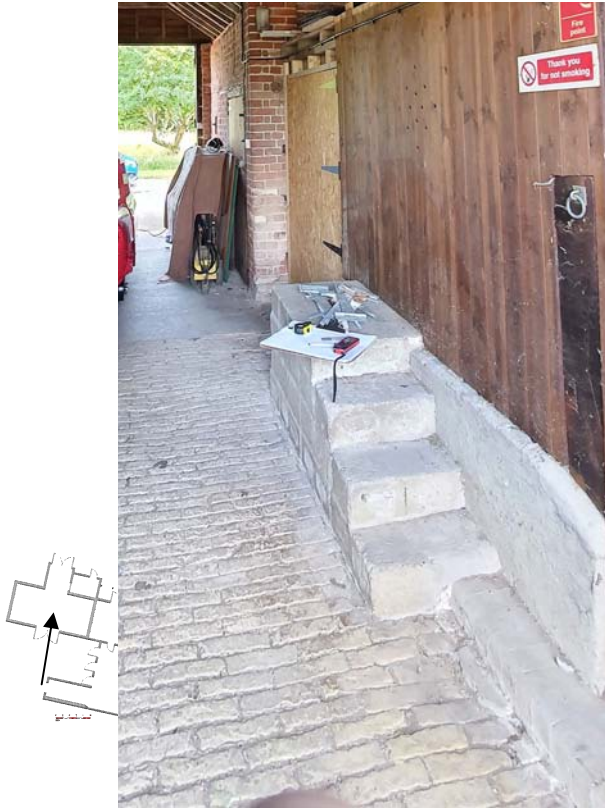
Fig. 5: Brick threshing floor looking north

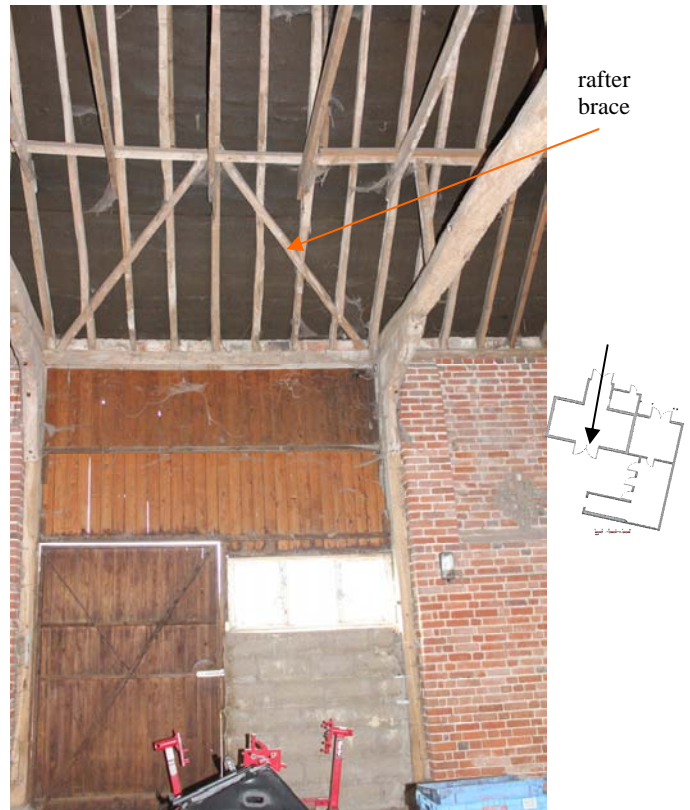
The barn has a clasped side purlin roof with common rafters divided into three bays by two tiebeams either side of the threshing bay, plus rafter bracing in the threshing bay (Figs. 6 & 8). The tiebeams have original knee braces on the south side between the tiebeams and the posts from carried the two large southern doors to the threshing bay (Figs. 6 & 7). There are no such braces on the north side as there no timber posts framing this side of the threshing bay. Roof covering is pantiles (Figs. 3 & 4).

Fig. 6: Rafter bracing south end of threshing bay

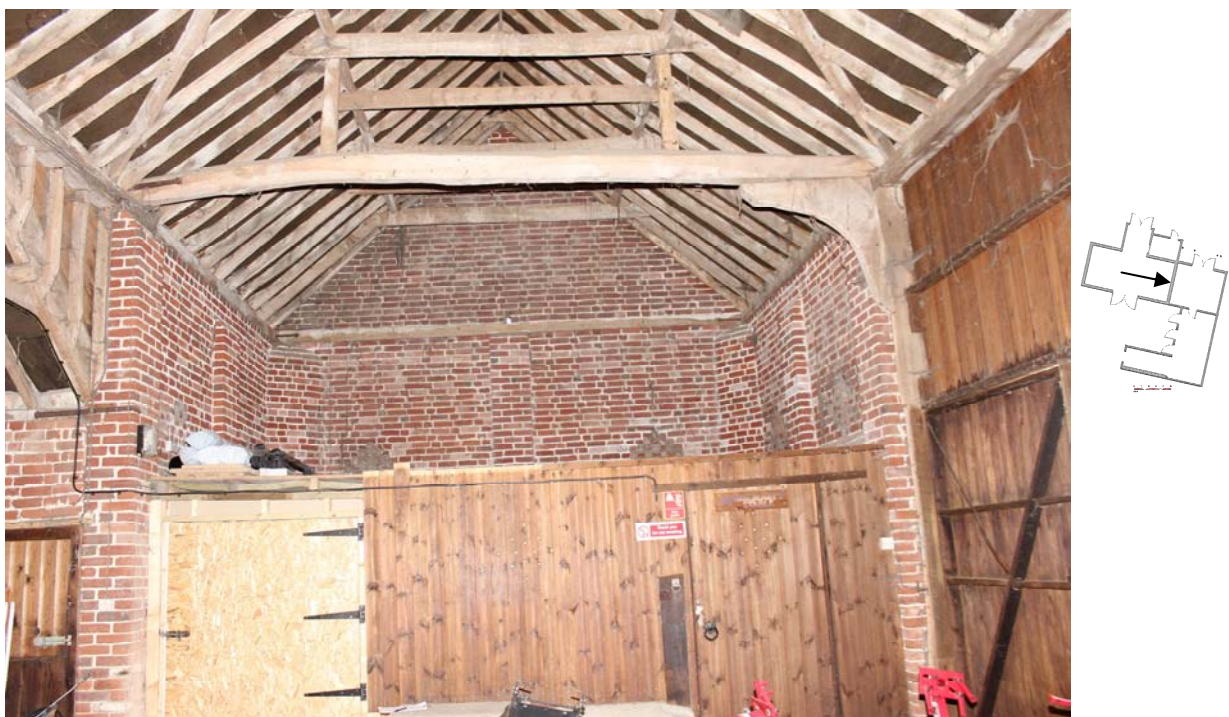
The barn was built for the storage of grain at the time of the Napoleonic Wars when grain prices rose rapidly in 1793-1820 and farmers switched from cattle to arable farming. The barn is unaisled, 12¼ metres long, 6¼ metres wide and 4¼ metres high to the wall plate. It is in three sections. The central section, the threshing bay with its brick threshing floor (Fig. 5), had full height doors to the south and to the north a one storey midstrey with timber framing between it and the barn's wallplate. Either side of this the walls are built of brick laid in lime mortar in monk bond (a variation of Flemish bond with two stretchers instead of one between each header), sometimes called Suffolk agricultural bond (Fig. 13). The brick sections are three bricks deep on the lower storey reducing to two for the upper storey between a series of brick plasters. It has a series of diamond shaped ventilation holes, most of which are now blocked (Figs. 8-10). The midstrey to the north of the threshing bay is probably contemporary with the barn as it is built of the same bricks and bonding, but is not bonded into the barn. At the south end of this bay the two full height doors have replaced as shown in Figures 11-12. Also in the 20<sup>th</sup> century a loft was inserted into the eastern section of the barn with two rooms below (Fig. 7).

Fig. 7: East half of barn showing tiebeam with knee brace only at south end.  
Loft is a later insertion

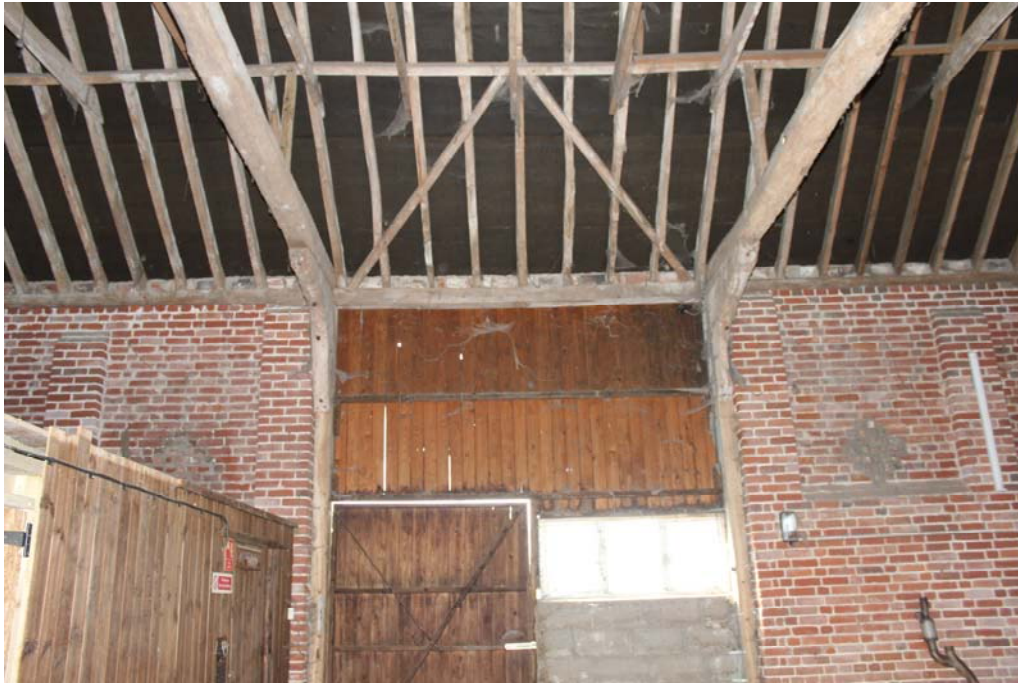
Fig. 11: South end of threshing bay where the large full height doors have been replaced

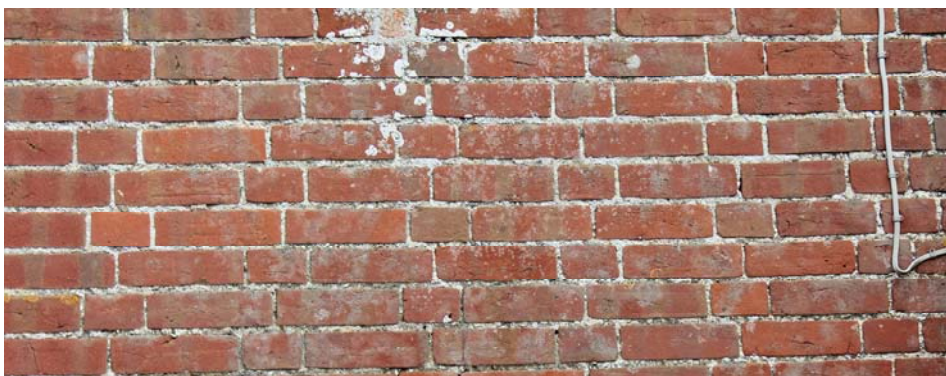
Fig. 13: Monk bond with two stretchers between each header

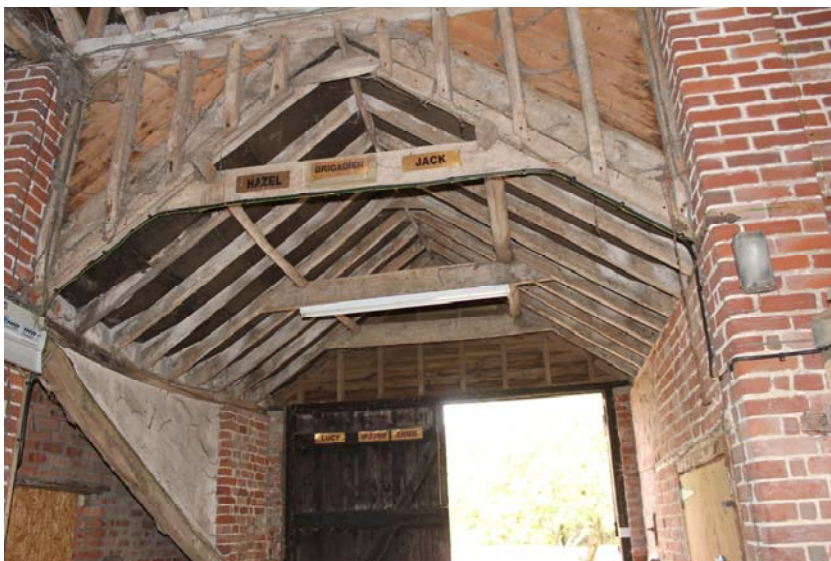
The midstrey is a single storey high built of brick but, as mentioned above, is not bonded in to north wall of the barn (Fig. 18). However it is probably contemporary as it is built of similar bricks laid in monk bond as in the barn and has a similar clasped side purlin roof (Fig. 15). Today the roof is also covered with pantiles (Fig. 3). Built into the west wall is the end rafter and front post of the end of a contemporary lean-to shed built against the north-west wall of the barn (Fig. 14). The Ordnance Survey map (Fig 2b) show this was still there in 1903, later being replaced by the present much larger building (Fig. 17). The gap above this end rafter and the midstrey's west wallplate is infilled with lath and plaster (Figs. 14 & 16) which still survives. Filling this gap with lath and plaster indicates that the builders in c.1800 were trying to reduce costs, as does the use of timber framing in the north wall of the barn above the south end of the midstrey (Fig 15).

Fig. 15: Midstrey's roof looking north

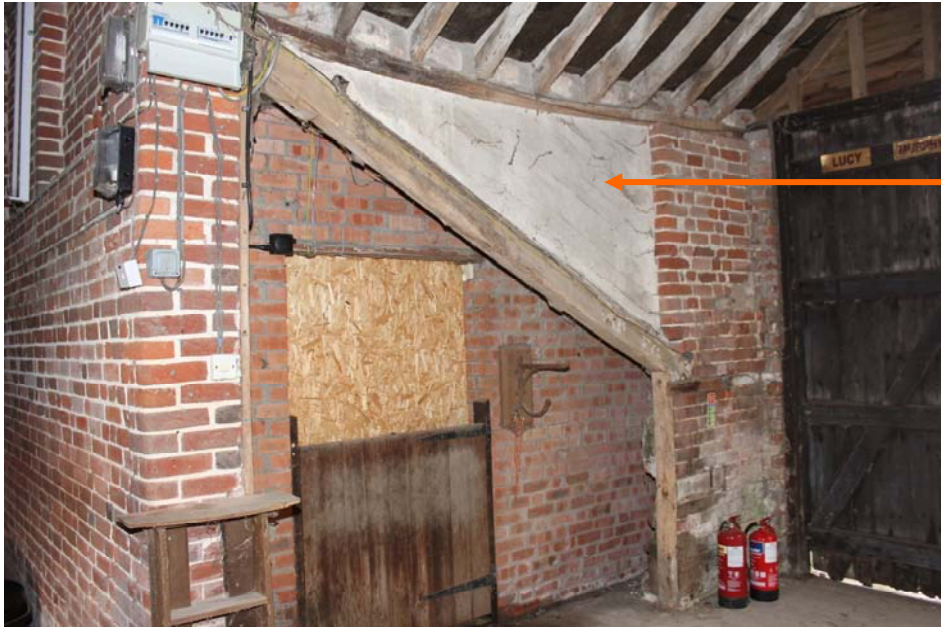
lath and  
plaster infill

Fig. 16: West wall of midstrey incorporating end wall of lost west lean-to shed

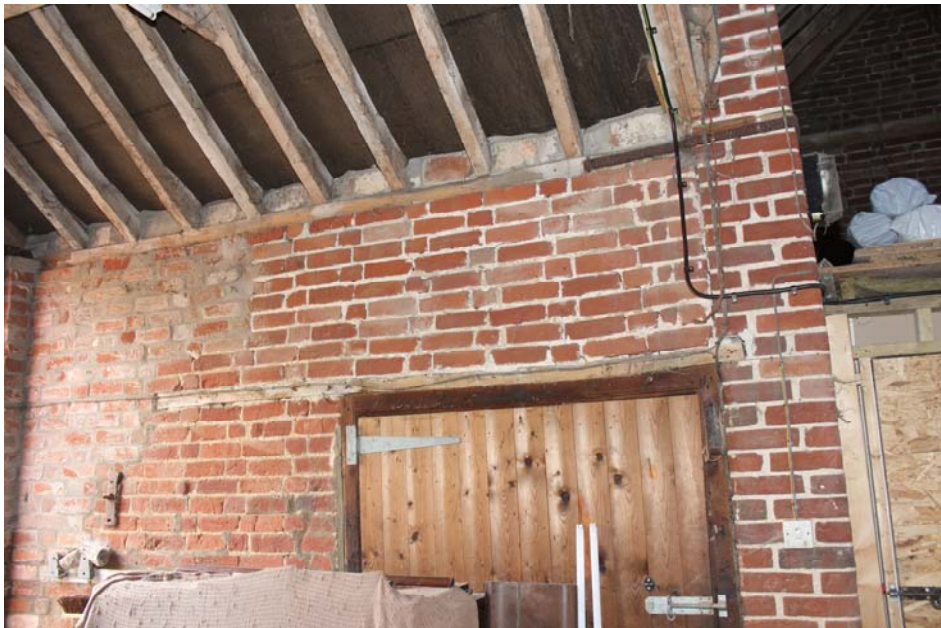
In the midstrey's east wall there is evidence of some repairs to its north end and a door has been cut to give access to a later lean-to shed built against the north-east wall of the barn (Figs. 14 & 18). The lean-to has another door in the front north wall. This lean-to's east brick wall is built in a very random bond (Fig. 21) showing this room is clearly a later addition, though from the Ordnance Survey map it was clearly added before 1885 (Fig 2a). Today the lean-to roof is covered with corrugated iron sheets (Fig. 3).

Fig. 18: East wall of midstrey

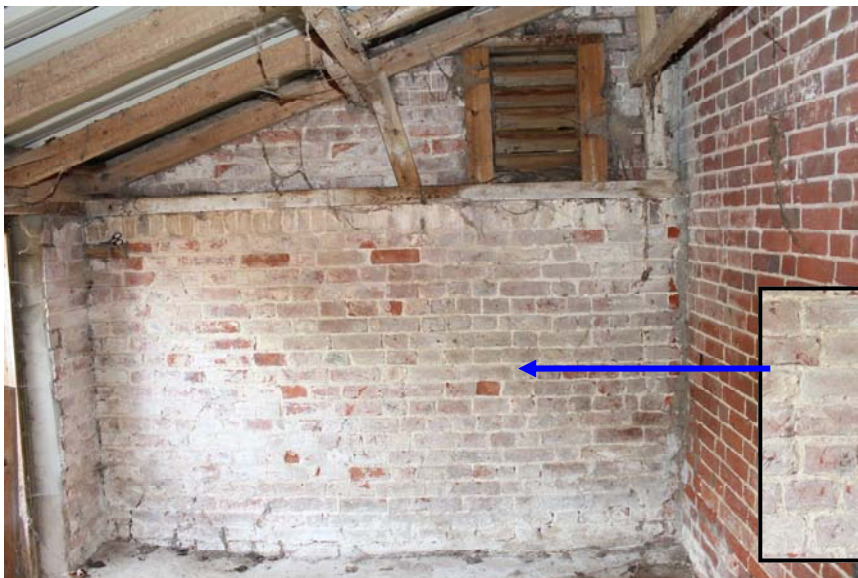
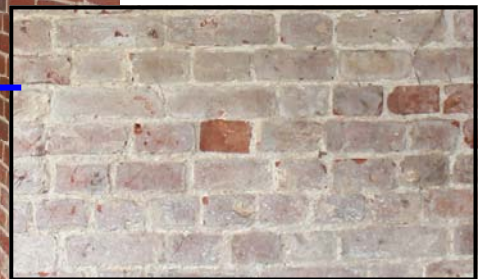
Fig. 21: East wall of lean-to shed on east side of midstrey is built in a mixed bond

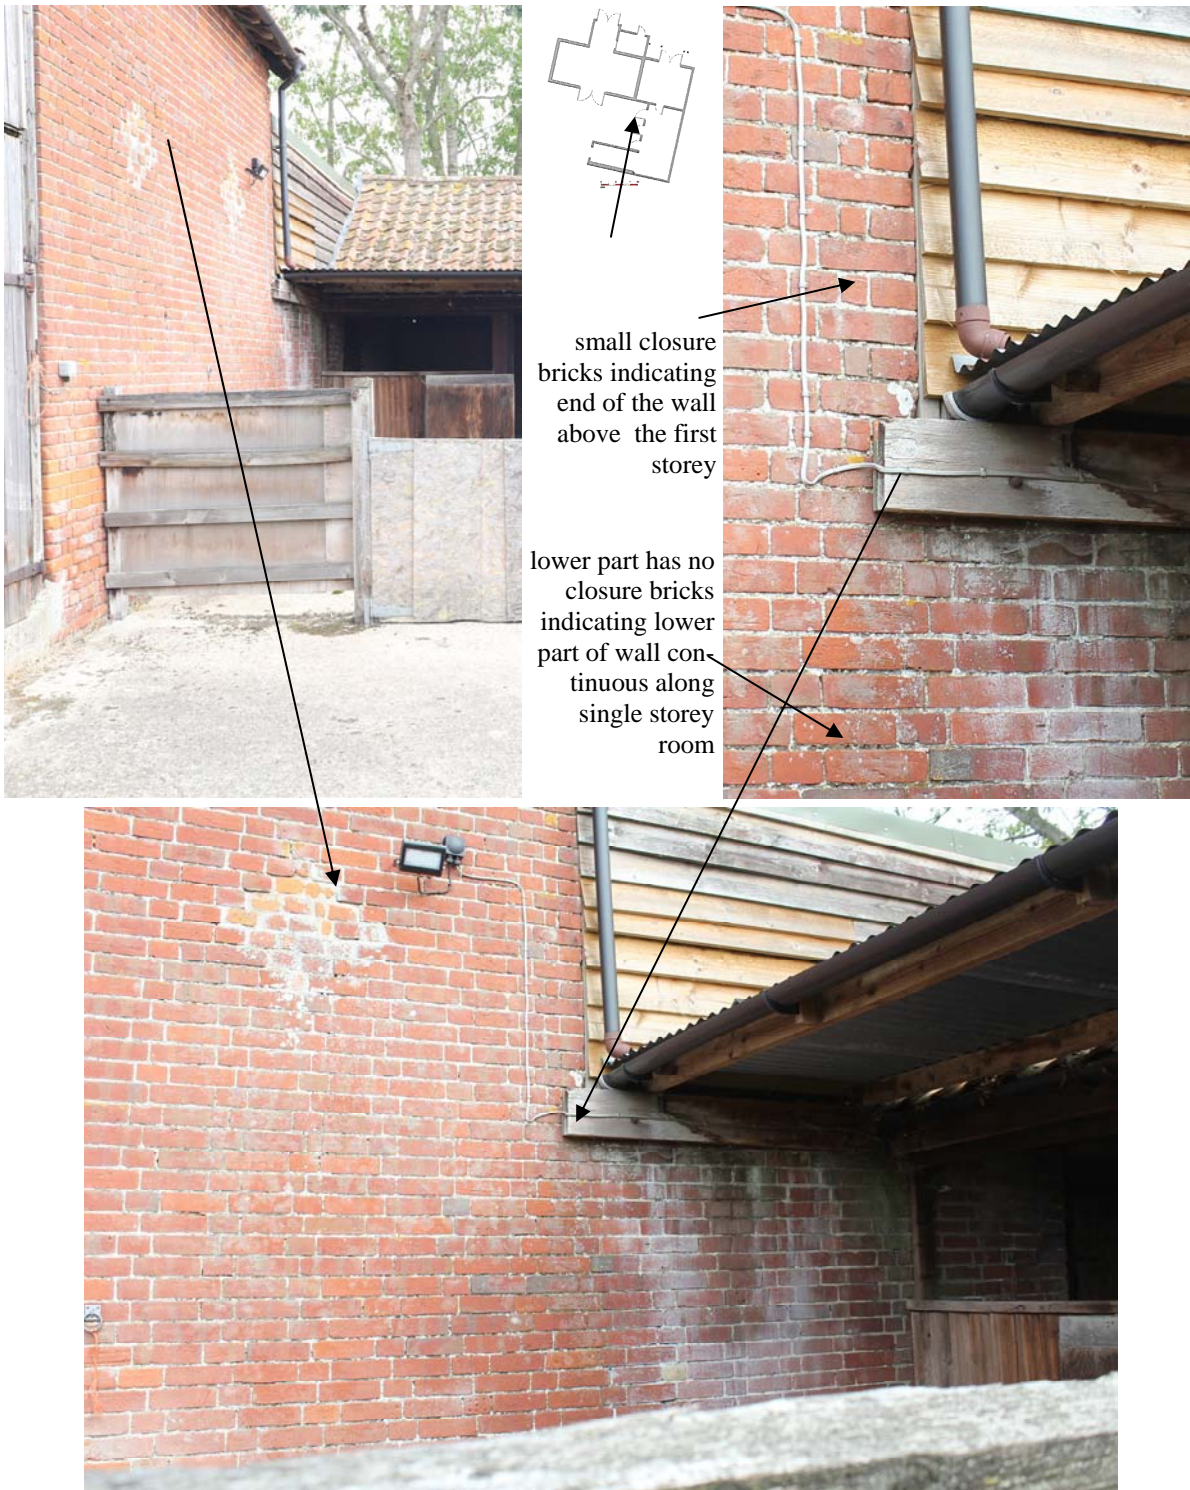
These are contemporary with the barn as the barn walls are continuous along the single storey rooms. Above them the ends of the barn have closure bricks showing that the end rooms were always single storey (Fig. 22). The room on the west has a pitched roof, but that on the east room has been replaced by a catslide roof of corrugated iron with the south wall raised by a timber-framed section (Fig. 28), possibly in the 20<sup>th</sup> century when an open fronted lean-to shed was added on the north side of the single storey room (Fig. 3). The east room has an original doorway in the south wall into the shelter shed behind (Fig. 28). Today a large double door has been inserted in the north wall which may have replaced an earlier smaller doorway.

Fig. 22: South-east rear side of barn along barn and east single storey room

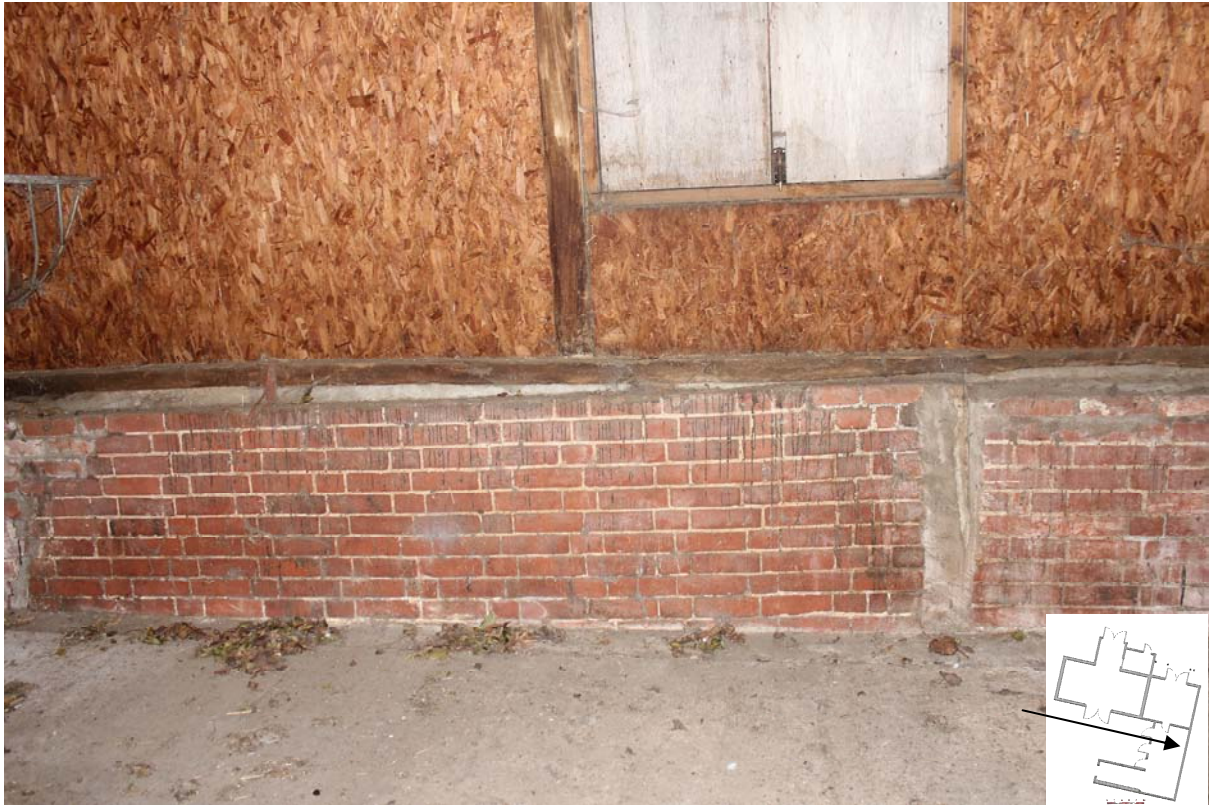
Fig. 26: Rear dwarf brick foundation wall of east shelter shed in monk bond

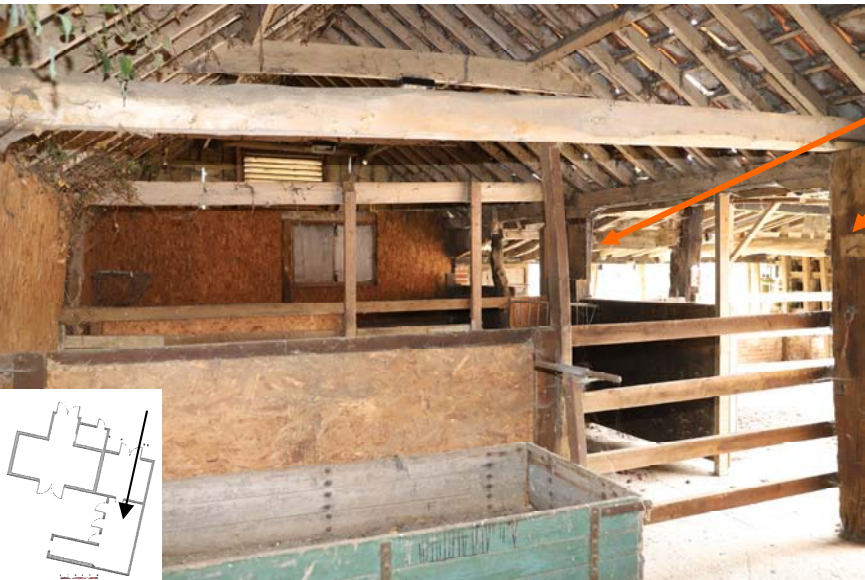
Fig. 29: East shelter shed looking south with its two original posts for west open front

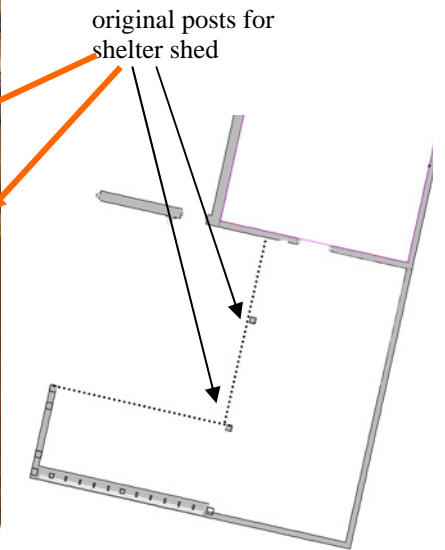
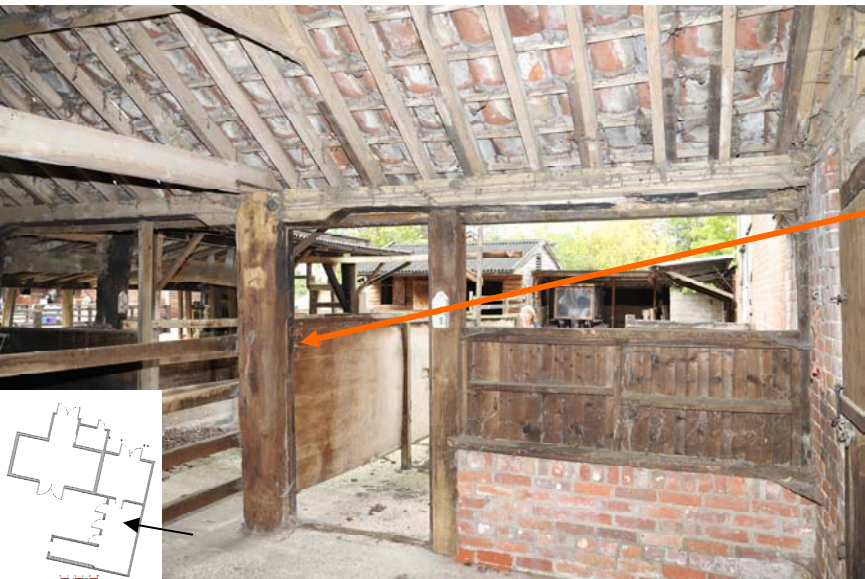
Fig. 30: West wall of shelter shed with northern original post highlighted

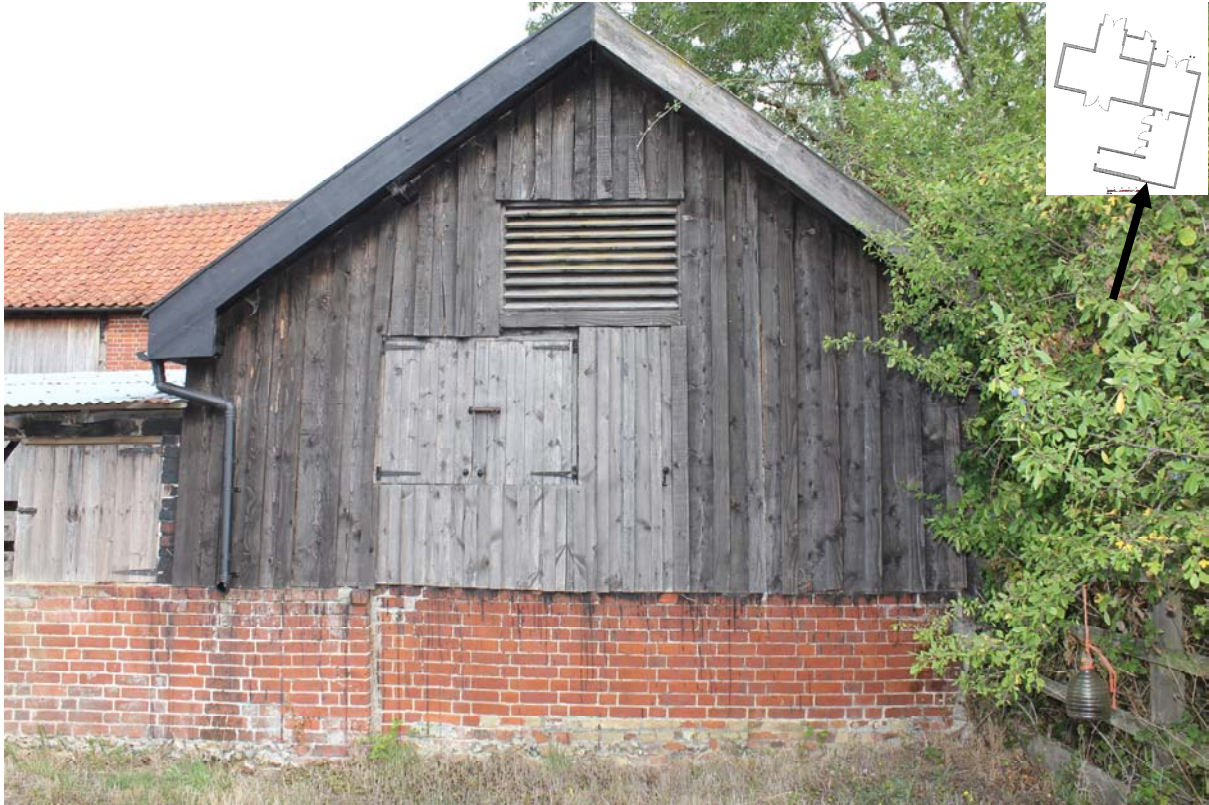
Fig. 31 Rear gable of east shelter shed - framing maybe later alteration as some rebuilding of the dwarf wall
