STRUCTURAL SURVEY

Barn at Kerswell
Cullompton
Devon
EX15 2ES

201/22

9 August 2022

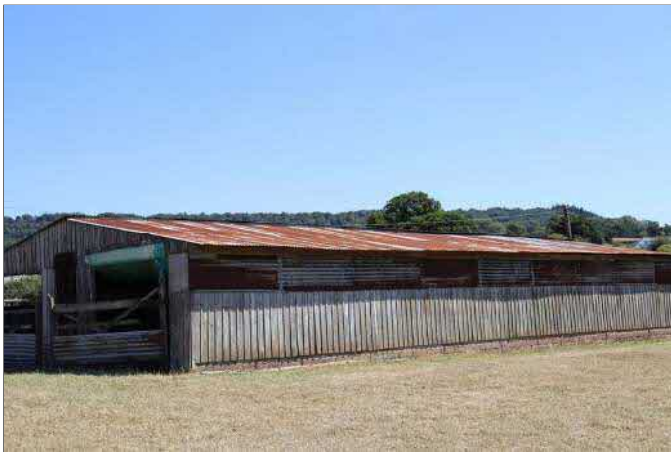
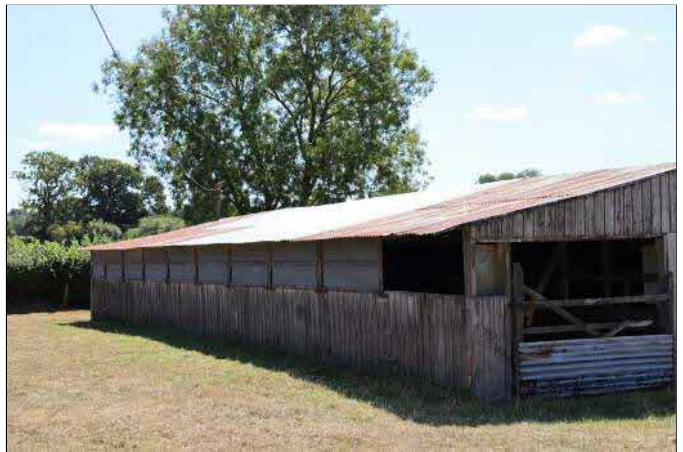
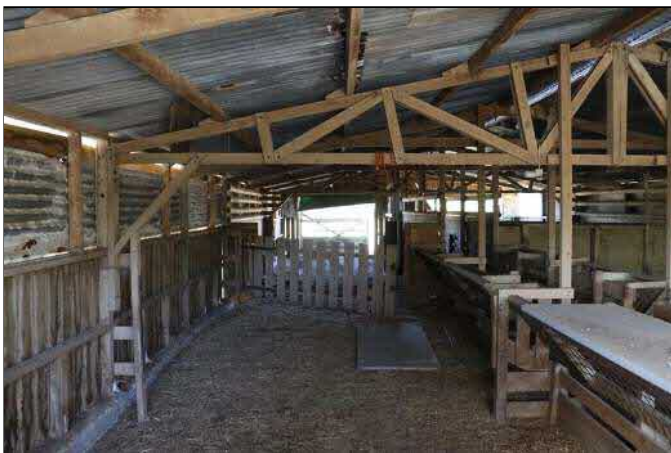
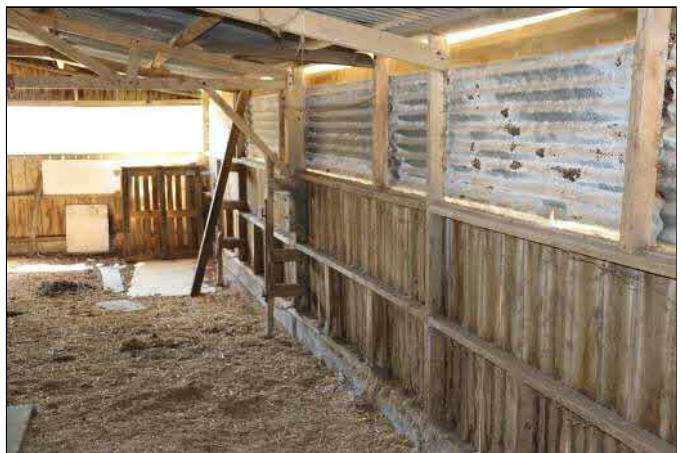
The building is of concrete strip foundations, timber framed walls, with timber boards and metal sheet cladding to the walls.

The building is provided with timber doors and shutters to the building.

The roof is provided with corrugated metal sheet cladding to the roof.

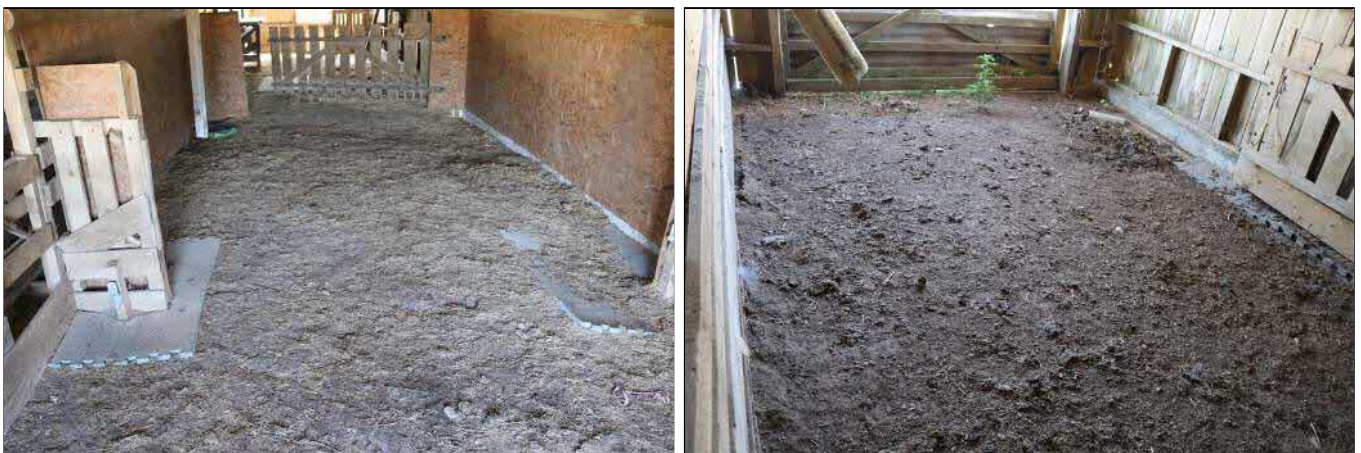
The ground floor is provided with a compacted earth floor finish, which appears to be in reasonable condition. The floor is relatively even and appears to have been well compacted by the previous agricultural use. There are no signs of movement or subsidence to the earth floor and generally it all appears to be in good order.

The existing compacted earth floor will require a degree of levelling up with hardcore and then provided with a concrete base. I can see no reason why the existing compacted earth slab would require any significant remedial works in this situation. The floor will however require some degree of updating with the provision of insulation to comply with current building regulations but this will require the provision of a new concrete slab, which can be laid directly on top of the existing compacted earth floor finish.

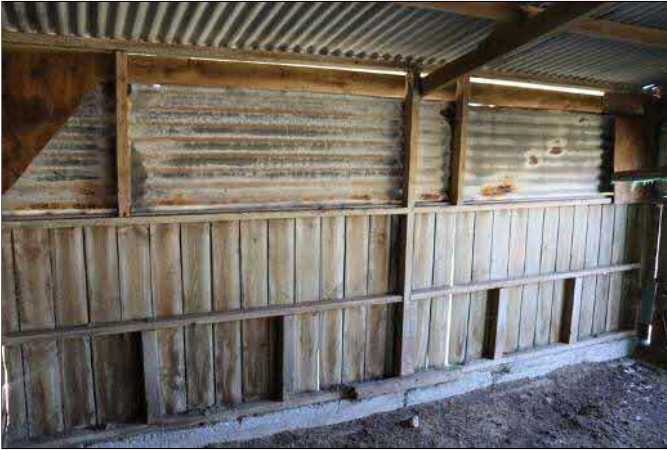
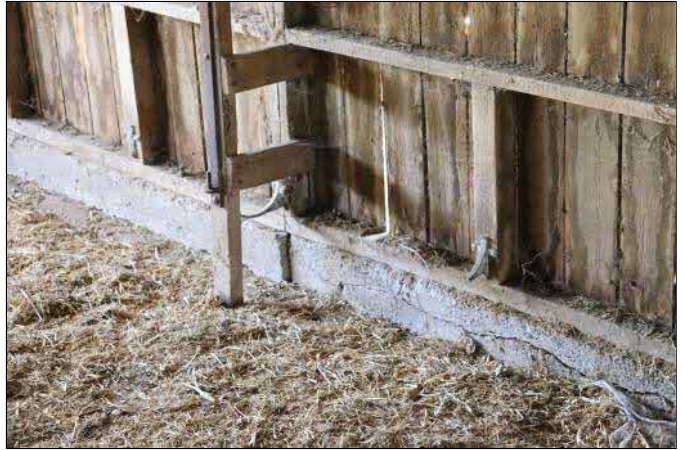
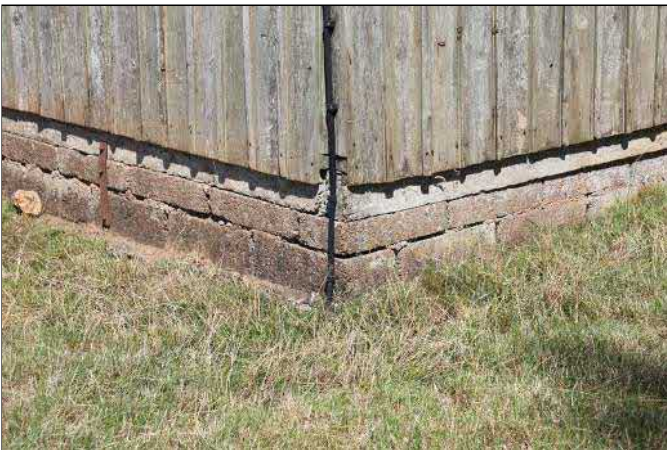
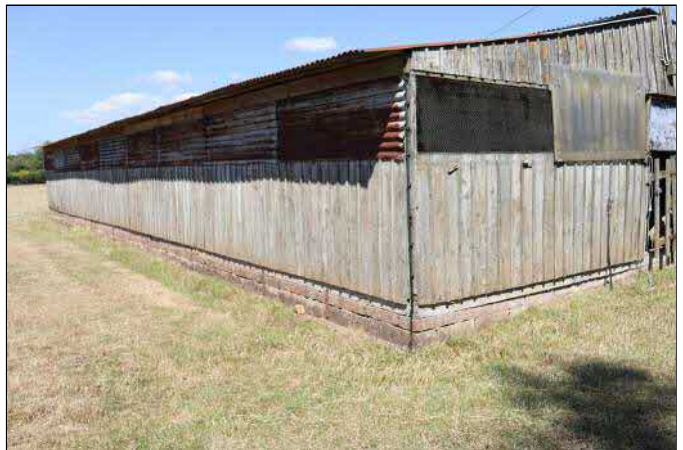
The walls are provided with a series of timber purlins, which have been used to support the corrugated metal and timber boarding to the walls, all of which appears to be in reasonable order. The mid rails are in the order of 75 x 50 mm timbers with the eaves beam being in the order of 100 x 50 mm timber. The purlins are supported on the main structural posts with metal angles and bolted connections, all of which appear to be in good order. There is some evidence of minor deflection to the purlins and generally they appear to be in good order and are suitable for retention in this location.

The lower section of the walls are provided with timber cladding, with the boards being in the order of 140 x 18 mm boards up to a height of about 1300 mm high. The upper section of the walls are then provided with corrugated metal sheet cladding which is fixed horizontally across the walls and appears to be in reasonable order at the time of the survey.

The base of the walls are sat on a 100 mm fair faced block work plinth which is laid level and is in good order, the block work plinth has prevented any significant decay to the base of the timber framing and cladding to the walls.

The timber frame and cladding to the building all appear to be in good condition with no signs of structural movement or failure. The structural condition of the building is therefore in good order to the main roof and wall elements with no structural repairs required at the time of the survey.

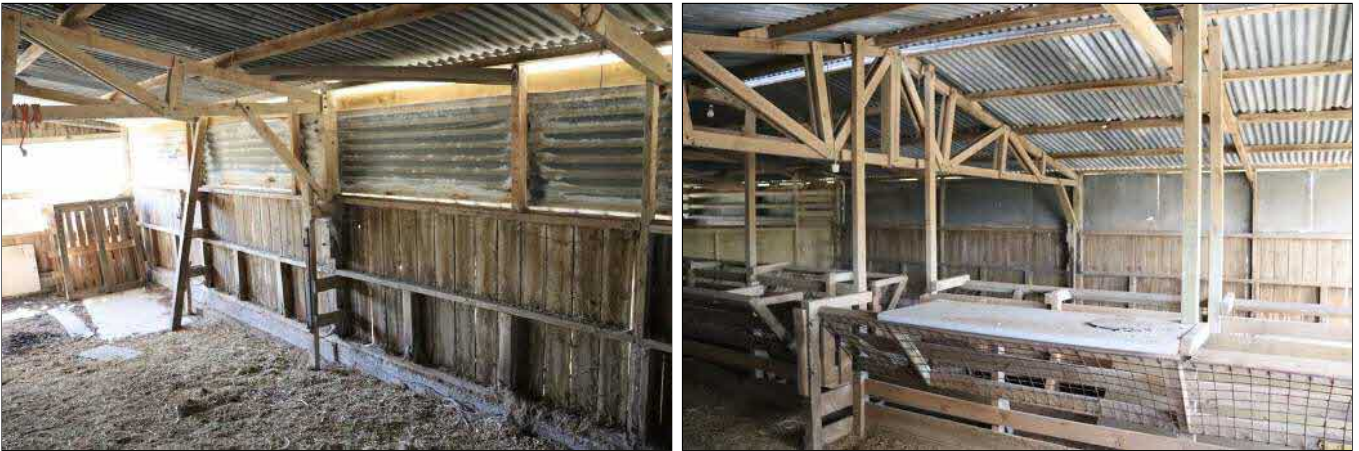
The building is primarily a four bay timber framed building, with a central ridge running front to back on the building. The building is provided with five main frames, one to the front, one to the rear and three to the middle bays. The bays are provided with 100 x 100 mm timber columns with 100 x 50 mm timbers to the main roof structure all of which appears to be in good order, with no evidence of deflection or decay noted at the time of the survey. The bays to the front and back of the barn are also provided with timber wind posts which are in good vertical order.

There were no signs of any movement or distortion or damage to any of the fixings on the junction between the roof and the wall members. It is clear that the timber frame to the walls and roof is generally in good structural order.

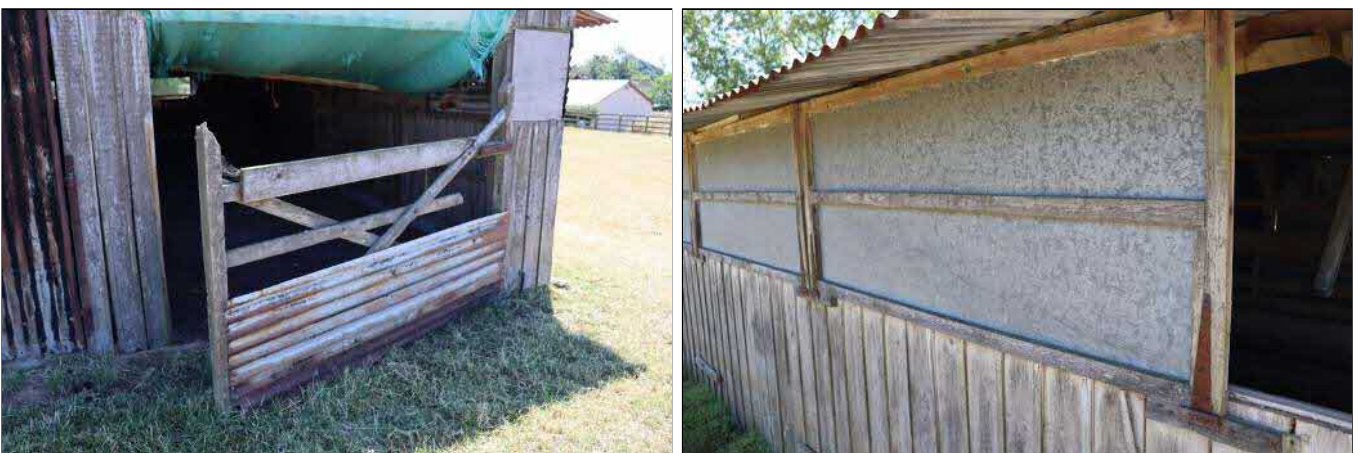
The external joinery is of metal faced gates, shutters and timber doors to the main structure to the individual elevations.

There is some evidence of wet rot attack to the base of the doors and the frames and to comply with current regulations, the existing joinery would need to be removed and replaced with more thermally efficient and suitable access arranged doors and windows. If required however, the current frames could be repaired to bring them up to a good standard of repair for use in regard to residential accommodation.

The building is not provided with any rainwater gutters to the building.

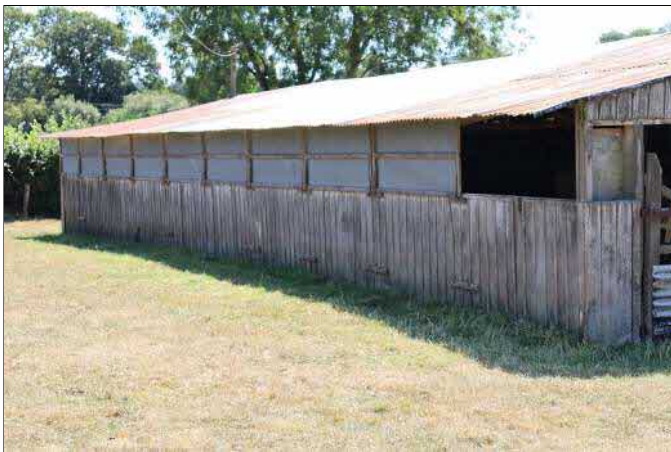
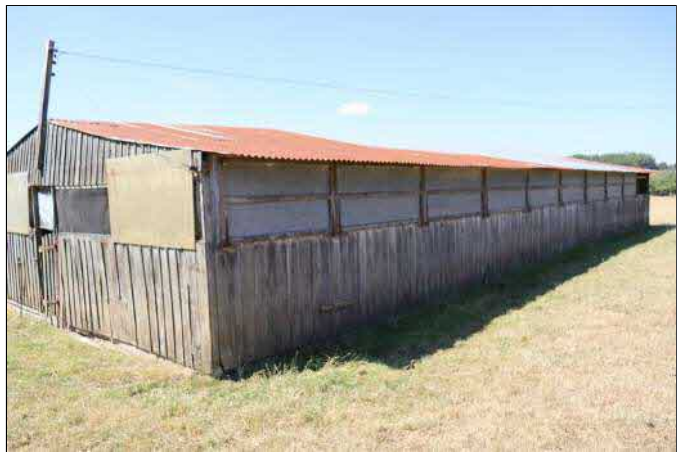
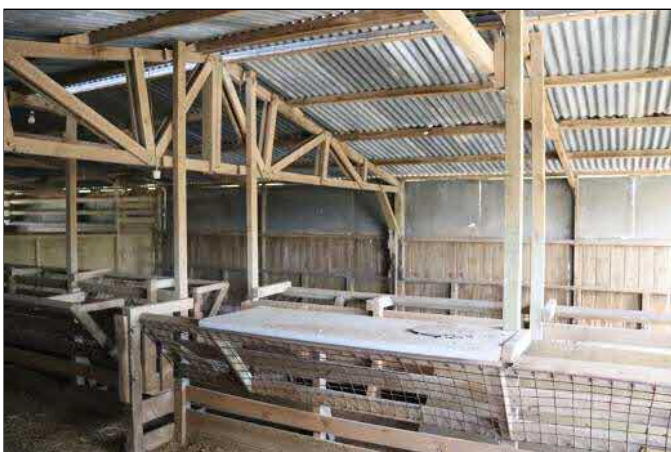
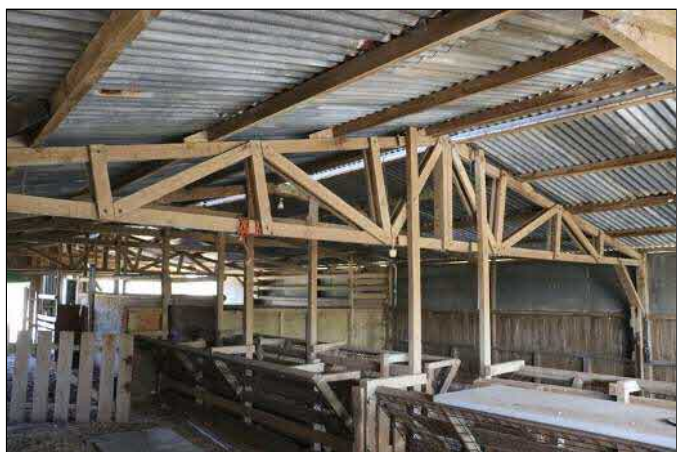
The roof is provided with a series of nine trusses with the truss being a mixture of a traditional and raised tie trusses. The trusses appear to be provided with timbers in the order of 100 x 50 mm timbers which appear to be in reasonable condition. The traditional trusses are provided with two sets of timbers which are bolted together and are in good structural order. There is no evidence of any movement to the roof, which appears to be in good order. The trusses

are then provided with a series of purlins which are supported between the trusses and also on the end structural gable walls. The purlins are in the order of 75 x 50 mm timbers and appear to be in relatively good condition, spaced at 600 mm centres and are in good structural order. There is some minor deflection and bowing to the timbers and this probably occurred shortly after the time of installation. The bowing could be due to the natural drying out of the timbers as there are no signs of any significant movement to the roof structure.

There is evidence of some wet rot attack to a couple of the timbers where they are situated adjacent to the outside walls. These timbers will need to be carefully removed and replaced with new timbers.

The roof is then provided with a metal profiled sheet covering to the roof externally and appears to be in good condition. There is evidence of some minor damage to the cladding to the roof but again this is not to be unexpected, given the age and previous use of the building. The cladding however generally appears to be in reasonable condition with no signs of significant damage or repairs required.

The trusses and roof timbers all appear to be in good order with no signs of any significant damage or decay.
