**HISTORICAL APPRAISAL
AND HERITAGE IMPACT STATEMENT**

MUSGROVE FARM YARD BUILDINGS

DUNKESWELL

4.0 VISUAL INSPECTION

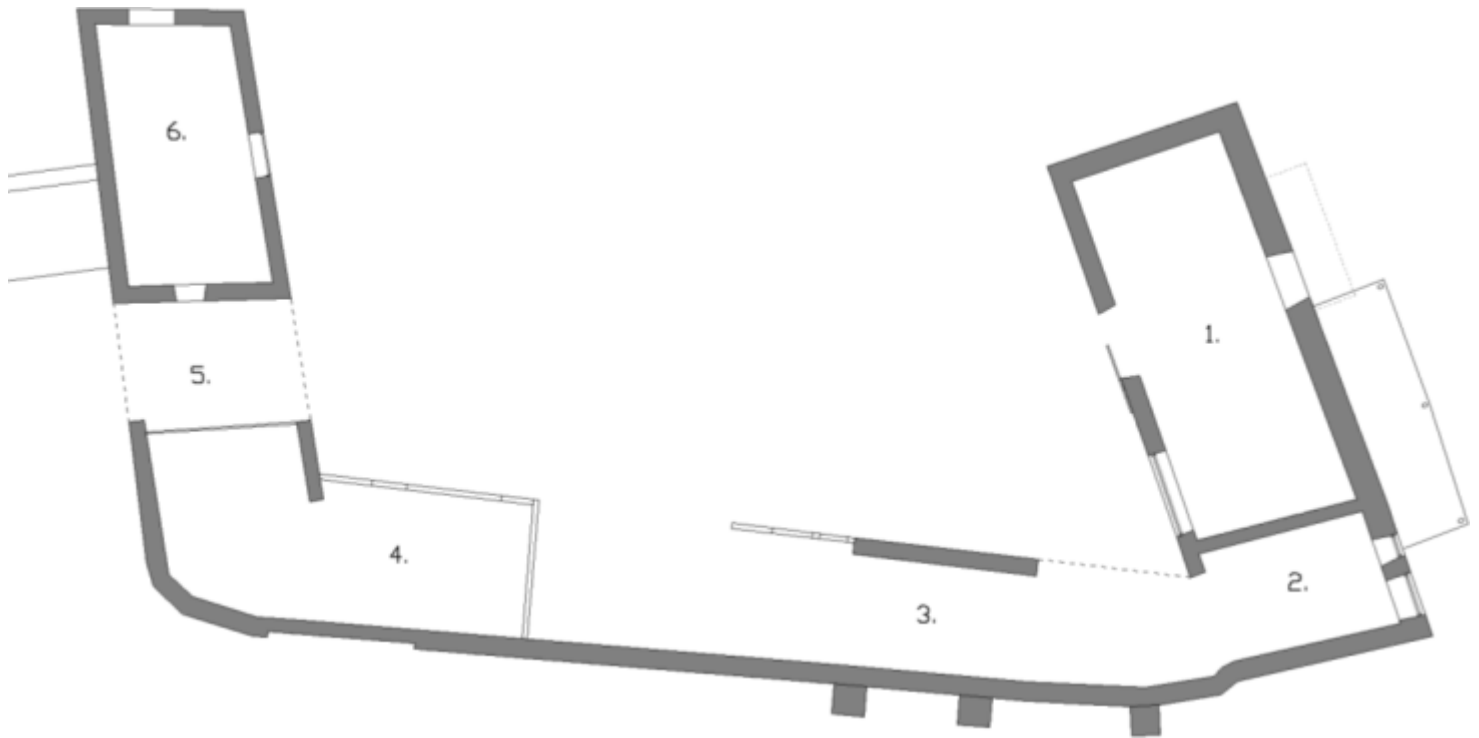
4.2 Labelled Existing Ground Floor plan:

4.1 The general arrangement of rooms is shown on P1 below. The areas are numbered for identification only and the sequence of numbering starts at the right hand building one.

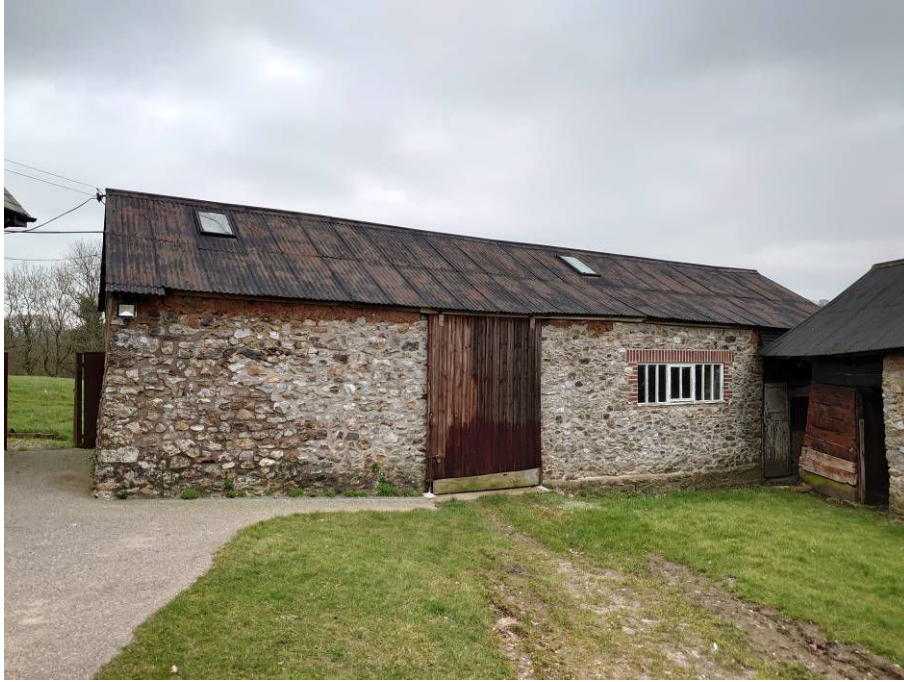
Originally a cross-passage threshing barn with double opposed doors forming the draught passage over the threshing floor. Roof is of light section imported timber trusses C1900 with purlins and galvanised steel roofing sheets. This building is reasonably intact and weather proof. A section of one end has been partitioned of to form a separate compartment which may have been used for rearing chickens or turkeys.

Figure 1 Threshing barn and part of cobbled yard

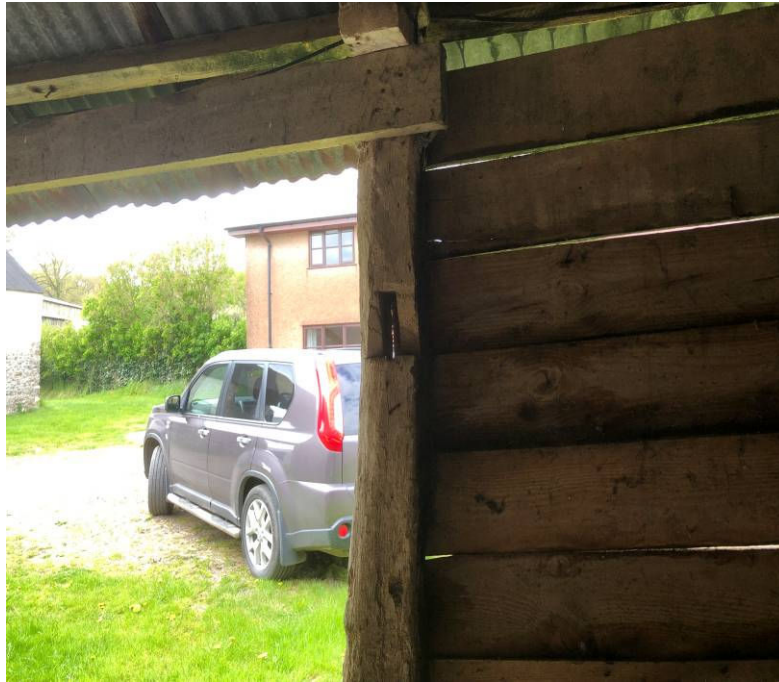
- 4.4 Area 2, partitioned off from the threshing barn and with a platform ceiling providing storage over accessed from the threshing barn. There are two openings in the rear wall and steel roof covering is corroded in parts.
- 4.5 Barn 3 and 4, these form the lower side of the courtyard and were probably stock housing originally. There is a short section of stone wall but the majority is open fronted and may have been a Linhay originally (largely open-fronted with posts supporting cross beams to store fodder above the cattle on the ground level:- evidence from mortise slot in one remaining post). A loose box has been formed from part of the open fronted area. The roof is much repaired and covered with steel sheeting which moves considerably in any breeze.

Figure 2 showing Linhay post with mortise hole.

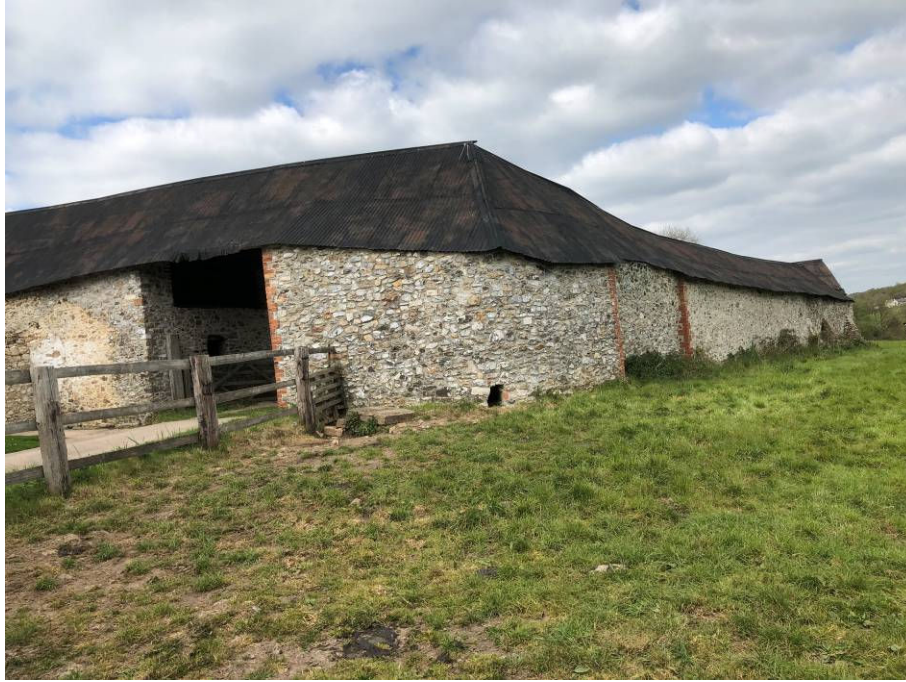
- 4.6 Area 5, covered way between barns 4 and 5. The roof over links the two buildings and would have provided a covered space to unload wagons into the barns on both sides but is not sufficiently high for modern farm equipment, resulting in the abandonment (by previous owners) of these barns and the construction of new buildings either side of the approach drive. Roof covering is galvanised steel coated in tar. The brick Quoins possibly indicate a widening of the opening and other alterations.

Figure 3 entrance to yard showing partly collapsed roof and repair.

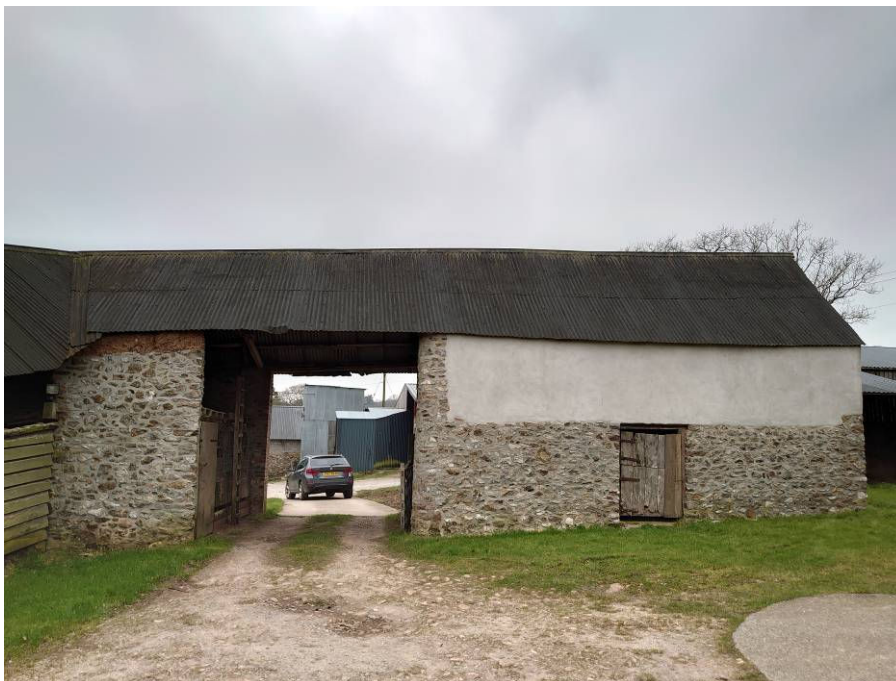
- 4.7 Barn 6, rectangular stone barn in need of urgent repair to prevent partial collapse of an area of stone wall at the rear. Rough concrete floor and galvanised steel roof on slender timber framework.

Figure 4 Barn 6, possibly stables for working horses?

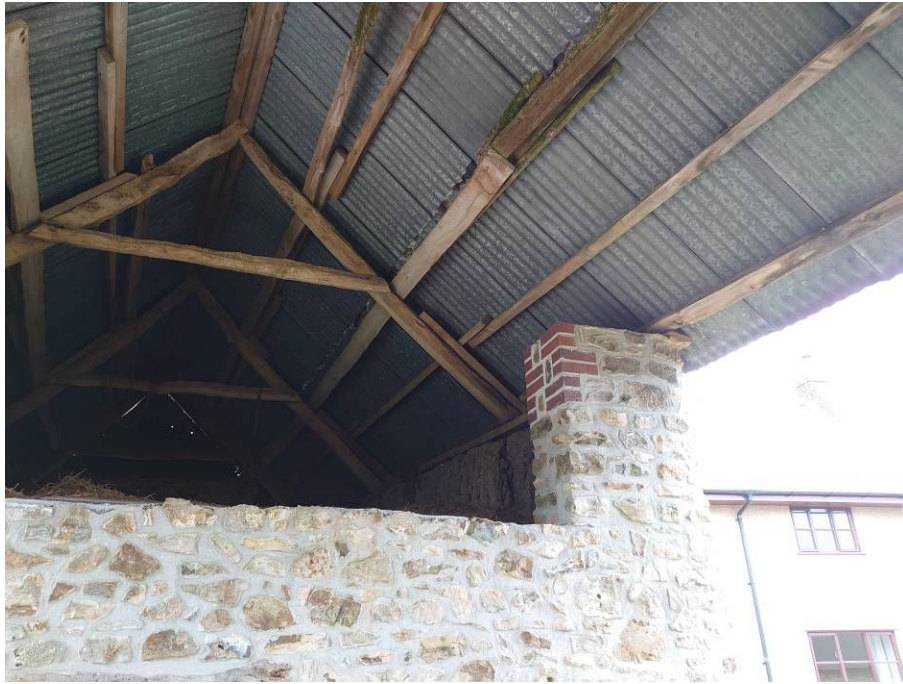
Figure 5 Roof over Barn 6

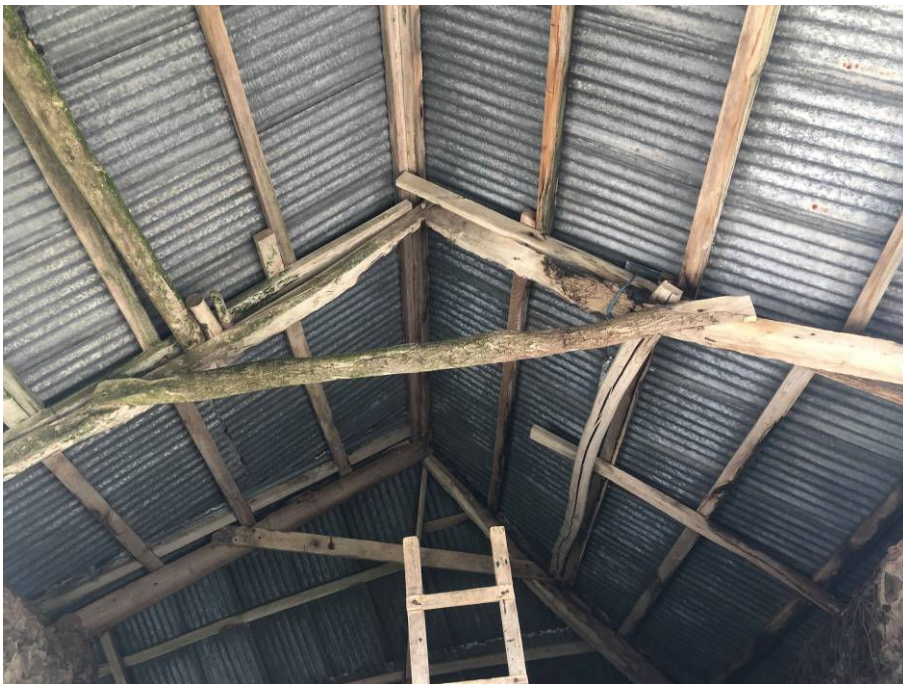
Figure 6. Roof over barn 5 showing structure

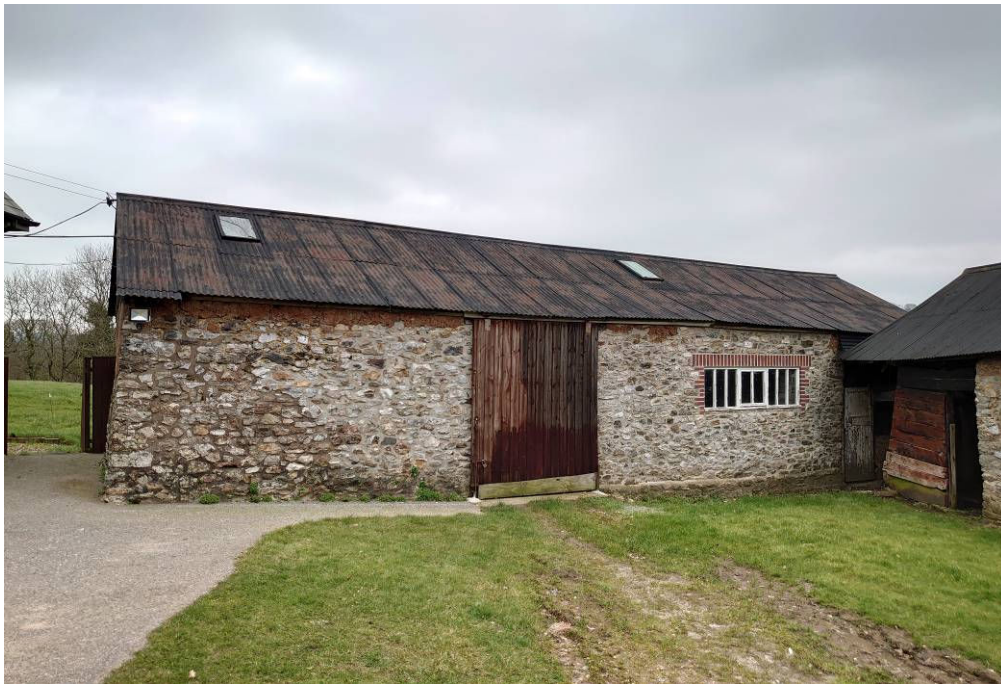
Figure 7 Yard elevation of threshing barn.

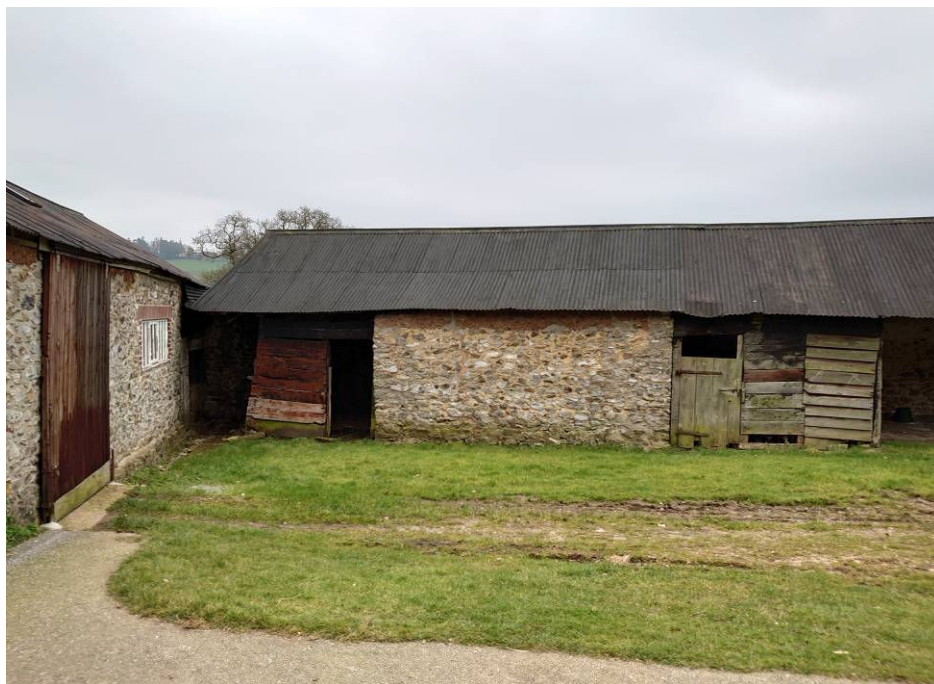
Figure 8. Yard elevation of Barn 2

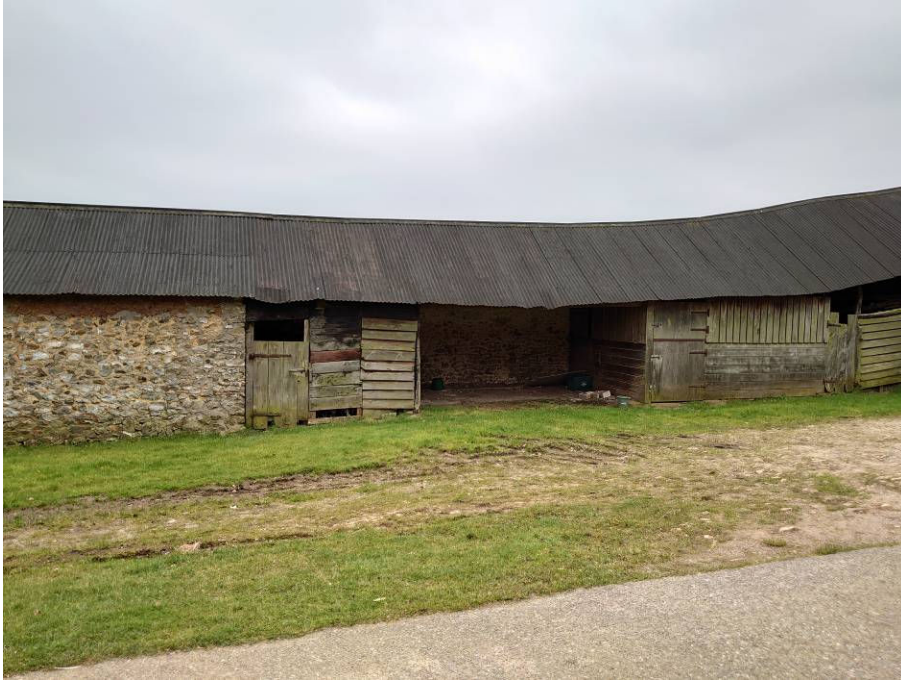
Figure 9. Yard elevation of Barn 3

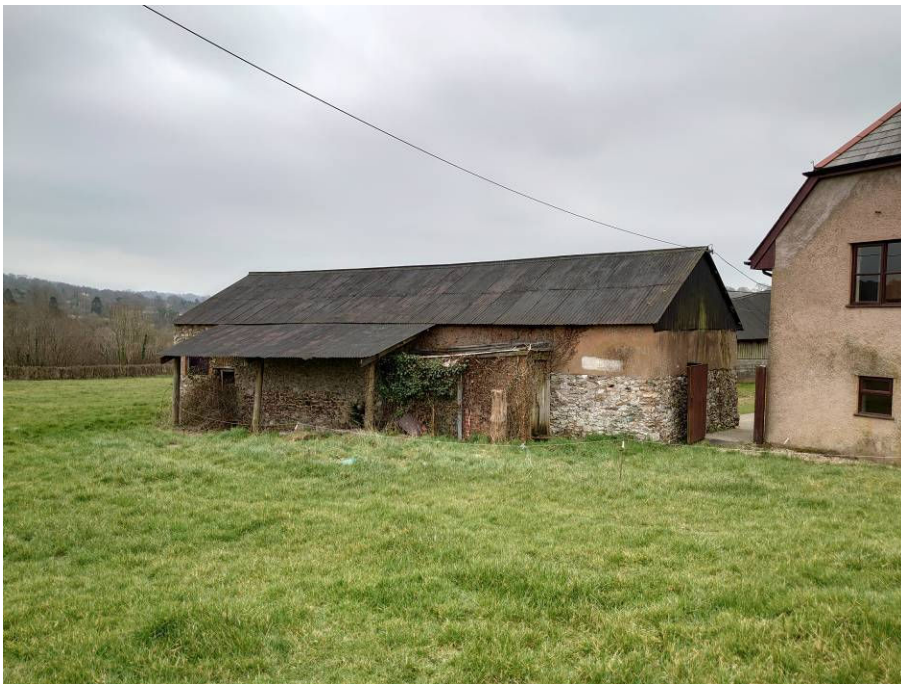
Figure 10 rear elevatio of barn 1

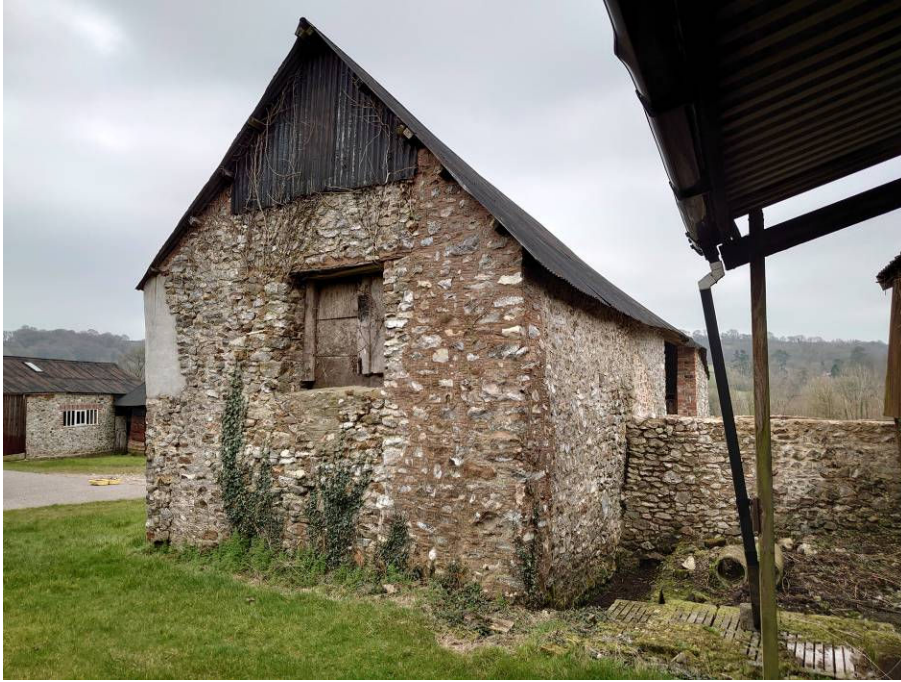
Figure 11. End elevation of Barn 6

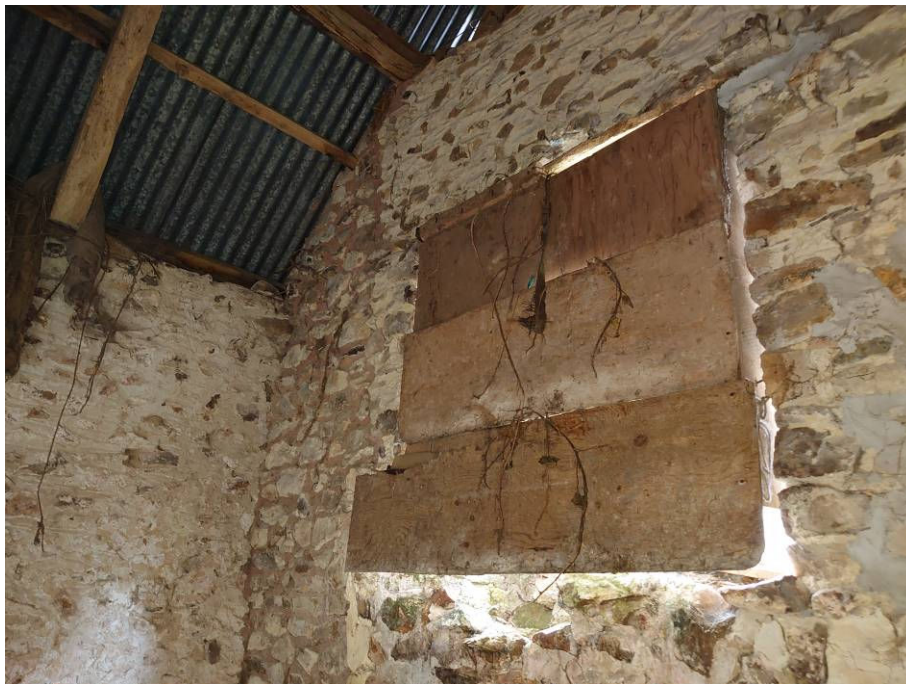
Figure 122. Internal of end elevation of Barn 6
