BARNS AT MUSGROVE FARM,
DUNKESWELL,
DEVON.
EX14 4RR.

REPORT ON THE STRUCTURAL CONDITION
OF THE EXISTING BARNS AND
THEIR SUITABILITY FOR CONVERSION

19th September 2022

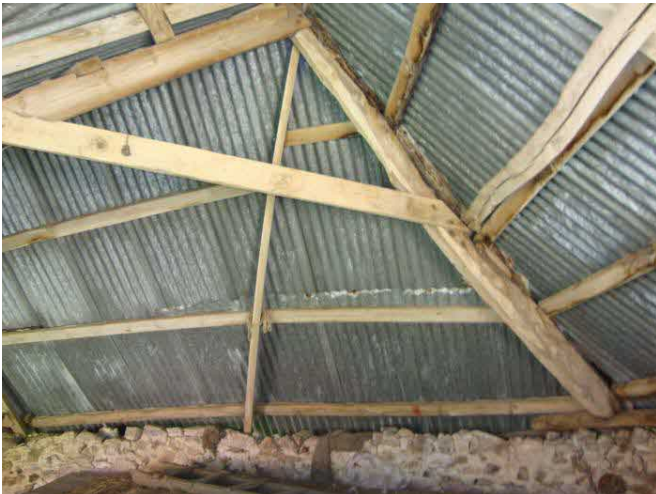
Photo 7 –South Corner Roof

The roof is similar to barn A but here is a diagonal corner truss supported on a diagonal timber bearer at the wall.

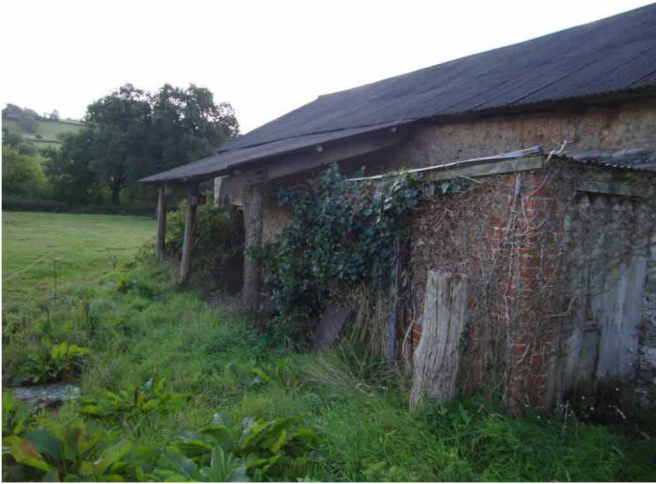
Photo 9 – North Eastern Wall

This wall is stone up to some 600mm from the eaves where it turns into cob. In general it is in satisfactory condition. Near the middle is a small access which has been partially blocked up in 215mm thick dense concrete block work. This access gave entrance to a small lean-to type room with brick work and corrugated iron walls. There is some loose stone work to the main wall at a lower level.

There is a small window in the southern part of this elevation and an external vertical crack approximately 50mm wide at the southern end off the wall.

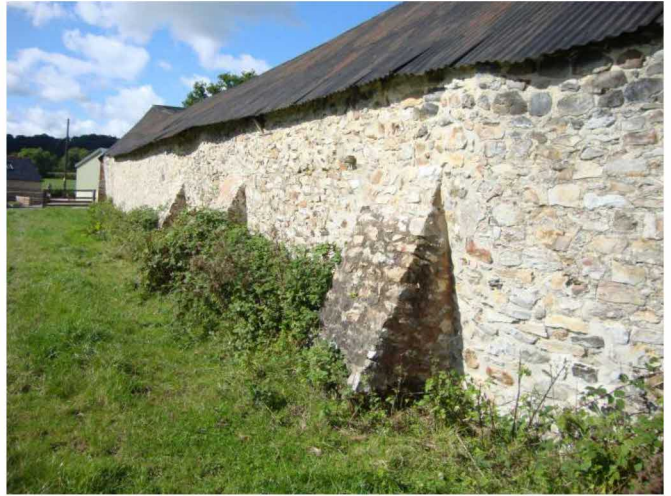
Photo 10- South Eastern Wall

This wall is in stone work with a varying height up to approximately 3.5m. At the western end the top of the wall has some cob to a height of some 600mm. In this area the wall leans outwards being out of plumb up to about 10 degrees. This section of wall would benefit from some re-building.

At the eastern end the wall also leans outwards but there are three external stone buttresses to provide additional support. There are some significant diagonal cracks at the top of the wall at this end up to some 20mm wide.

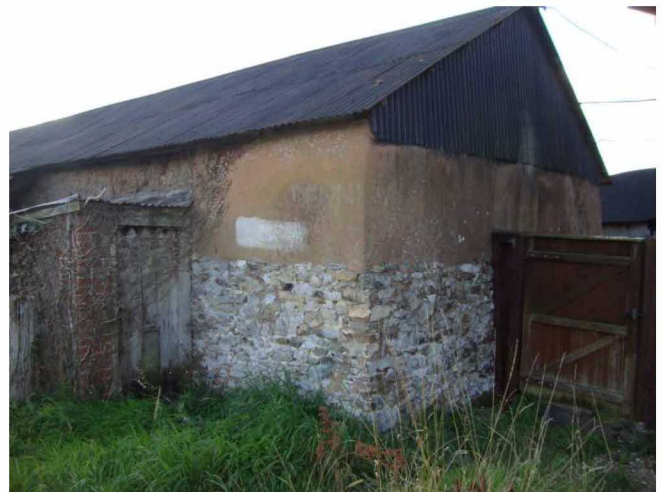
Photo 12 – North Western Wall

The north west wall is also stone with a central first floor 1.3m square access which has been boarded up. The timber lintels are in poor condition. There may originally have been a first floor in this area which has now disappeared. The eastern corner of this wall has some significant cracking internally and externally indicating some settlement and re-building of this corner with new foundations is recommended. The upper spandrel is in corrugated iron sheeting on timber frame work.
