# Heritage Report on Moss Farmhouse Tannington Rd, Worlingworth, Suffolk IP13 7LT

By  
**John Walker**  
Vernacular Buildings Historian  
April 2019

# Heritage Report on Moss Farmhouse, Tannington Rd, Worlingworth, Suffolk IP13 7LT

*This report provides an historic analysis at English Heritage (2006) Level 3 of the fabric of Moss Farmhouse, Worlingworth, Suffolk IP13 7LT. It analyses only the 16<sup>th</sup> century farmhouse and does not consider the later outshot along the rear of the property or include any documentary or map evidence of ownership or development.*

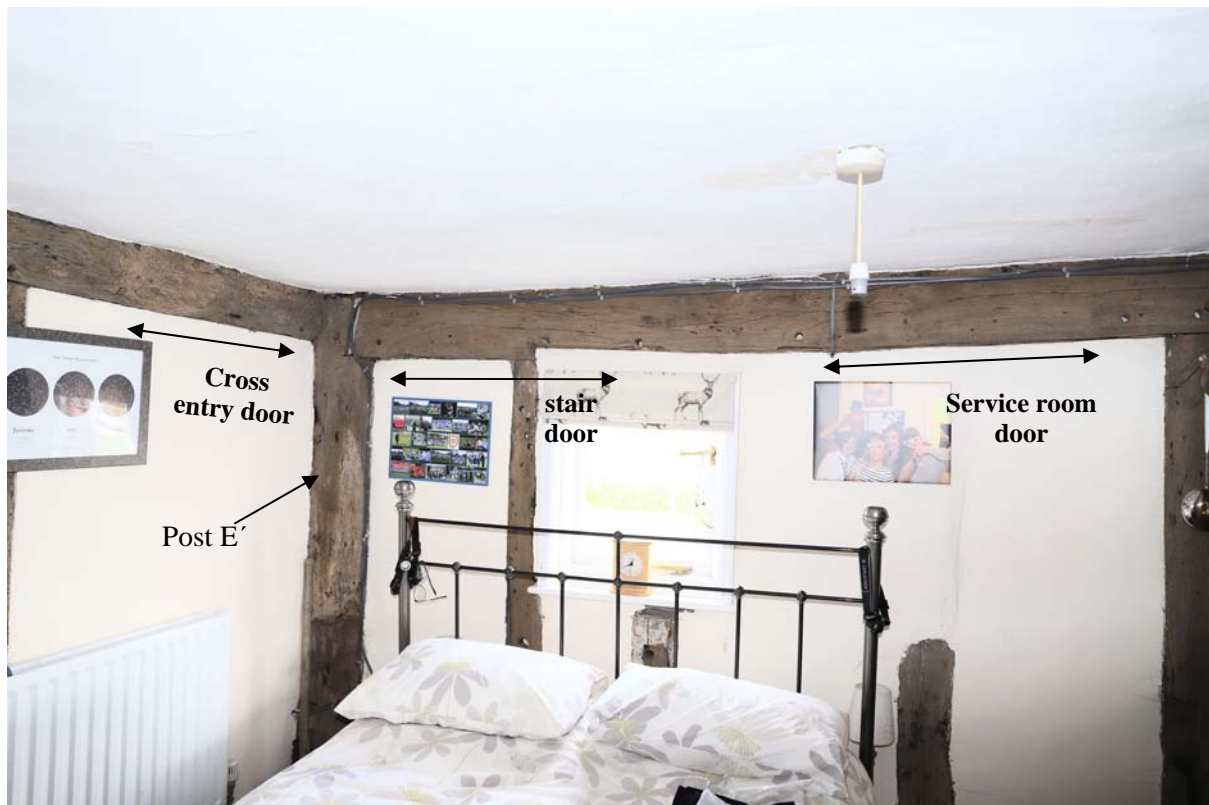
In the east end wall of the hall, now the east gable, only one of the original studs survives (EE' drawing 1a). However pegs in the midrail indicate that there were gaps for three doors in the wall, two in the middle which would have led into two service rooms in the lost right hand bay. The third was against the rear wall, and doors in this position are usually for the stairs to the chamber over the service rooms (Fig 5). Similarly gaps in the pegs in the midrails of the front and rear walls show there were originally doors in these walls against the service end of the hall (EE' in Drawing 1a), now the east end of the house, forming the cross-entry. One interesting aspect here is that the rear door is smaller than the front door, something has been noted elsewhere, but is not common. The present front door to the right hand cottage is more or less in the position of the 16<sup>th</sup> century front door.

Fig 5: North-east corner of hall on ground floor  
(left the north cross entry door; right of principal post E' the doors to the stair & service end)

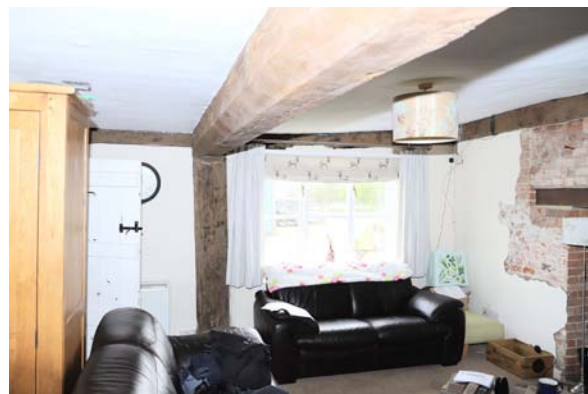
The large central binding joist in the centre of the hall (DD' drawing 1a) is visible but the common joists are plastered over and none are visible (Fig 6). It is therefore not possible to see if there is an opening in the ceiling for an original set of stairs within the hall. Such stairs are unlikely; I have

Fig 6: Hall on ground floor looking south  
(modern window replaces a narrower window)

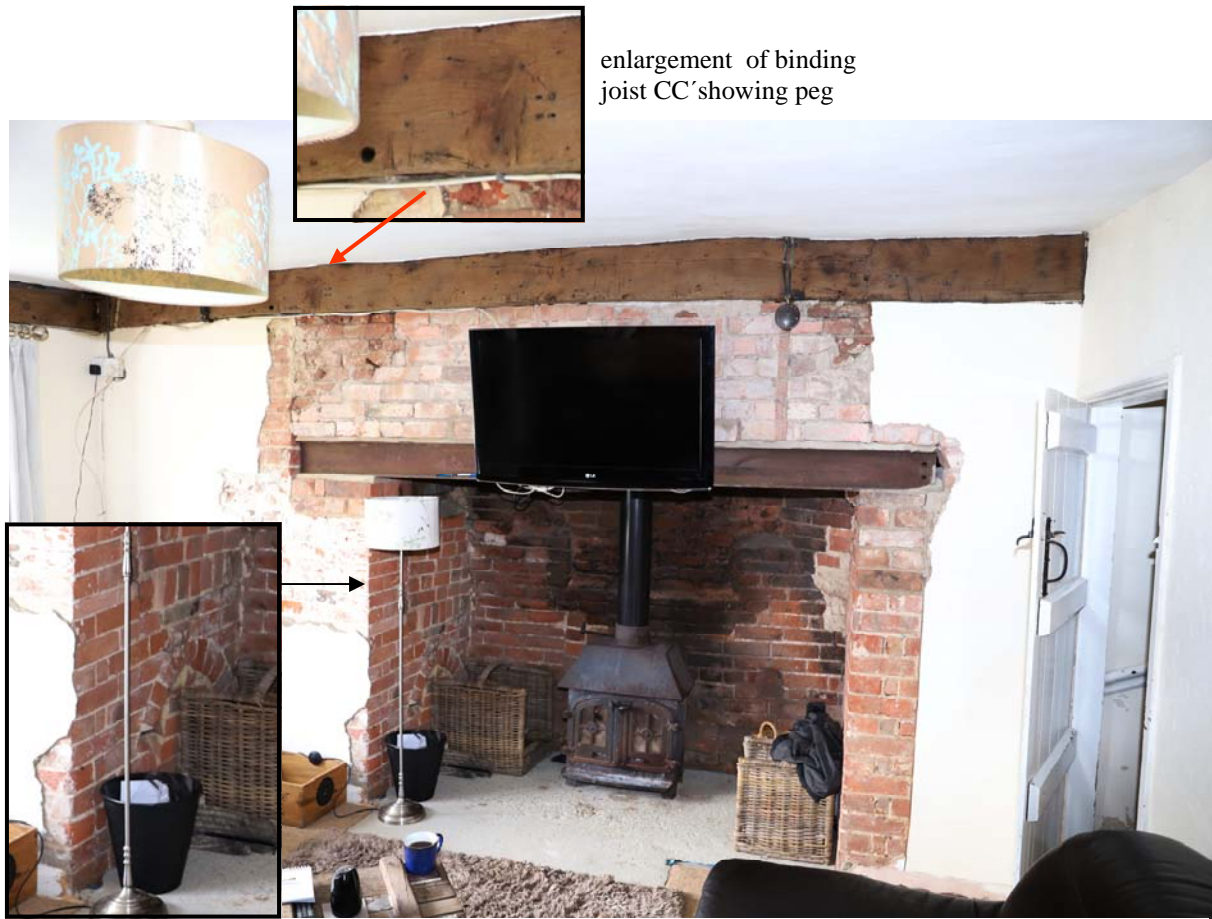
enlargement of binding joist CC' showing peg

Fig 7: Hall fireplace with evidence of an oven to left and corbelling for the stairs to the right

The hall fireplace has retained its original shape, but the brickwork around it has been subject to considerable rebuilding, with the original bressumer having been removed and replaced by an iron girder (Fig 7). There is evidence of a brick oven on the south side of the fireplace, now completely removed, and of corbelling on the north side of the opening for a circular stairs to the parlour chamber. To the south of the fireplace there is now a later brick wall which extends to the front wall, with a single peg in the bridging joist above it (Fig 7), suggesting a door into the lobby on the south side of the fireplace (CC' in drawing 1a). This area was probably just storage space, not an entrance to the parlour as it would have been partly blocked by the brick oven. To the north of the fireplace pegs in the principal post C' indicate there was an arched headed doorway through into the parlour (Fig 8). This is now blocked by the later stairs.

because the carpenters building the houses were unsure about the size the bricklayer would build the chimney. In the hall of Moss Farmhouse there is a peg for a stud in the binding joist CC' on the east side of chimney stack (Fig 7), so the problem in the parlour may have been uncertainty over the size of the parlour fireplace as the one built is larger than usually found in 16<sup>th</sup> century parlours.

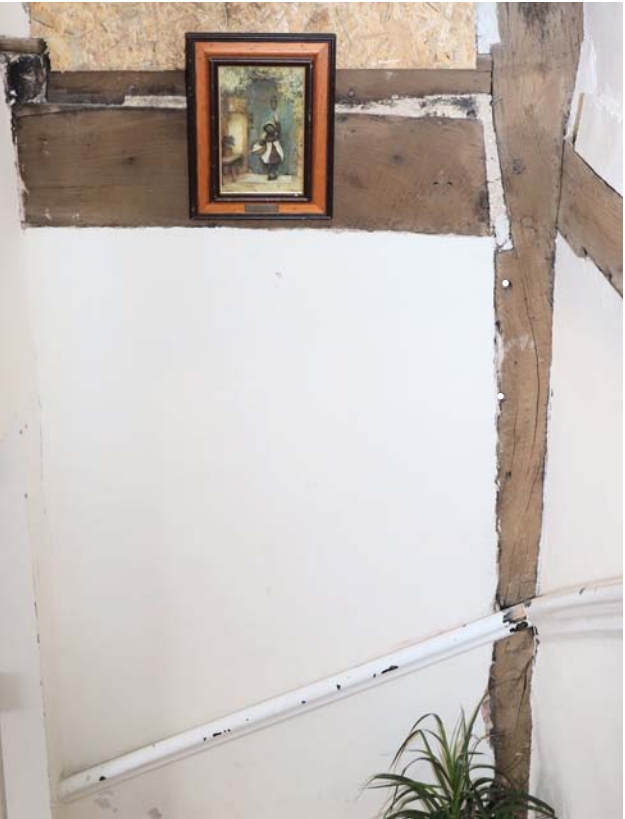
Fig 8: East face of principal post C' with pegs for an arched headed door

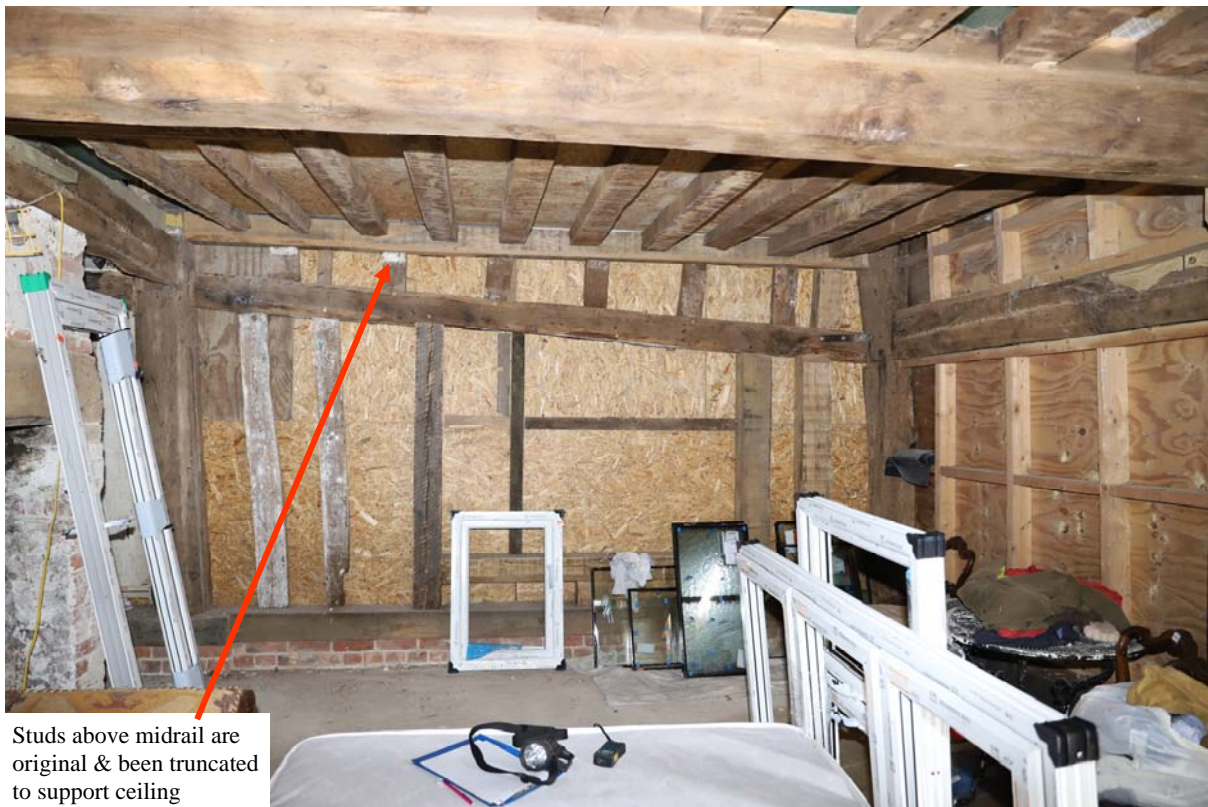
Studs above midrail are original & been truncated to support ceiling

Fig 9: Parlour looking south to front wall

All the later fitments have been removed from this area, exposing the surviving timber framing (Fig 9). The parlour is 4.2m (13¾ft) long by 5.6m (18½ft) wide. All the principal joists, midrails and principal posts survive, as do most of the studs in the rear wall of the chimney bay (Fig 10). No studs survive in the rear wall of the parlour or the west gable, while in the front wall two original studs remain but none in the front wall of the chimney bay, the latter probably removed when a door was inserted for the left hand cottage. With two exceptions all the common ceiling joists remain, along with the central east-west principal joist.

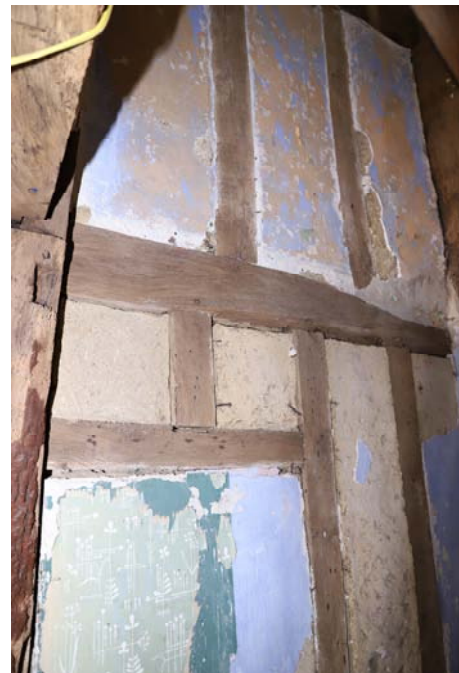
Fig 10: Rear wall of chimney bay showing ground and first floor studs (blocked door is a later insertion)

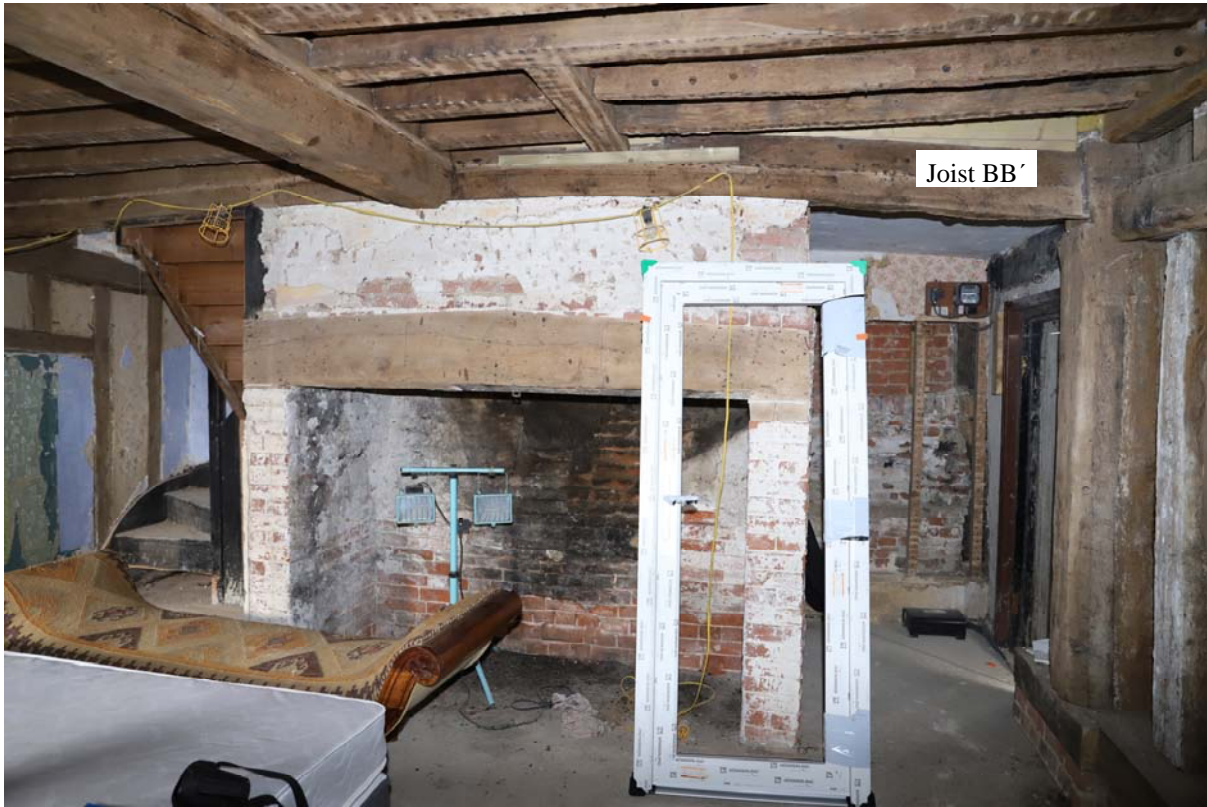
The timber framed ceiling is complete apart from the two common rafters immediately in front of the fireplace in the southern half of the ceiling, which looks as if an opening was created for stairs at some stage, though this is not a good position for any stairs (Fig 11). Apart from this, there are no openings in the ceiling for stairs. The common joists are 140mm by 102mm (5½ by 4in), laid on their largest side, and finished square with no chamfers, something which usually indicates that the ceiling was plastered over from the start and the common joists not visible.

Fig 11: Parlour fireplace with immediately in front of it two cut common joists.

The original fireplace has survived intact, complete with its bressumer (Fig 11). Unusually it is the same size as the hall fireplace. Usually it is smaller as in Thurstons in Figure 3. There is a later stairs now occupying the whole area to the north of the fireplace (Fig 12), but originally there would have been a circular stairs against the fireplace - as evidenced by the corbelling in the hall fireplace (Fig 7) - that would have occupied about half the space, leaving room for an entrance passageway between the hall and parlour as at Thurstons (Fig 3). Mortices in the binding joist BB' show there was a floor over where this passage would have been (Fig 13).

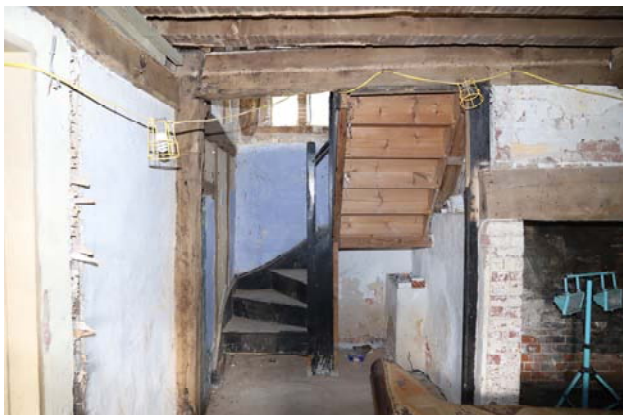
Fig 12: Stairs now in lobby on north side of fireplace in the chimney bay

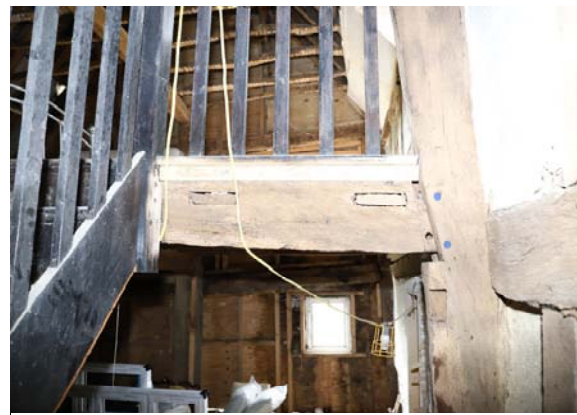
Fig 13: Looking west at east face of bridging joist BB' showing mortices for joists over lobby in chimney bay on north side of chimney stack

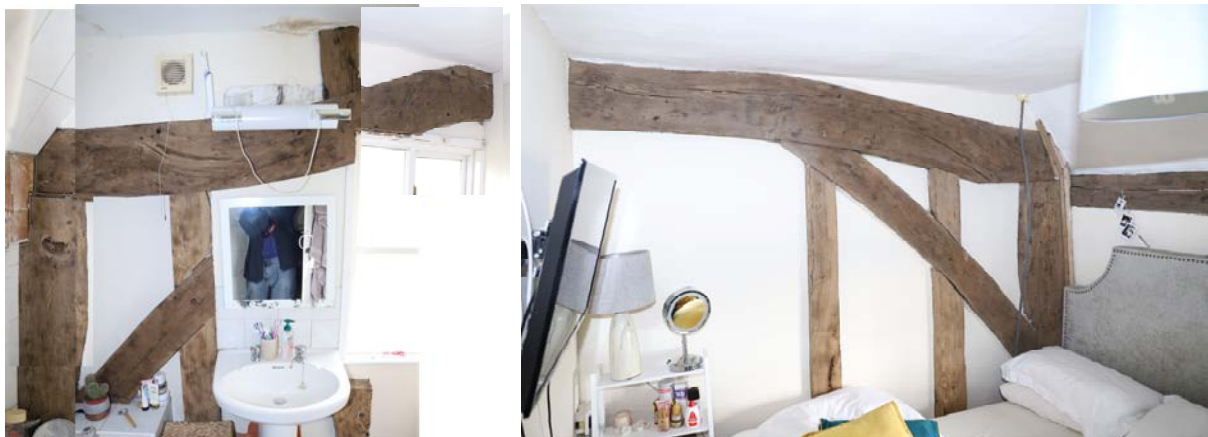
Fig 14: West face of cambered tiebeam over east gable EE' - north end to the left, south to the right

The hall chamber was probably entered from the service chamber by a door in the middle of east wall. There is a wider space between the two central studs in this wall, just about enough for a door, but more importantly the tiebeam is heavily cambered rising about 30cm (a foot) in the centre to provide greater height over the door (Fig 14). The first floor is relatively low, only about 1.55m (5ft 1in) from the floor to the soffit of the straight tiebeam in truss BB'. The tiebeam of the open truss in the centre of the hall chamber is also heavily cambered to allow easier access between the two parts of the room (Fig 15).

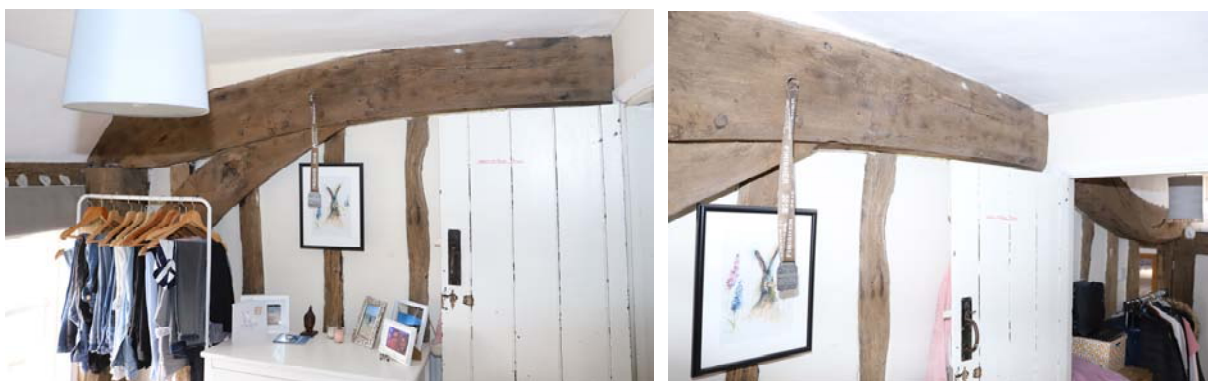
Fig 15: West face of tiebeam on truss DD' - south end to the left and north to the right

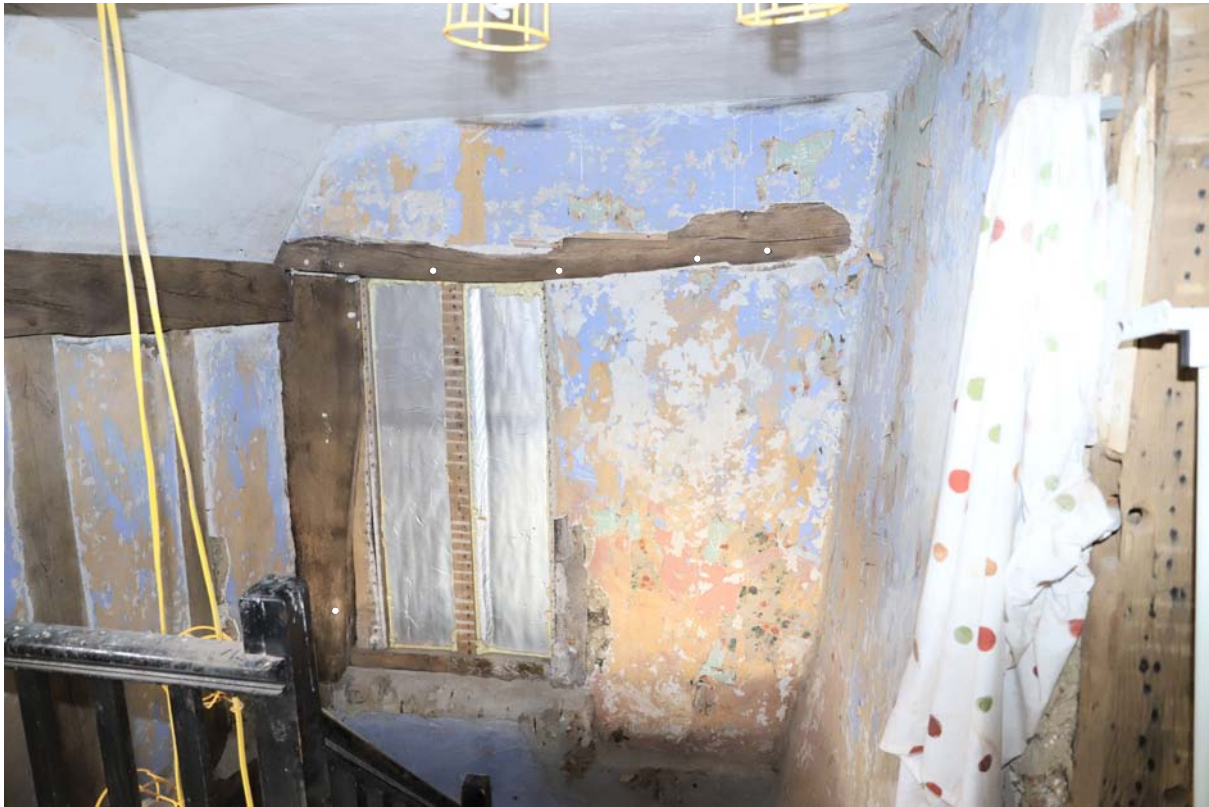
Fig 16: West face of north end tiebeam and principal post C' in chimney bay - pegs picked out in white

show that there were three studs here with an arch brace rising across them from the north post C' (Fig 16). This is an unusual feature as most houses of this type have a door in this position so that the hall chamber could also be entered directly from the stairs behind the chimney stack. A later door appears to have been inserted and then subsequently blocked.

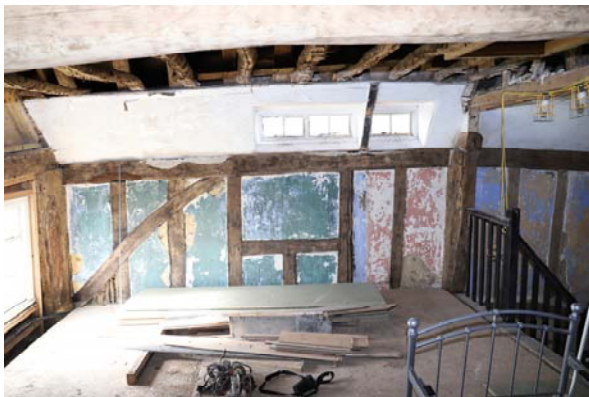
Fig 17: Rear wall of parlour chamber

As on the ground floor all the later fitments have been removed from this area exposing the timber framing (Figs 17 & 18). All the wallplates, tiebeams and principal posts survive in this area and all the studs survive in situ in the rear (north) wall (Fig 17), but none elsewhere, apart from the lower part of front wall studs which now support the ground floor ceiling joists (Figs 9 & 19). All three external walls had arch braces rising from the west end principal corner posts A and A' (drawing 2b); only the brace in the north wall survives. All of these were, or are, half the thickness of the studs and halved across the internal face of the studs, and thus were not visible externally. The room was originally open to the roof.

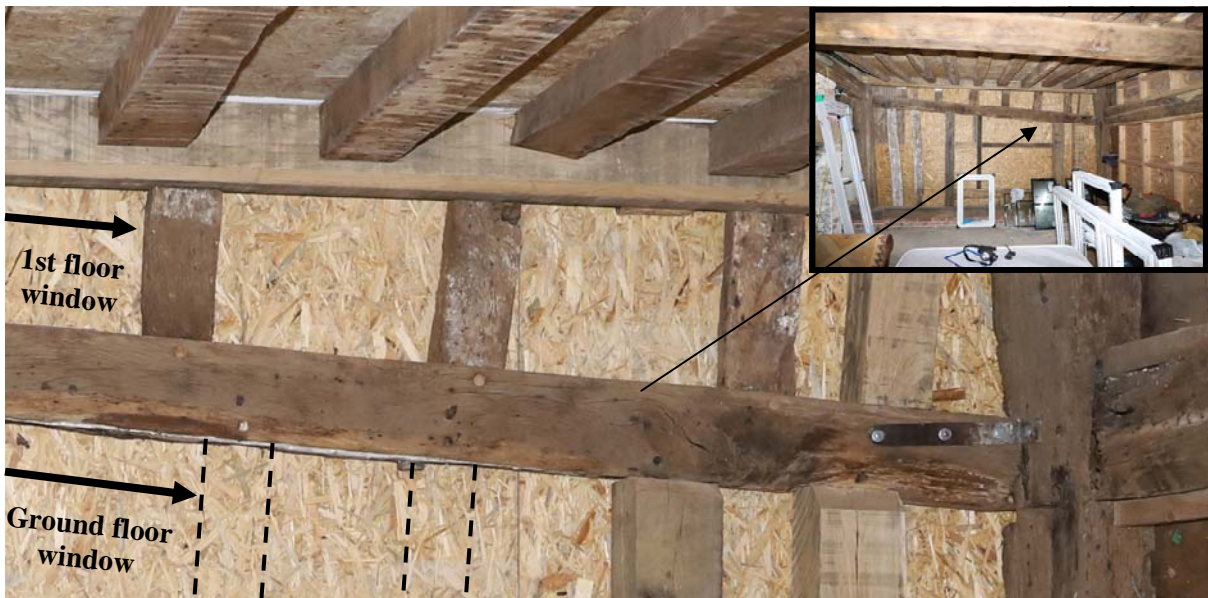
Fig 19: Midrail in front wall of parlour where pegs & the surviving lower stubs of the first floor studs show that the first floor window was not directly over the ground floor window

unglazed. Most likely the other two windows also had diamond mullions. The front and west windows have grooves for sliding shutters, but not that in the north wall. One interesting feature is that the first floor windows in the north and south walls of the parlour chamber are not directly over the ground floor windows. That in the north wall is offset to the west of the one below in the parlour, while that in the front wall is offset about 127mm (5in) to the east (drawing 2a & Fig 19). Also the first floor front window in the west bay of the hall chamber is larger than that below in the hall (drawing 2a). This lack of symmetry in the positioning and size of windows has been noted in a number of 16<sup>th</sup> century houses, though little has been published on it.<sup>1</sup>

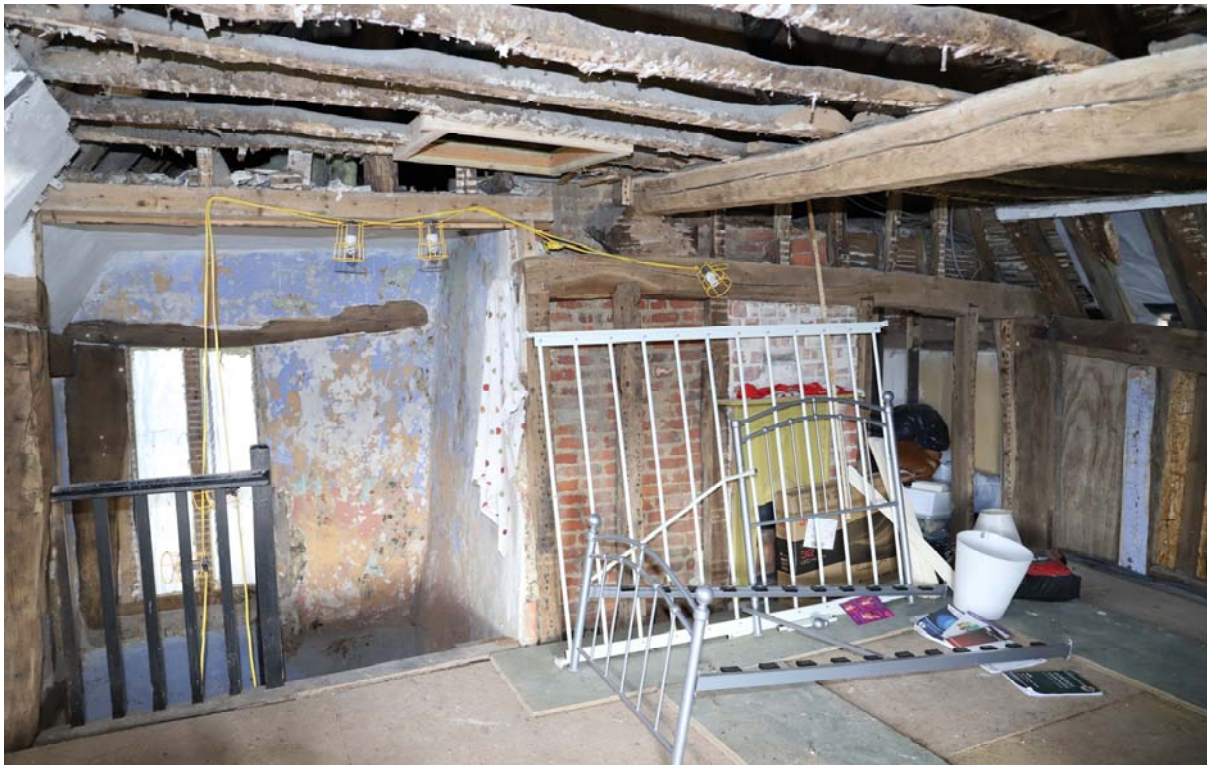
The parlour chamber was originally unheated. A Victorian fireplace has been inserted into the chimney stack (Fig 20). The room was accessed via stairs on the north side of the stack in the chimney bay, entry being somewhat restricted by the low tiebeam BB', which is why it has been cut out north

Fig 20: East side of parlour chamber  
(Victorian fireplace at right hand end of chimney stack)

of the chimney stack (Fig 20). There are no mortices in the tiebeam to the south of the chimney stack, but again there would have been a wedged partition under the tiebeam with a door at the north end against principal post B', while south of the chimney stack there could have been a solid stud partition with no access to or from the hall chamber. If so, it would mean that the parlour chamber had no access to the rest of the first floor because, as described above, there was no original door north of the chimney stack in truss CC' to give the hall chamber access to the stair lobby and parlour chamber. This would mean that the occupier of the parlour also controlled the parlour chamber, providing a separate apartment at the west end of the house. It was not unusual for 16<sup>th</sup> and early 17<sup>th</sup> century houses to be divided on the first floor, with no access at first floor level between the two ends of the house.

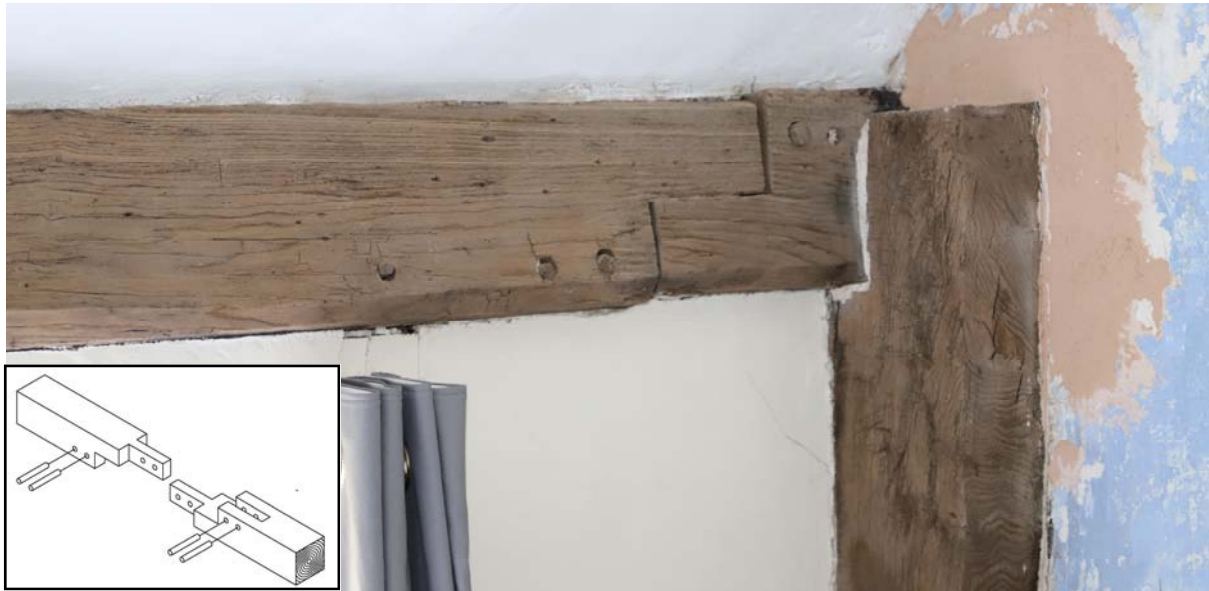
Fig 26: Edged halved and bridled scarf joint in south front wall east of post C.
