Our Ref: R3482aI-No22ChurchRdSilverton-VTA 190922

Visual Tree Assessment of Two Oak Trees Adjoining No22 Church Road Silverton

Location	Treneer, 22 Church Road, Silverton, Exeter, EX5 4HS		Ref:	R2657aI R3482
Client	Mr & Mrs Salisbury		Report Date	22-06-20. 19/09/22
Survey Inspector(s)	A M Lane MIC For., F. Arbor A., MRICS		Inspection Date	22-06-20. 19/09/22
Report Prepared By:	A M Lane MIC For., F. Arbor A., MRICS	Report Checked By:	Unchecked

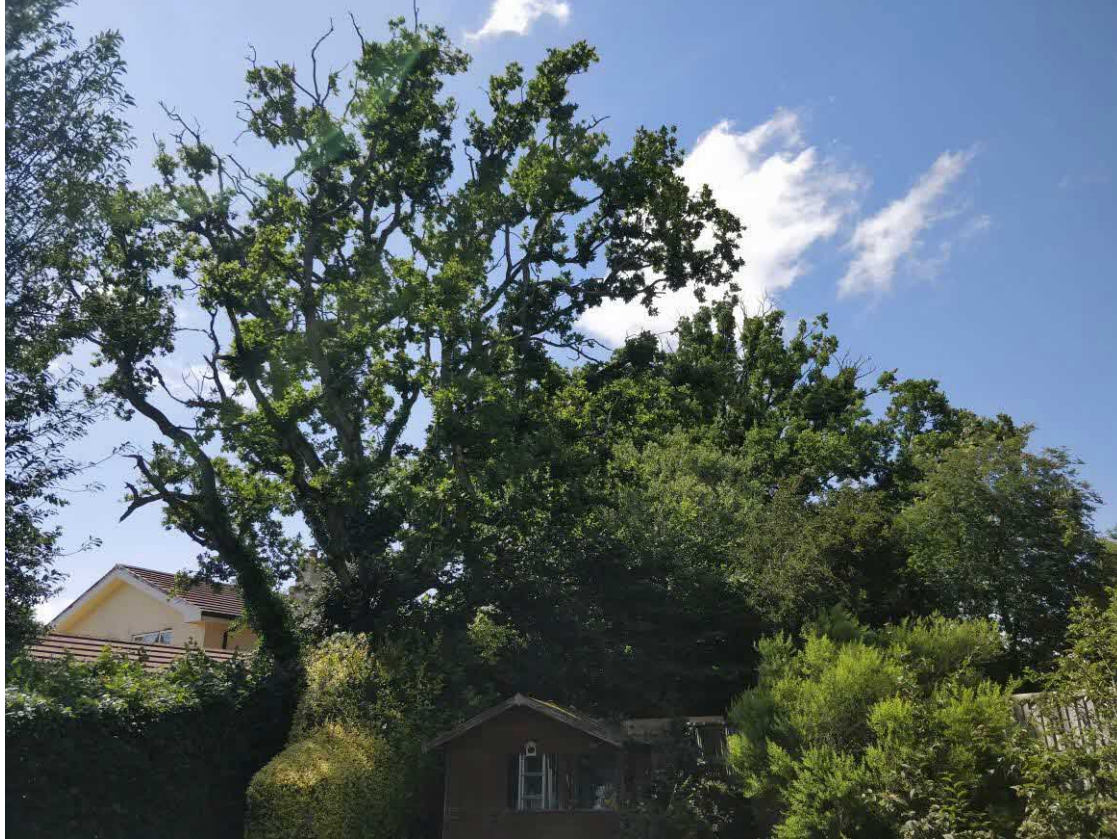
5. The crown has been reduced in the past with some internodal cuts and others of a more targeted nature. The crown is showing increasingly reduced vigour with a variable, but generally moderate, very poor vigour or vitality. (See Plate 1 at Appendix 1)

6. Large diameter deadwood is noted throughout as well as smaller diameter more friable dead branches.
7. There is a significant amount of live reiterative growth showing an attempt to retrench however this is now increasingly isolated and thin. The tree was showing decline in 2005 & 2020 when last inspected and this decline has progressed albeit very slowly significantly now extending to approximately 70-80% of the expected crown volume. There are no signs of structural failure or root insecurity.

12. Normal vigour and good vitality was observed in the lower half of the crown however the central upper crown, particularly on the east side, has a significant degree of distal dieback. Vigorous growth along the retrenching limbs is notable however and the dieback appears to be slow.

Plate 1: 22/06/22 Taken from the garden of No14 Hederman Close. T1 in the foreground showing extensive crown debility. T2 is observable in the background with the central upper crown on the north east side (right of picture) showing dieback.

1. Consider the removal of the tree before it stands dead so that it is stable on which to work. (M2)
2. Unstable and small diameter deadwood to be removed however the larger deadwood where it is stable should be retained where safe and unlikely to cause major concerns. (M3)
3. Reinspect the tree in 2 years from the date of this report.

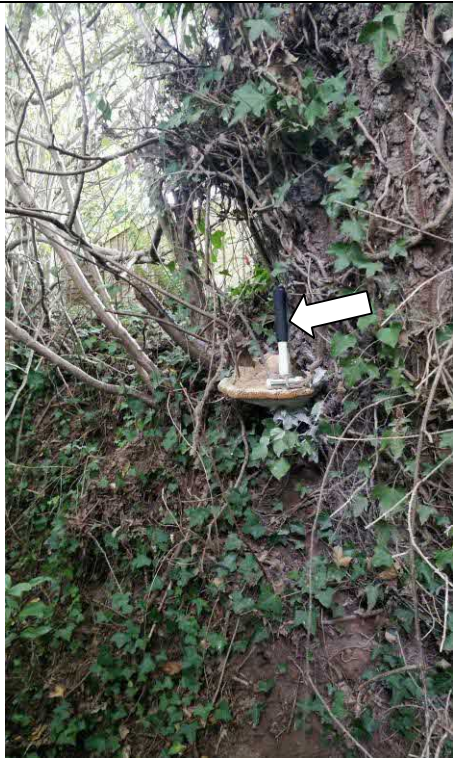
13. 19/09/22 Inspection of the lower trunk on the streamside identified a fresh fungal fruiting body of *Pseudoinonotus dryadeus* commonly known as 'Eifel Tower Fungus' located level with the top of the bank on the NW side. (See Plate 2 at Appendix 1). The old remains of two further fungal brackets of the same species were noted midway down the bank face on the west side and associated with a buttress root column extending down the bank.

6. 19/09/22 Eifel Tower fungus causes a white of the central heartwood of tree and is mostly associated with the root crown and lower trunk. Hollowing is a normal long term outcome with the retained buttress roots forming the supporting legs hence the 'Eifel Tower' description. It is therefore significant but not an immediate concern. In very rare situations the remaining columns can fail however this not before the decay becomes extensive.

Plate 2 – 19/09/22 Fungal bracket viewed from the stream.

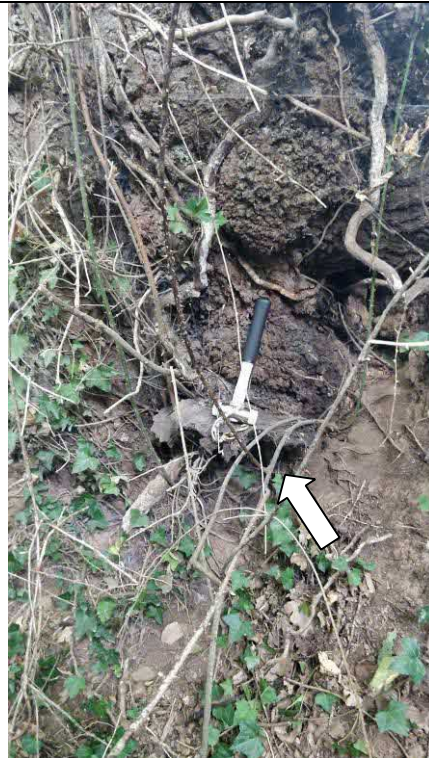
Plate 3: 19/09/22 Old remains of a fungal bracket.
