Burnthouse Farm – Samples of Existing Timber Frame & Plinth Wall Condition Following Exposure in Sitting Room (South & West Elevations)

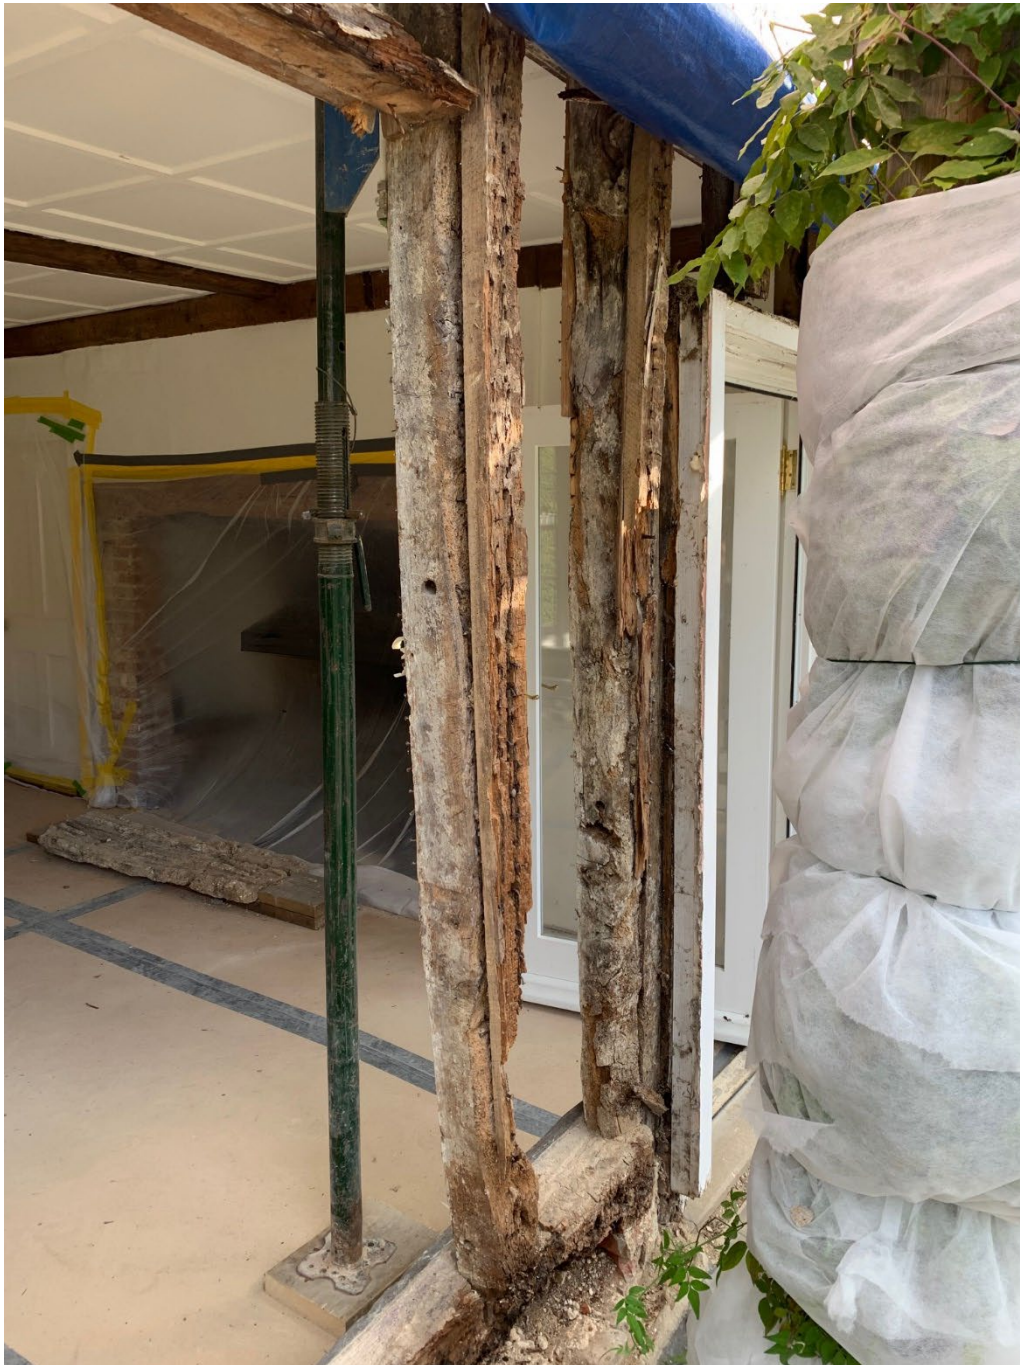
Sitting Room – South Elevation (note removed and stored wattle & daub panel in front of fireplace)

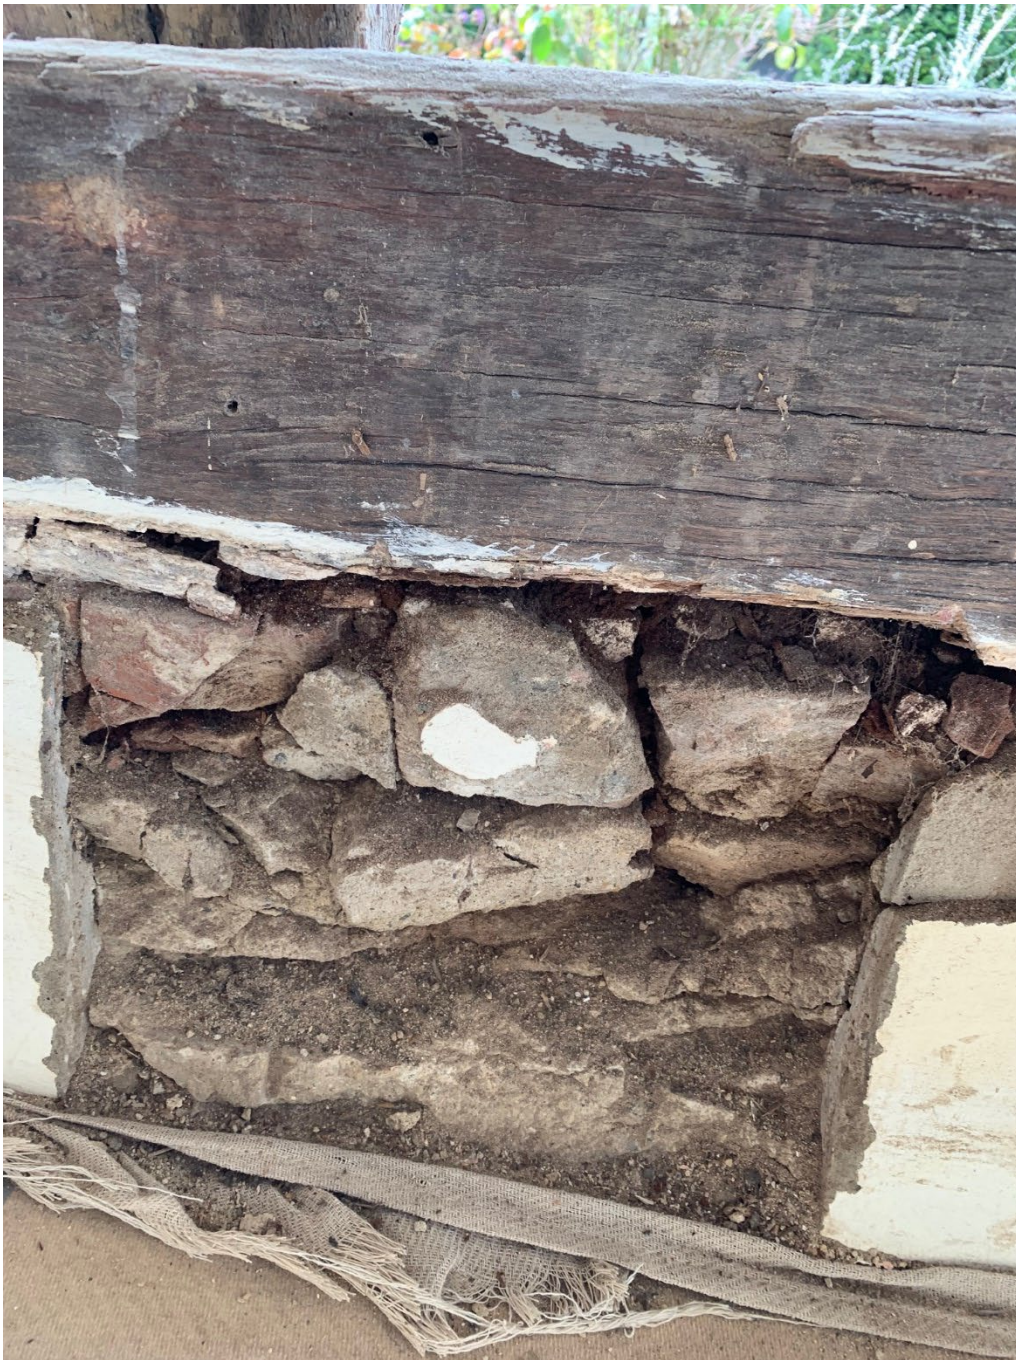
Sitting Room – West Elevation (note concrete & rubble infill)
