AFP CONSULTING ENGINEERS LTD

Burnt House Farm

PHOTOGRAPH SHEET
Burnt House Farm – Living Room

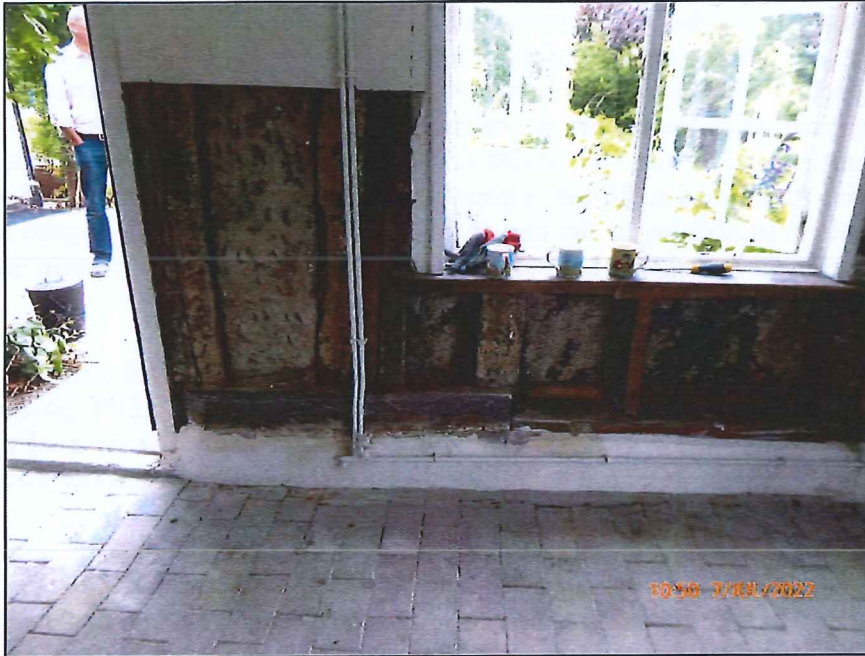
Photograph 1 – Living Room, Rear

The attached photographs 1-6 show the extent of the opening up carried out. Whilst some of the original timber framing members and studs are original, many are replacement members, including a large section of the soleplate to the rear wall. We indicate on the attached drawing extracts the locations of original members and where the original members have been replaced. It is thought that the lath and plaster removed is not original and provided following the various historic repairs and interventions with sawn softwood members. Inspection of the external render shows that much of it has been replaced with a cement render on metal lathing, which has also started to rust as a consequence of the humid conditions and trapped moisture within the wall construction.

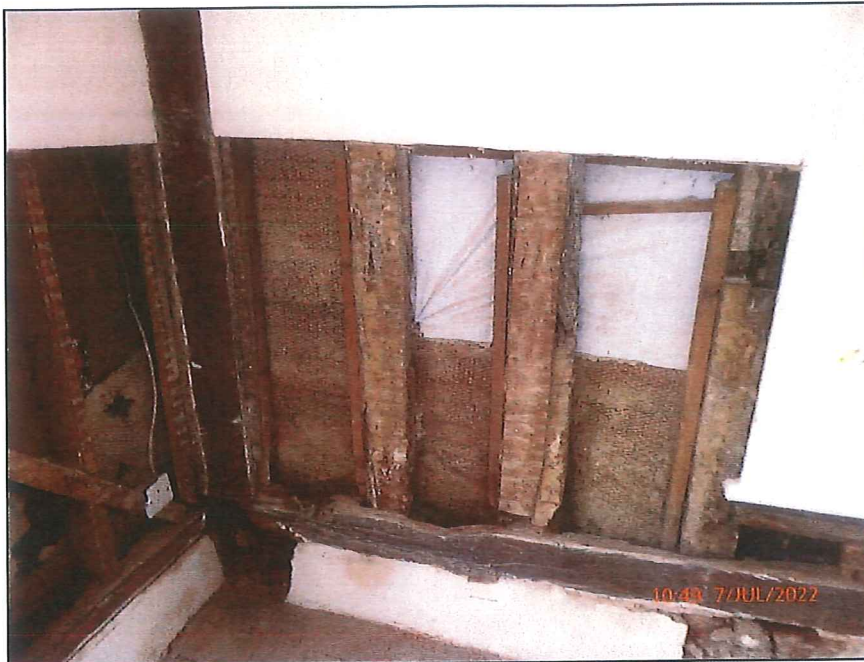
Photograph 7 – Corner/Side Wall Soleplate

You are aware from our initial report our concerns about the condition of the soleplate. This further investigation highlights significant decay in each of the sections exposed, with the exception of the side wall where it has been partly replaced. The majority of positions inspected revealed decay in excess of 50% of the original section. The bottom of each of the timber studs have also decayed and this decay continues up the external timber face where it is in contact with the cementitious render on metal lathing, (see photographs 7 to 11).

It is recommended that the soleplate to be replaced in oak, incorporating a DPC (assumed to be slate) to separate it from the plinth masonry at, or slightly higher than the existing level. Ideally the external ground levels would be slightly lower.

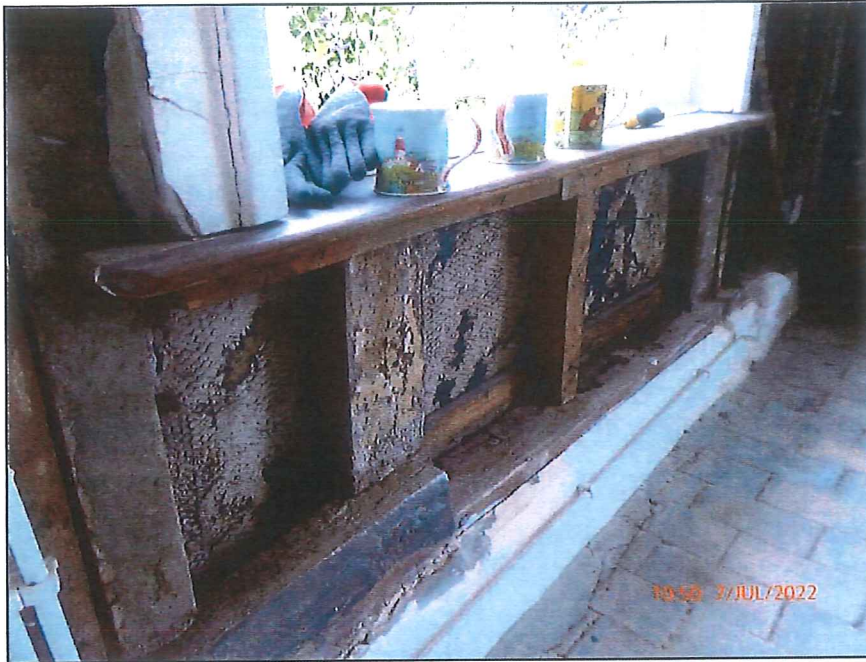
Photograph 11 – Rear Wall

Inspection of the rear window suggests that the current windows have been introduced at a later date with various timber studs used under the sill (see photograph 11).

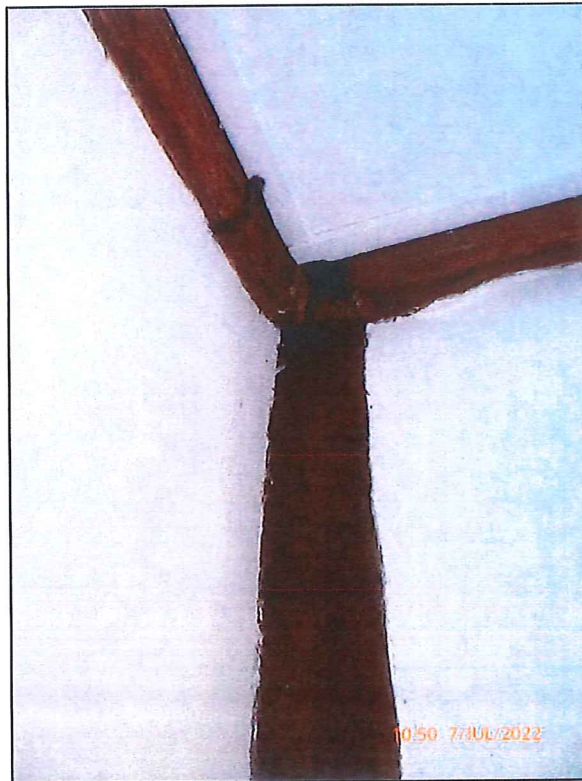
Photograph 12 – Corner Post

The original timber corner post is of larger section (c.180 x 150) that is thought to be damaged to the outside face where it is in contact with the cement render. This has previously been cut at the base when earlier soleplate works have been carried out. The soleplate under the corner has completely decayed. Inspection of the top of the corner post shows no significant connection between the post and the first floor beams (see photographs 12 to 14).

The corner post and post at the wall separating the living room from the study are poorly connected at the top to the first floor beams. These will require fabricated metal straps installed to improve the connections. This is a detail that will require confirmation during the works.

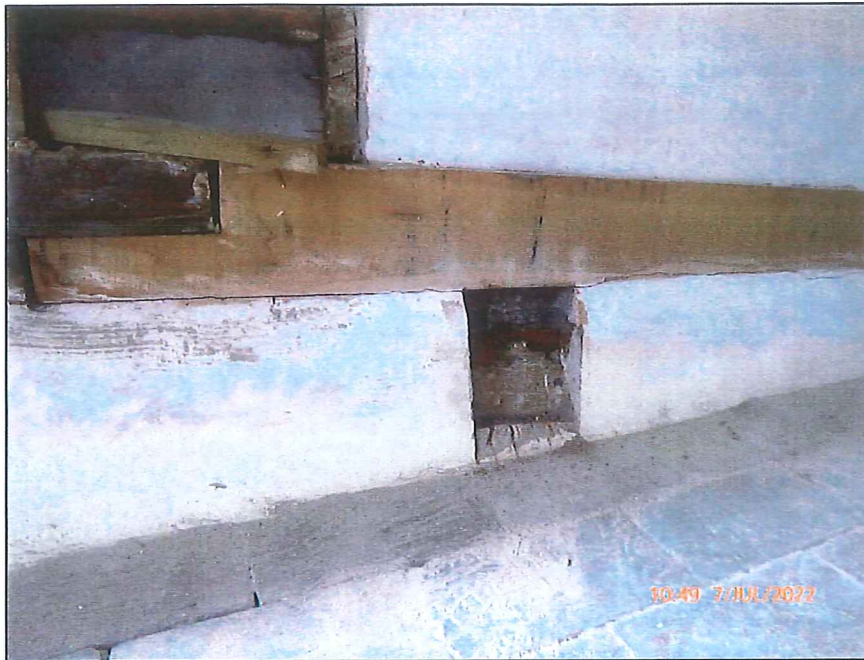
Photograph 15 – Side Wall Replacement Soleplate

Inspection of the plinth wall directly under the soleplate shows that no damp proof course (DPC) was introduced when the soleplate was introduced, although the studs appear to be original members (see photograph 15).

The timber decay has occurred because of the lack of a DPC and re-rendering the external elevations on metal lathing using a cement render.

We suggest that the soleplate and the new/repaired studs are connected using mortice and tenon, or other agreed housing joints. The soleplate will require a DPC positioned under it (and possibly set 1 to 2 courses below the soleplate). The external plinth arrangement will require careful detailing of the render to ensure that water does not penetrate into or onto the soleplate.

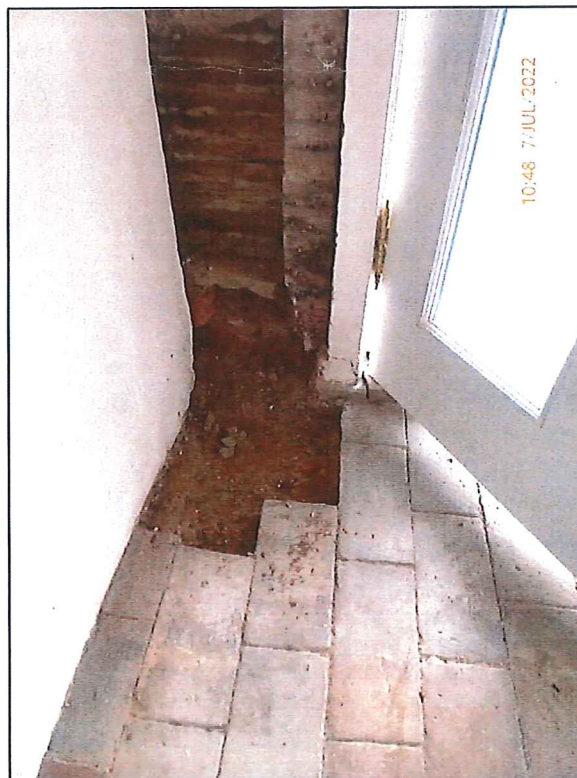
Photograph 16 – Left Hand Side Door

Inspection of the wall to the left hand side of the rear entrance door shows the soleplate to be totally decayed and the lower section of the stud (to the side of the door frame) to be damaged for the lower 4-500mm. The external render to this section of wall is lath and render (see photograph 16). The floor bricks were locally lifted in this location. They are around 50mm thick, and sand bedded onto earth.

The section and extent of soleplate to the left hand side of the external door (viewed from inside) will require the work to be executed from outside to avoid damage in the pantry area.

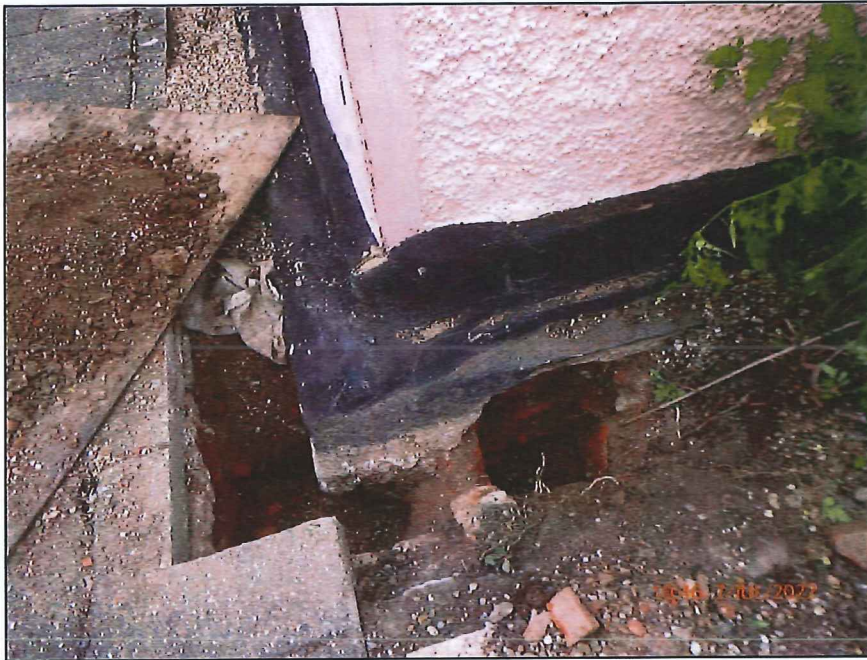
Photograph 17 – External Trial Hole

A trial hole was opened to the external corner. This showed the brick foundation to be slightly corbelled at the base and bearing around 550mm below external ground level that is similar to internal floor level in the living room (see photographs 17 and 18).

Inspection of the foundation and the walls generally suggests that the foundation is adequate, and that underpinning or other improvements are not required except rebuilding 1 or 2 courses when a new soleplate and DPC is introduced. The type of DPC used is to be agreed.
