Structural Inspection Report

**Distortion of Estate Wall
Bretton Lodge
1, Park Lane
West Bretton
WF4 4JT**

Date: 29th April 2022

TSI 22115

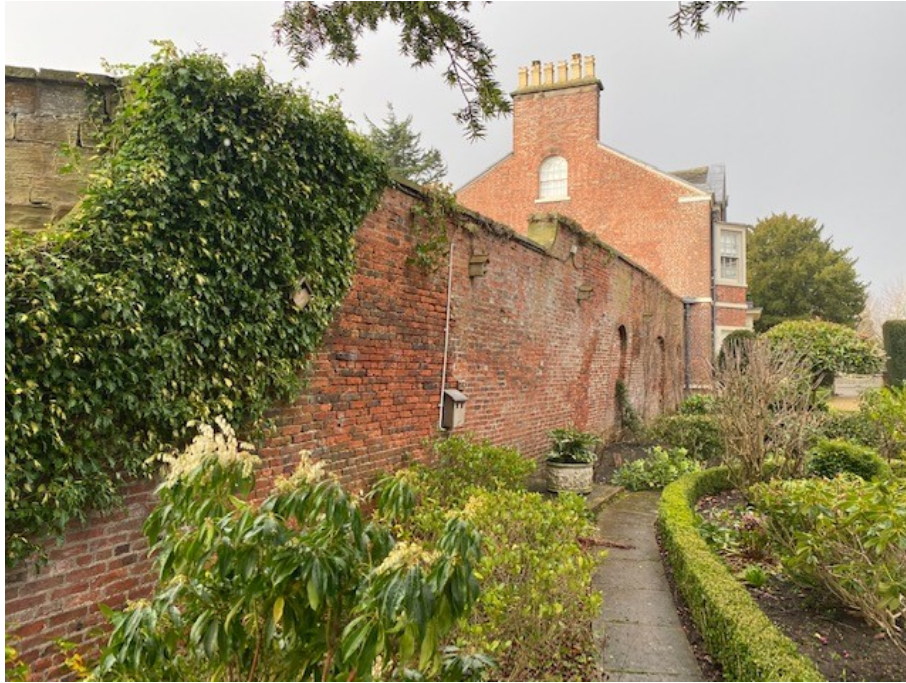
Photo A1.1 : The wall as viewed from the north-east.

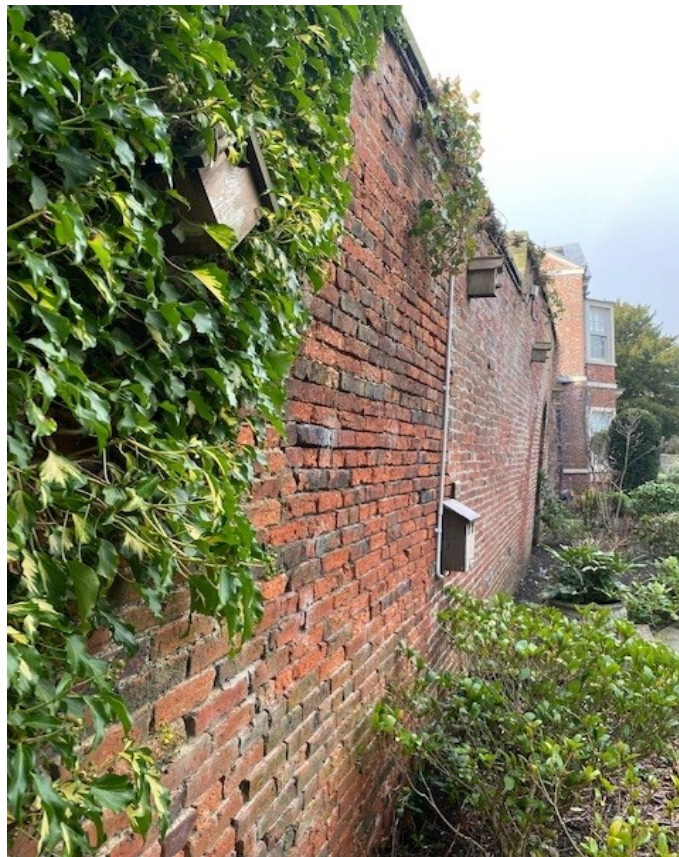
- 7.2.1 The wall has a pronounced lean to the north, and in the worst location is estimated visually to be approx. 600mm out of plumb. (Photo A1.2).
- 7.2.2 The top edge of the wall has distorted accordingly into a smooth curve over approx. three quarters of its length. (Photo A1.3).

8.2.3 The lean of the wall has also reached a point where the vertical line of thrust through the wall's centre of mass lies well outside the middle third of its width. Indeed, in places, the line of thrust would appear to lie outside the northern face of the wall altogether.

8.2.4 The implication of this is that in order for stability to be maintained, tensile stresses will be being induced in the southern face of the wall. Brickwork has a very low capacity to resist tensile stress, and the structural calculations indicate that the applied stress may be between two and three times greater than the resistance that would typically be expected.

9.1 The most probable cause of the damage is considered to be strong differential wind pressure occurring across the wall. Suitable conditions for this situation to arise would have occurred during the severe storms of February 2022.

Photo A1.2 : The wall has a pronounced lean of up to approx. 600mm to the north.

9.2 The area to the north side of the wall should be cordoned off to prevent local access, and temporary shoring measures should be considered to ensure the stability of the wall in the short term.

- 9.5 It is possible that further, gradual deformation will occur, and therefore it should not be presumed that the wall will remain stable indefinitely.
- 9.6 It is recommended that permission should be sought from Historic England to dismantle the wall carefully, salvaging as many of the original bricks as possible, and to reconstruct the wall as a reinforced masonry wall of substantially similar visual appearance.

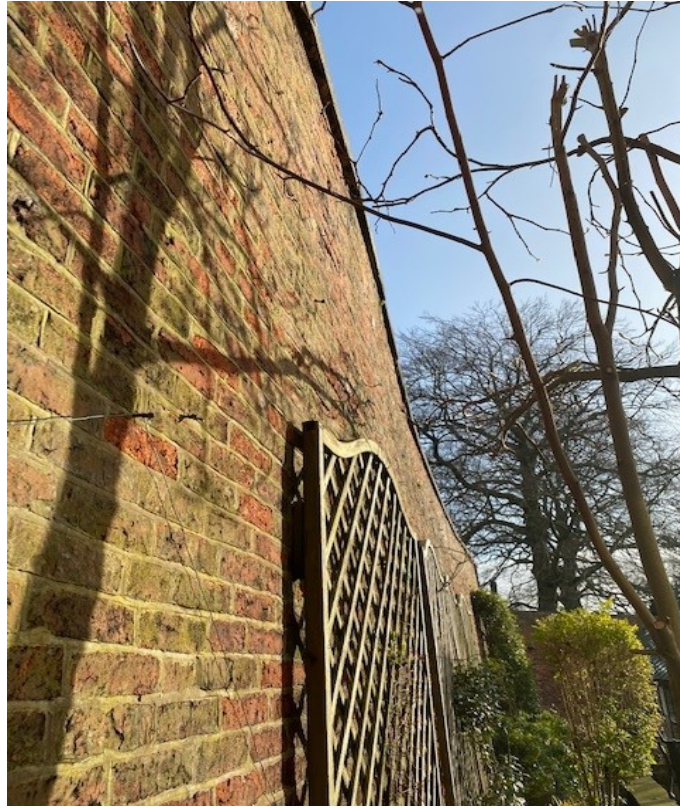
8.2.2 Moreover, the even, curved shape of the distorted wall would suggest that a more longitudinally distributed, progressive load has been applied, such as would be the case due to lateral wind loading.

Photo A1.3 : The head of the wall has distorted into a smooth curve over approx. three quarters of its length.

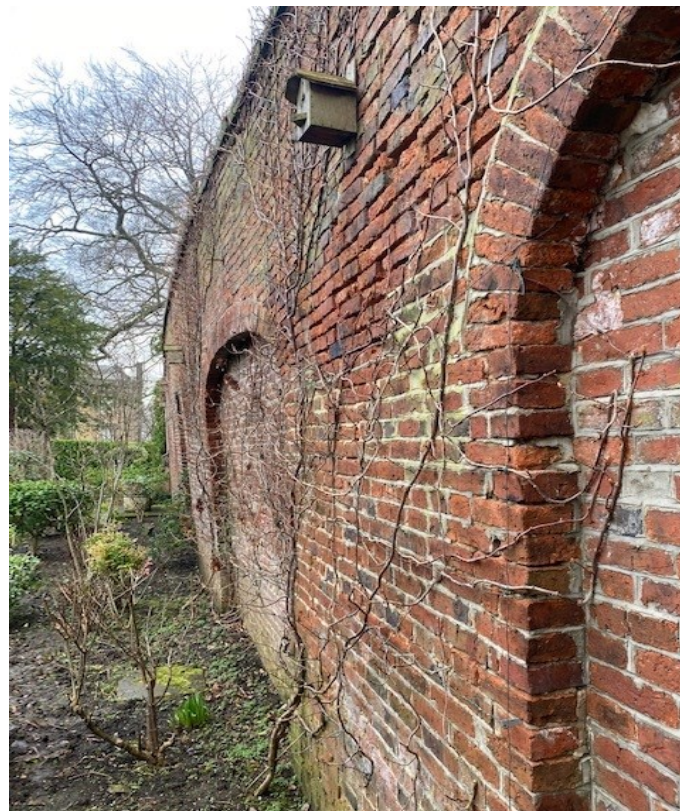
- 7.3.1 There are widespread signs of freeze / thaw damage and saturation-related decay to the brickwork. The decay was noted generally to be worse on the northern (shaded / damper) side of the wall. (Photo A1.4).
- 7.3.2 Erosion of the pointing and mortar is visible to both sides of the wall, though this was noted generally to be worse on the northern (shaded / damper) side.
- 7.3.3 There has been no visible disruption to the sandstone copings at the head of the wall.
- 7.3.4 There are no visible signs of impact or abrasion to the south face of the wall. (Photo A1.5).

Photo A1.4 : There are widespread signs of erosion to the brickwork.

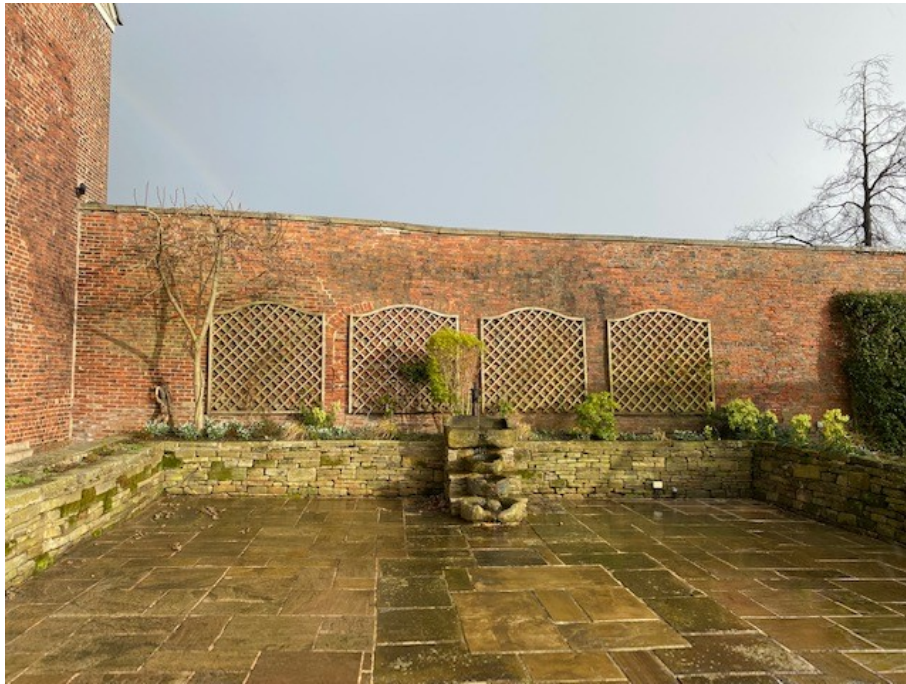
8.2.1 It would not appear that tree branch impact has played a part in causing the wall to lean, as there are no signs of localised damage or abrasion to the south face of the brickwork, or of shifting of the sandstone lintels at the head of the wall, as might be expected.

Photo A1.5 : There are no signs of physical impact or abrasion to the south face of the wall.

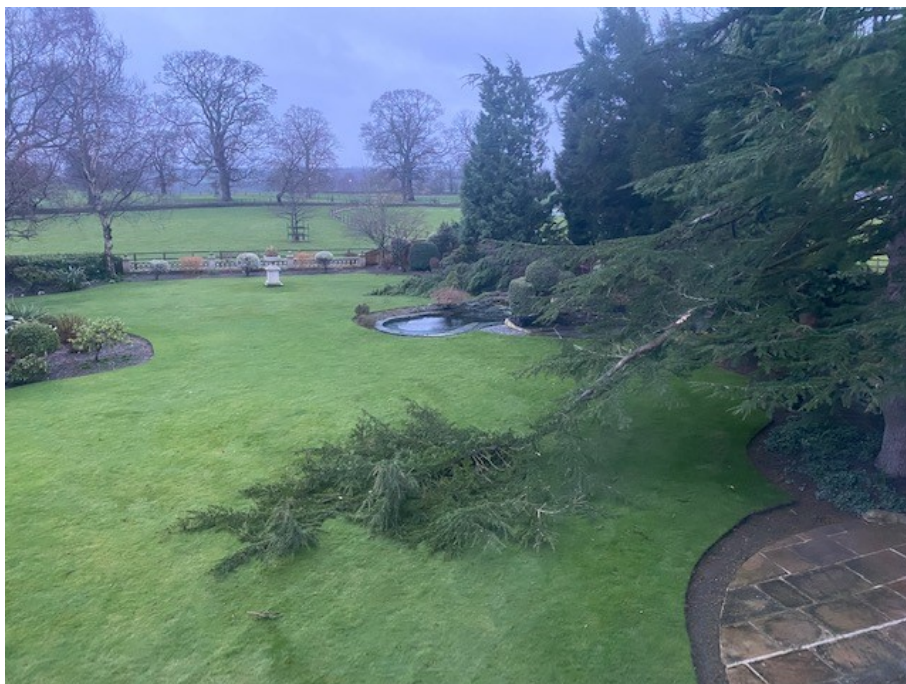
- 7.6.3 The storms caused significant damage and disruption across the UK, including damage to buildings and the loss of many trees.
- 7.6.4 This was the case in the vicinity of Bretton Lodge, where several trees were either snapped off, or were uprooted, though fortunately, none of them landed on the buildings themselves, or on the estate wall described in this report. (Photos A1.6, A1.7, A1.8).

Photo A1.6 : View across the open land to the south and west of the estate wall at Bretton Lodge, showing tree damage caused by Storms Dudley and Eunice, February 2022.

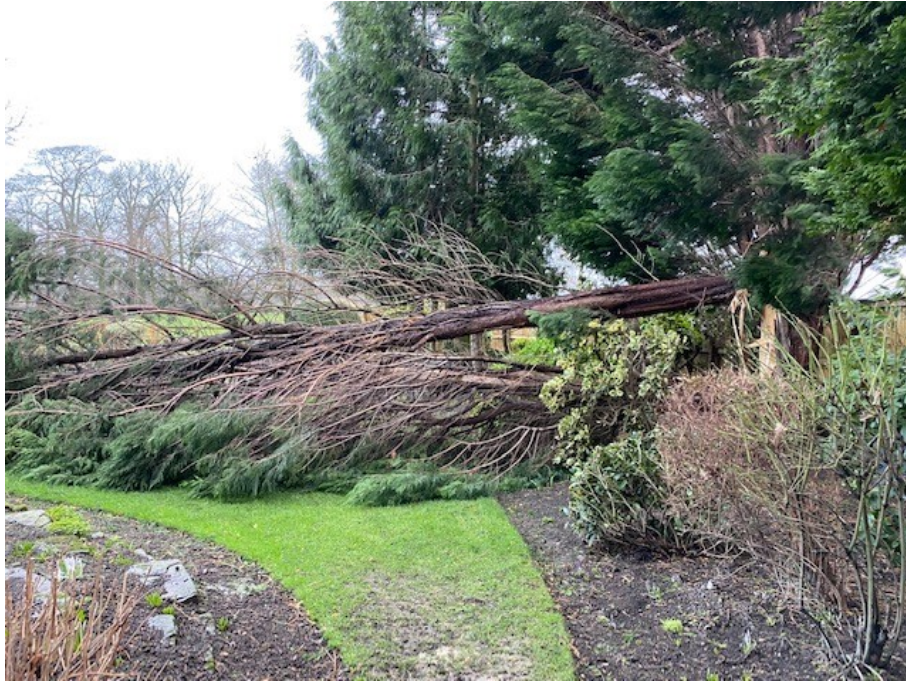
Photo A1.7 : Cypress trees felled by Storm Eunice, February 2022.

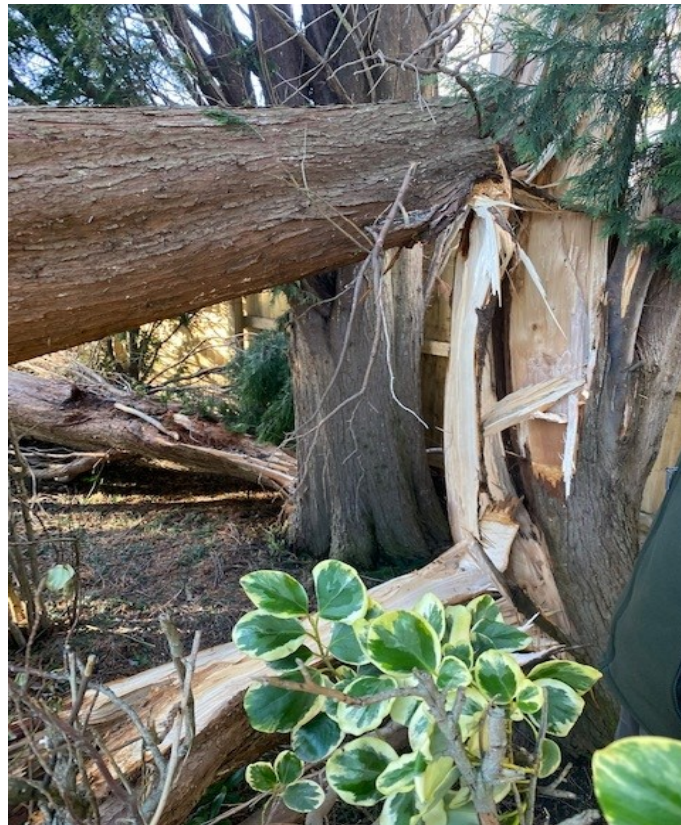
Photo A1.8 : Close-up of tree trunks at Bretton Lodge, split by Storm Eunice.
